MERIVALE AND JAMIE **AUTO GARAGE**

1871 MERIVALE ROAD OTTAWA, ONTARIO

TREE CONSERVATION REPORT

09 SEP, 2014 TCR 01

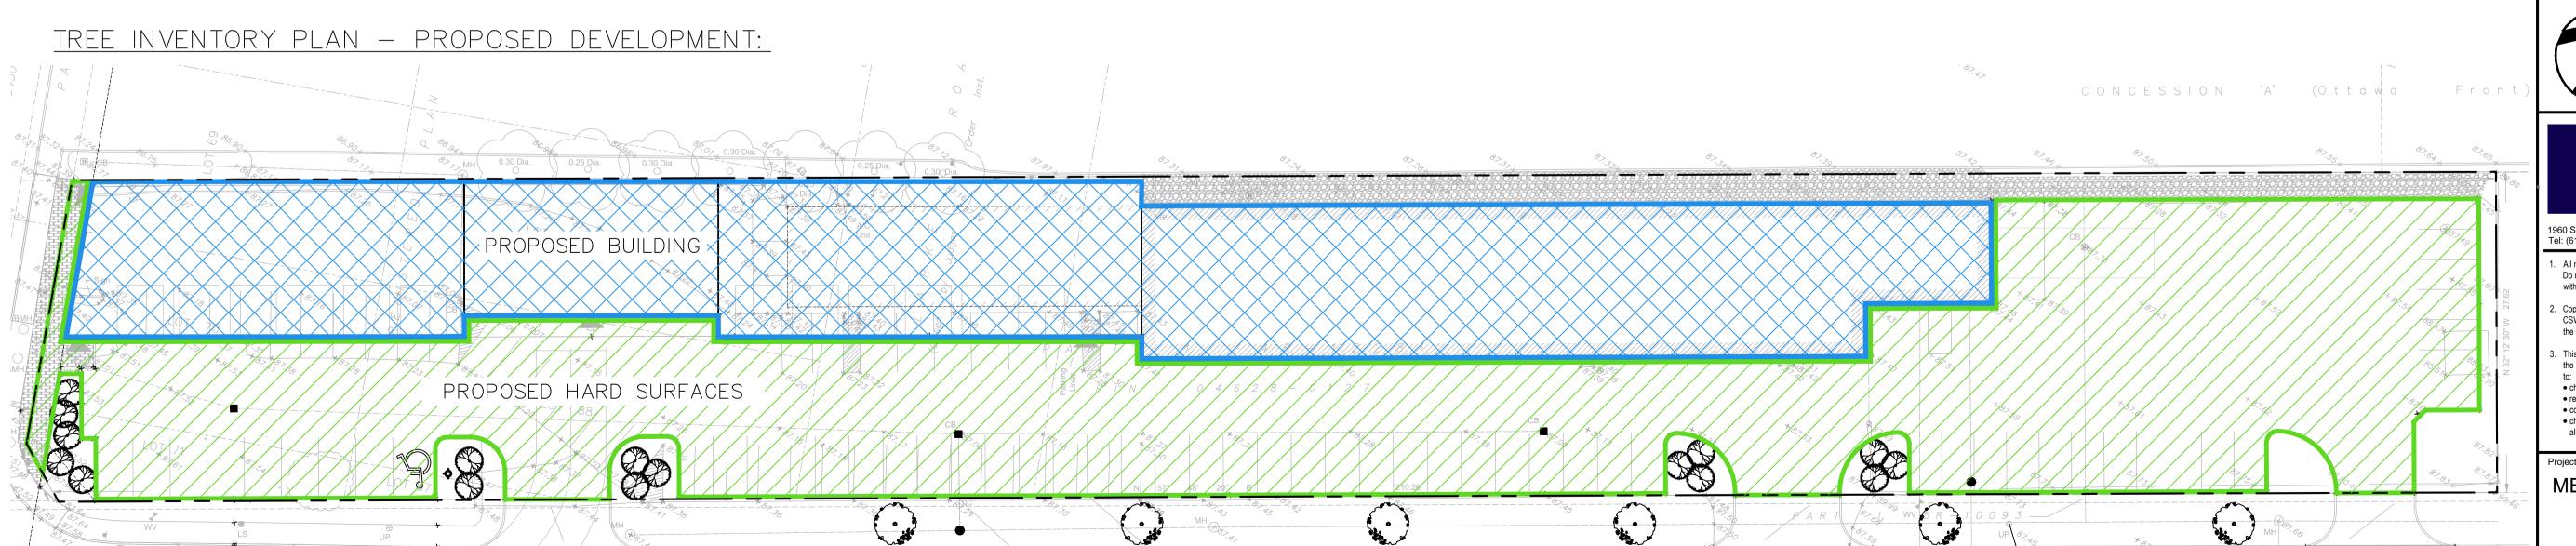
TREE INVENTORY PLAN - AERIAL PHOTOGRAPHY:

Tree No.	Botanical Name	Common Name	Caliper (cm)	Condition	High Quality Tree	High Quality Tree	Comments	To Be Preserved
1	Acer platanoides	Norway Maple	30	Dead	No	No	This tree is dead, many branches have died and fallen. This tree is a hazard.	No
2	Acer platanoides	Norway Maple	32.5	Dead	No	No	This tree is dead, many branches have died and fallen. This tree is a hazard.	No
3	Acer platanoides	Norway Maple	33	Poor	No	No	Central leader of tree is dead, there is approximately 40% die back in the canopy.	No
4	Acer platanoides	Norway Maple	32	Poor	No	No	Central leader of tree is dead, there is approximately 40% die back in the canopy.	No
5	Acer platanoides	Norway Maple	31	Moderate	No	No	Tree is in moderate condition.	No
6	Acer platanoides	Norway Maple	30	Moderate	No	No	Tree is showing approximately 20% die back in the canopy.	No
7	Acer platanoides	Norway Maple	31	Moderate	No	No	Tree is showing approximately 10% die back in the canopy, and some rot appearing at branch unions.	No

THERE IS A ROW OF SEVEN TREES ALONG THE NORTHERN PROPERTY LINE THAT WILL BE REMOVED TO ACCOMODATE THE PROPOSED BUILDING. A PORTION OF THE SOFT LANDSCAPE IS REQUIRED TO BE REMOVED. THIS IS NECESSITATED BY THE NATURE AND SCALE OF THE PROPOSED USE. THIS WILL HAVE IMPACT ON THE DRAINAGE OF THE SITE, PLEASE REFER TO THE CIVIL LOT GRADING AND DRAINAGE PLAN.

REMOVAL OF SEVEN TREES APPROVED BY ADJACENT LANDOWNER LORENZO NICOLINI, NICOLINI CONSTRUCTION; AS PER EMAIL DATED JUNE 02, 2015.
