May 26, 2018

RE: TREE CONSERVATION REPORT – 2140 BASELINE ROAD, OTTAWA

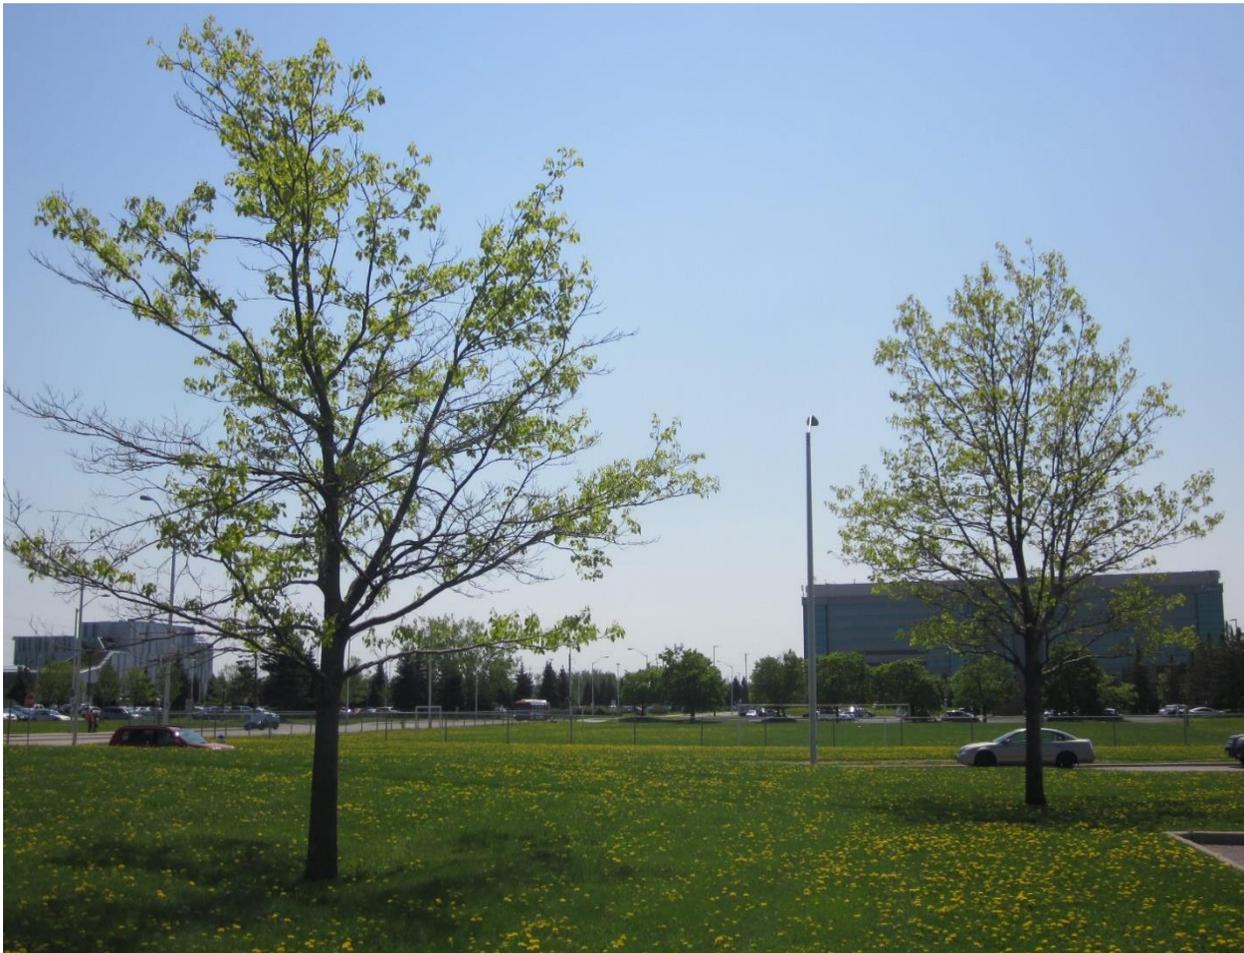
Picture 1. Trees #2 (right) and 3 at 2140 Baseline Road.

Tree No.	Tree Species	Condition (VP→E)	DBH ¹ (cm)	Tree Condition Notes, age class & Preservation Status (to be removed or preserved and protected)
1	Jack pine (<i>Pinus banksiana</i>)	Fair	9	Stunted form; maturing; native species; to be preserved and protected
2	Red oak (<i>Quercus rubra</i>)	Good	24	Broad crown; internal deadwood only; maturing; native species; to be removed
3	Red oak	Fair	23	Moderate amount of dead, declining branches on north side of crown; maturing; native species; to be preserved and protected
4	Scots pine (<i>Pinus sylvestris</i>)	Fair	17	Co-dominant stems at 2m; maturing; introduced species; to be preserved and protected
5	Ash (<i>Fraxinus</i> spp.)	Very poor	-	In advanced decline due to Emerald ash borer (<i>Agrilus planipennis</i>) – coppicing from base; native species; to be removed
6	Ash	Very poor	-	In advanced decline due to EAB – coppicing from base; native species; to be removed

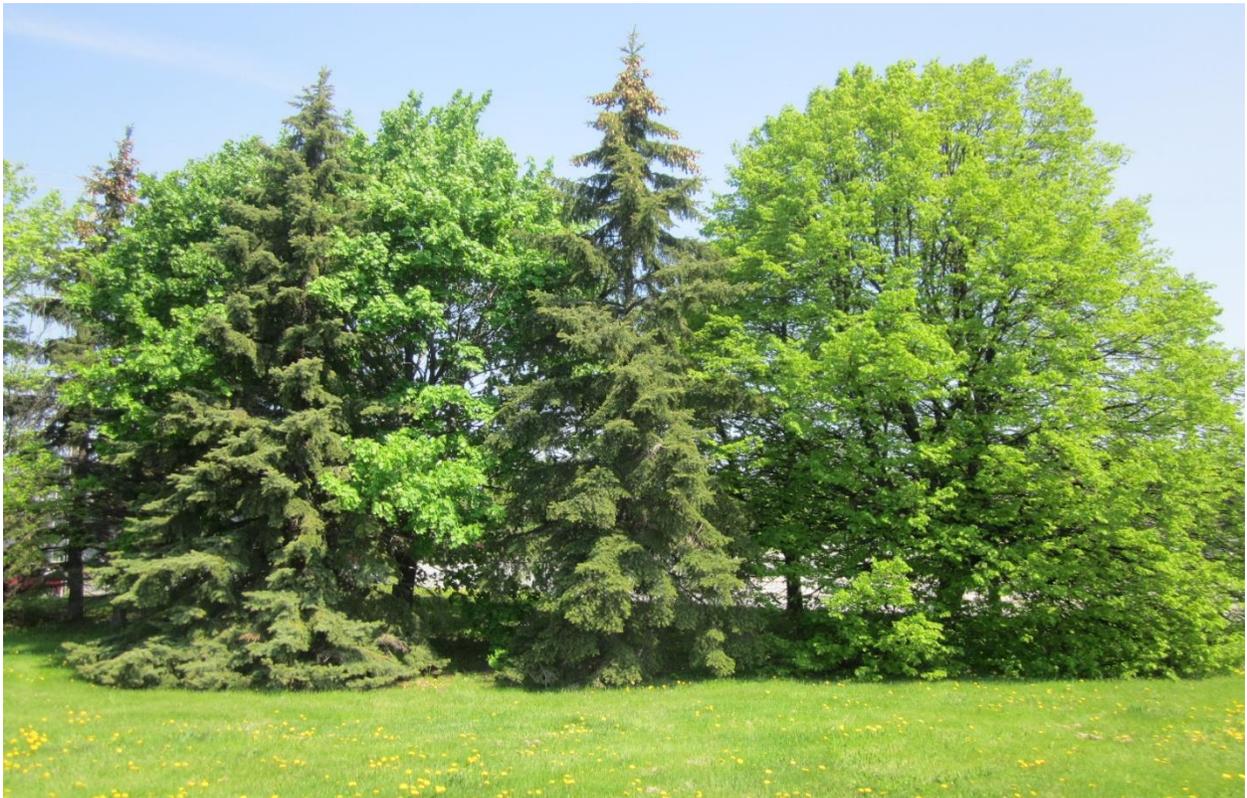
Picture 3. Trees #12, 13, 14 and 17 (left to right) at 2140 Baseline Road.

12	Norway maple	Fair	40	Central stem with competing laterals at 2m – broad crown; primary union weak (included bark); introduced species; to be removed
13	Colorado spruce	Fair	26	Good density, increment and colour in outside of crown, inside dead due to shading by tree #12; introduced species; to be removed
14	Colorado spruce	Fair	26	Good density, increment and colour in outside of crown, inside dead due to shading by trees #12 and 17; introduced species; to be removed
15	Little-leaf linden (<i>Tilia cordata</i>)	Fair	31	Growth slowed by shade from adjacent trees (esp. #16); central stem with completing lateral at 2m; introduced species; to be removed
16	Little-leaf linden	Good	44	Central stem with multiple competing laterals at 2m – very broad crown; introduced species; to be removed
17	Ash	Very poor	-	In advanced decline due to EAB – coppicing from base; native species; to be removed

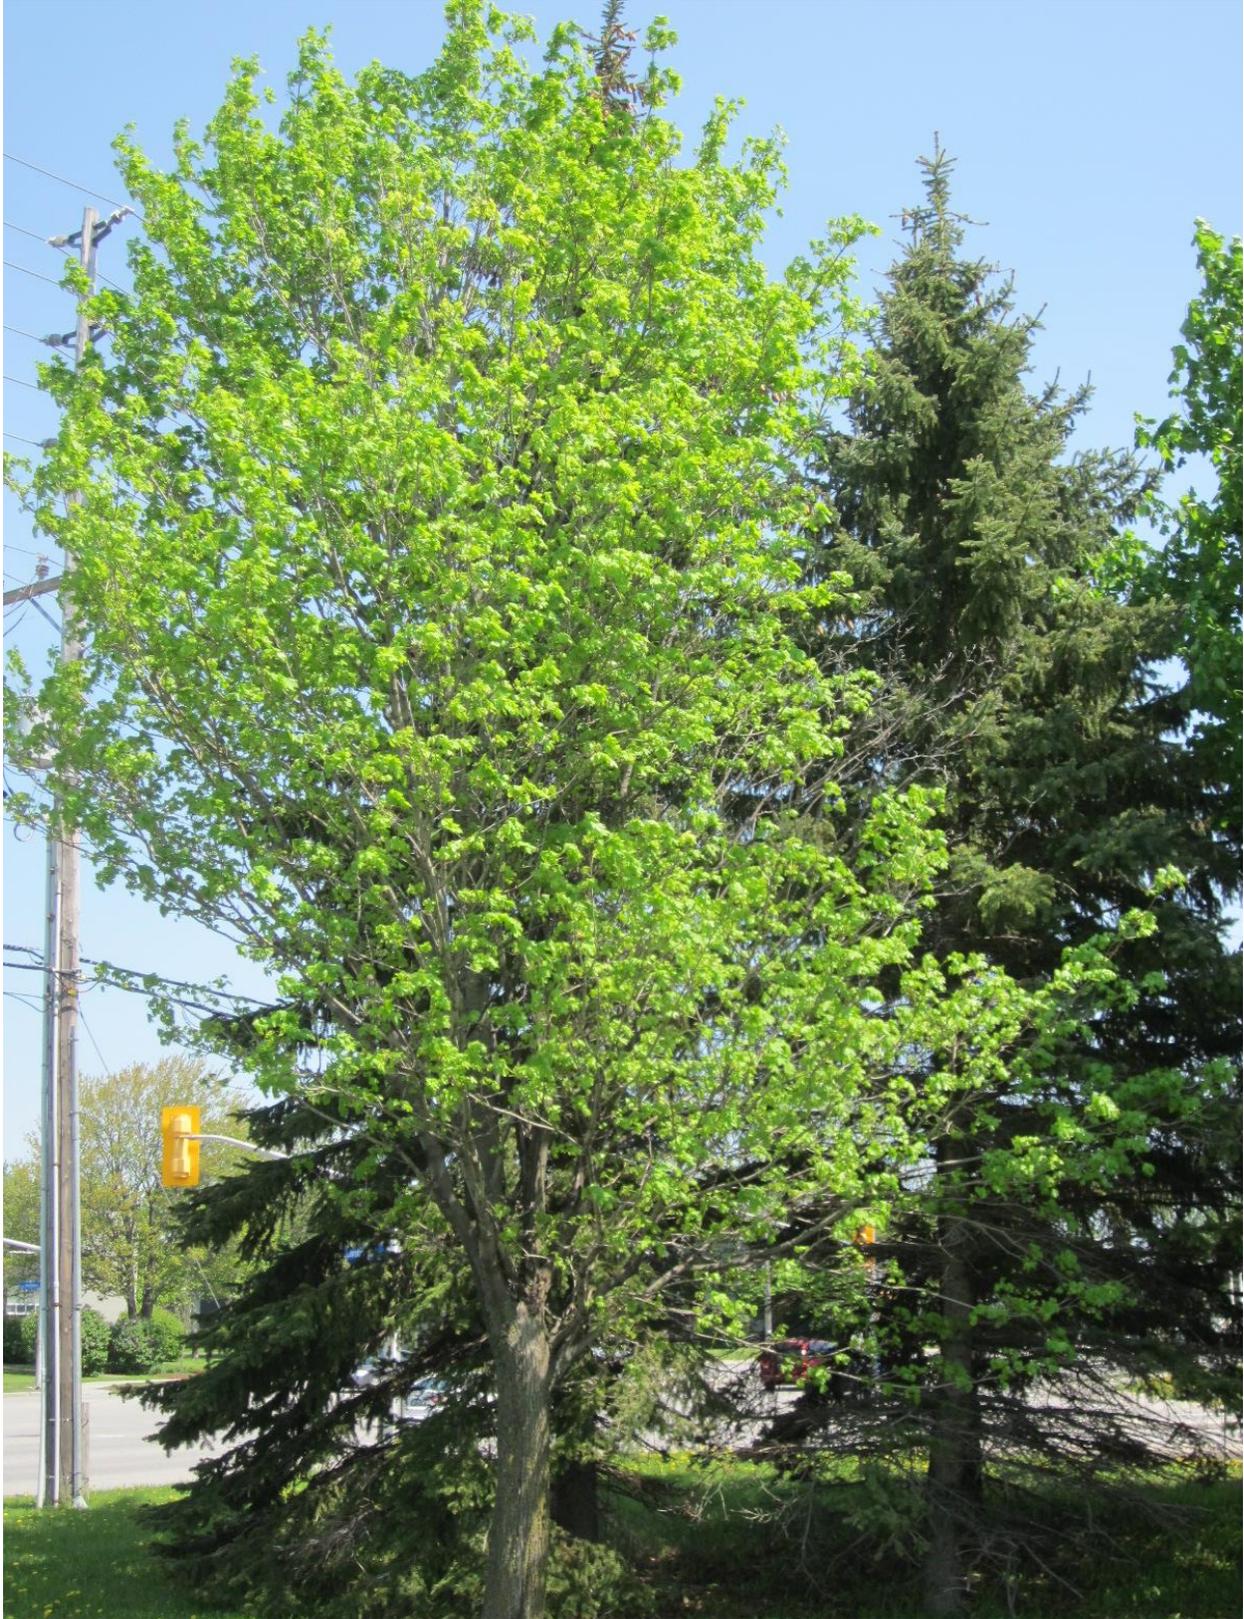
Picture 4. Trees # and 11 at 2140 Baseline Road.

7	Norway maple (<i>Acer platanoides</i>)	Poor	31	Eutypella canker (<i>Eutypella parasitica</i>) has killed main stem at 2m – lateral stem now dominant; introduced species; to be removed
8	Colorado spruce (<i>Picea pungens</i>)	Good	28	Good crown density, growth increment and needle colour; inside, lower crown dead due to inter-competition for sunlight between spruce trees; introduced species; to be removed
9	Colorado spruce	Good	23	Good density, increment and colour; inside, lower crown dead due to inter-competition for sunlight; introduced species; to be removed
10	Colorado spruce	Good	35	Good density, increment and colour; inside, lower crown dead due to inter-competition for sunlight; introduced species; to be removed
11	Colorado spruce	Fair	22	Good density, increment and colour in upper crown; lower crown dead due to shading by tree #7 and inter-competition for sunlight; introduced species; to be removed
