TREE CONSERVATION REPORT – 2390 STEVENAGE DRIVE, OTTAWA

September 11, 2018

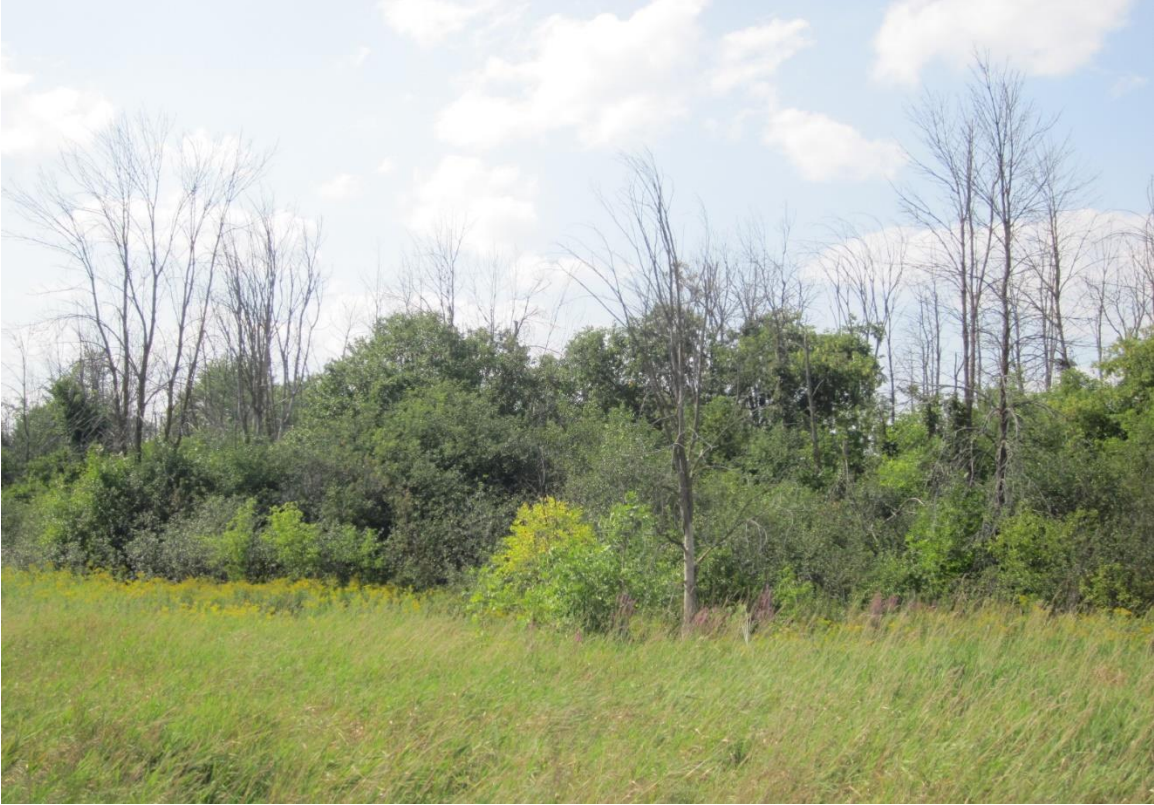
As shown above in Table 1, the most frequent native tree species present which are over 10cm in diameter are scattered individual and groupings of red maple, ash species and white elm. Also present are native bur oak. However, many, if not most, of the elm and ash over 10cm are dead due to Dutch elm disease (*Ophiostoma ulmi* and *Ophiostoma novo-ulmi*) and Emerald ash borer (*Agrilus planipennis*), respectively. All of the aforementioned species are well adapted to disturbance and so often respond quickly in terms of recolonizing former agricultural fields through seed dispersal from adjacent trees. The nearby hedgerow would have likely been the source of most of the four native species dominating the overstory.

Picture 1. Cultural meadow in foreground with dead ash and elm in forested area.

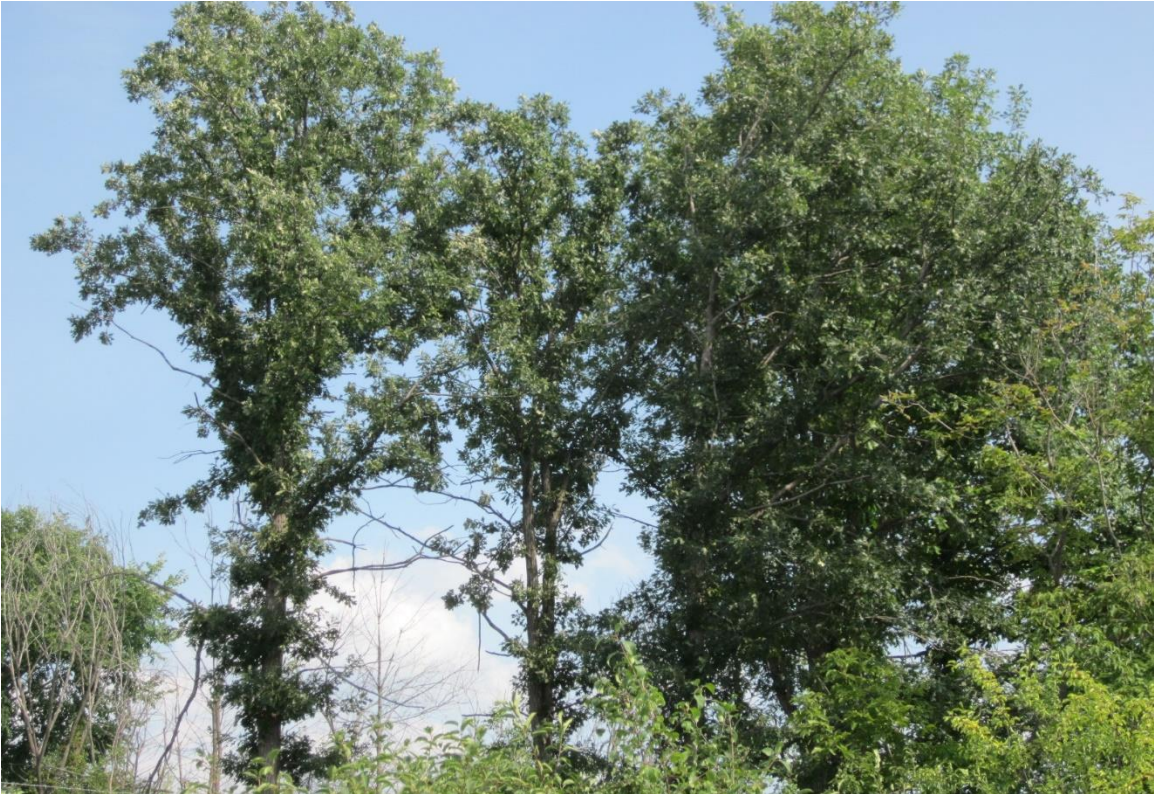
Several groups of mature, native trees are present within the forested area – two groupings of bur oak and a larger stand of bur oak/red maple. Although desirable, the placement of these groupings in the middle of the site prohibits their retention.

Picture 2. Grouping of mature bur oaks at 2390 Stevenage Drive.

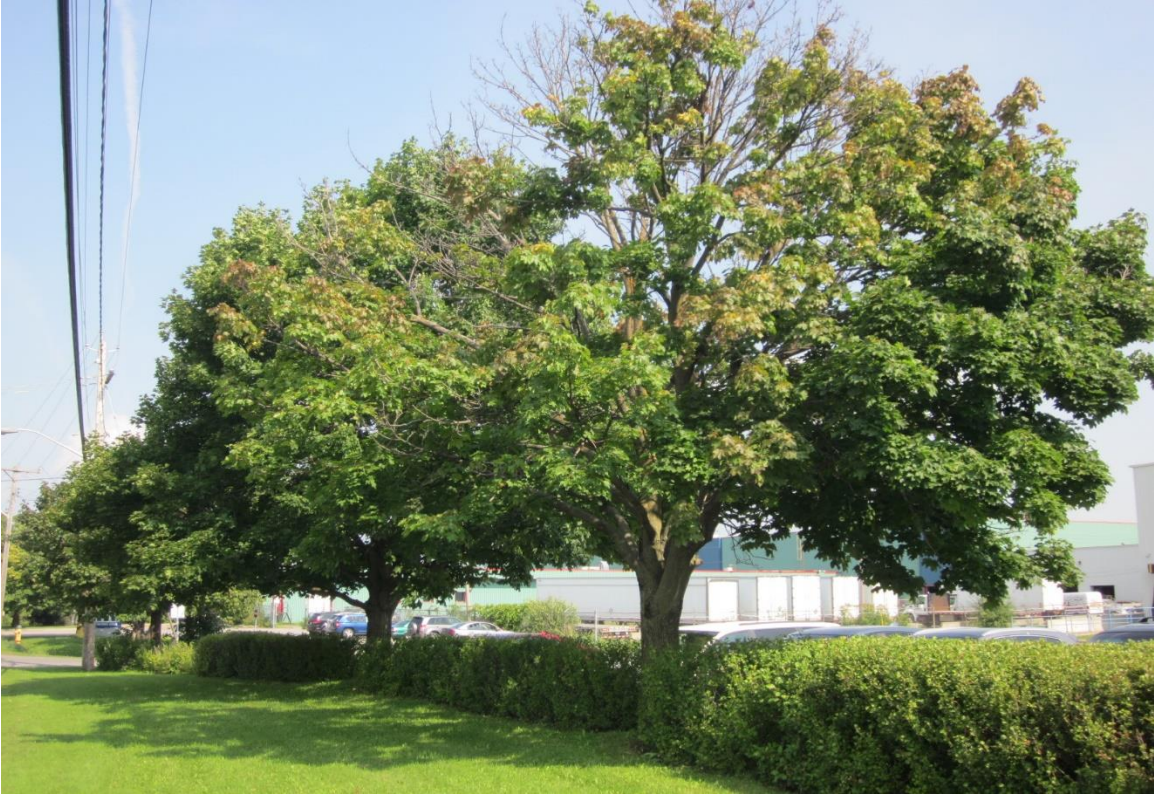
| 6 | Norway maple | 39 | Poor; mature; top half of crown in advanced decline due to branch cluster; to be removed (conflicts with construction) |
| 7 | Norway maple | 43 | Fair; mature; top half of crown in advanced decline due to branch cluster; to be preserved and protected |
| 8 | Norway maple | 25 | Fair; mature; moderately pruned by Hydro as tree is below lines; to be preserved and protected |

Picture 3. Street trees #6-8 in front of 2390 Stevenage Drive.

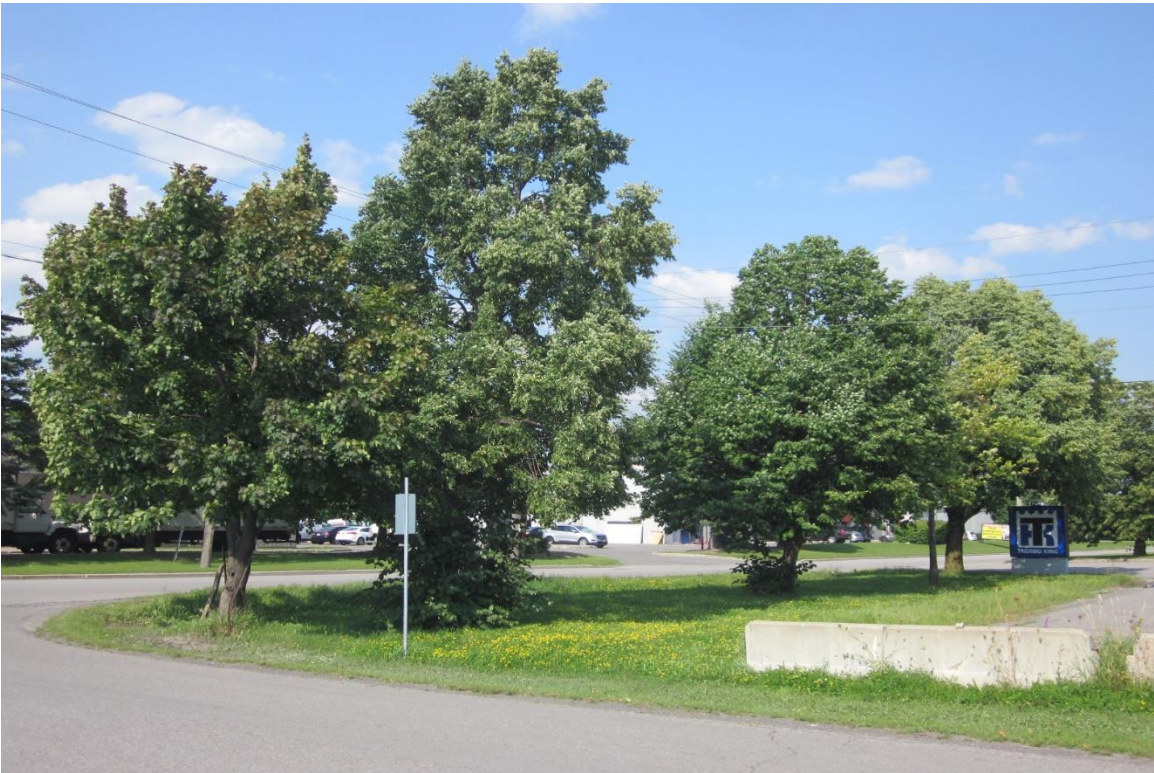
| 10 | Little-leaf linden | 35 | Fair; mature; heavy basal sprouting; to be removed (conflicts with construction) |
| 11 | Little-leaf linden | 34 | Fair; mature; heavy basal sprouting; to be removed (conflicts with construction) |
| 12 | Norway maple | 17 | Very poor; mature; advanced canker at 0.25m; in moderate decline; to be removed (conflicts with construction) |
| 13 | Little-leaf linden | 54 | Good; mature; co-dominant stems at 2.25m; dense crown; to be removed (conflicts with construction) |

Picture 4. Street trees #10-13 in front of 2390 Stevenage Drive.
