October 10, 2017

RE: TREE CONSERVATION REPORT – 1375 CLYDE AVENUE, OTTAWA

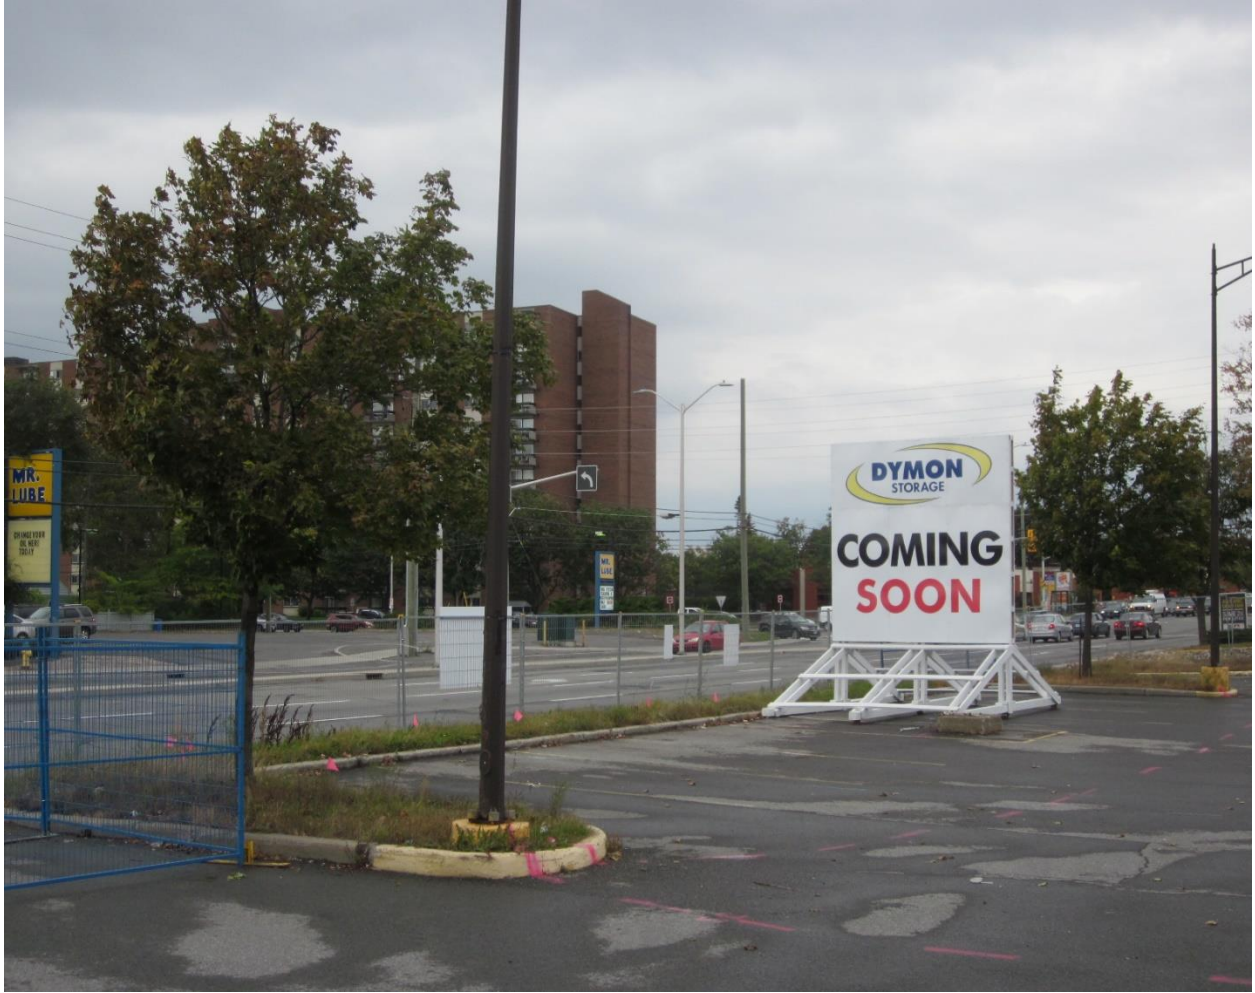
Picture 1. Norway maples #3 and 4 at 1375 Clyde Avenue.

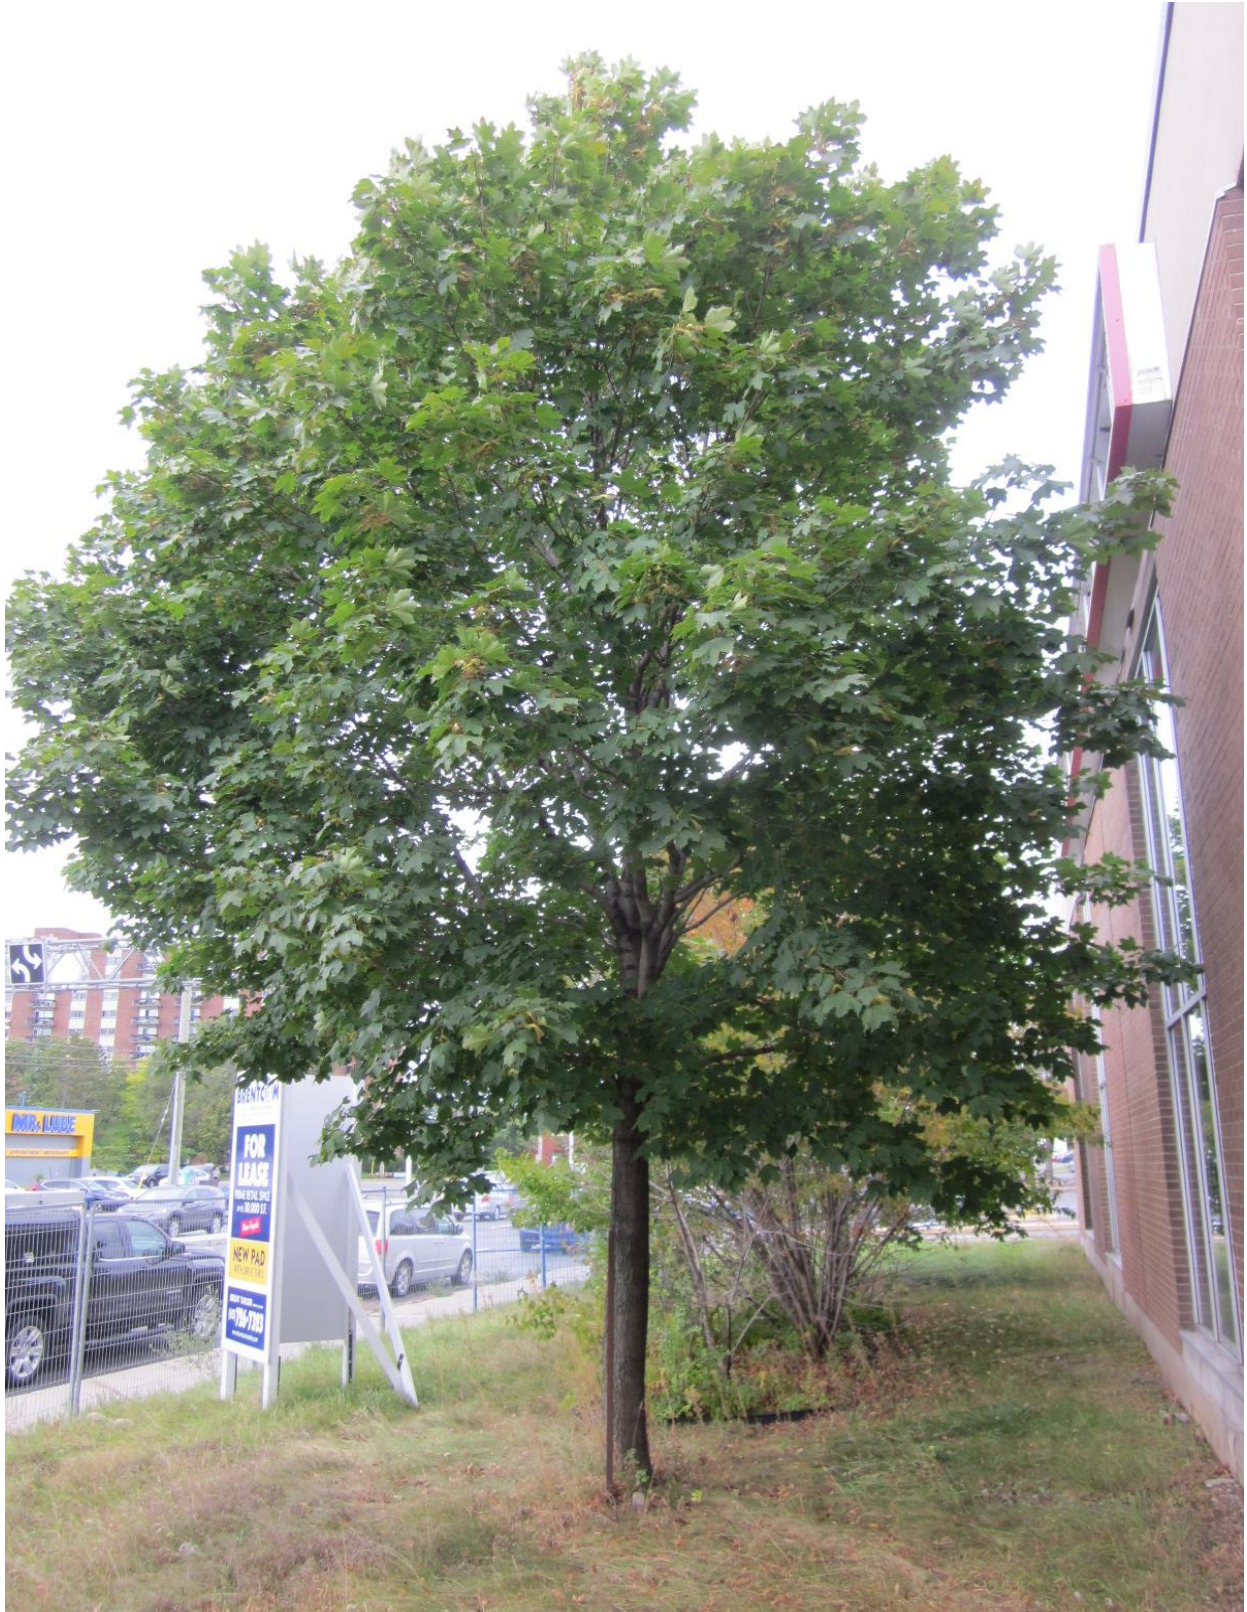
Picture 2. Norway maple #1 at 1375 Clyde Avenue.

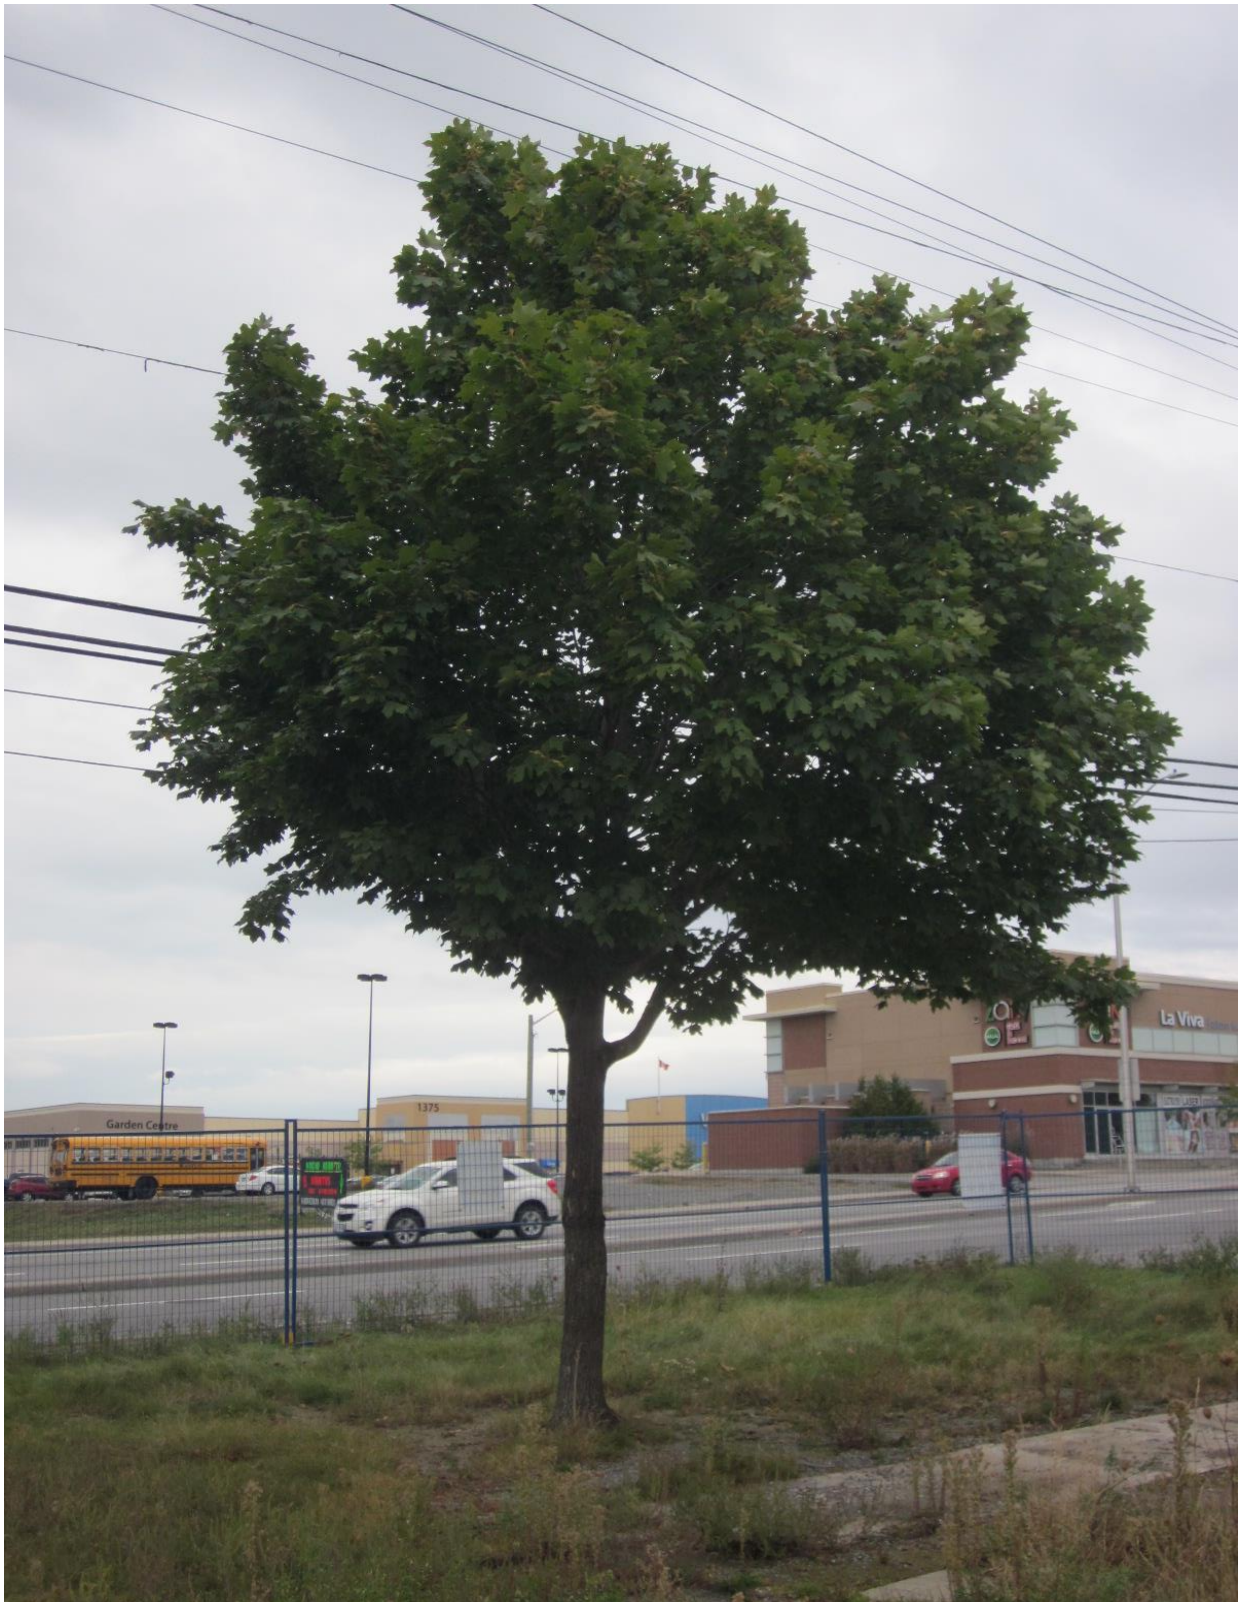
Picture 3. Norway maple #6 at 1375 Clyde Avenue.
