TREE CONSERVATION REPORT – 2390 STEVENAGE DRIVE, OTTAWA

March 4, 2019

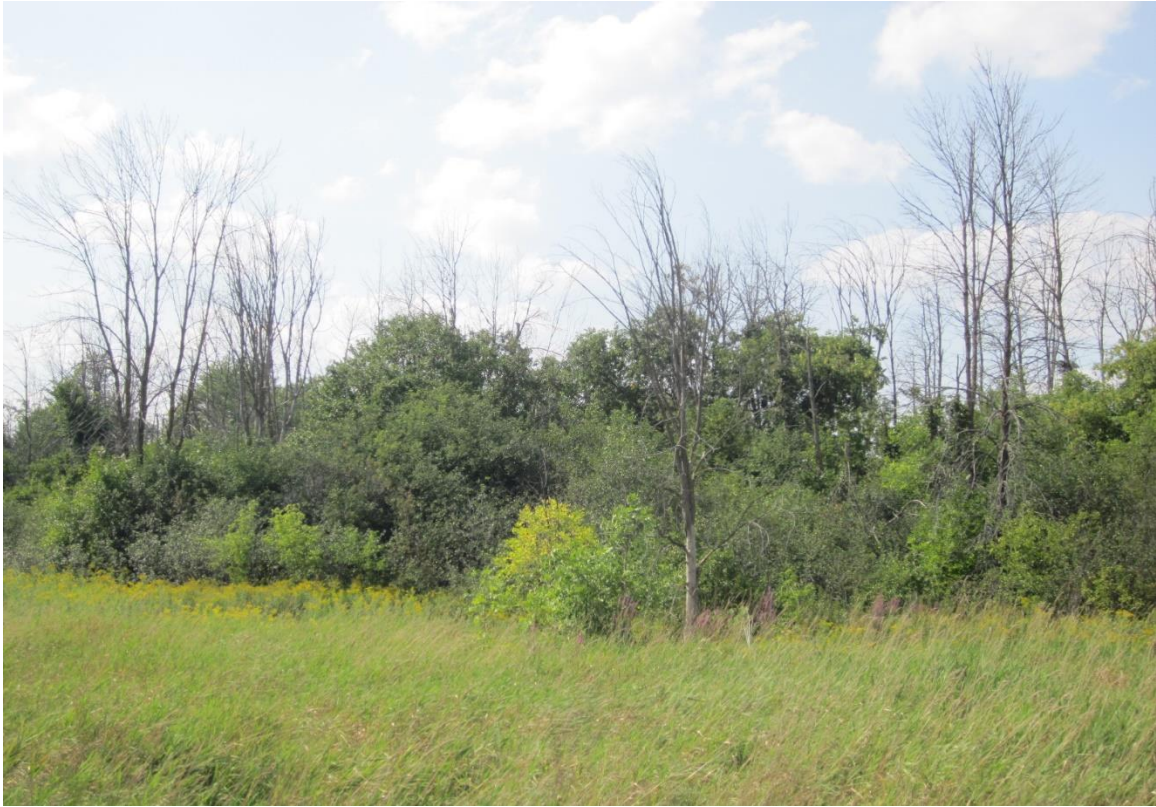
As shown above in Table 1, the most frequent native tree species present which are over 10cm in diameter are scattered individual and groupings of red maple, ash species and white elm. Also present are native bur oak. However, many, if not most, of the elm and ash over 10cm are dead due to Dutch elm disease (*Ophiostoma ulmi* and *Ophiostoma novo-ulmi*) and Emerald ash borer (*Agrilus planipennis*), respectively. All of the aforementioned species are well adapted to disturbance and so often respond quickly in terms of recolonizing former agricultural fields through seed dispersal from adjacent trees. The nearby hedgerow would have likely been the source of most of the four native species dominating the overstory.

Picture 1. Cultural meadow in foreground with dead ash and elm in forested area.

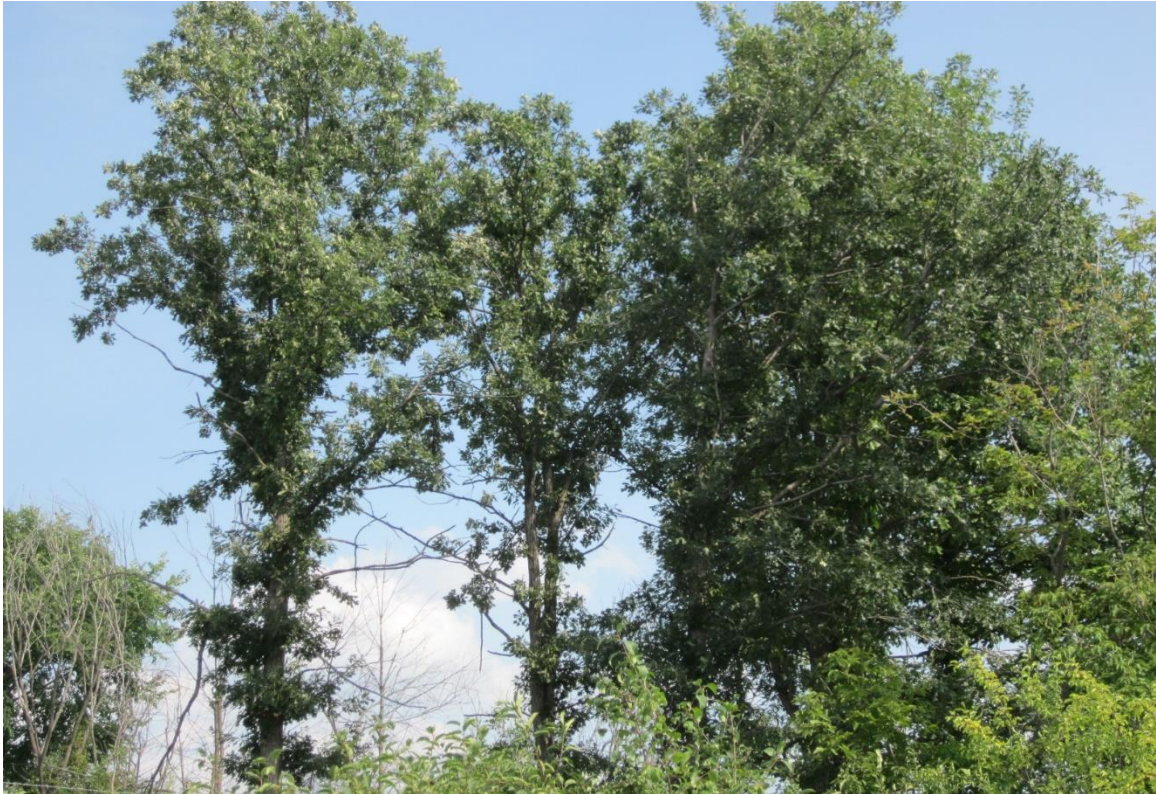
Several groups of mature, native trees are present within the forested area – two groupings of bur oak and a larger stand of bur oak/red maple. Although desirable, the placement of these groupings in the middle of the site prohibits their retention.

Picture 2. Grouping of mature bur oaks at 2390 Stevenage Drive.

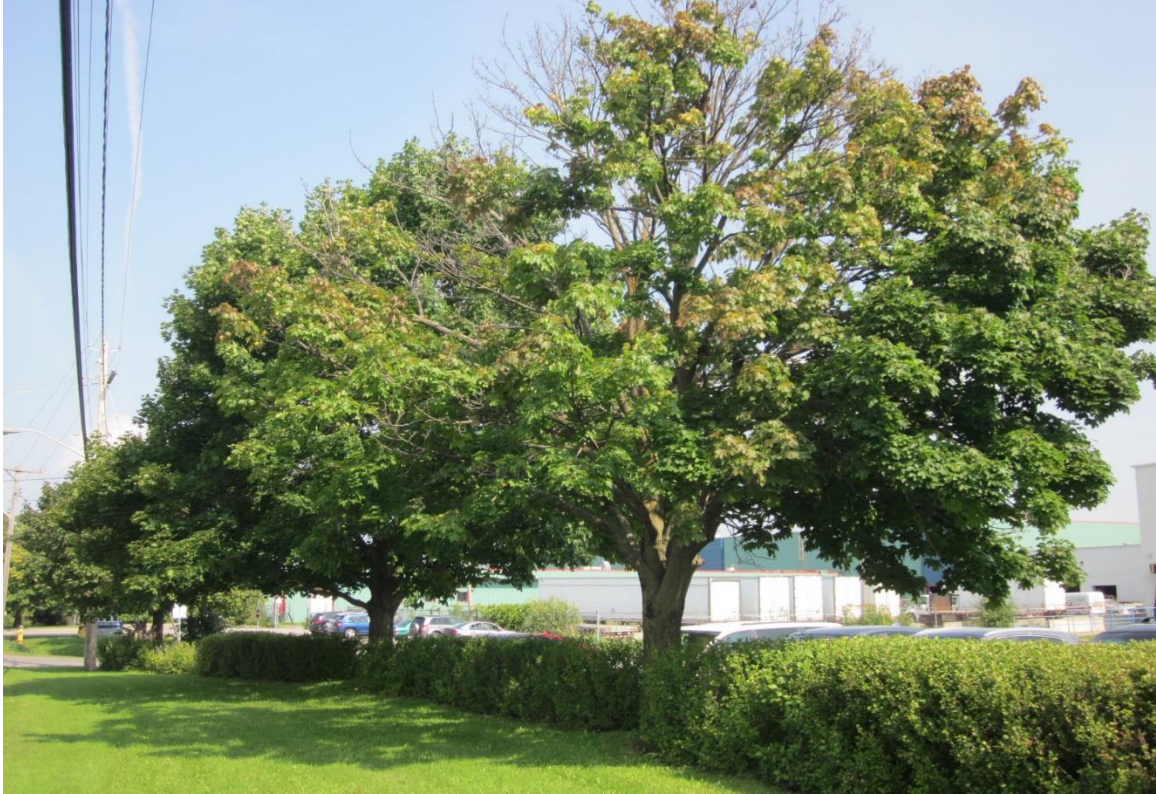
3	Norway maple	38	Very poor; mature; top half of crown dead due to branch cluster; primary union with split - failing; to be removed (due to condition)
4	Norway maple	46	Fair; mature; to be preserved and protected
5	Norway maple	35	Poor; mature; top half of crown in advanced decline due to branch cluster; to be preserved and protected
6	Norway maple	39	Poor; mature; top half of crown in advanced decline due to branch cluster; to be removed (conflicts with construction)
7	Norway maple	43	Fair; mature; top half of crown in advanced decline due to branch cluster; to be preserved and protected
8	Norway maple	25	Fair; mature; moderately pruned by Hydro as tree is below lines; to be preserved and protected
9	Norway maple	22 avg.	Fair; mature; double stemmed at 0.5m; to be preserved and protected
10	Little-leaf linden	35	Fair; mature; heavy basal sprouting; to be removed (conflicts with construction)
11	Little-leaf linden	34	Fair; mature; heavy basal sprouting; to be removed (conflicts with construction)

Picture 3. Street trees #6-8 in front of 2390 Stevenage Drive.

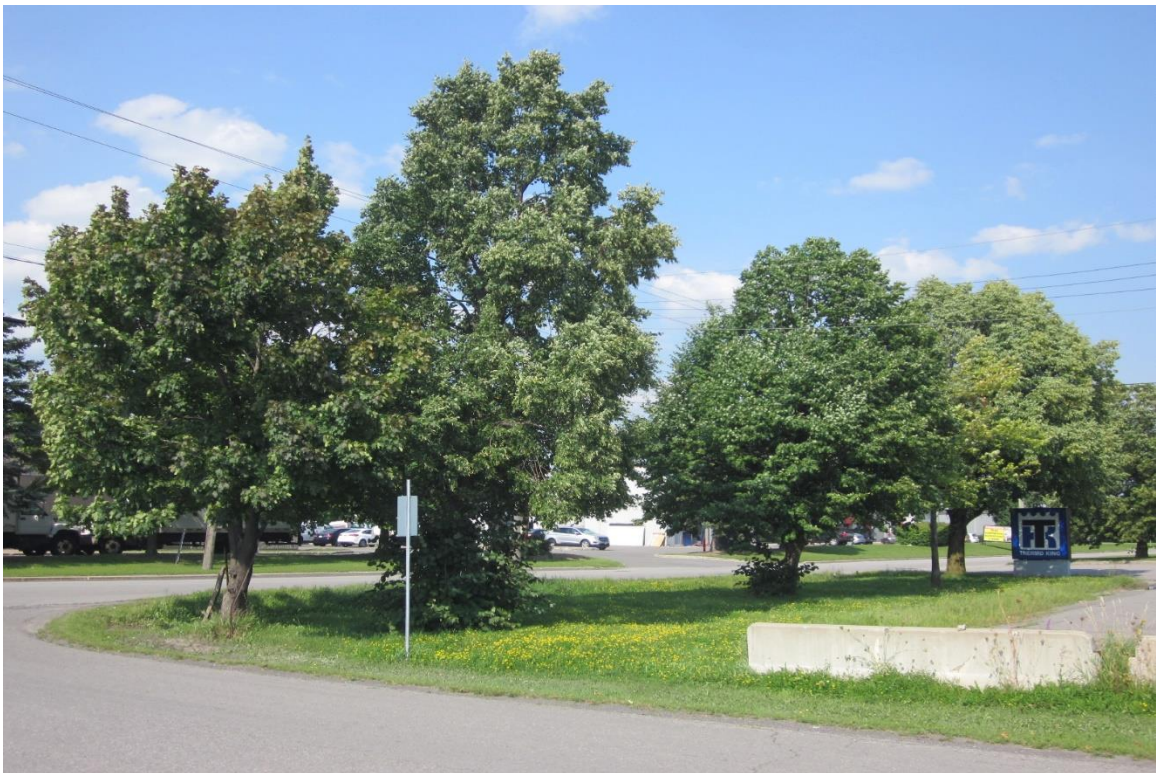
12	Norway maple	17	Very poor; mature; advanced canker at 0.25m; in moderate decline; to be removed (conflicts with construction)
13	Little-leaf linden	54	Good; mature; co-dominant stems at 2.25m; dense crown; to be removed (conflicts with construction)

Picture 4. Street trees #10-13 in front of 2390 Stevenage Drive.
