Project:  
**KHM HAZELDEAN ROAD**

5986-5992 Hazeldean Road  
OTTAWA, ONTARIO

Drawing:  
**TREE CONSERVATION REPORT**

Project Number: 2031-01 Sheet Number: TCR 01

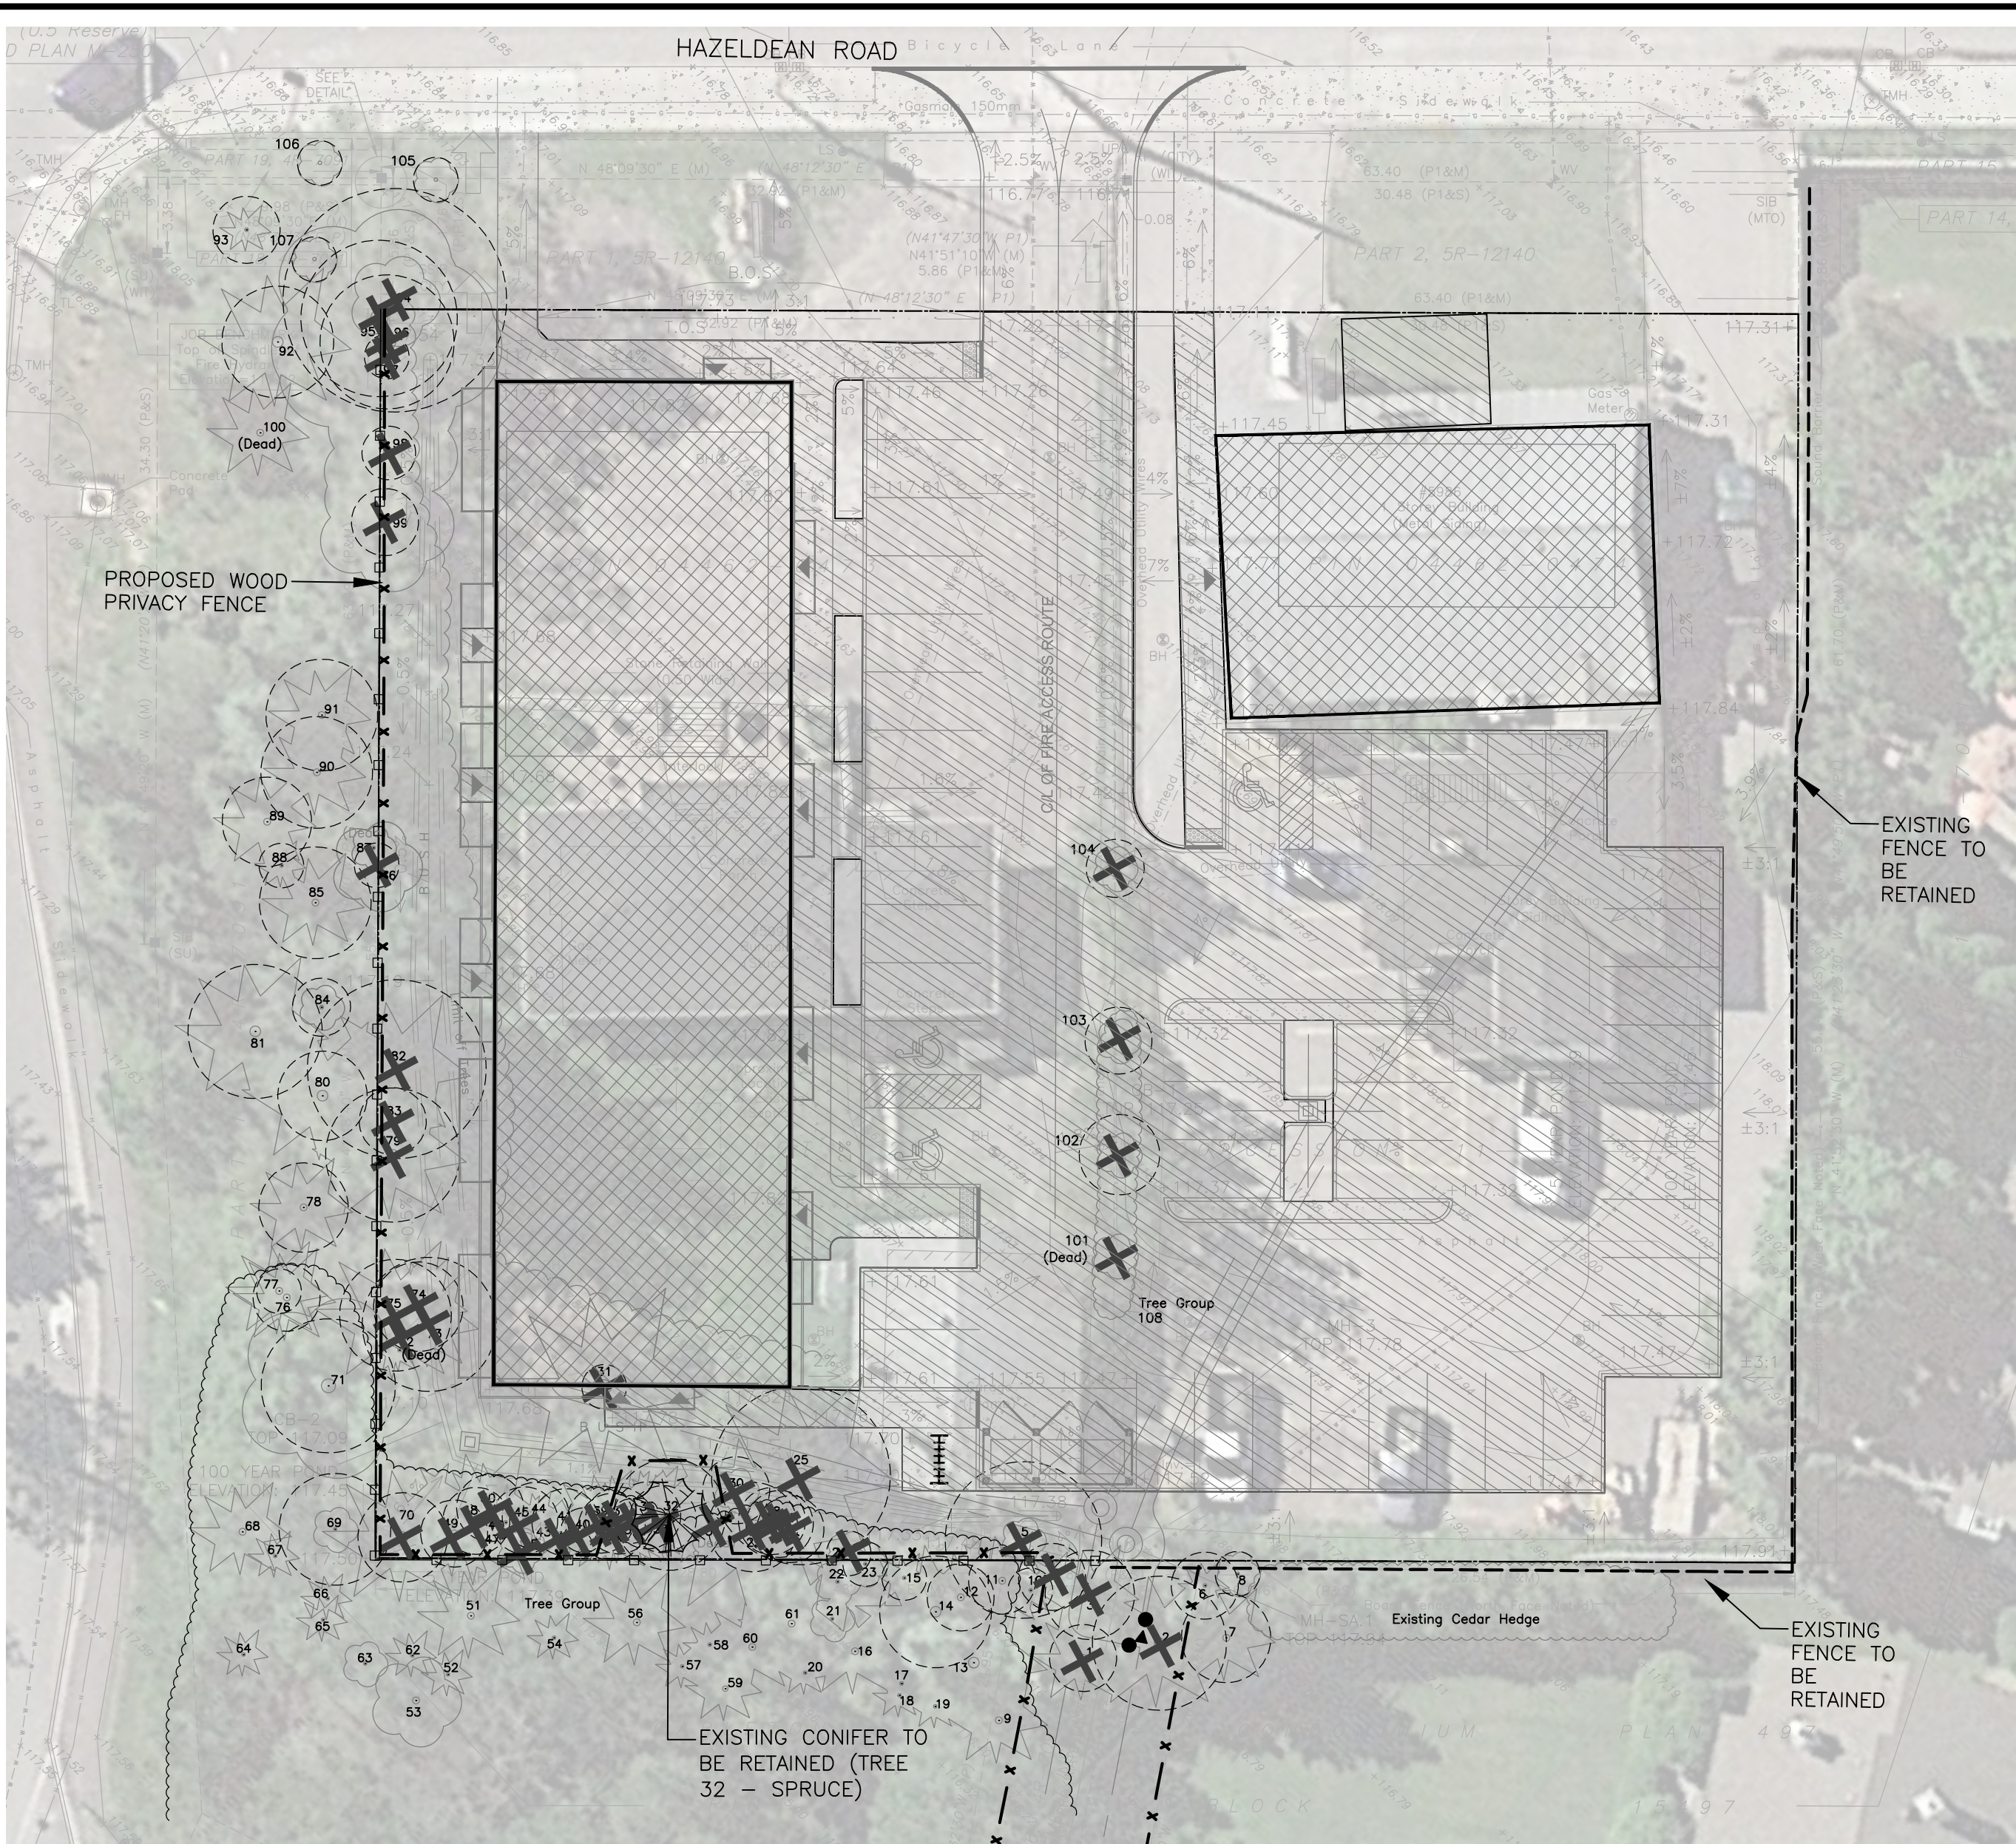
2 PROPOSED DEVELOPMENT AND CONSERVED VEGETATION

THE PROPOSED DEVELOPMENT REQUIRES THE REMOVAL OF APPROX. 49 EXISTING TREES TO FACILITATE CONSTRUCTION ACCESS AND PROPOSED FENCING. THE TREES TO BE REMOVED ARE PRIMARILY ELM (IN POOR CONDITION), CEDAR AND SOME MATURE CONIFERS. TREE NOS 1-4 (WITHIN EASEMENT) ARE REQUIRED TO BE REMOVED FOR PROPOSED UTILITY CONNECTIONS.
