Urban Forestry & Forest Management Consulting

August 27, 2019

### Re: Tree Conservation Report for 1009 Thomas Spratt Place, Ottawa

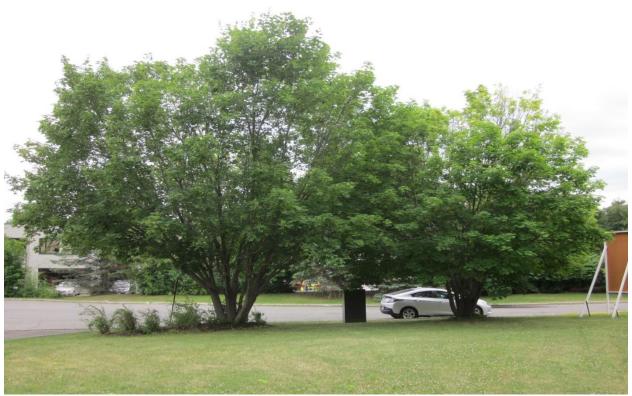
Tree	Tree Species	DBH <sup>1</sup>	Ownership	Condition, Age Class, Tree Condition
No.	area apeares	(cm)	o wasamp	Notes & <b>Status</b> (to be removed or
1,0,		(4111)		retained)
1	Norway maple	17 avg.	Private	Fair; mature; seven stems from grade –
	(Acer platanoides)	_		broad crown; introduced, invasive
				species; to be removed (due to access
				requirements)
2	Norway maple	15 avg,	Private	Fair; mature; nine stems from grade –
				broad crown; introduced, invasive
				species; to be removed (due to access
				requirements)
3	Austrian pine	Pine:	Private	Pine: seven trees in total - good;
	(Pinus nigra)/	38 avg.	(possibly	mature; fair crown density, growth
	Amur maple	Maple:	shared)	increment and needle colour;
	(Acer tataricum	10 avg.		introduced species; to be retained
	var. ginnala)			Maple: five trees in total – fair; all
				multi-stemmed from grade; heavy seed
				year in 2019; <b>to be retained</b>

Picture 1. Trees #1 and 2, mature Norway maples located at 1009 Thomas Spratt Place.

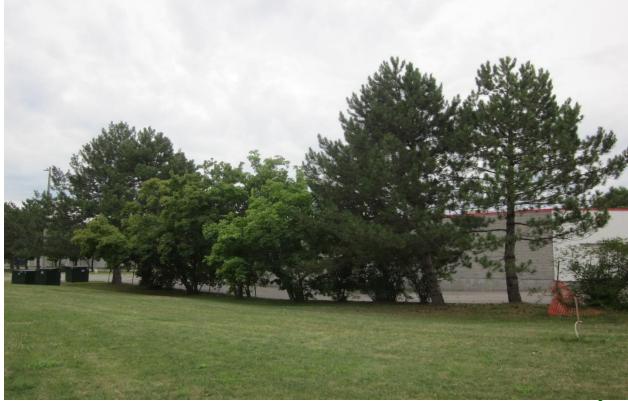
Picture 2. Tree grouping #3 (Austrian pines and Amur maples) located at 1009 Thomas Spratt Place.

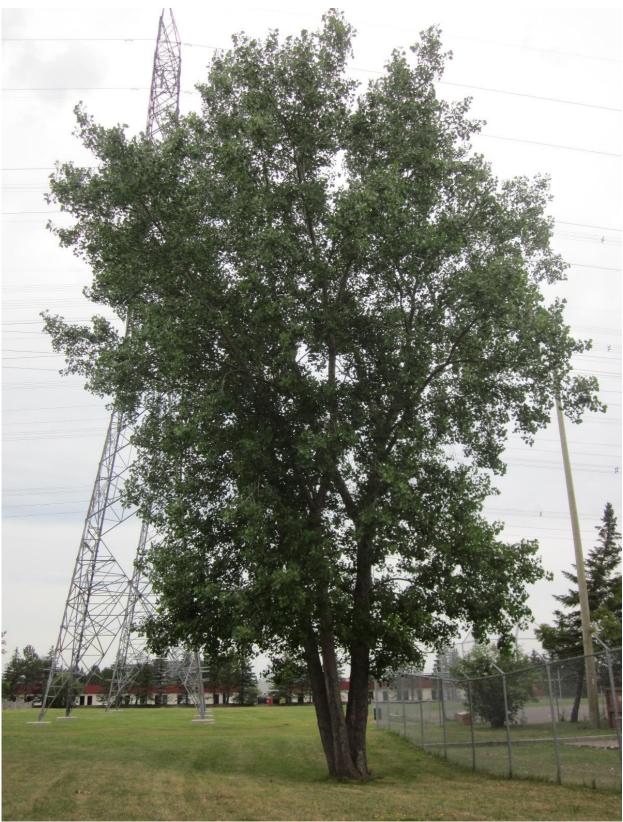
4	Eastern cottonwood	46 avg.	Private	Good; mature; tri-stemmed from grade;
	(Populus deltoides)			native species; to be removed
				(conflicts with building footprint)
5	Crab apple	27	Private	Poor; mature; tree is in advanced
	(Malus spp.)		(possibly	decline - half dead (may be the result of
			shared)	root loss from excavation for nearby
				Hydro pole); to be retained
6	Fraser fir	21	Private	Fair; mature; divergent growth form;
	(Abies fraseri)			introduced species; to be retained
7	Amur maple	12 avg.	Private	Fair; three trees in total – all mature
				and multi-stemmed from grade; heavy
				seed year in 2019; to be retained
8	White cedar	6 avg.	Private	Good; mature hedge; native species; to
	(Thuja occidentalis)			be retained

Picture 3. Tree #4, cottonwood located at 1009 Thomas Spratt Place.

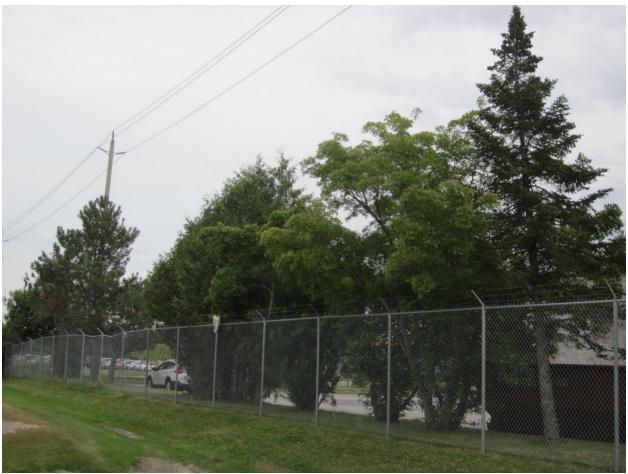
Picture 4. From right to left - tree/grouping #6 (Fraser fir), 7 (amur maples) and 8 (white cedar hedge) located at 1009 Thomas Spratt Place.
