**KHM HAZELDEAN ROAD**

5986-5992 Hazeldean Road  
OTTAWA, ONTARIO

**TREE CONSERVATION REPORT**

Project Number: 2031-01 Sheet Number: TCR 01

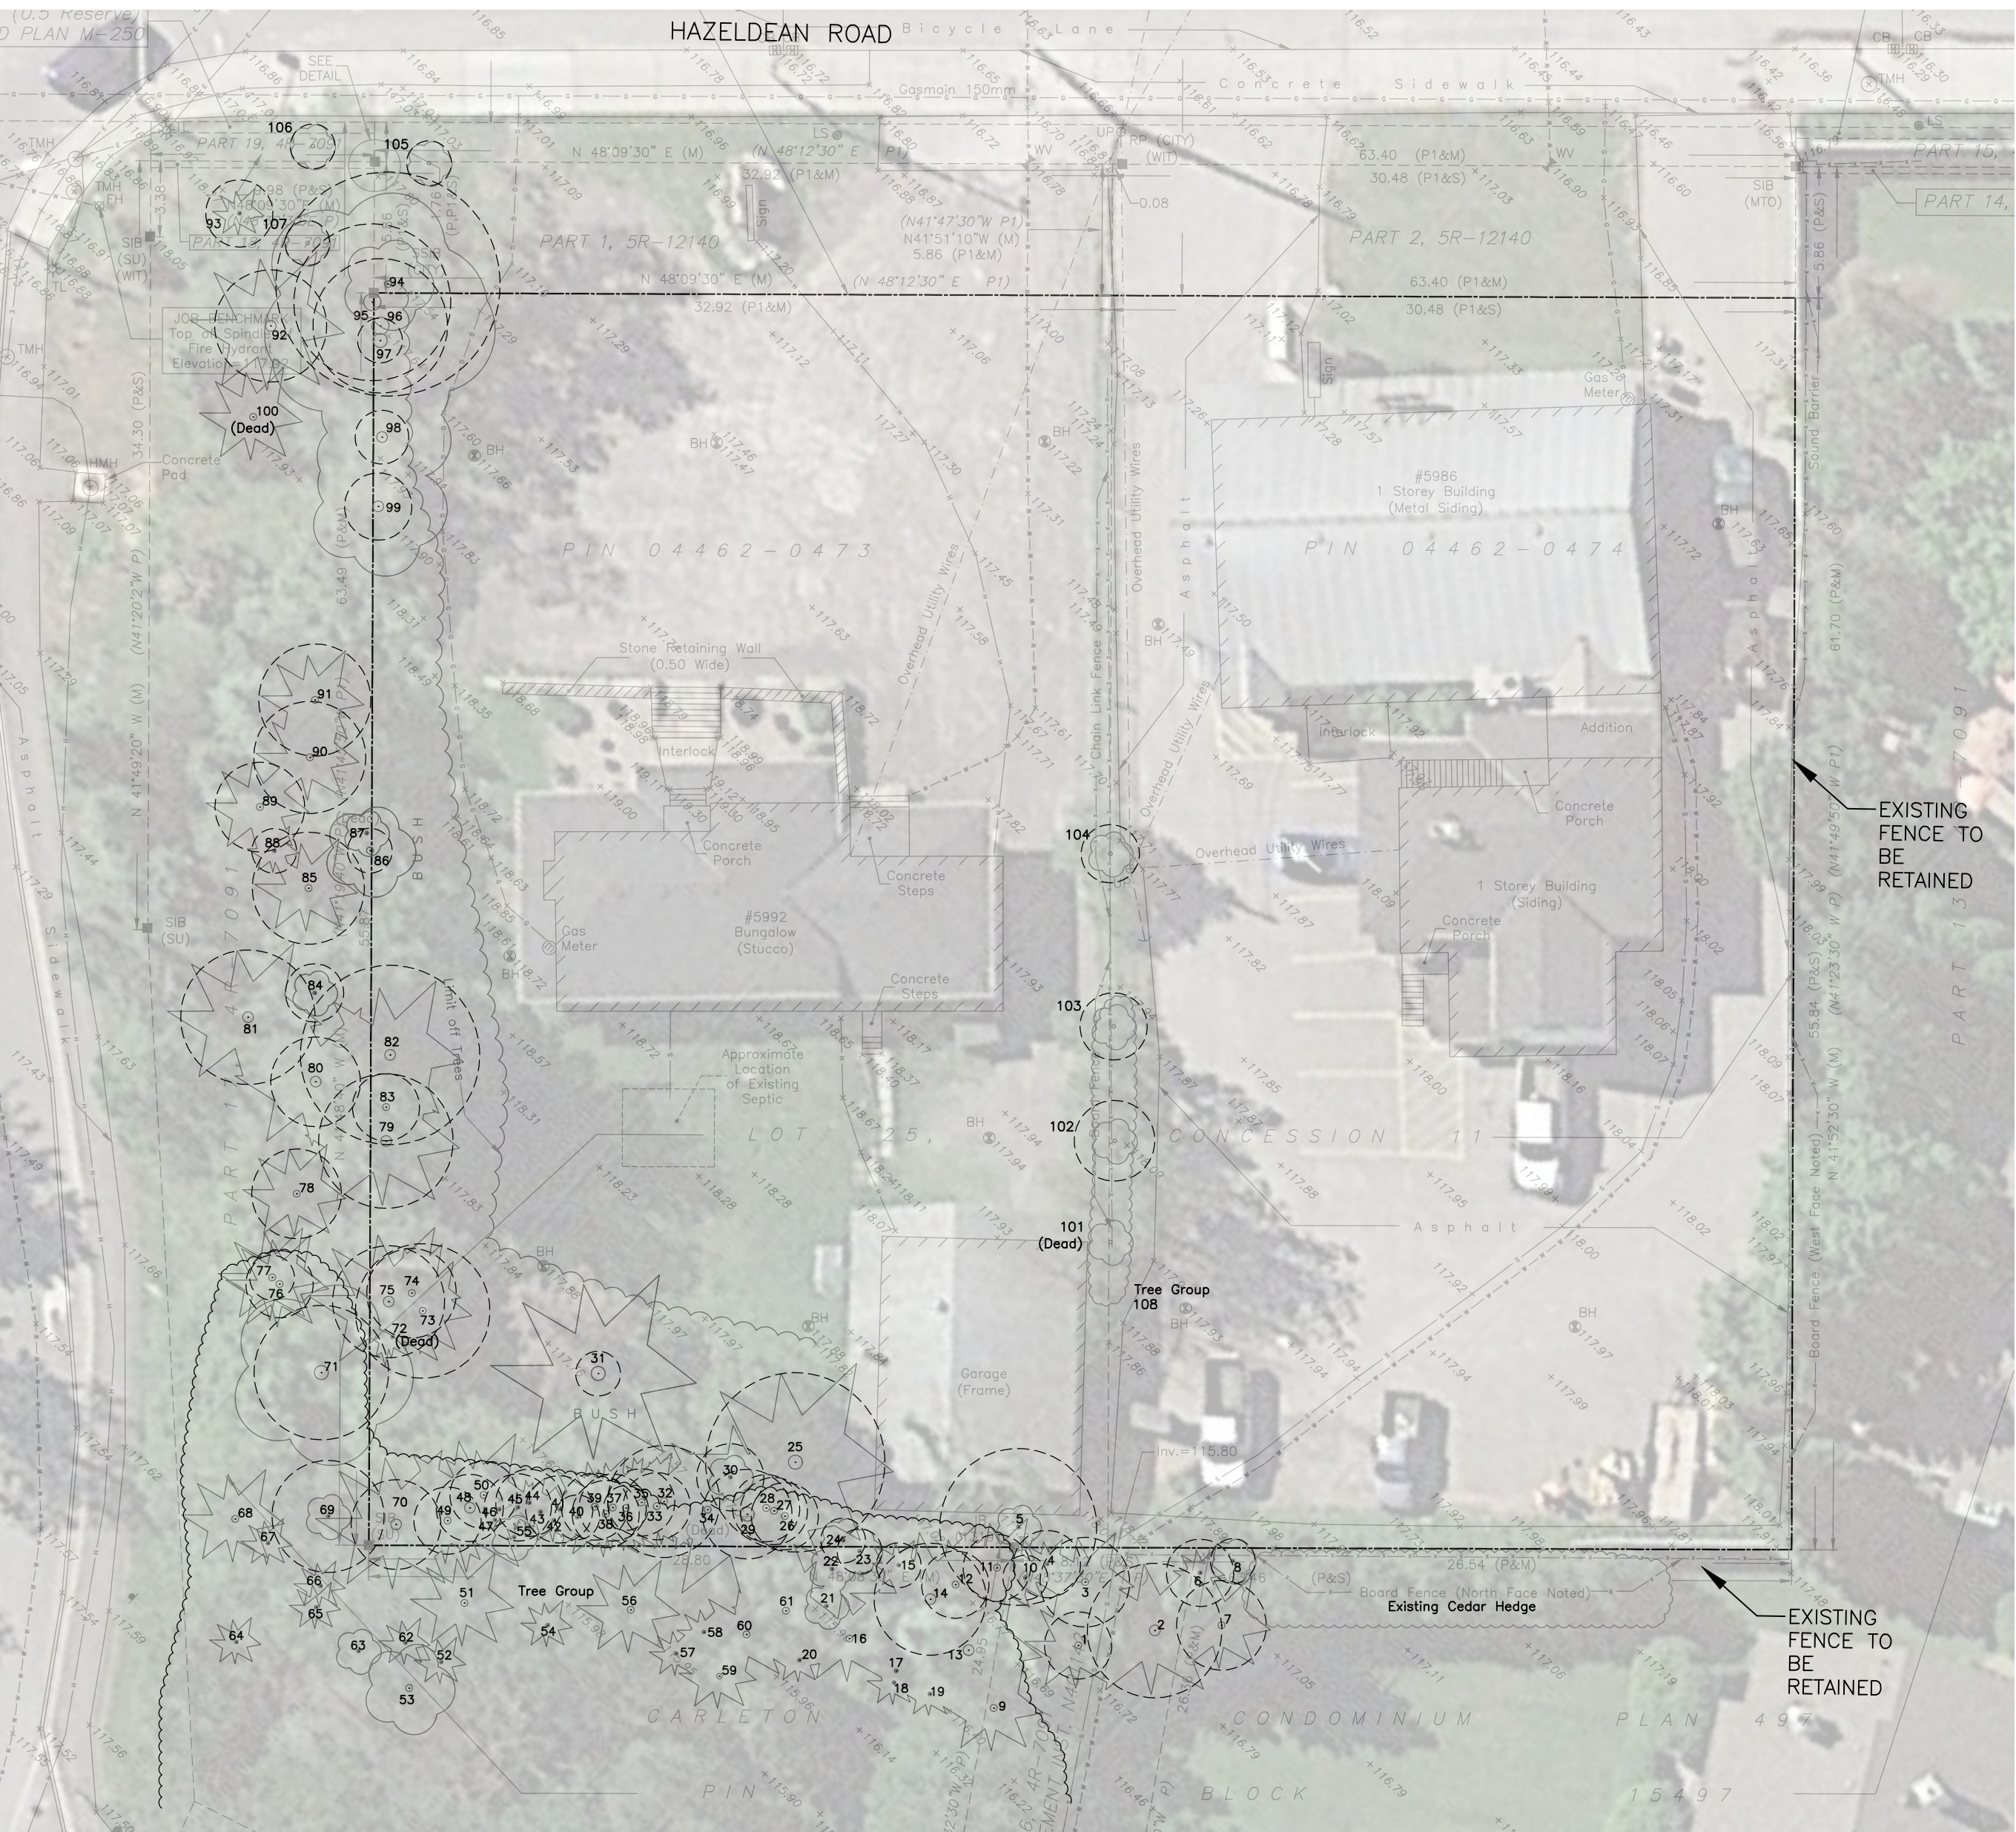
1 CURRENT VEGETATION

**SITE DESCRIPTION:**  
THE SITE INCLUDES EXISTING COMMERCIAL / OFFICE BUILDINGS WITH ASPHALT ACCESS DRIVE AND BOTH ASPHALT AND GRAVEL PARKING AREAS. THE ENTRANCE AREAS AND SOUTH WEST CORNER ARE MAINTAINED AS MOWN GRASS.

THE EAST AND SOUTHEAST BOUNDARY OF THE SITE ARE DEFINED BY A NOISE BARRIER AND EXISTING WOOD PRIVACY FENCE. THE WEST AND SOUTHWEST BOUNDARY ARE BORDERED BY AN EXISTING WOODLOT PLANTED AS PART OF THE CONDOMINIUM DEVELOPMENT TO THE SOUTH. THE WOODLOT CONSISTS OF PRIMARILY OF CEDARS AND SPRUCE TREES WITH A DENSE UNDERSTORY OF BUCKTHORN AND VINES.

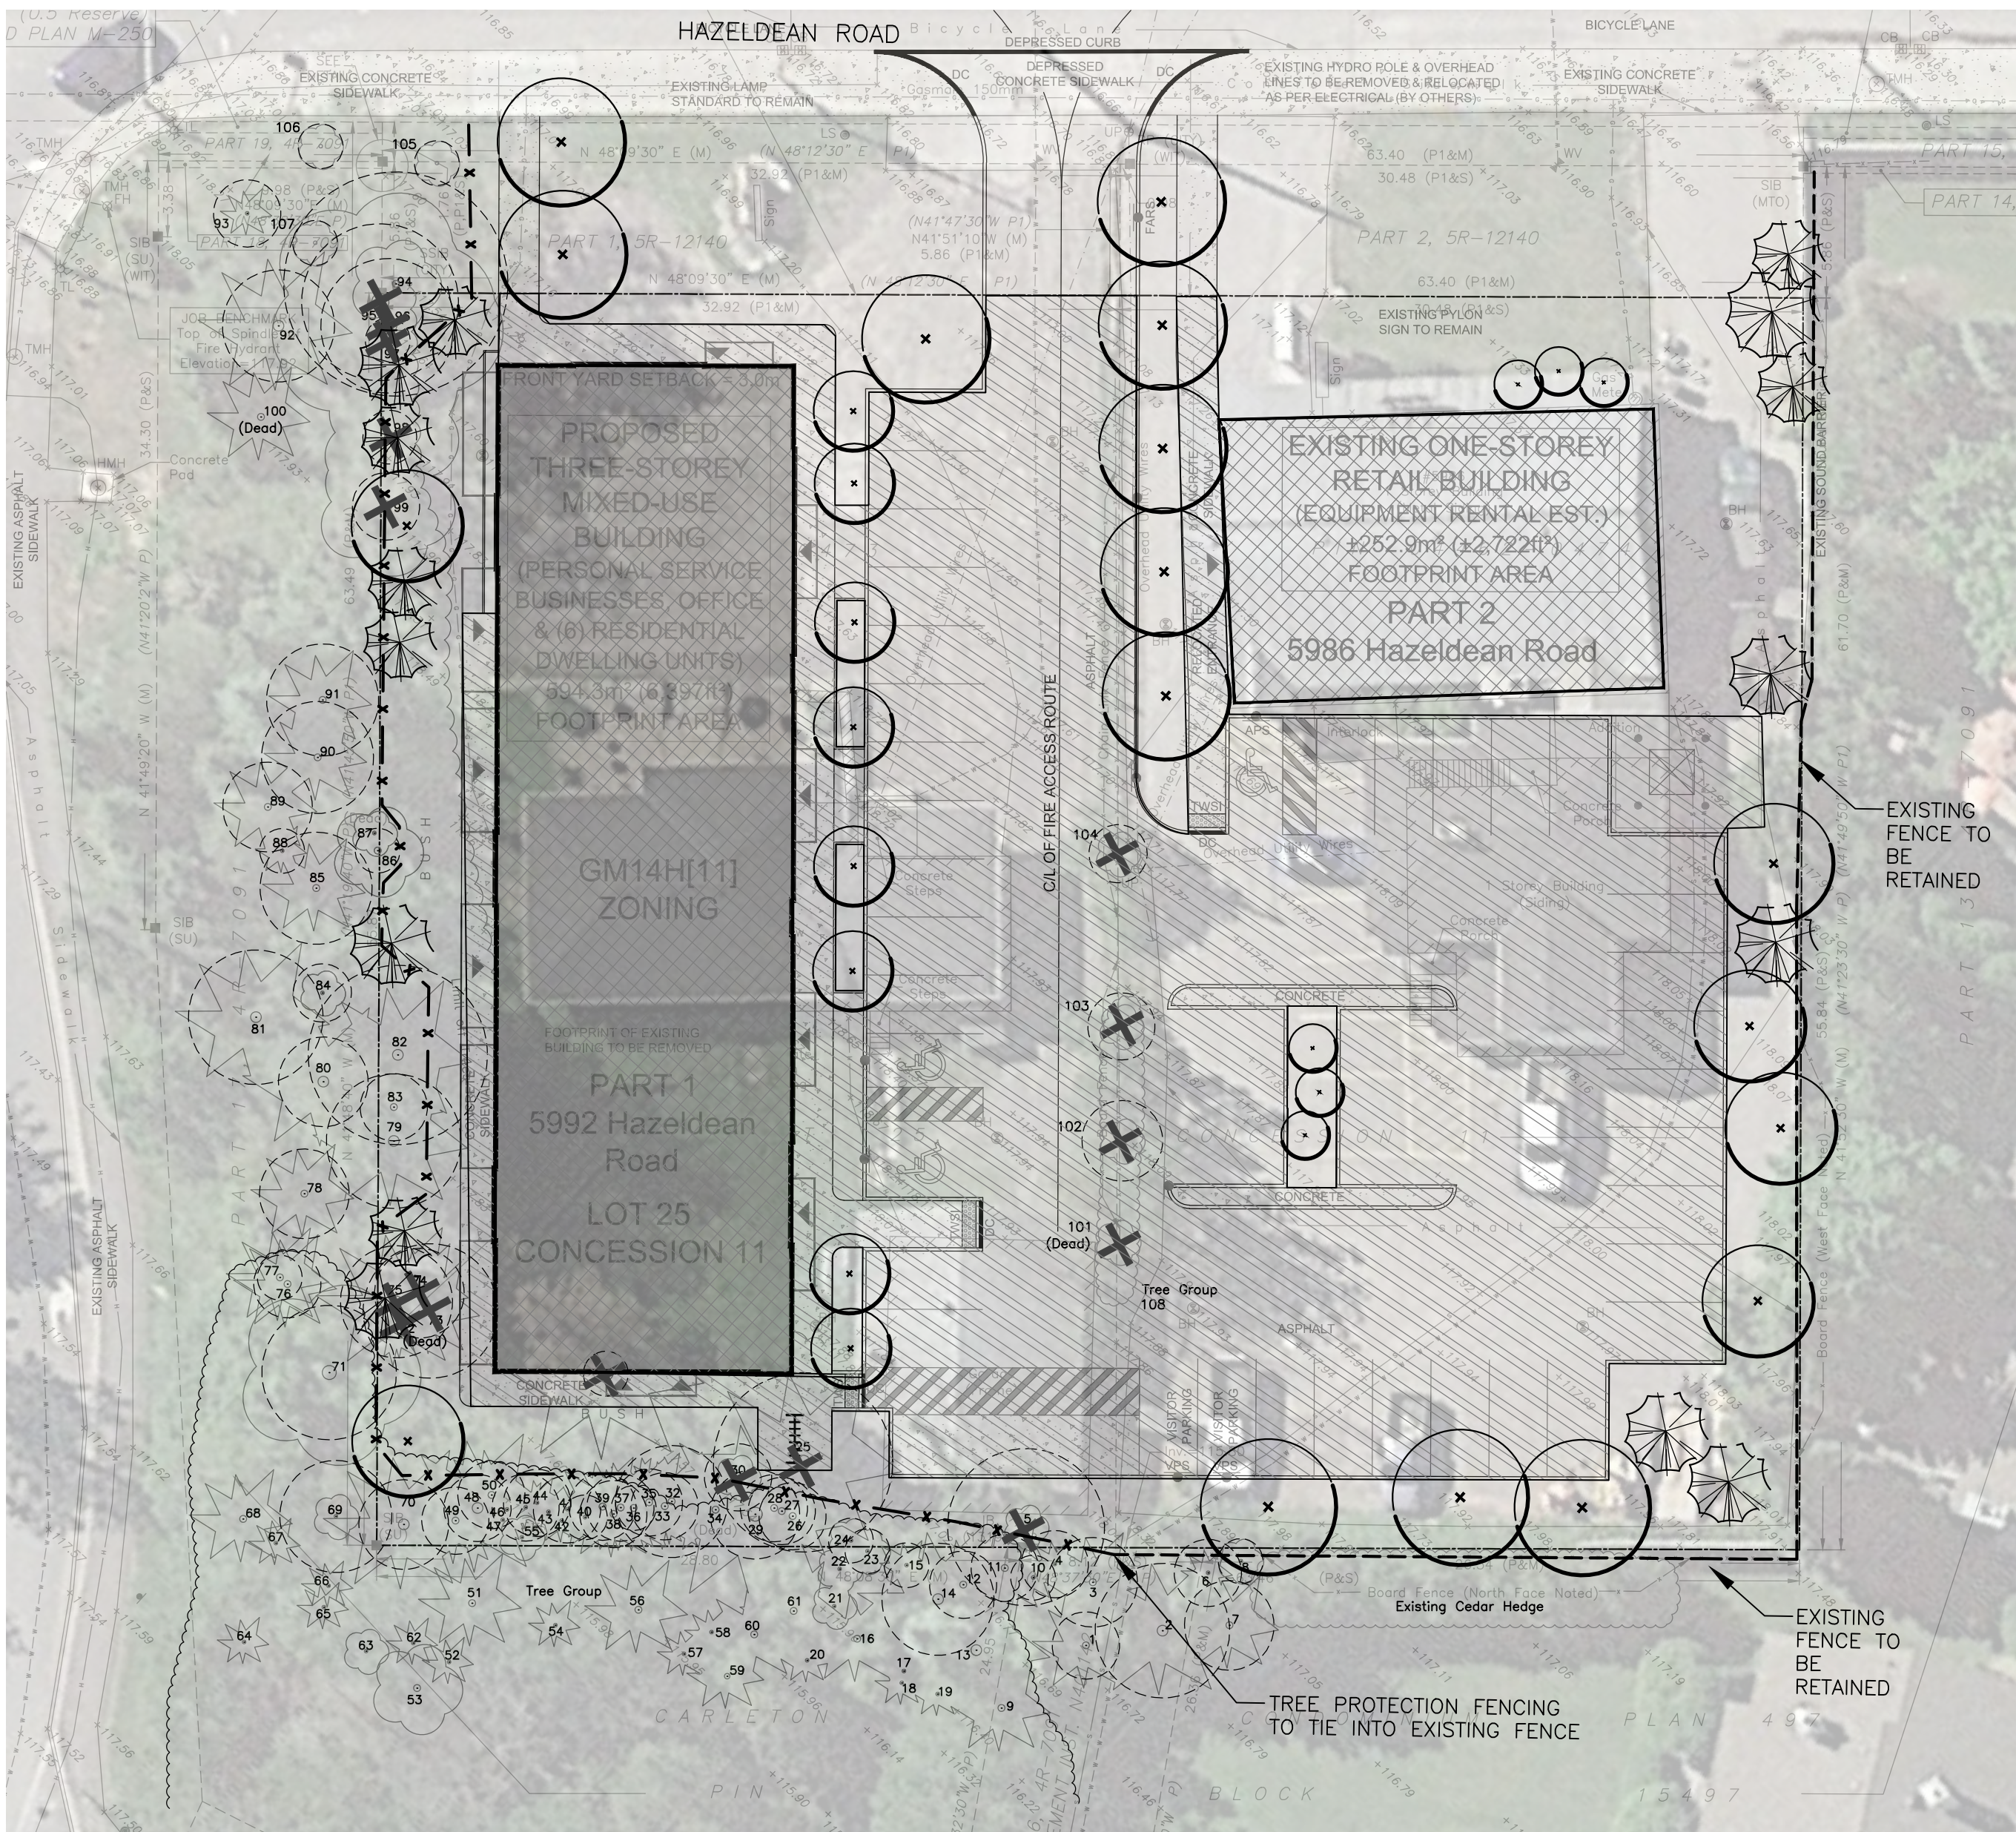
2 PROPOSED DEVELOPMENT AND CONSERVED VEGETATION

THE PROPOSED DEVELOPMENT REQUIRES THE REMOVAL OF APPROX. 17 EXISTING TREES TO FACILITATE CONSTRUCTION ACCESS AND PROPOSED FENCING. THE TREES TO BE REMOVED ARE PRIMARILY ELM (IN POOR CONDITION), CEDAR AND SOME MATURE CONIFERS.
