**KHM HAZELDEAN ROAD**

5986-5992 Hazeldean Road  
OTTAWA, ONTARIO

**TREE CONSERVATION REPORT**

Sheet Number: TCR 01

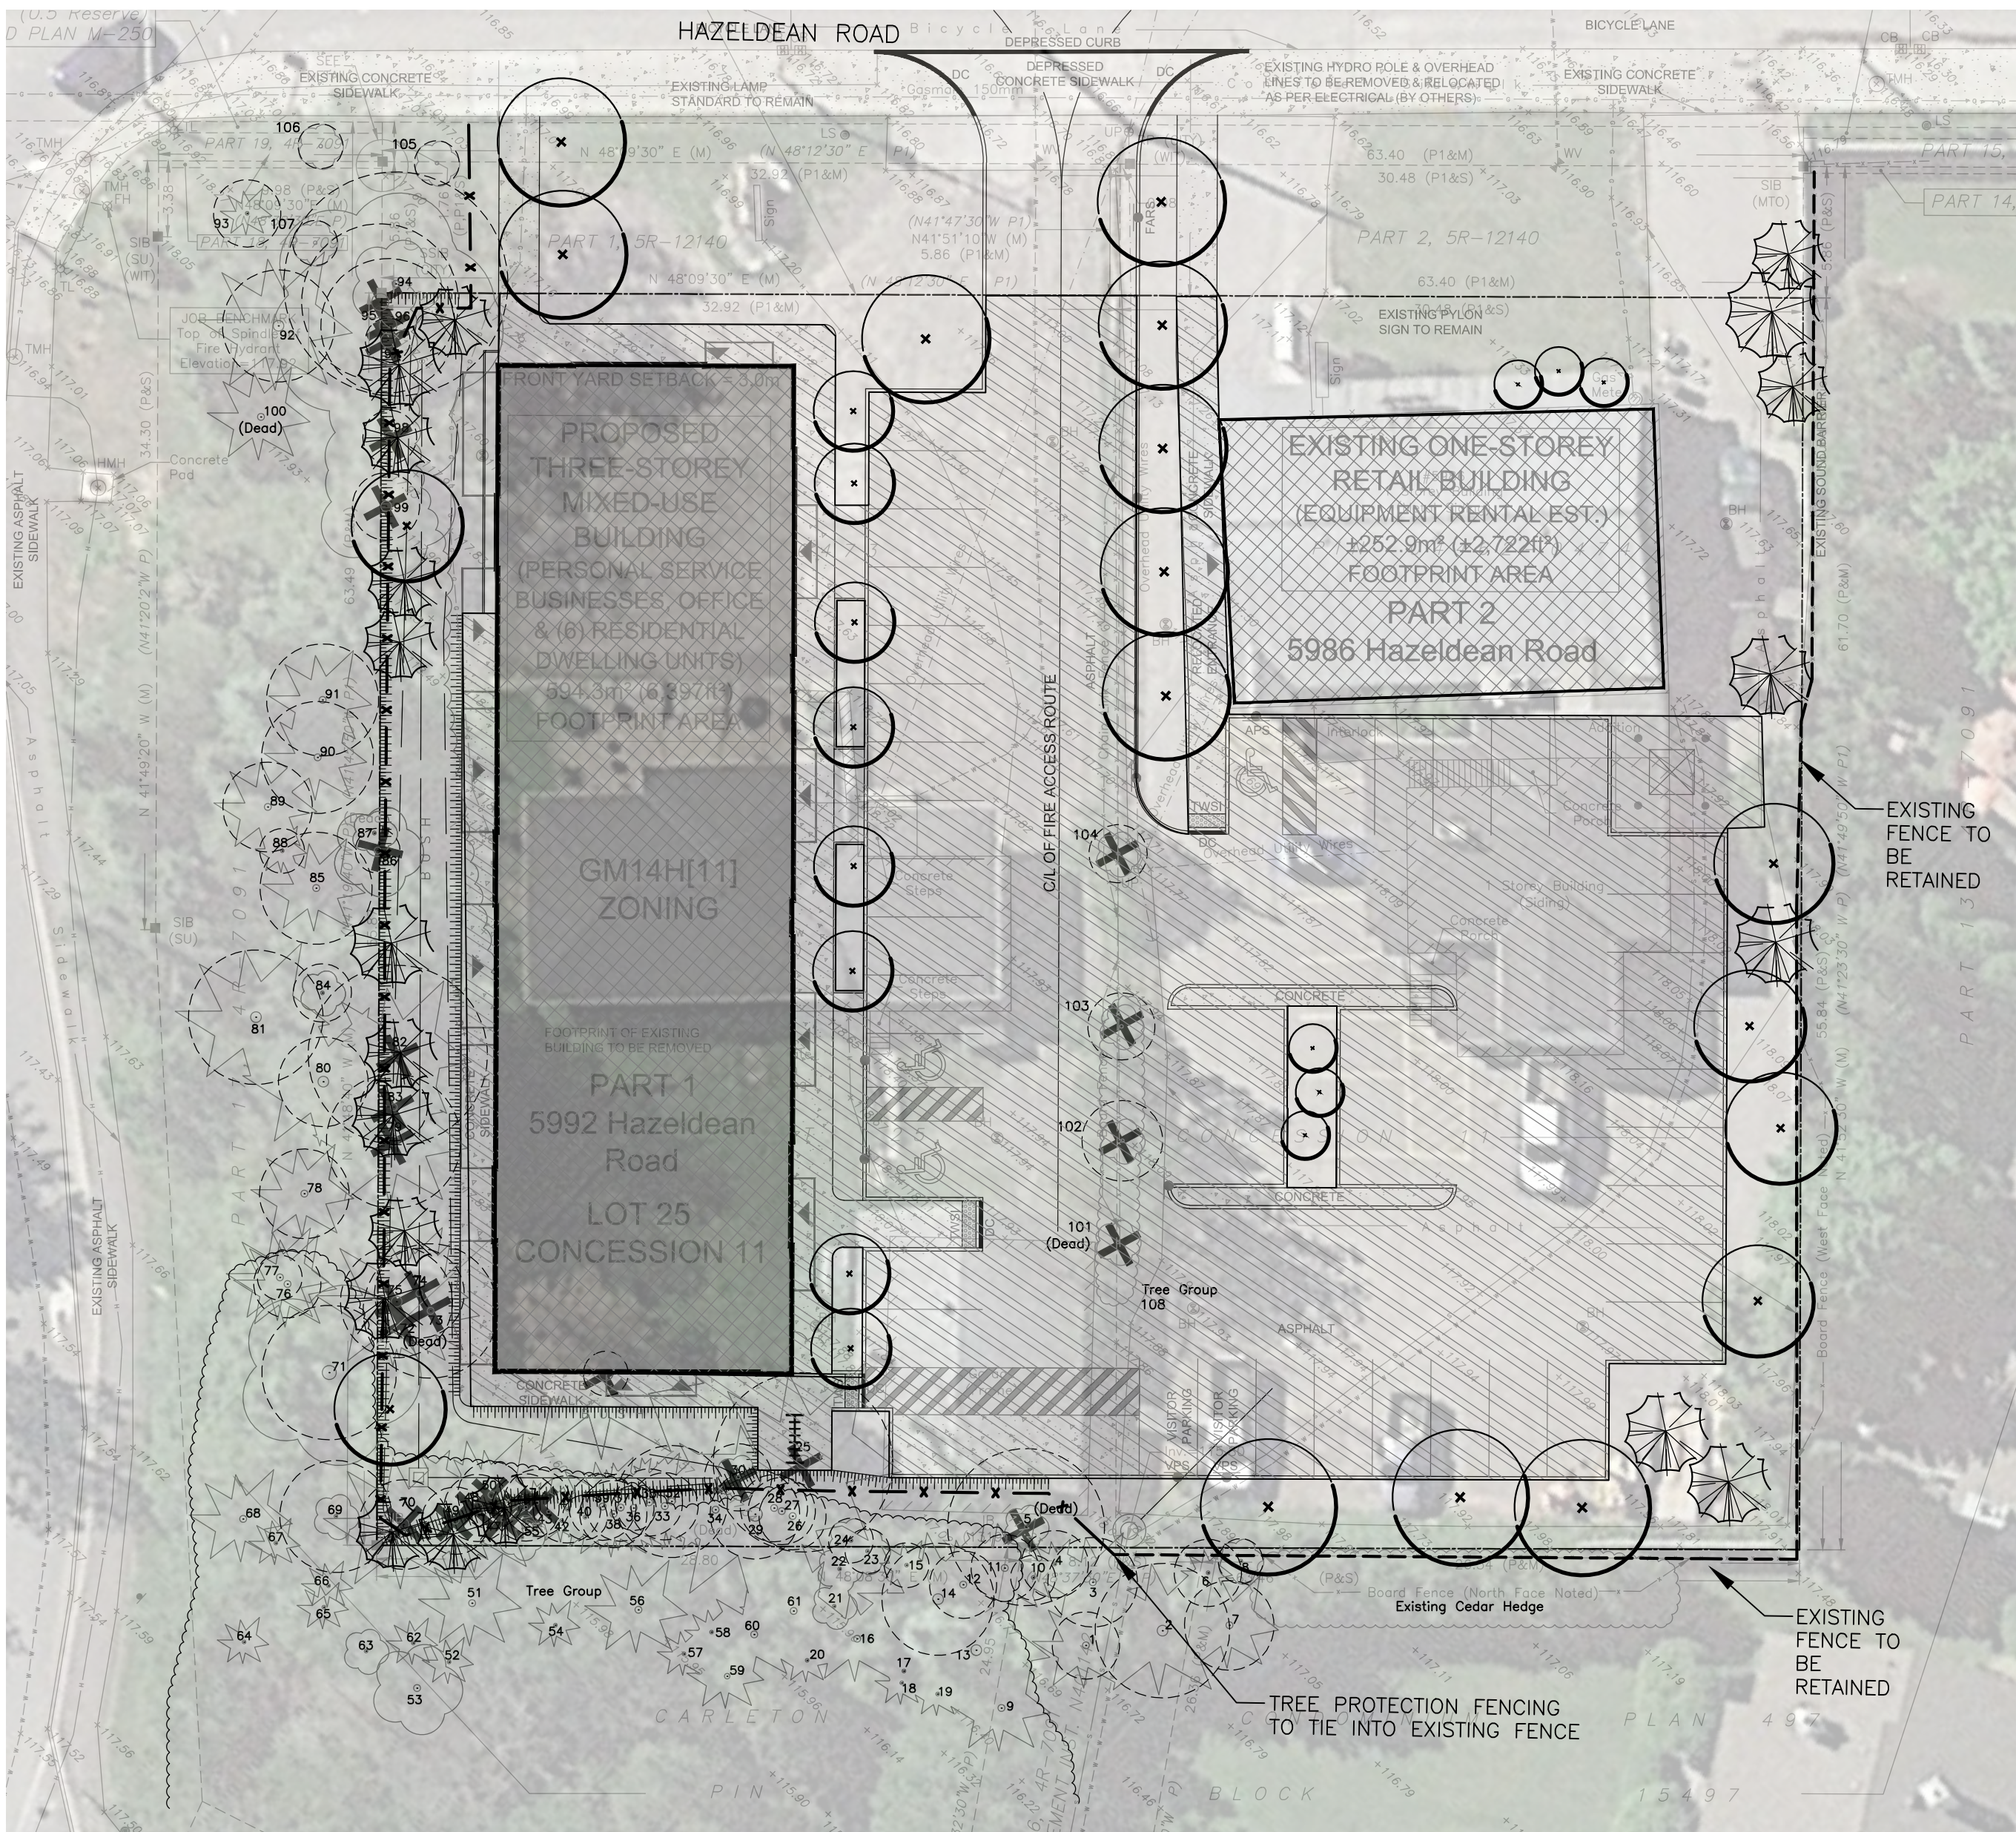
2 PROPOSED DEVELOPMENT AND CONSERVED VEGETATION

THE PROPOSED DEVELOPMENT REQUIRES THE REMOVAL OF APPROX. 28 EXISTING TREES TO FACILITATE CONSTRUCTION ACCESS AND PROPOSED FENCING. THE TREES TO BE REMOVED ARE PRIMARILY ELM (IN POOR CONDITION), CEDAR AND SOME MATURE CONIFERS.
