January 16, 2020 File: PE4809-LET.02

Subject: Phase II - Environmental Site Assessment Update 289 Carling Avenue

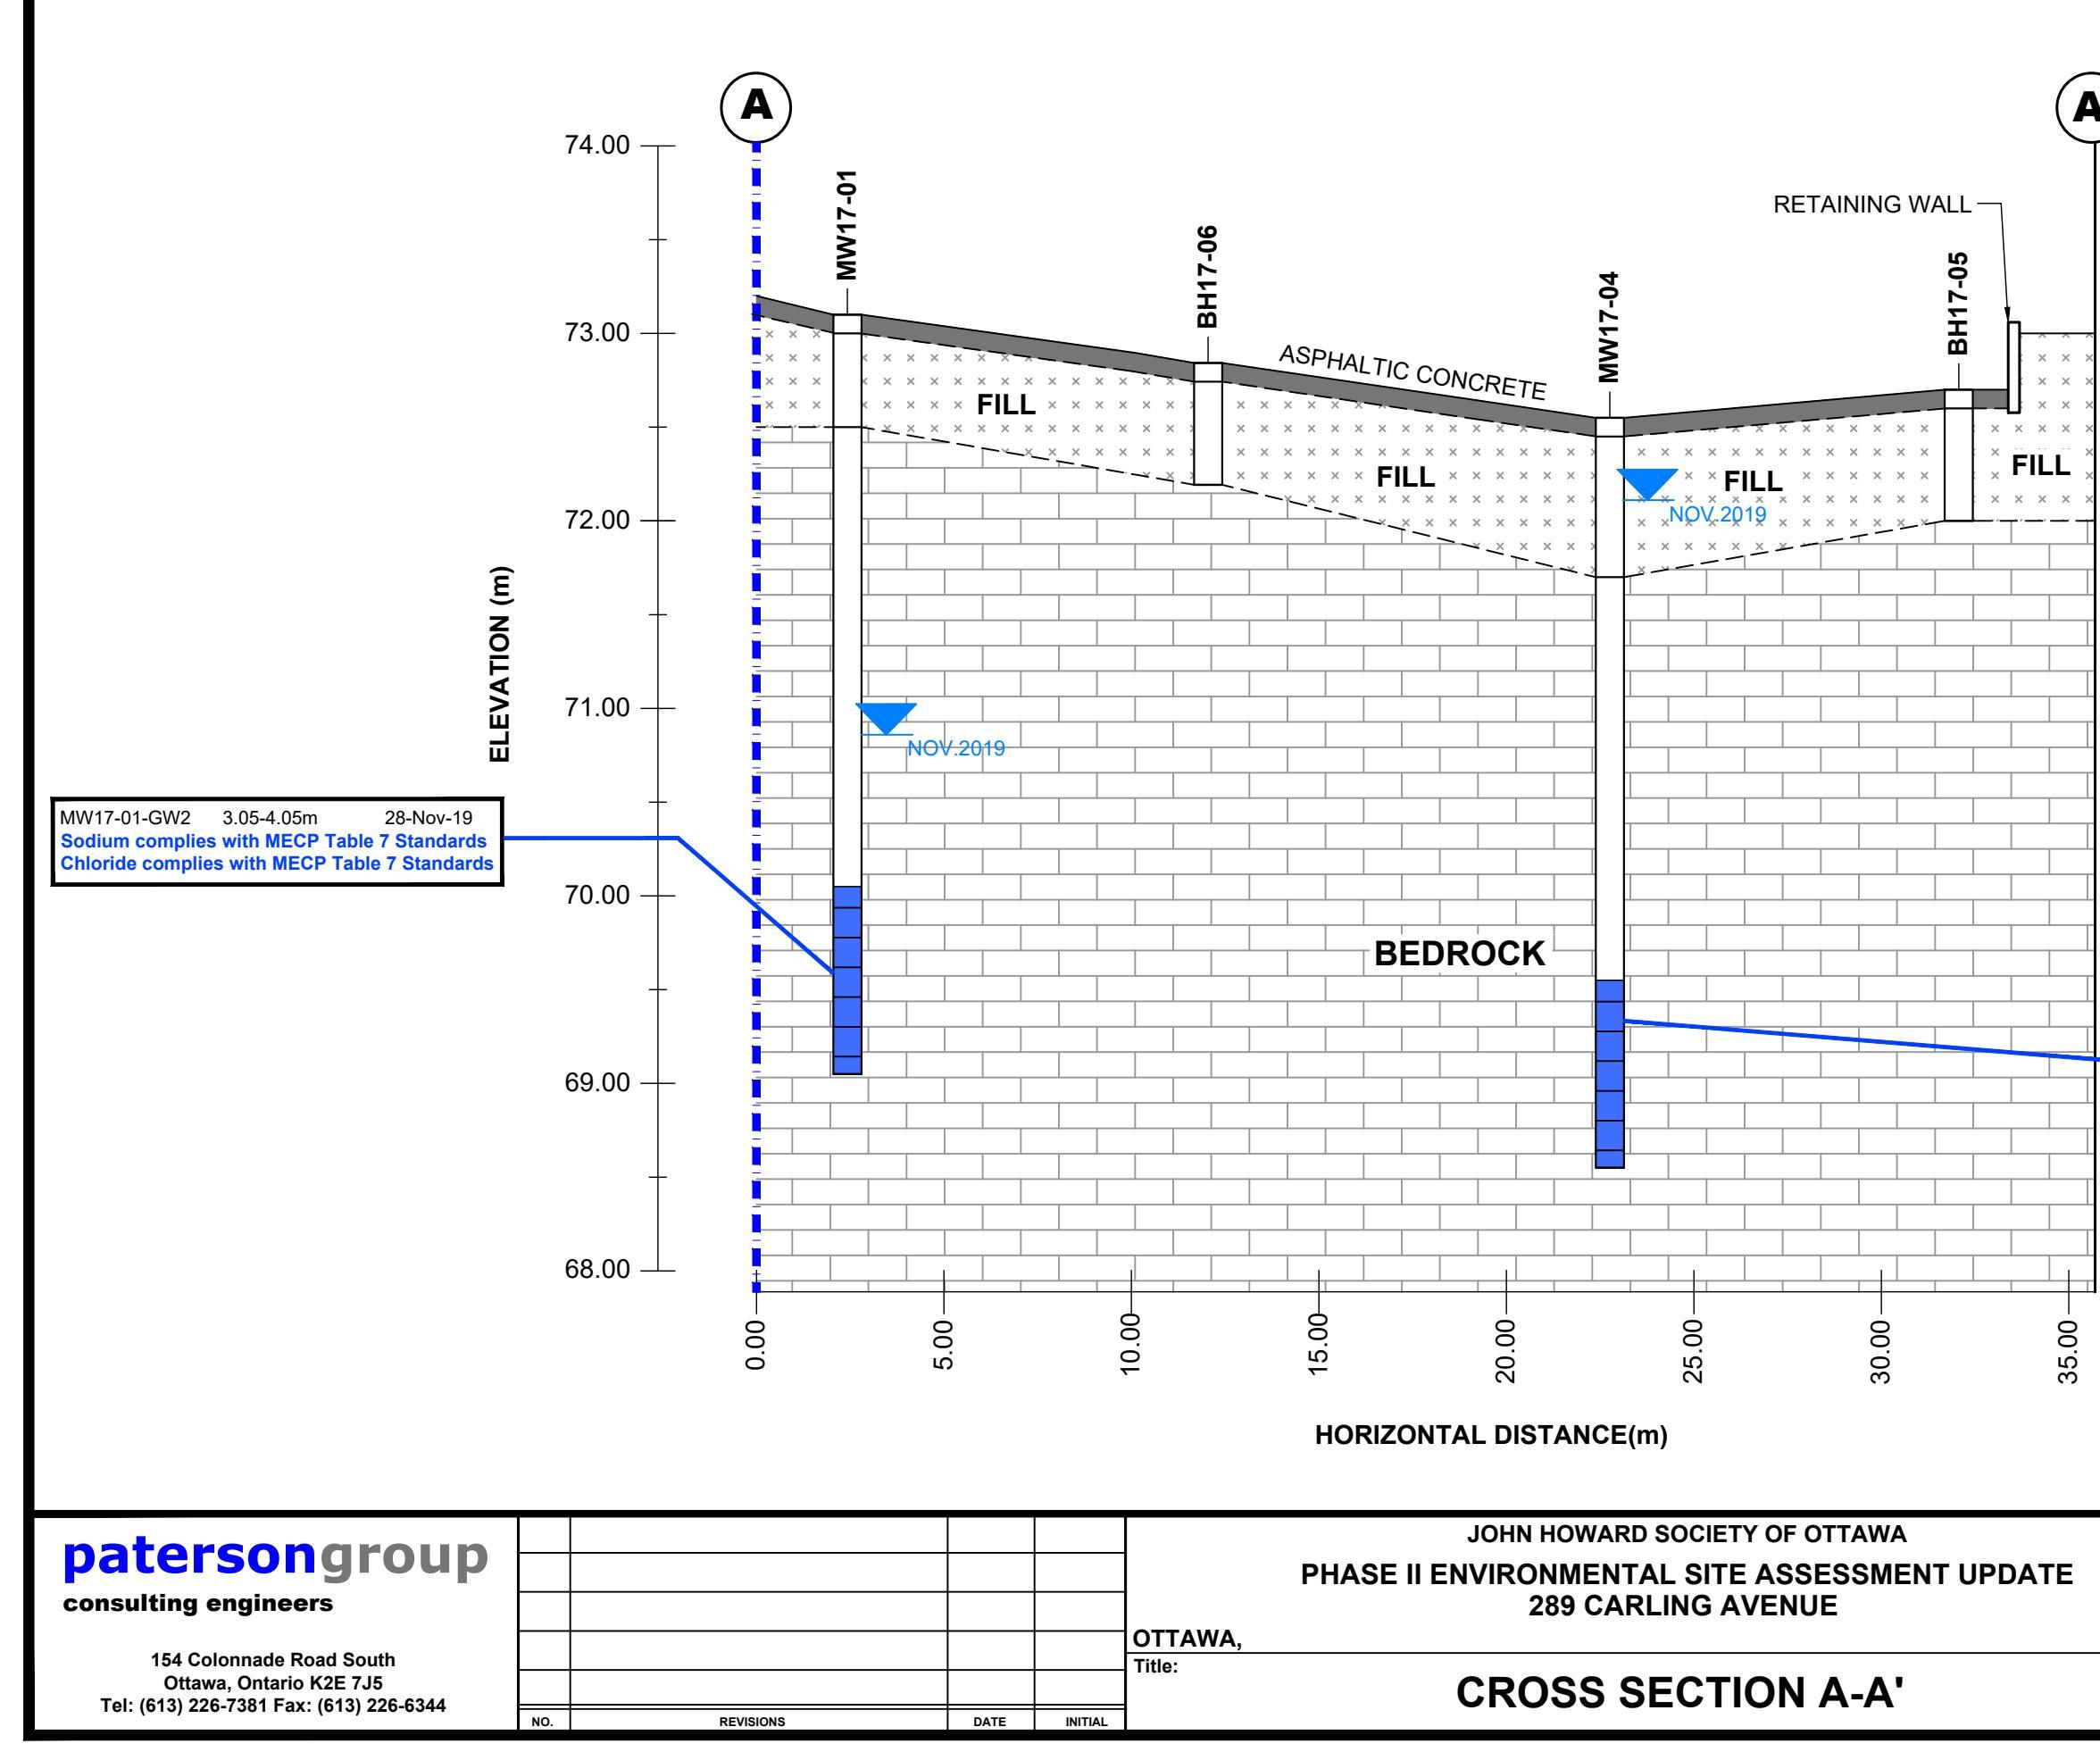
Scale:		Date:
		1:250	01/2020
	Drawn by:		Report No.:
		RCG	PE4809-LET.02
ONTARIO	Checked by:		
		RG	PF4809-6
	Approved by:		
		SD	Revision No.:

MW17-04-GW2	3.00-4.00m	28-Nov-19
Sodium complie	s with MECP T	able 7 Standards
Chloride compli	es with MECP 1	Table 7 Standards
MW17-04-GW2	3 00-4 00m	12-Dec-19

MW17-04-GW2 3.00-4.00m 12-Dec-19 Cyanide complies with MECP Table 7 Standards

GROUNDWATER RESULTS COMPLY WITH MECP TABLE 7 STANDARDS
