URBAN FORESTRY & FOREST MANAGEMENT CONSULTING

September 27, 2019

RE: TREE CONSERVATION REPORT – 7 MACLEAN STREET

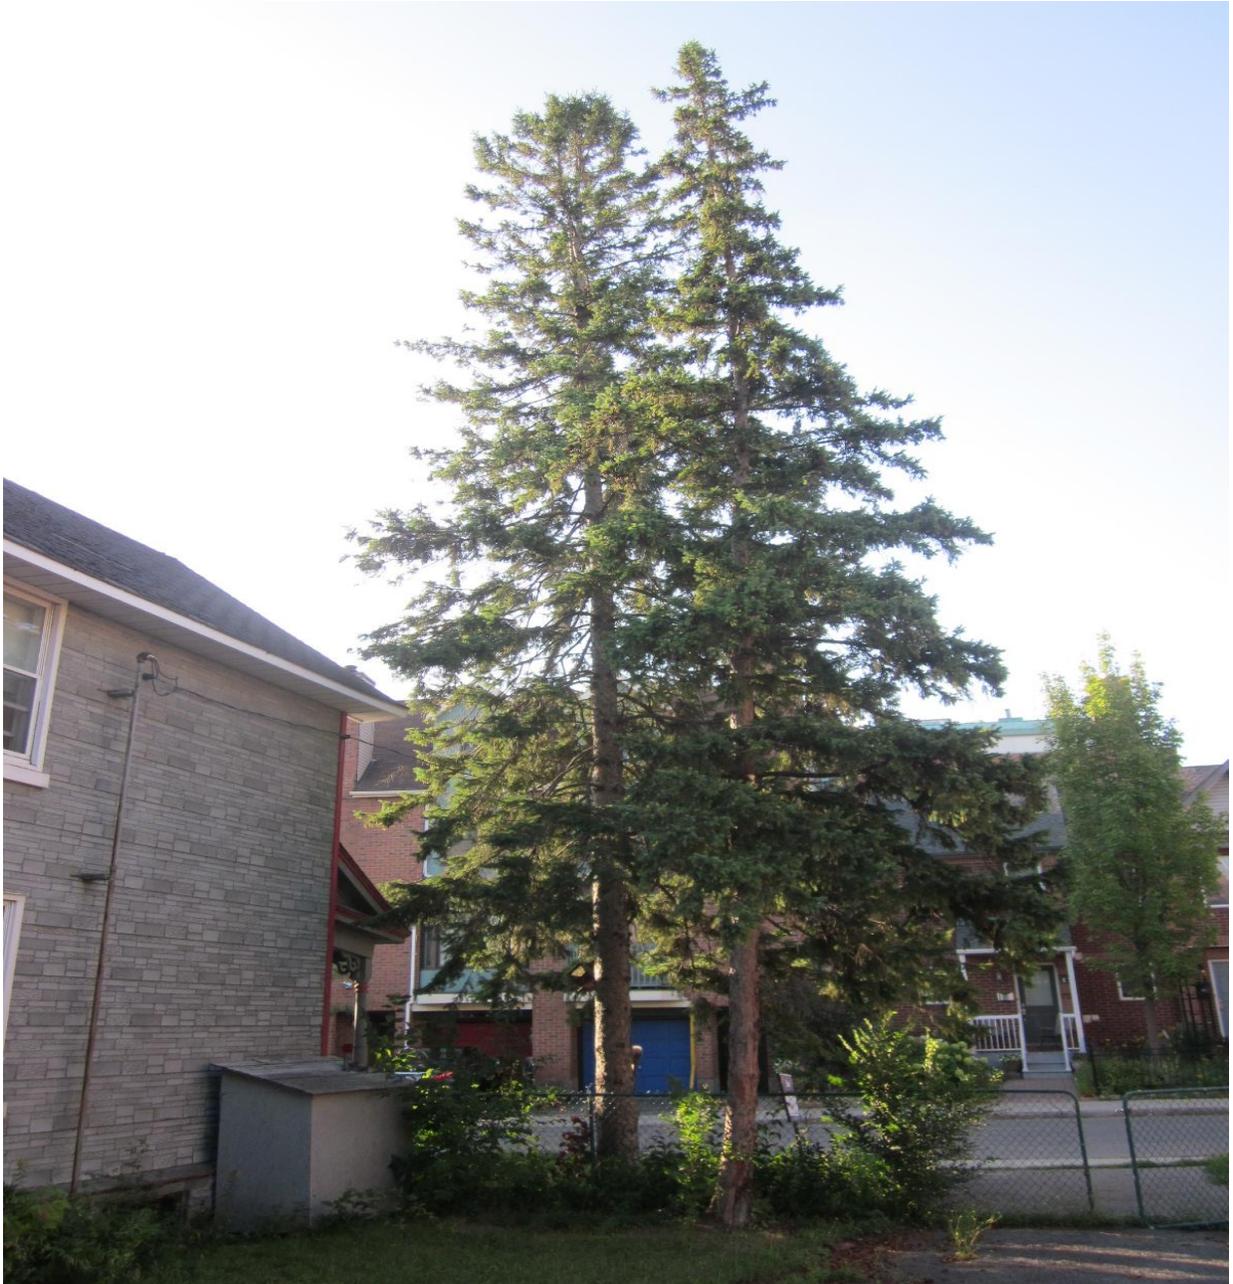
Tree No.	Tree Species	DBH ¹ (cm)	CRZ ² (m)	Ownership	Tree health, condition and Status (to be removed or preserved and protected)
1	White spruce (<i>Picea glauca</i>)	23.6	-	Private	Poor; stem divergent and crown asymmetric due to influence of tree #2; heavy physical damage to main stem grade to 3m in height; fair crown density, growth increment and needle colour; native species; to be removed due to conflicts with development
2	White spruce	35.2	-	Private	Fair; lower crown slightly asymmetric due to influence of tree #1; fair crown density, growth increment and needle colour; scattered deadwood throughout crown; native species; to be removed due to conflicts with development

Picture 1 on page 3 shows the two trees on the subject property.

Picture 1. Japanese tree lilac on private property in front of 24 Hawthorne Avenue (picture taken May 2017).
