Urban Forestry & Forest Management Consulting

October 23, 2019

RE: TREE CONSERVATION REPORT FOR 24-30 PRETORIA AVENUE, OTTAWA

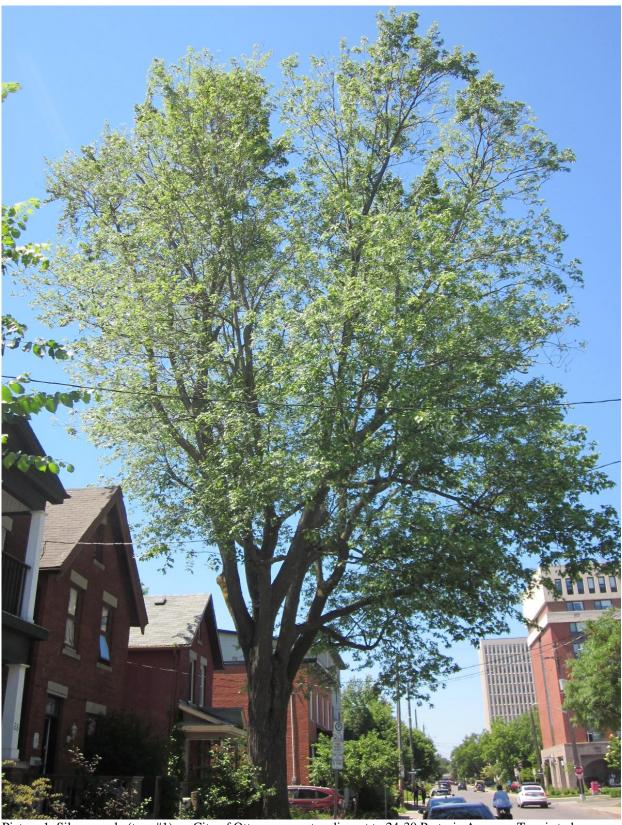
Table 1	Table 1. Species, condition, diameter, ownership and status of trees at 24-30 Pretoria Avenue.								
Tree	Tree Species	Condition	DBH ¹	Owner	Tree Condition Notes &				
No.		$(VP \rightarrow E)$	(cm)	-ship	Preservation Status (to be removed				
					or preserved and protected)				
1	Silver maple	Fair	110	City	Very mature; five co-dominant				
	(Acer				stems at 4m from grade; broad				
	saccharinum)				crown – slightly asymmetrical due				
					to clearance pruning from house;				
					good flower bud set for 2019; within				
					very restricted rooting area; native				
					species; to be removed due to				
					conflicts with excavation – in				
					particular the underground				
					parking garage which will be				
					within 0.5 metres of its trunk				
2	White spruce	Fair	16	Private	Maturing; vine growth into lower				
	(Picea glauca)				and mid-crown; heavy cone crop in				
					2019; to be removed

Picture 1. Silver maple (tree #1) on City of Ottawa property adjacent to 24-30 Pretoria Avenue. Tree is to be removed.

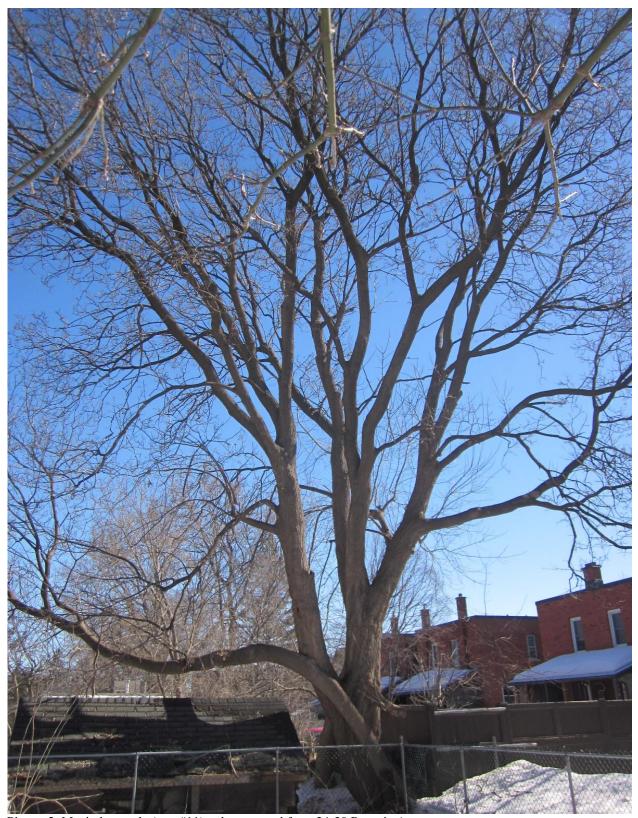
1.1	Manitalea marila	Toin.	00	Duizzot -	Variations of densire and states at
11	Manitoba maple	Fair	98	Private	Very mature; co-dominant stems at
					2.5m; very broad crown; secondary
					lateral stem very divergent towards
					northwest; to be removed
12	Manitoba maple	Good	32	Private	Mature; upright growth form; to be
					removed
13	White cedar	Poor	5 avg.	Private	Immature; likely planted as a hedge;
	(Thuja				native species; to be removed
	occidentalis)				•
14	Manitoba maple	Fair	64	Private	Very mature; tri-stemmed at 1m
					from grade – broad crown; to be
					removed
15	Manitoba maple	Fair	12	Neigh-	Maturing; likely originated from
			avg.	bour	seed; some stems overhanging
					property line – will have to be cut
					back; to be preserved and
					protected

Picture 2. Manitoba maple (tree #11) to be removed from 24-30 Pretoria Avenue.

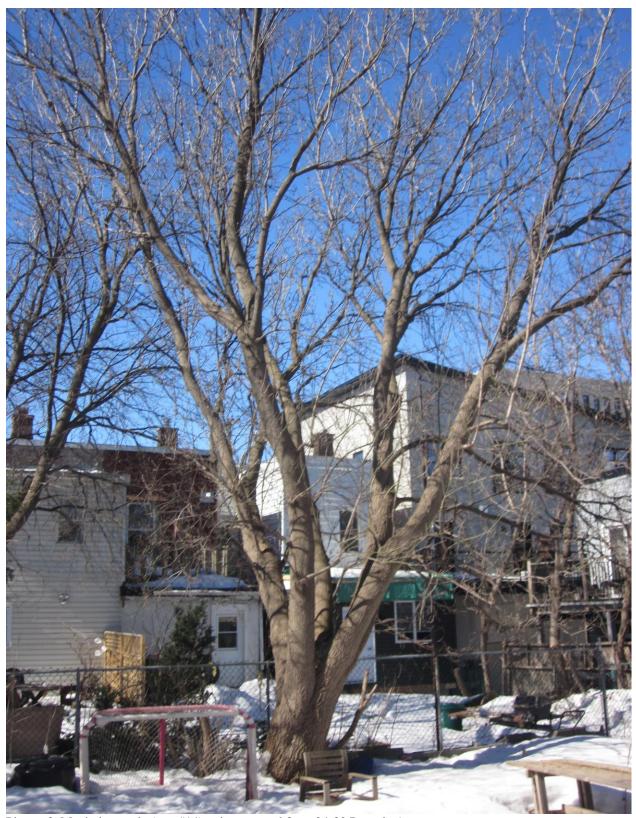
Picture 3. Manitoba maple (tree #14) to be removed from 24-30 Pretoria Avenue.

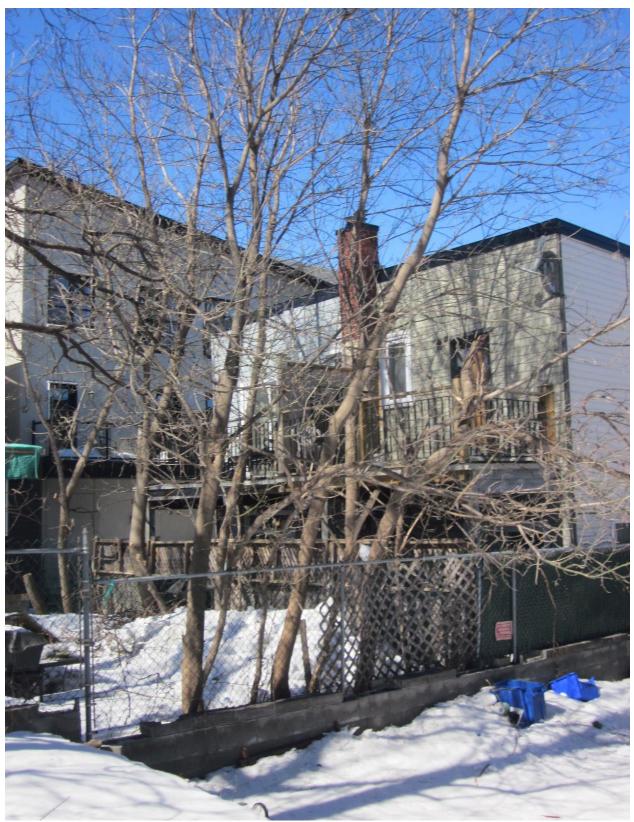
Picture 4. Manitoba maple grouping (#15) to be preserved and protected adjacent to 24-30 Pretoria Avenue.

- 1. Erect a fence at the critical root zone (CRZ¹) of trees;
- 2. Do not place any material or equipment within the CRZ of the tree;
- 3. Do not attach any signs, notices or posters to any tree;
- 4. Do not raise or lower the existing grade within the CRZ without approval;
- 5. Tunnel or bore when digging within the CRZ of a tree;
- 6. Do not damage the root system, trunk or branches of any tree;
- 7. Ensure that exhaust fumes from all equipment are NOT directed towards any tree's canopy.
