Subject: Desktop Review of Slope and Meander Belt Setback

Re-Development of AIM Recycling Ottawa East

2555 Sheffield Road, Ottawa Ontario

DST Ref No: TS-SO-037029

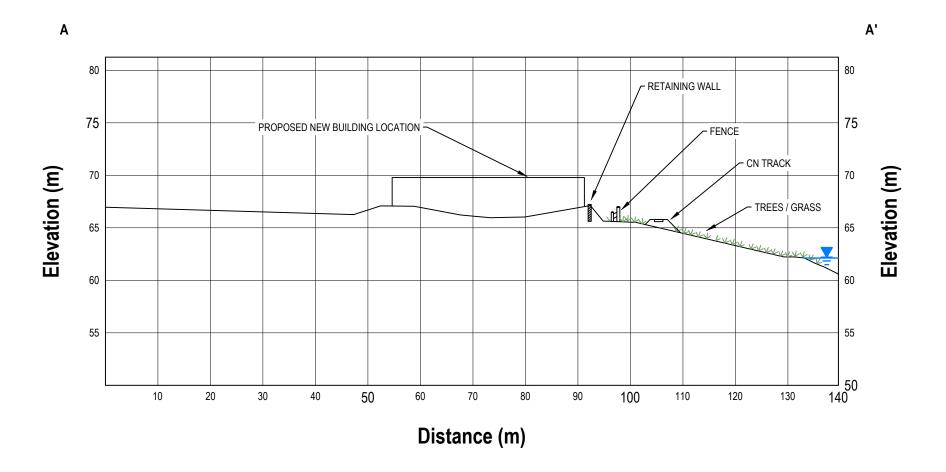
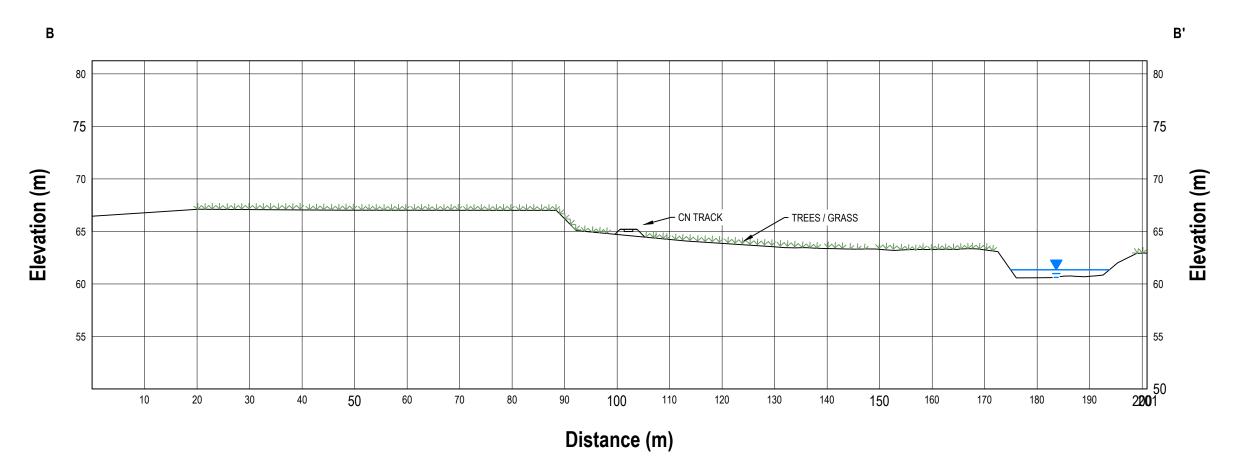
Cross-Section Views

DST visited AIM recycling facility on October 16, 2019, to inspect slope between the AIM property and Ramsay Creek. Following that, DST conducted a topographic survey to establish ground elevations at the boundaries of the mentioned property, to come up with two cross-sections (Refer to Figure 2, Appendix A for cross-section locations), which demonstrate the shape of the slope and land between the mentioned property and Ramsay Creek.

- The Stable Slope Allowance used by JTB is based on a 5:1 slope. Based on DST's site visit and topographic survey, the toe of the valley slope is located more than 15 m away from the stream bank. Therefore, DST believes that a stable slope allowance based on a 3:1 slope should be used.

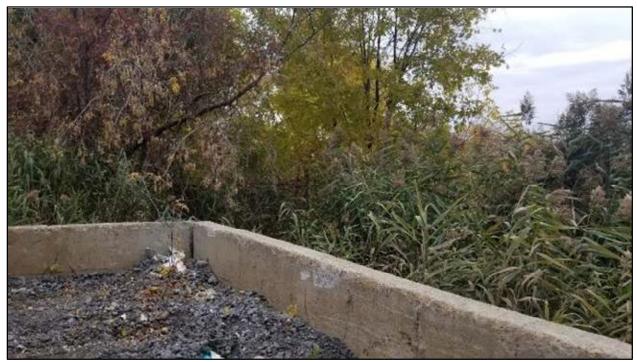
Figure 3: Retaining Wall at North East Side of Property

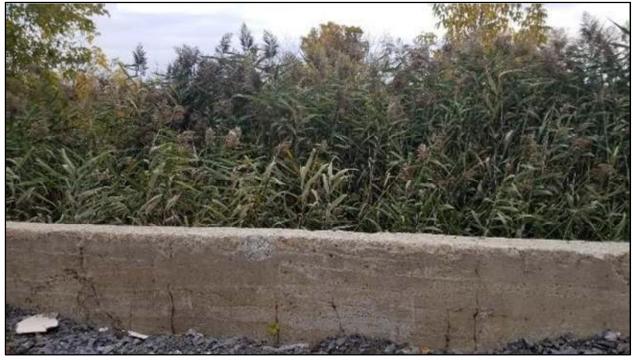
Figure 4: Retaining Wall at North East Side of Property

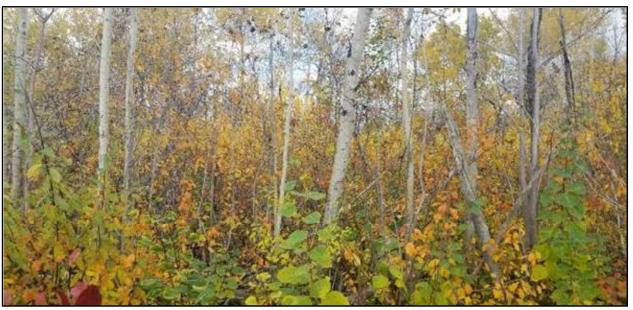
Figure 6: Vegetation at Cross-Section 1

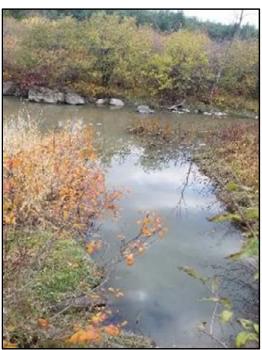
Figure 7: Creek Banks at Cross-Section 1

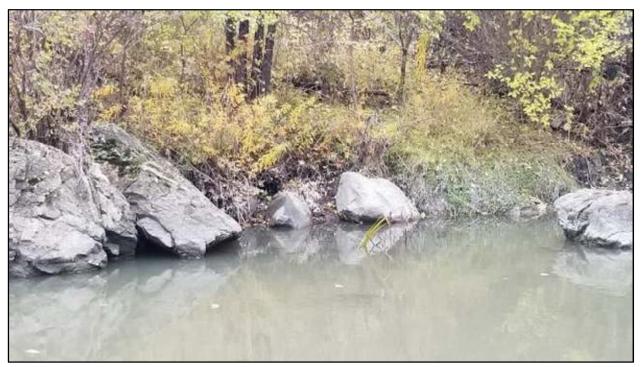
Figure 9: Creek Bank at Cross-Section 1

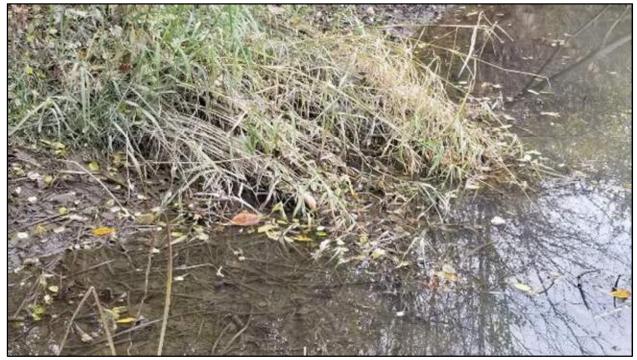
Figure 10: Water Covering Vegetation at Cross-Section 2 Near Creek Bank

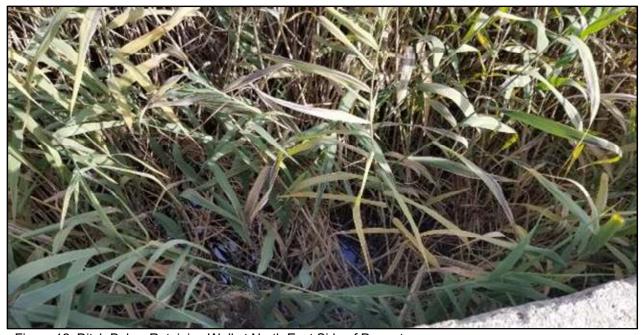
Figure 12: Ditch Below Retaining Wall at North East Side of Property
