URBAN FORESTRY & FOREST MANAGEMENT CONSULTING

April 17, 2020

RE: TREE CONSERVATION REPORT FOR 2 BILL LEAHAM DRIVE, OTTAWA

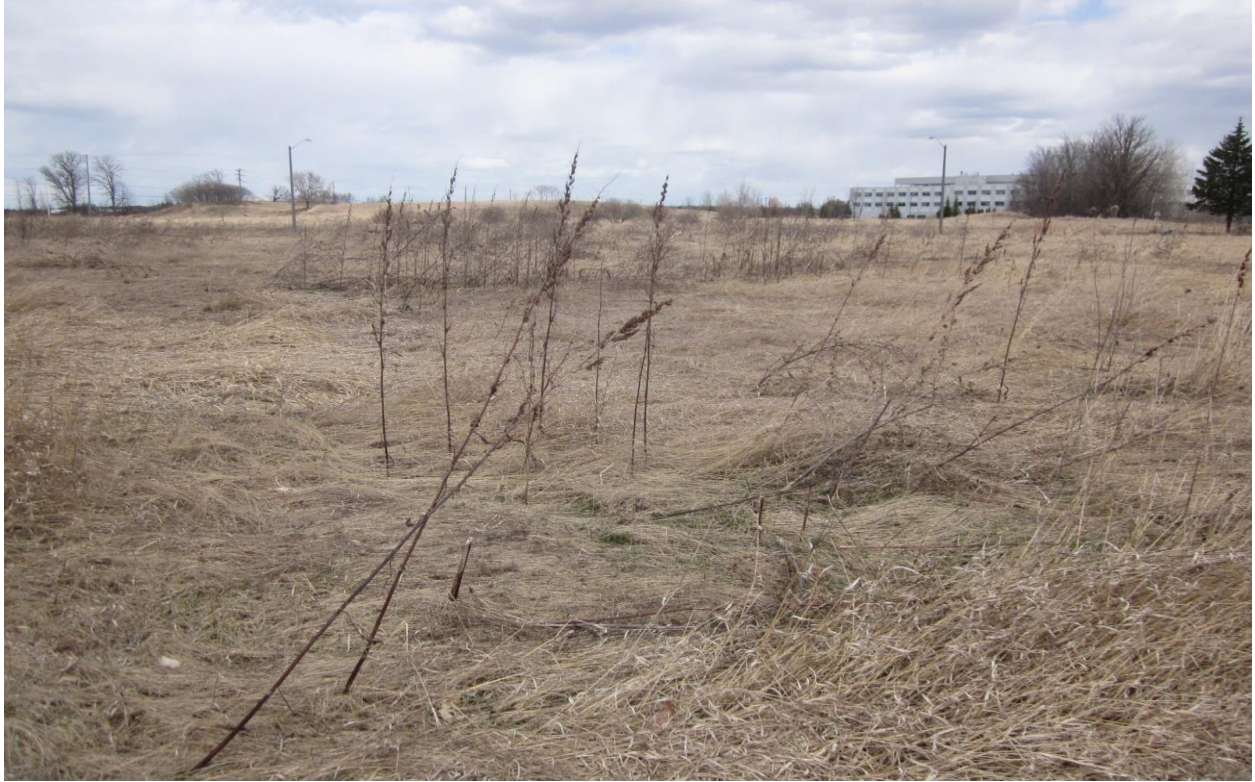
Picture 1. Cultural meadow at 2 Bill Leaham Drive – this portion of the property is to be developed

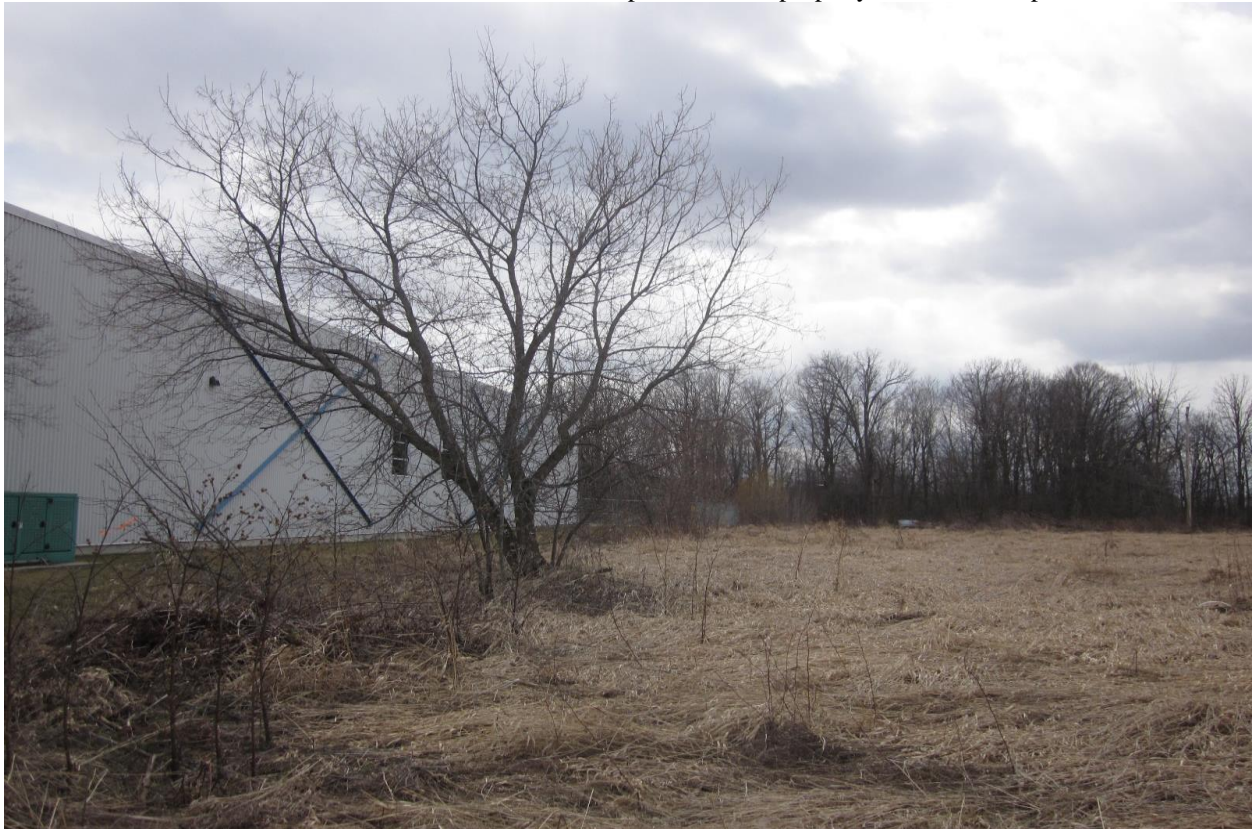
Picture 2. Manitoba maple adjacent to construction zone at 2 Bill Leaham Drive

Preservation and protection measures intended to mitigate damage during construction will be applied for the trees to be retained adjacent to the subject property. The following measures are the minimum required by the City of Ottawa to ensure tree survival during and following construction:

1. Erect a fence at the critical root zone (CRZ¹) of trees;
2. Do not place any material or equipment within the CRZ of the tree;
3. Do not attach any signs, notices or posters to any tree;
4. Do not raise or lower the existing grade within the CRZ without approval;
5. Tunnel or bore when digging within the CRZ of a tree;
6. Do not damage the root system, trunk or branches of any tree;
7. Ensure that exhaust fumes from all equipment are NOT directed towards any tree's canopy.

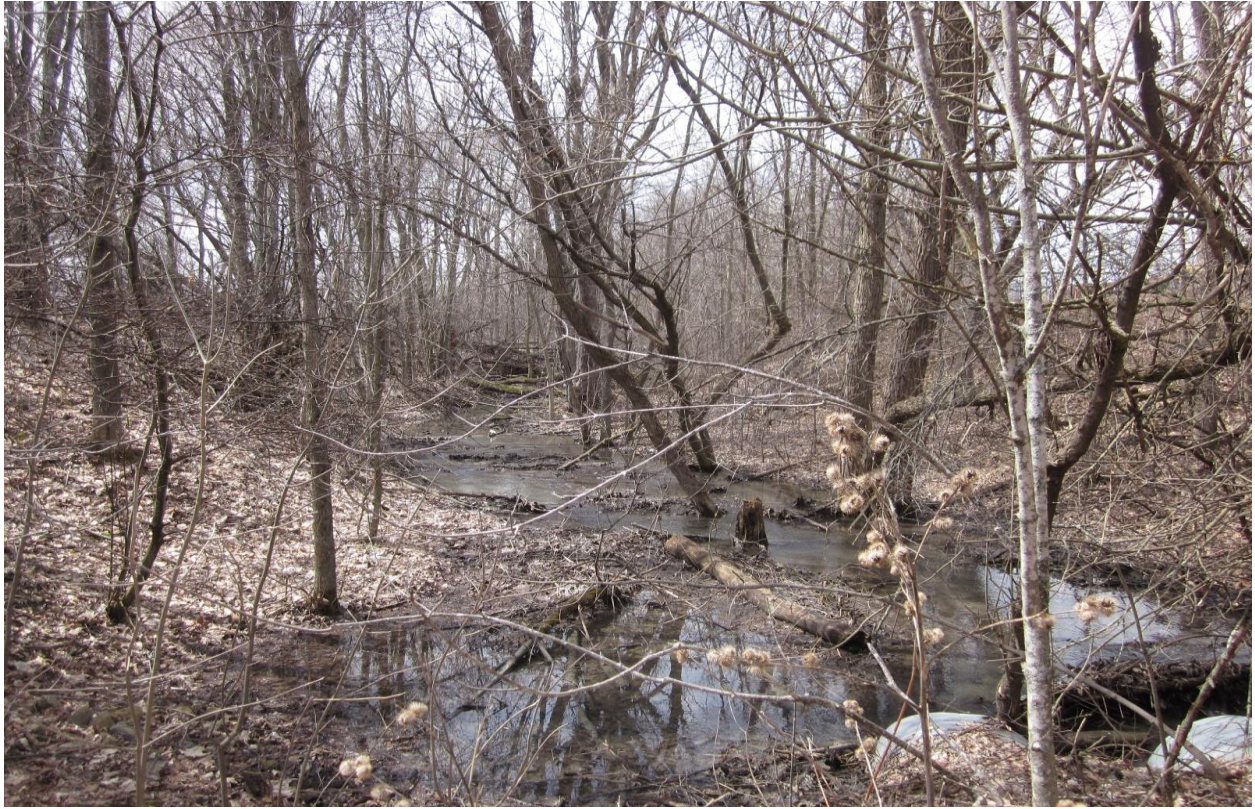
Picture 3. Forested riparian area at 2 Bill Leaham Drive

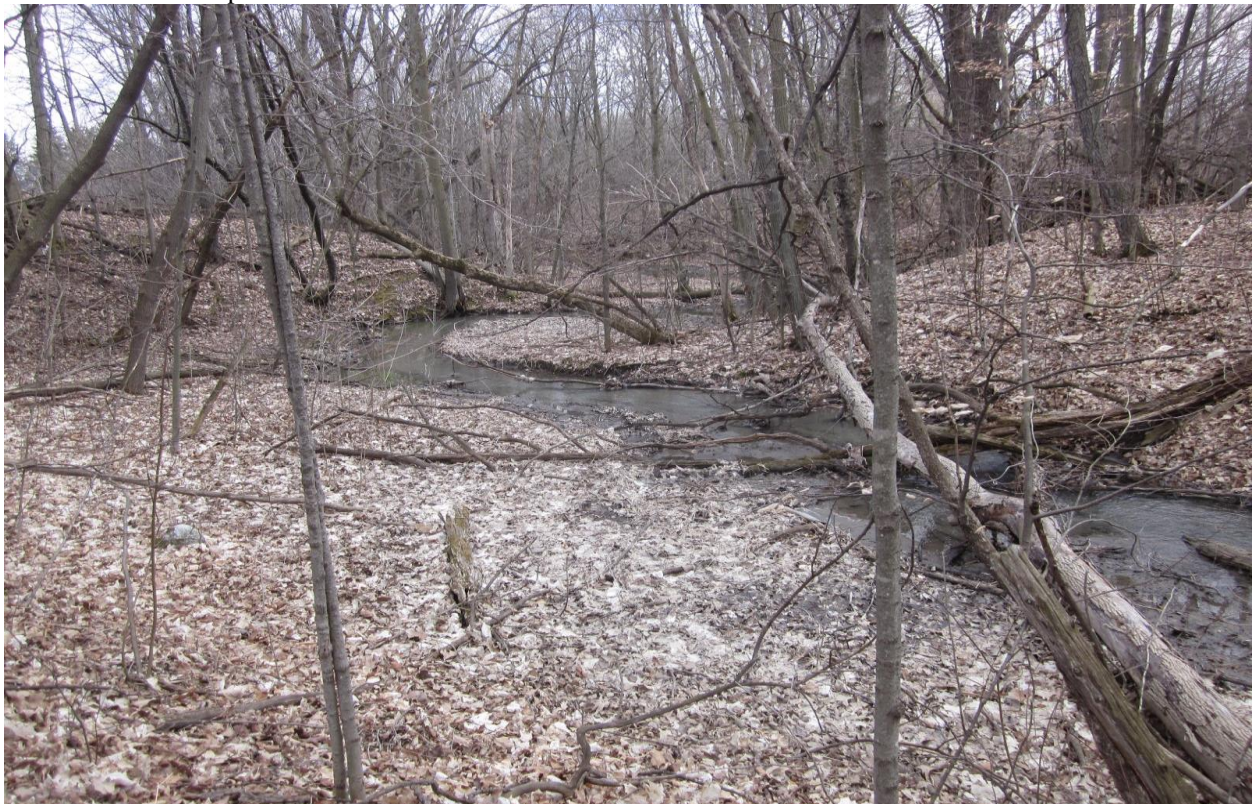
Picture 4. Forested riparian area at 2 Bill Leaham Drive
