SERVICING BRIEF AND GRADING & DRAINAGE REPORT

4 Range Road
Ottawa, Ontario

Report No. 20057

July 27, 2020

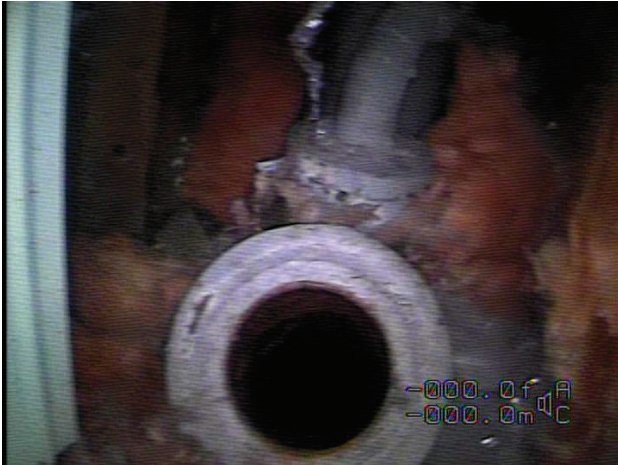
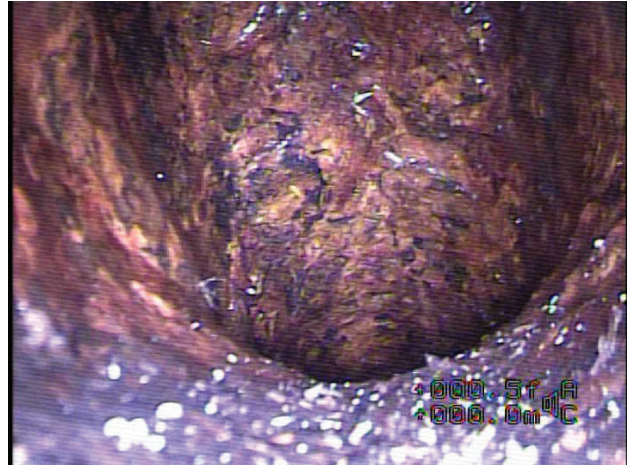
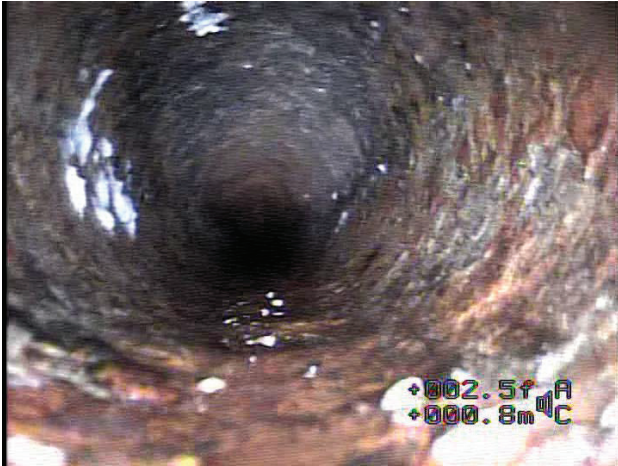
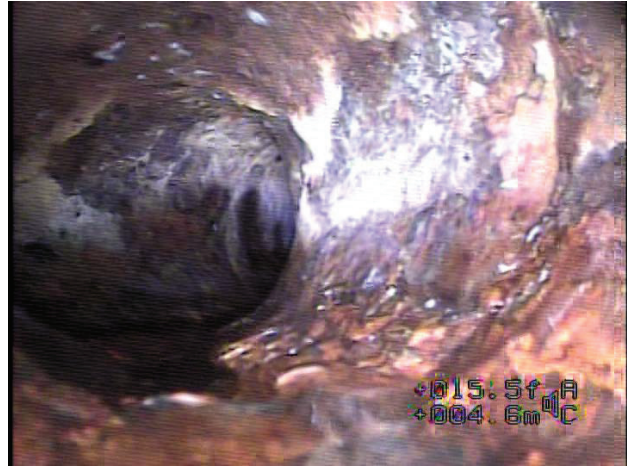
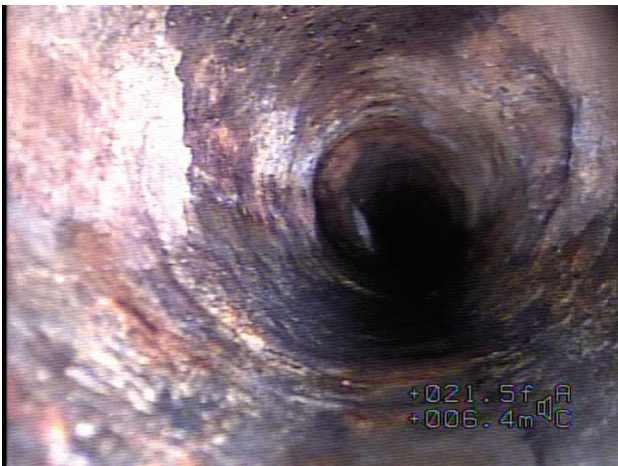
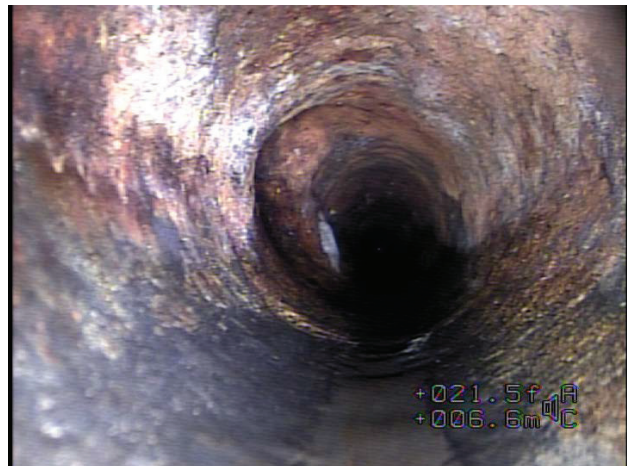
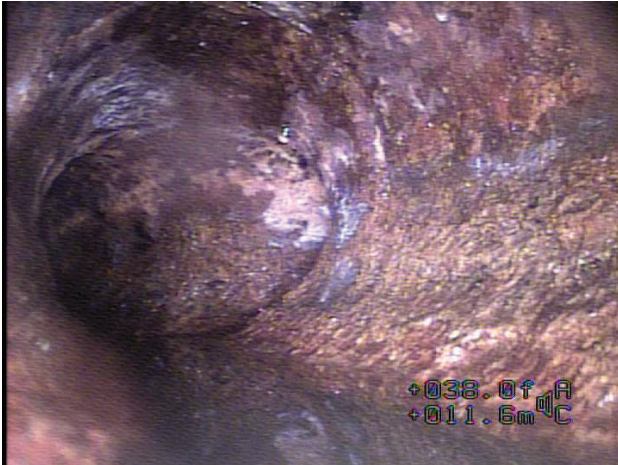
VIDEO 1

CUSTOMER:	Manfred	START OF INSPECTION:	0 Meters
JOB NO.:	93736	END OF INSPECTION:	12.0 Meters
LOCATION:	4 Range Rd OTTAWA, ONTARIO	SEWER USE:	Sanitary
DATE:	June 15 th , 2020	PIPE DIAMETER(S):	4"
OPERATOR:	Rick B	PIPE MATERIAL(S):	Cast Iron
		DIRECTION OF FLOW:	Downstream
		VIDEO FILENAME:	Video #1
		REPORT NUMBER:	1 of 2

DISTANCE (M)	CODE	INSPECTION COMMENTS	CODE	DESCRIPTION
0.0	C/O	START OF INSPECTION – CLEANOUT	AIF	ACTIVE INFILTRATION
0.2	LBD	Line Bends Down	BKJ	BROKEN JOINT

0.8	LBS	Line Bends Straight	BSG	START OF SAG
4.8	LBL	Line Bends Left	BWV	BACKWATER VALVE
5.0	WYE	TY Connection – Right	C/O	CLEANOUT
6.6	SC	Service Connection – 3 o'clock	CAL	CALCITE

6.8	SC	Service Connection – 9 o'clock	CFL	COLLAPSE
11.6	LBL	Line Bends Left	CRC	CIRCULAR CRACK
11.8	WYE	TY Connection – Left	DC	DIAMETER CHANGE
12.0	LBL	Line Bends Left	DEB	DEBRIS

12.0	END	END OF INSPECTION	DEF	PIPE DEFORMATION
			EIF	EVIDENCE OF INFILTRATION
			ESG	END OF SAG
			EXG	EXPOSED GASKET
			EXR	EXPOSED REBAR
			F/D	FLOOR DRAIN
			FRC	FRACTURE
			GRS	GREASE
			HOLE	HOLE IN PIPE
			LBD	LINE BENDS DOWN
			LBL	LINE BENDS LEFT
			LBR	LINE BENDS RIGHT
			LBS	LINE BENDS STRAIGHT
			LGC	LONGITUDINAL CRACK
			MAIN	MAIN SEWER IN BUILDING
			MC	MATERIAL CHANGE
			MH	MANHOLE
			MSP	MISSING PIPE PIECE
			OBS	OBSTRUCTION IN PIPE
			OFJ	OFFSET JOINT
			OPJ	OPEN JOINT
			PFL	PARTIAL COLLAPSE
			PSC	PROTRUDING CONNECTION
			PUN	PUNCTURE
			RTS	ROOTS
			SC	SERVICE CONNECTION
			WYE	WYE CONNECTION

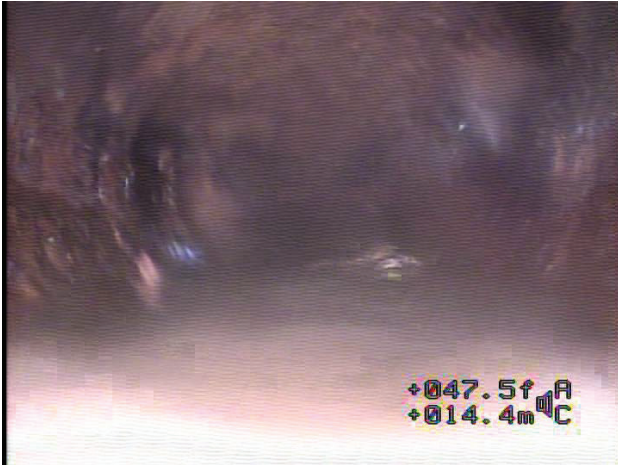
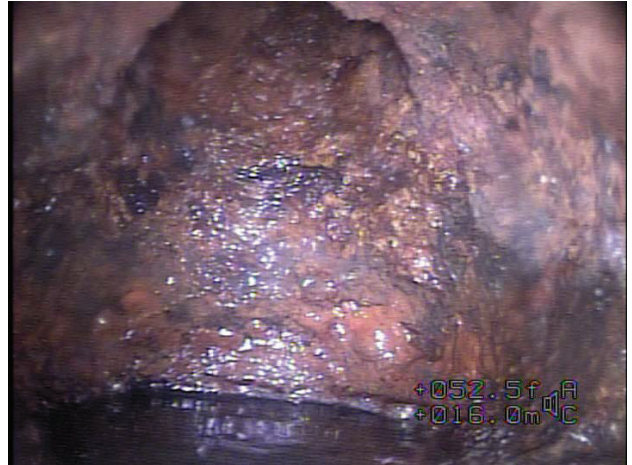
VIDEO 2

CUSTOMER:	Manfred	START OF INSPECTION:	12.0 Meters
JOB NO.:	93736	END OF INSPECTION:	16.0 Meters
LOCATION:	4 Range Rd OTTAWA, ONTARIO	SEWER USE:	Sanitary
DATE:	June 15 th , 2020	PIPE DIAMETER(S):	4"
OPERATOR:	Rick B	PIPE MATERIAL(S):	Cast Iron
		DIRECTION OF FLOW:	Downstream
		VIDEO FILENAME:	Video #2
		REPORT NUMBER:	2 of 2

DISTANCE (M)	CODE	INSPECTION COMMENTS	CODE	DESCRIPTION
12.0		START OF INSPECTION	AIF	ACTIVE INFILTRATION
14.6	SC	Service Connection – 9 o'clock	BKJ	BROKEN JOINT

16.0	LBD	Line Bends Down	BSG	START OF SAG
16.0	END	END OF INSPECTION – P Trap	BWV	BACKWATER VALVE
			C/O	CLEANOUT
			CAL	CALCITE
			CFL	COLLAPSE
			CRC	CIRCULAR CRACK
			DC	DIAMETER CHANGE
			DEB	DEBRIS
			DEF	PIPE DEFORMATION
			EIF	EVIDENCE OF INFILTRATION
			ESG	END OF SAG
			EXG	EXPOSED GASKET
			EXR	EXPOSED REBAR
			F/D	FLOOR DRAIN
			FRC	FRACTURE
			GRS	GREASE
			HOLE	HOLE IN PIPE
			LBD	LINE BENDS DOWN
			LBL	LINE BENDS LEFT
			LBR	LINE BENDS RIGHT
			LBS	LINE BENDS STRAIGHT
			LGC	LONGITUDINAL CRACK
			MAIN	MAIN SEWER IN BUILDING
			MC	MATERIAL CHANGE
			MH	MANHOLE
			MSP	MISSING PIPE PIECE
			OBS	OBSTRUCTION IN PIPE
			OFJ	OFFSET JOINT
			OPJ	OPEN JOINT
			PFL	PARTIAL COLLAPSE
			PSC	PROTRUDING CONNECTION
			PUN	PUNCTURE
			RTS	ROOTS
			SC	SERVICE CONNECTION
			WYE	WYE CONNECTION
