Tree Conservation Report Wateridge Village Phase 2B, Block 1

April 2020
Prepared for Uniform Developments

RE: Tree Conservation Report - Wateridge Village Phase 2B, Block 1

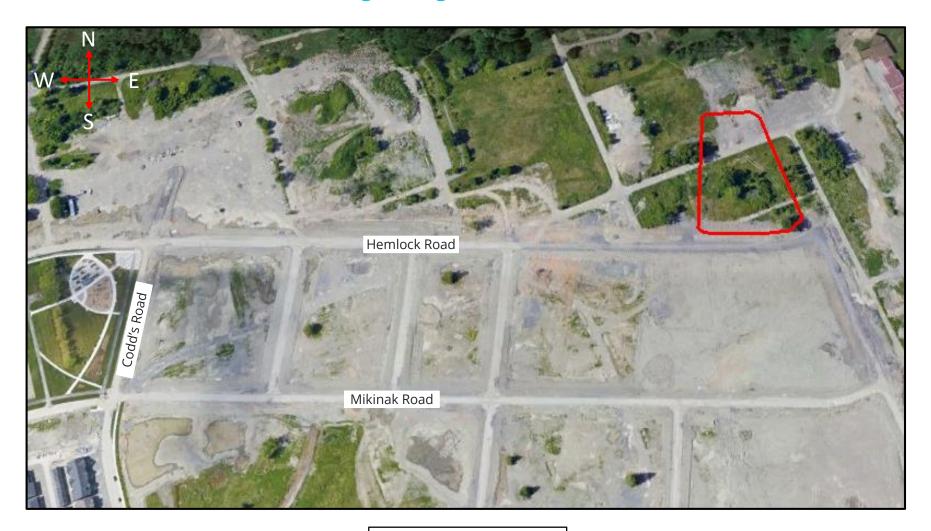
FIGURE 1: SITE OVERVIEW

Block 1 of Wateridge Village Phase 2B is approximately 1.1 ha in size (the Site) (Refer to Figure 1). Block 1 is located north of Hemlock Road. The Site elevation is approximately 93 m Above Sea Level (ASL) and the Site is predominantly flat and well drained. The areas immediately south and west of the Site were recently cleared of natural vegetation cover and graded. At the current time, the areas south and west of the Site consist primarily of compacted gravel and crushed concrete. The areas east and north of the Site were historically developed as part of the former CFB Rockcliffe. The areas east and north of the Site have been extensively disturbed by demolition and remediation activities, and currently include limited areas of natural vegetation. As described below, Block 1 itself has been cleared of all tree coverage and currently consists primarily of compacted gravel and crushed concrete.

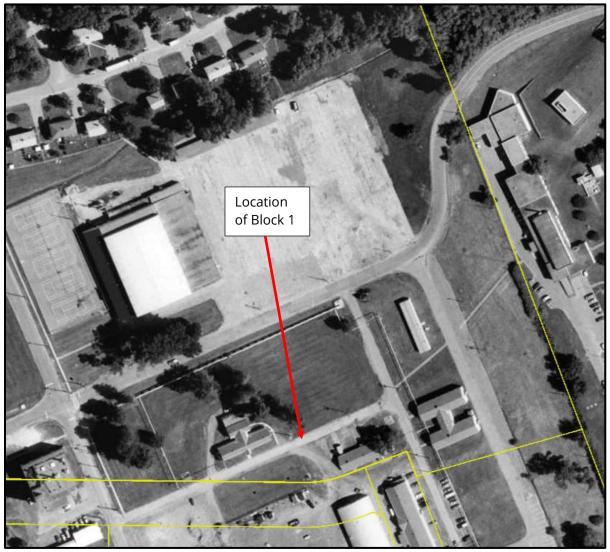
Historic Air Photograph 1: Historic Air Photo from 1991. In 1991, Block 1 was developed as part of the former CFB Rockcliffe, with several buildings present (Photo from City of Ottawa 2020).

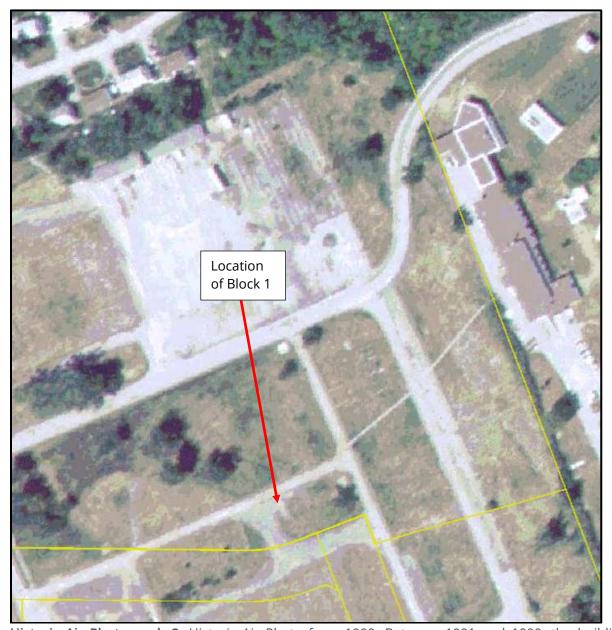
Historic Air Photograph 2: Historic Air Photo from 1999. Between 1991 and 1999, the buildings within Block 1 were demolished. Negligible tree cover is present adjacent to Block 1 in 1999 (Photo from City of Ottawa 2020).

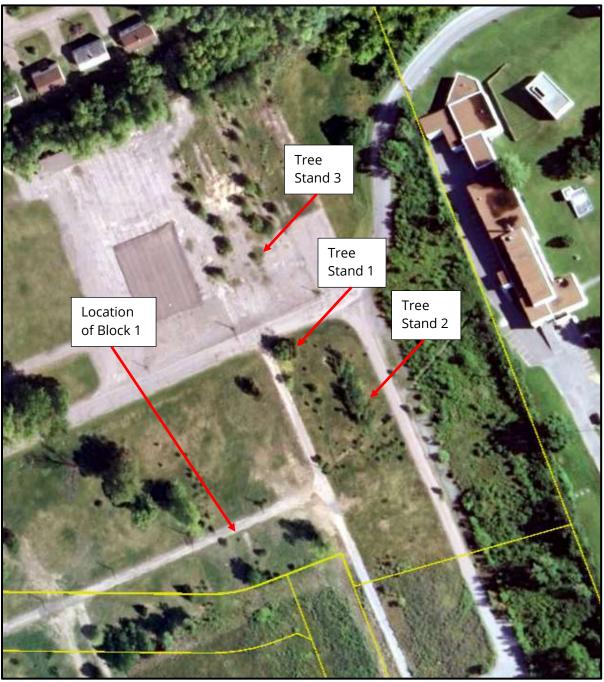
Historic Air Photograph 3: Historic Air Photo from 2008. In 2008, young recent regrowth trees and shrubs are present in the locations currently occupied by Tree Stand 1, Tree Stand 2, and Tree Stand 3 (Photo from City of Ottawa 2020).

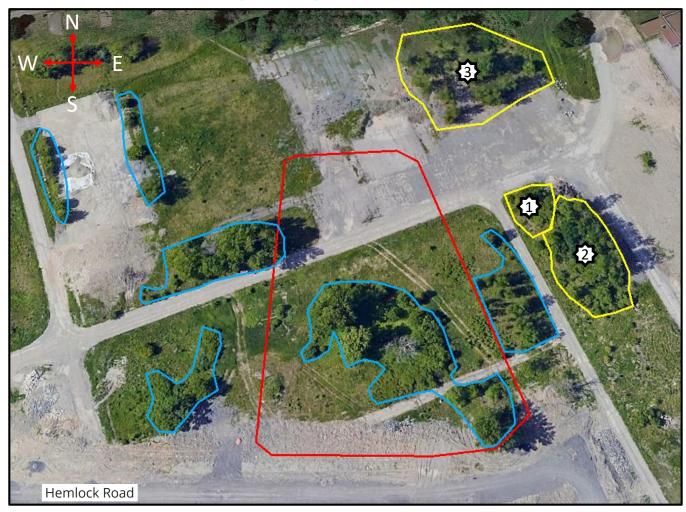
FIGURE 2: VEGETATION FEATURES

Photographs of the Site are included below. As shown below in Figure 2, until recently several trees and tree stands were present within Block 1 and within the area immediately to the west. During the April 2020 site visit, the areas immediately south and west of the Site were observed to have been recently cleared of natural vegetation cover and graded. At the current time, the areas south and west of the Site consist primarily of compacted gravel and crushed concrete. Block 1 itself was also recently cleared of all trees and shrubs, and currently consists primarily of compacted gravel and crushed concrete.

Several tree stands are present in the vicinity of the Site to the east and north of Block 1. The areas east and north of the Site were historically developed as part of the former CFB Rockcliffe. Although several tree stands are present, the areas east and north of the Site have been extensively disturbed by demolition and remediation activities. As described above, the oldest trees found east and north of the Site are approximately fifteen (15) years of age. None of the tree stands are large enough to qualify as forest or woodlot habitats, and therefore a Significant Woodlot assessment was not required. The tree stands found east and north of the Site include the following:

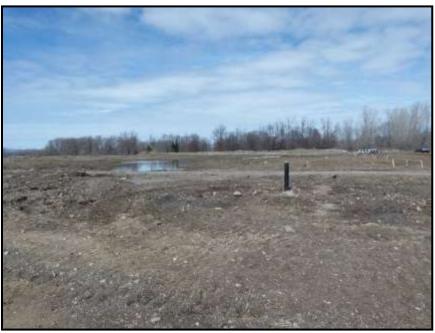
Photograph 1: Looking north across Block 1 (April 4th, 2020).

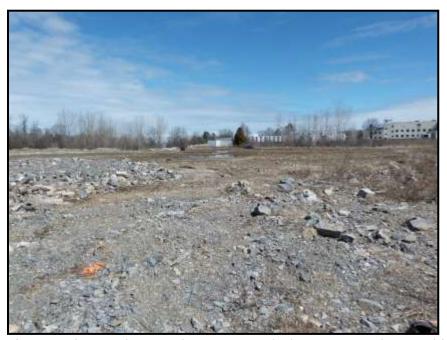
Photograph 2: Looking northeast across Block 1. Tree Stand 1 is visible in the background (April 4th, 2020).

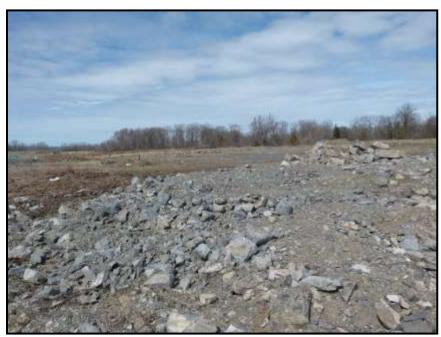
Photograph 3: Looking west across Block 2, which is located immediately west of Block 1. The area shown previously included a Butternut Tree (discussed below) (April 4th, 2020).

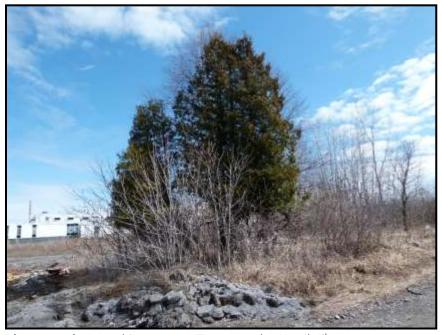
- Tree Stand 1: Tree Stand 1 is present east of Block 1. Tree Stand 1 includes seven (7) White Cedar (*Thuja occidentalis*) stems that vary in size between 10 cm and 25 cm diameter at breast height (dbh). There are also four (4) Basswood (*Tilia americana*) stems measuring 17 cm, 23 cm, 27 cm, and 35 cm dbh in size. Shrub cover within Tree Stand 1 and the adjacent Tree Stand 2 includes Staghorn Sumac (*Rhus typhina*), Red Osier Dogwood (*Cornus sericea*), young American Elm (*Ulmus americana*) stems (<10 cm dbh).

Photograph 4: Looking east at Tree Stand 1 (April 4th, 2020).

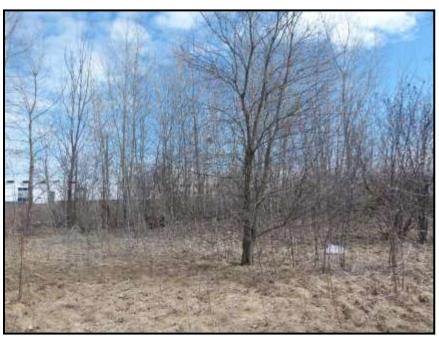
- Tree Stand 2: Tree Stand 2 is dominated by Trembling Aspen (*Populus tremuloides*), with some White Birch (*Betula papyrifera*) and American Elm present. The trees within Tree Stand 2 vary in size between 10 cm and 30 cm dbh.

Photograph 5: Looking east at Tree Stand 2 (April 4th, 2020).

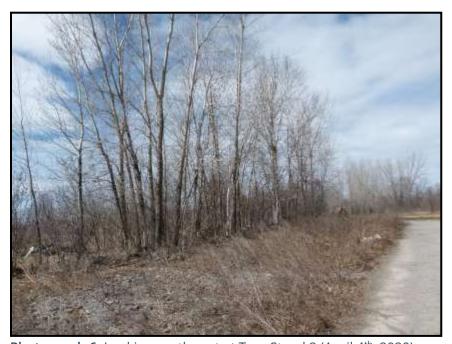
Photograph 6: Looking northwest at Tree Stand 2 (April 4th, 2020).

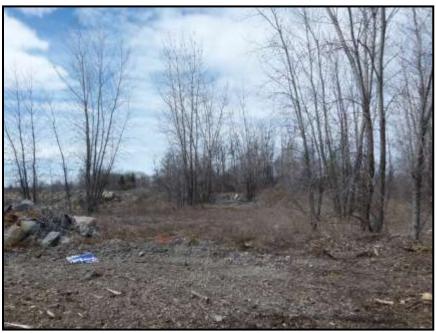
- Tree Stand 3: Tree Stand 3 consists of several small groups of trees that predominantly include Trembling Aspen, although several White Ash and American Elm are also present. The trees within Tree Stand 3 vary in size between 10 cm and 30 cm dbh.

Photograph 7: Looking west at Tree Stand 3 (April 4th, 2020).
