TREE CONSERVATION REPORT

APARTMENT BUILDING DEVELOPMENT

DUNBAR COURT

October 21, 2020

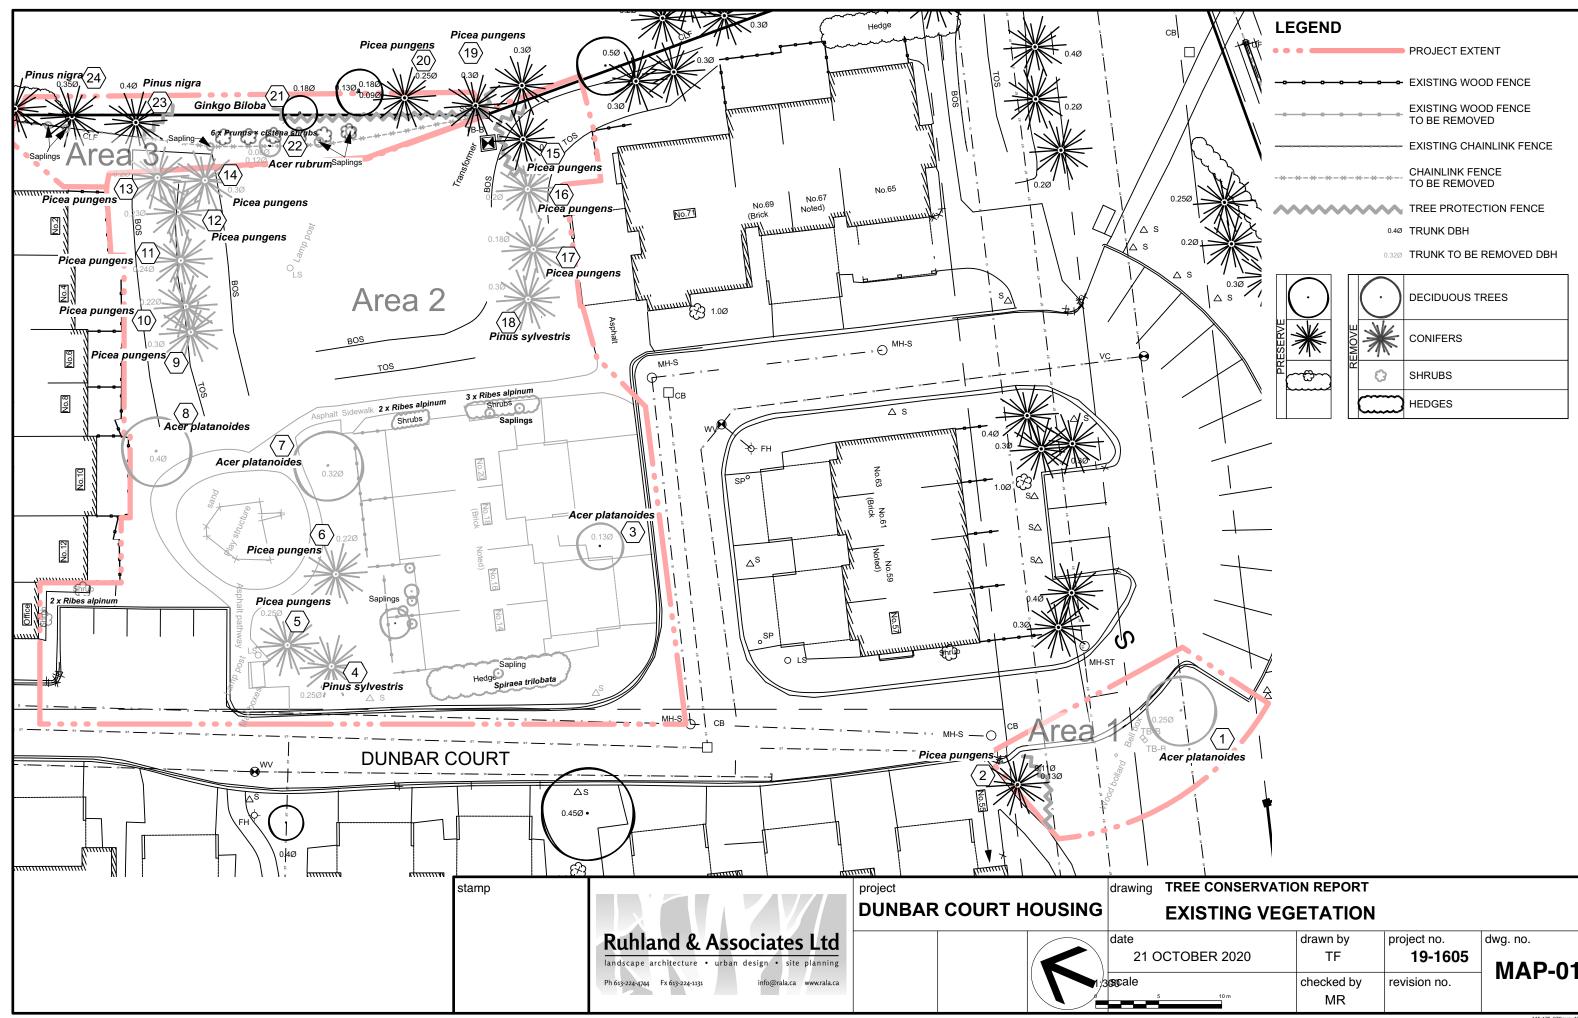
EE	CONSERVATION REPORT
(IS	TING VEGETATION

PLANT ID #	SIZE DBH* / ht. (cm)	COMMON NAME	BOTANICAL NAME	DISTINCTIVE	CONDITION	COMMENTS	ACTION	RATIONALE
AREA 1								
1	25	Norway Maple	Acer plantanoides		Р	Poor, thinning, large scar @±2m - diseased?	Remove	In middle of new parking
2	13,11	Blue/Colorado Spruce	Picea pungens		G	Unpruned, split @±0.5m, leader cut?	Preserve if feasible	Review excavation limits / grade changes at time of construction
AREA 2								
3	13	Norway Maple	Acer plantanoides		F	Unpruned volunteer	Remove	In hardscape footprint
4	25	Scots Pine	Pinus sylvestris		Р	Split @±2m, very sparse	Remove	In hardscape footprint, poor condition
5	25	Blue/Colorado Spruce	Picea pungens		G		Remove	In hardscape footprint
6	22	Blue/Colorado Spruce	Picea pungens		G		Remove	In building footprint
7	32	Norway Maple	Acer plantanoides		F	Thinning centre of crown, tourniquet on major branch	Remove	In building footprint
8	40	Norway Maple	Acer plantanoides		E	-	Remove	In hardscape footprint

9	30	Blue/Colorado Spruce	Picea pungens		G		Remove	In building footprint
10	22	Blue/Colorado Spruce	Picea pungens		G		Remove	In building footprint
11	24	Blue/Colorado Spruce	Picea pungens		Р	Very sparse pale needles	Remove	In building footprint
12	23	Blue/Colorado Spruce	Picea pungens		G		Remove	In building footprint
13	20	Blue/Colorado Spruce	Picea pungens		Р	Stunted, sparse branches	Remove	In building footprint, poor condition,
14	30	Blue/Colorado Spruce	Picea pungens		G	15º slant at base	Remove	In building footprint
15	30	Blue/Colorado Spruce	Picea pungens		F	On slope	Preserve if feasible	Review excavation limits / grade changes at time of construction
16	20	Blue/Colorado Spruce	Picea pungens		F	On slope	Remove	In building footprint
17	18	Blue/Colorado Spruce	Picea pungens		F	On slope	Remove	In building footprint
18	30	Scots Pine	Pinus sylvestris		F	Sparse, browning needles, 10° slant at base	Remove	In building footprint

AREA 3								
19	30	Blue/Colorado Spruce	Picea pungens		Р	Some needle browning	Preserve	Next property, good size
20	25	Blue/Colorado Spruce	Picea pungens		G	Heavy pruning north side, some browning	Preserve	Next property, good tree
21	18,13,9	Maidenhair tree	Ginkgo biloba		G	Spindly leader, just other side of property line	Preserve	Next property, good tree
22	12,6	Red Maple	Acer rubrum		F	Volunteer, unpruned, multistem	Remove	Volunteer, poor habit, on old fence to be removed.
23	40	Austrian Pine	Pinus nigra		F	Split trunk about 2/3 up. Slight needle browning	Preserve	Fair condition, good size
24	35	Austrian Pine	Pinus nigra			Slight needle browning	Preserve	Fair condition, good size
					CONDITION
