URBAN FORESTRY & FOREST MANAGEMENT CONSULTING

September 22, 2020

RE: TREE CONSERVATION REPORT FOR 320 MCRAE AVENUE, OTTAWA

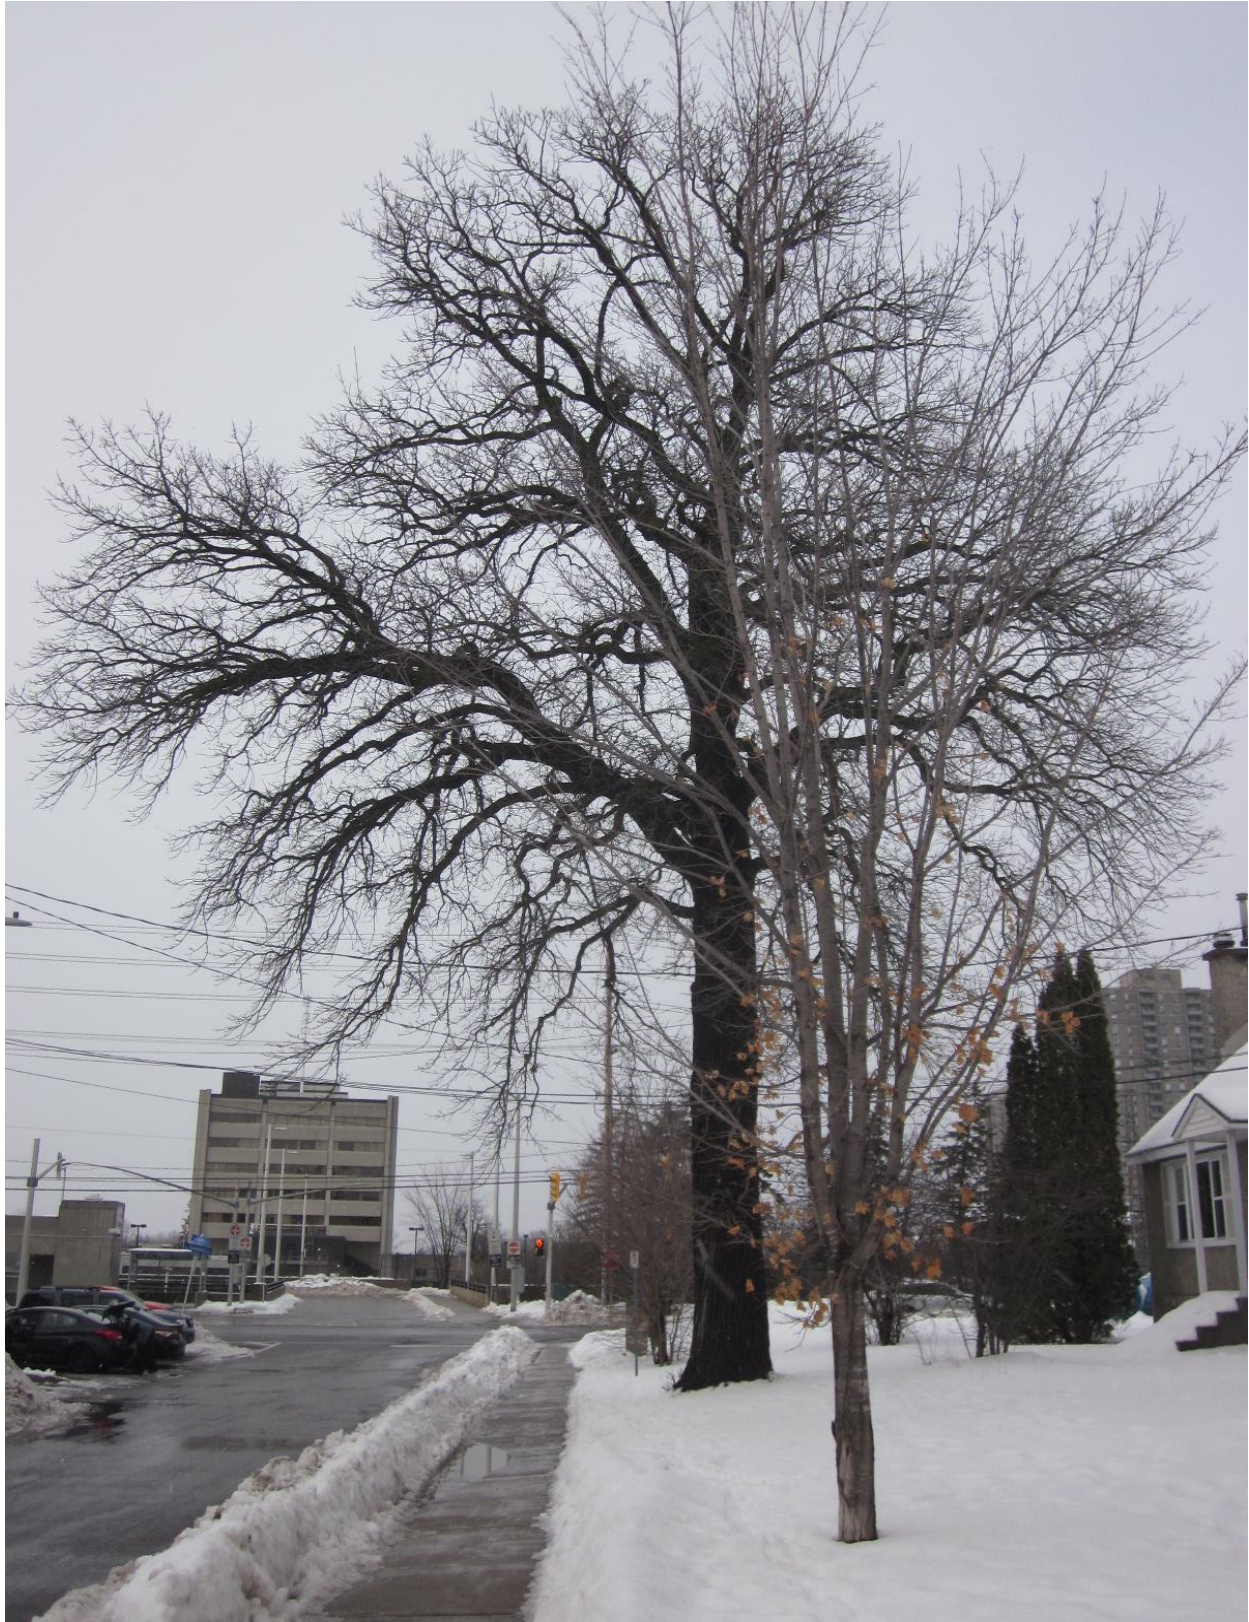
Picture 1. Sugar maple (tree #1 – in foreground) and bur oak (#2) adjacent to the development site.

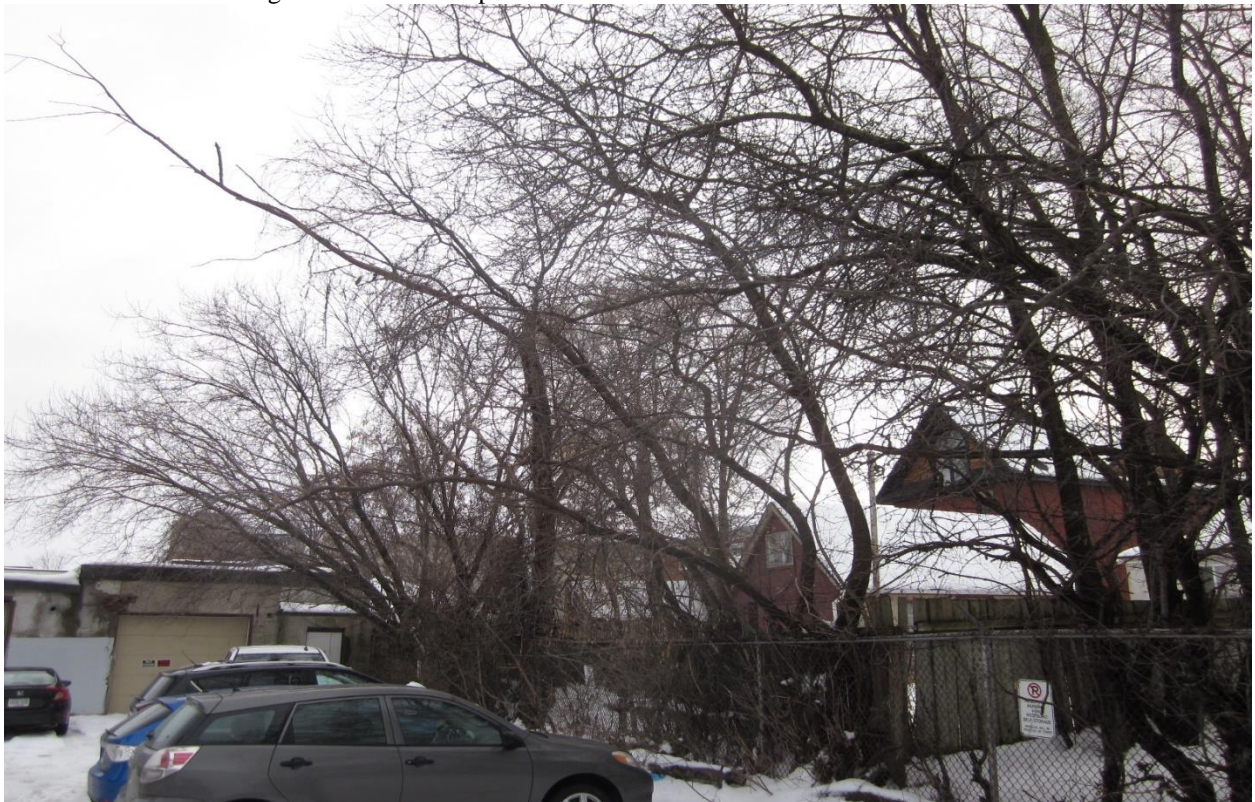
Picture 3. Trees #8 through 14 along property line of the development site (in distance stems of tree #14 far overhang property line).

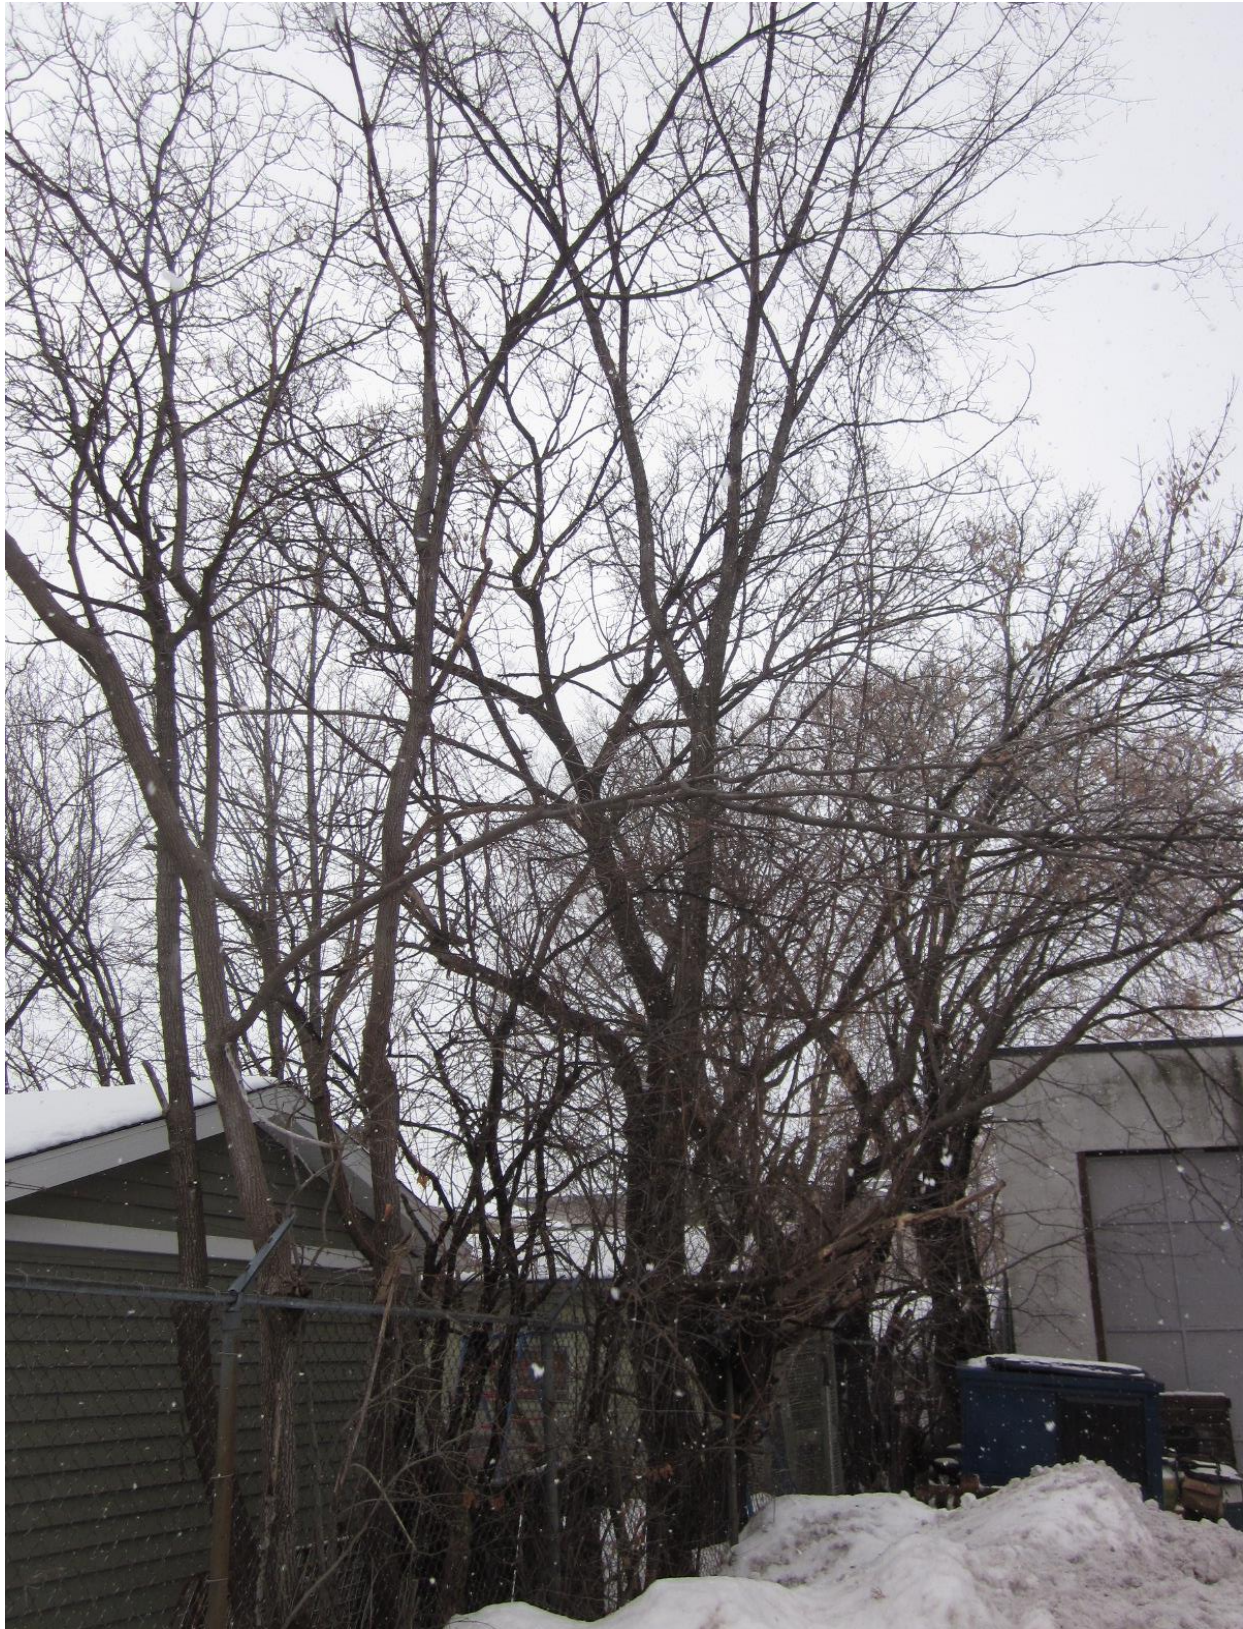
Picture 4. Tree grouping #16 on far side of property line of the development site (most trees overhang property line).

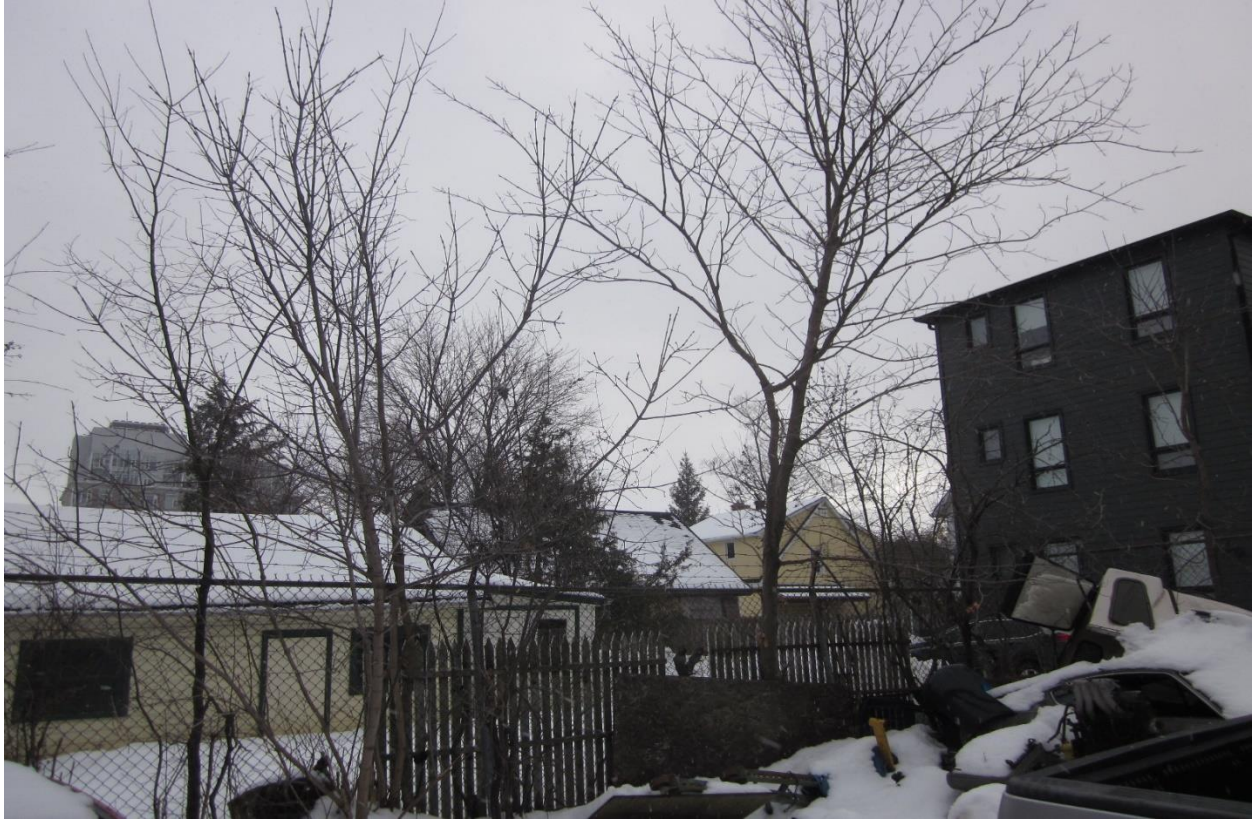
Picture 5. Trees #15, 16 and 17 on the development site.

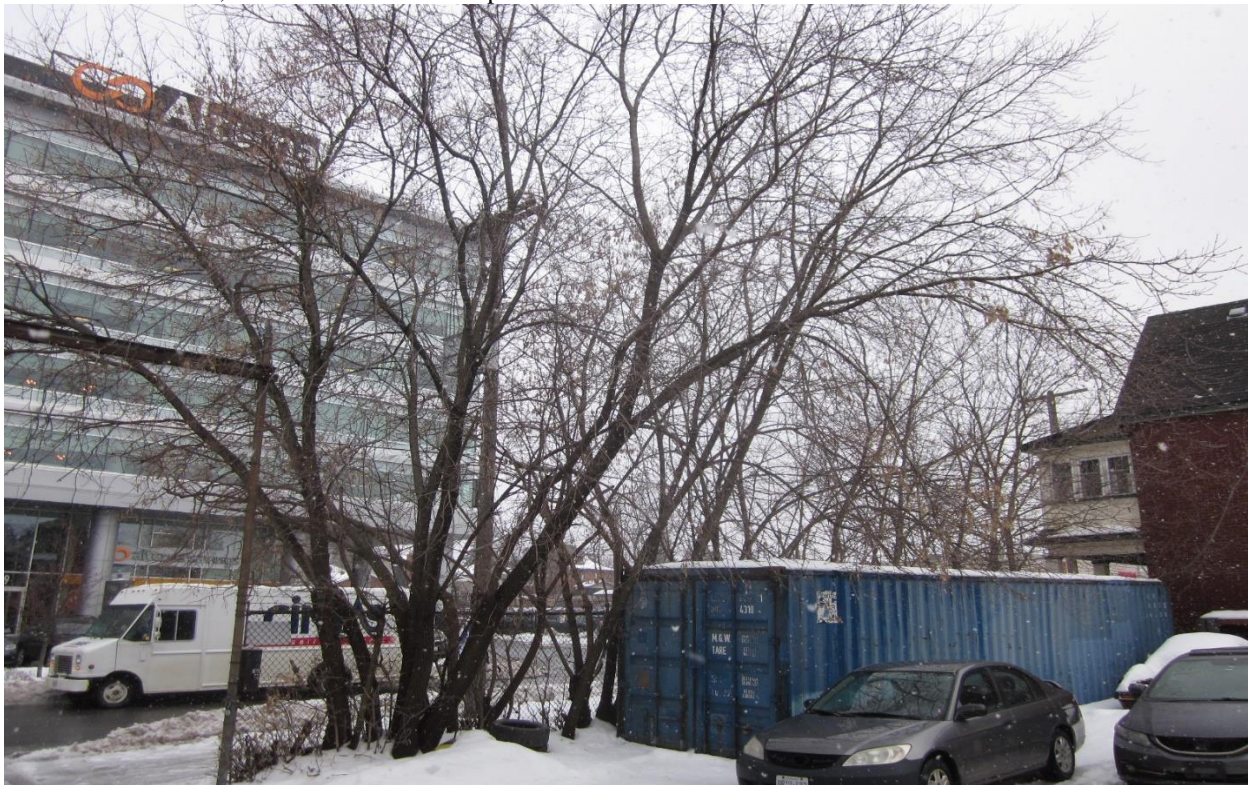
Picture 6. Tree grouping #19 on the development site
