244 Fountain Place Tree Conservation Report

244 Fountain Place, Ottawa Proposed Apartment Building Project 160401234

Prepared for: TC United Group

Prepared by: Stantec Consulting Ltd.

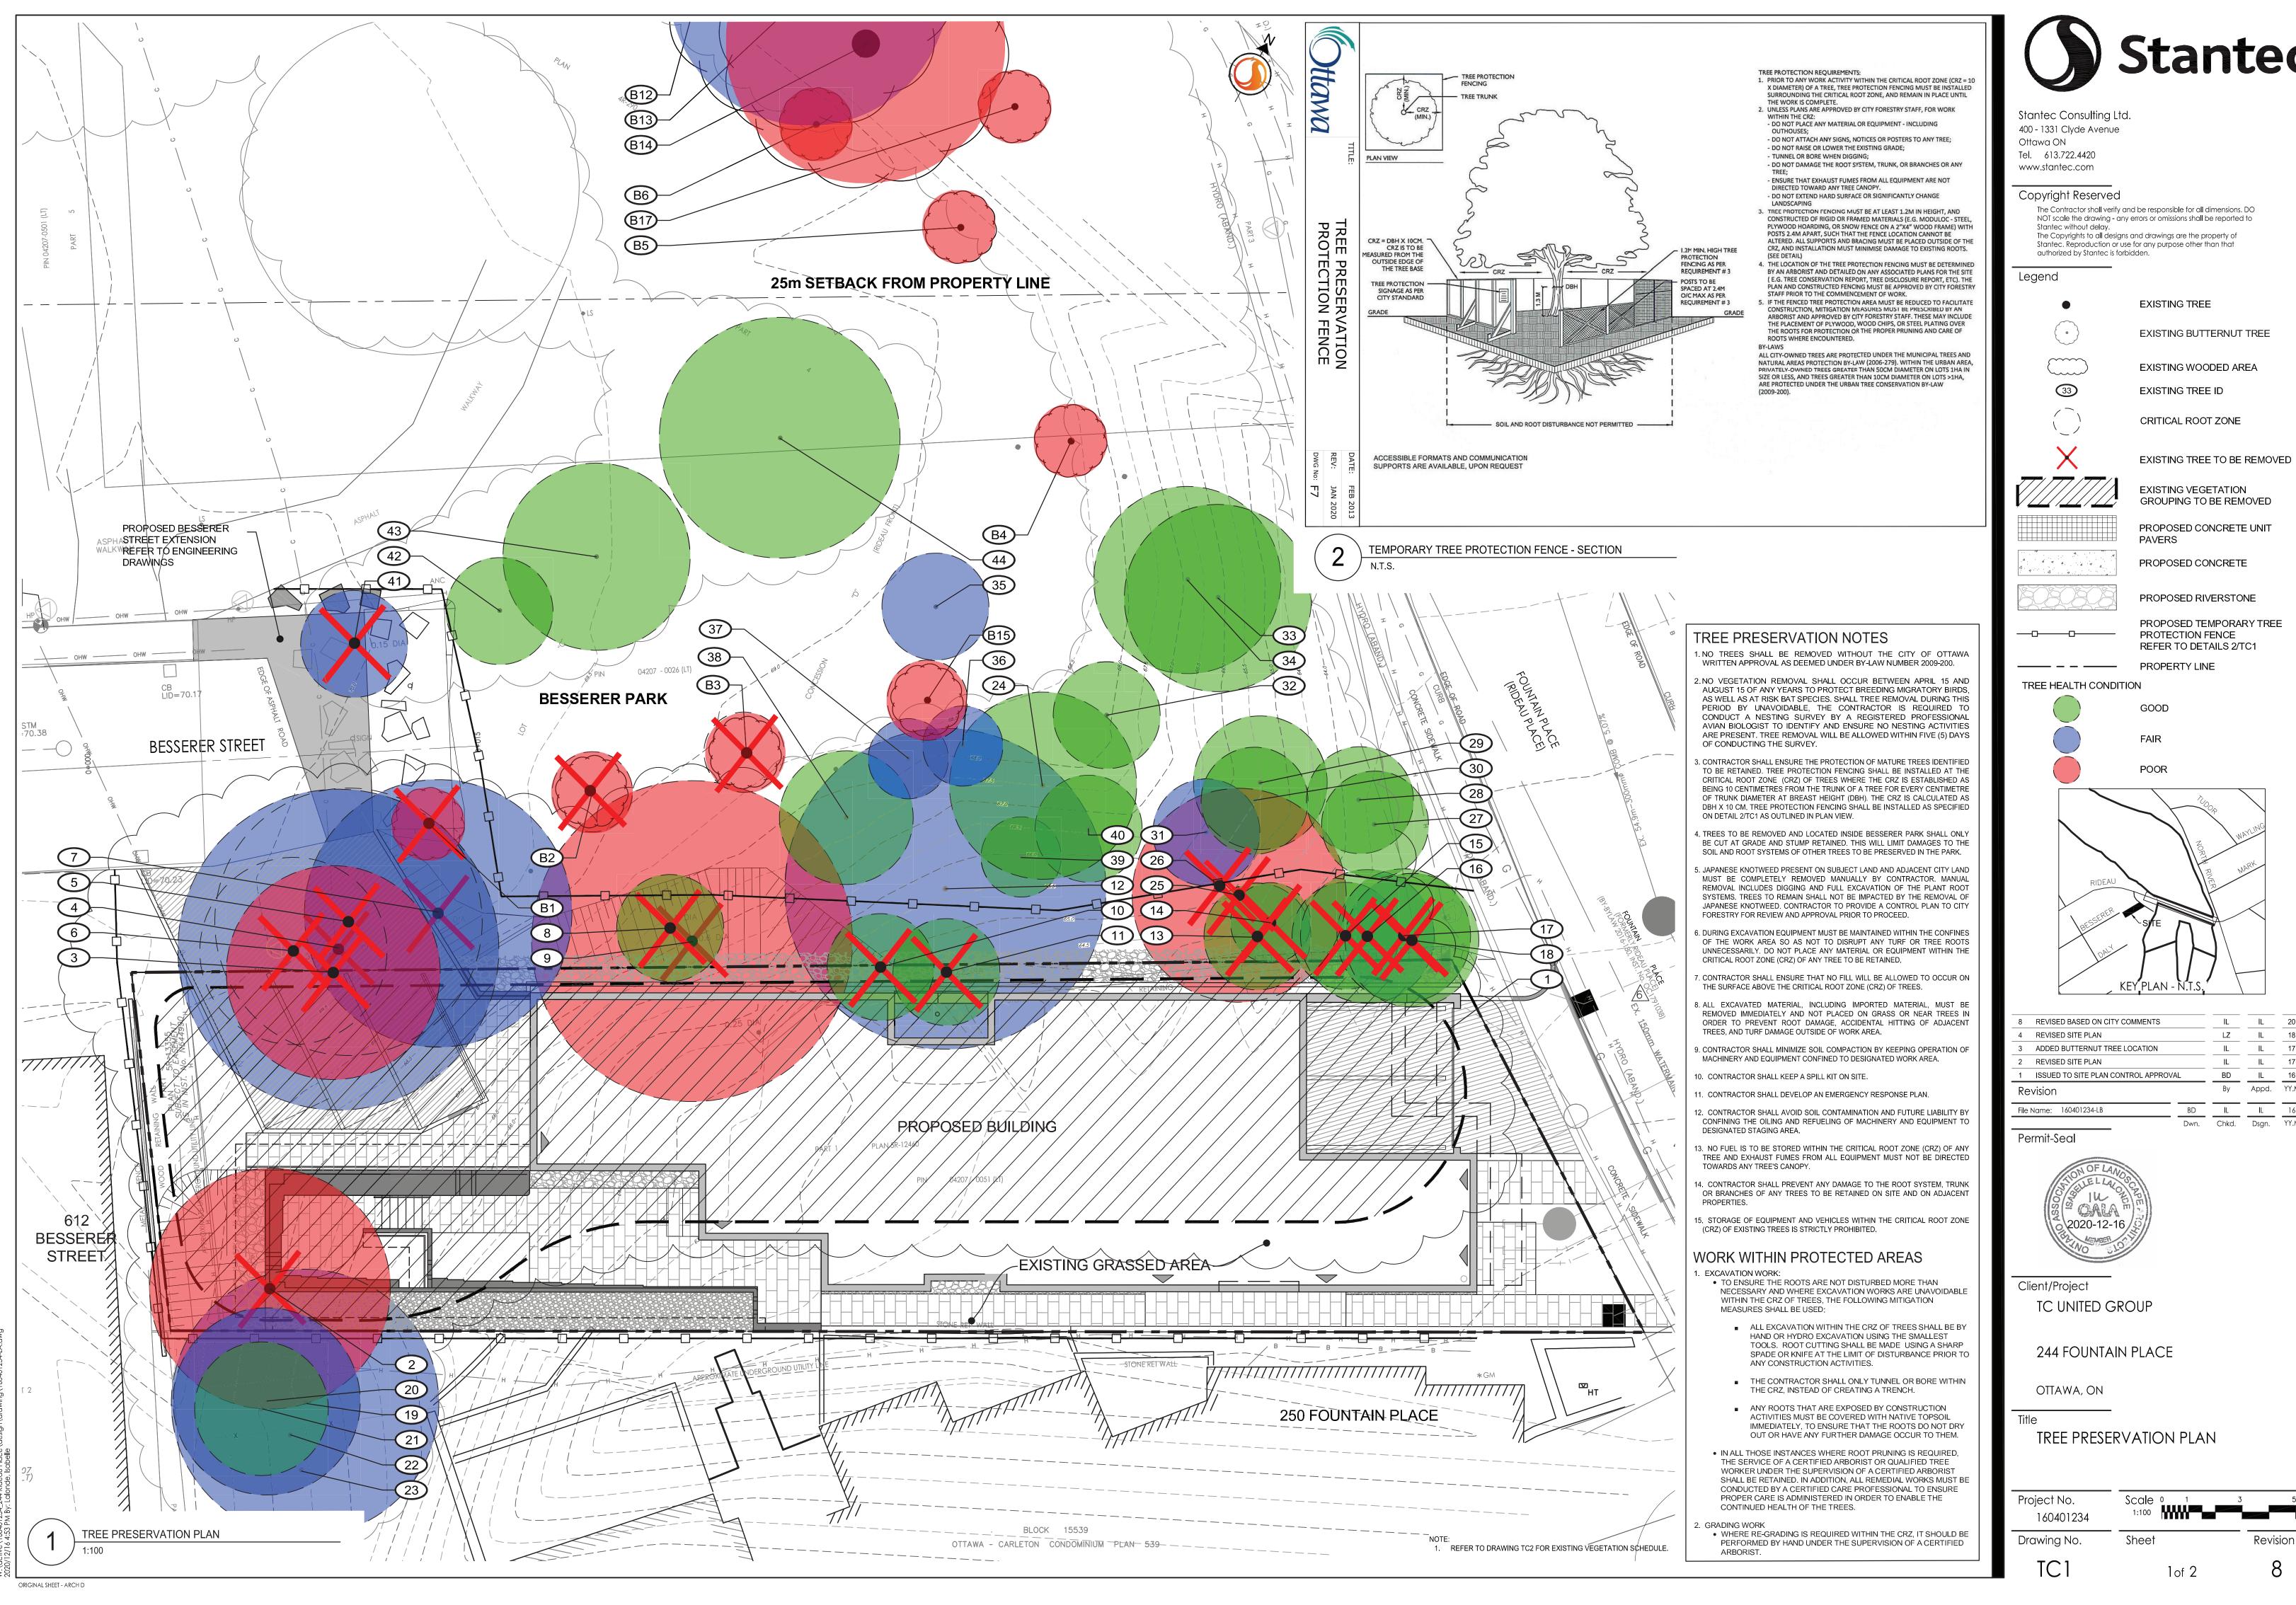
ſ			
	EXISTING VEGETATION TREE ASSESSMENTS CONDUCTED	SCH	EDULE
	April 20, 2016, September 19, 2019, June 22,2017 (Butternut DIAMETER AT BREAST HEIGHT (cm	ΗΕΔΙ ΤΗ	
	Acer negundo / Manitoba Maple - 45% Acer platanoides / Norway Maple - 45% 1 Populus grandidentata / Large tooth aspen - 1% Rhamnus cathartica / Buckthorn - 6% Ulmus americana / American Elm - 3%	Good to Poor t Dead	Grouping of trees; A number of trees are dead or in poor condition; GROUPING TO BE REMOVED TO ALLOW FOR CONSTRUCTION OF BUILDING
	RIDEAU STREET 2 Acer negundo / Manitoba Maple 50 3 Acer negundo / Manitoba Maple 40	Fair to Poor	TO BE REMOVED Growing on the slope; Tree is falling towards 244 Fountain Place with large crack in the trunk; TO BE REMOVED TO ALLOW CONSTRUCTION OF NEW
	4 Acer negundo / Manitoba Maple 60	Fair	PARKING AREA Municipal tree (Besserer Park); Tree growing on top of slope; Tree is standing with some pruning; tree is leaning towards Hydro Pole; TO BE REMOVED TO ALLOW CONSTRUCTION OF NEW PARKING AREA

5 Acer negundo / Manitoba Maple 50	Dead	Municipal tree (Besserer Park); Tree fell inside the park (spring 2020); TO BE REMOVED
	6 Acer negundo / Manitoba Maple 40	Poor	Municipal tree (Besserer Park); Growing on top of slope; Bark is pealing; Rotted; Damaged by wildlife; Leader was pruned in the past approximately 6m above ground; TO BE REMOVED TO ALLOW CONSTRUCTION OF NEW PARKING AREA
	7 Acer negundo / Manitoba Maple 50	Fair	Municipal tree (Besserer Park); Growing on top of slope; Tree is leaning towards 244 Fountain Place; Tree opens up into 2 leaders at approximately 2m above ground; large stem at 1m from base was pruned back in the past; TO BE REMOVED TO ALLOW CONSTRUCTION OF NEW PARKING AREA
		Good	Municipal tree (Besserer Park); Growing on a slope; TO BE REMOVED DUE TO REGRADING
	Som SETBACK FROM PROPERTY LINE 9 Acer negundo / Manitoba Maple 50 PART 2	Fair to Poor	Municipal tree (Besserer Park); Growing on a slope; Large 40cm branch broke naturally and fell inside 244 Fountain Place with lenght of branch extending entire width of property; Other smaller branches are broken due to this failure; Other dead branches are visible at top of tree; TO BE REMOVED DUE TO REGRADING

10 Acer platanoides / Norway Maple 20	Good	Tree on property line; Growing on a slope; TO BE REMOVED
	11 Acer platanoides / Norway Maple 20	Good	Growing on slope adjacent to existing stone retaining wall to be removed; TREE TO BE REMOVED
	12 Acer negundo / Manitoba Maple 60	Fair	Municipal tree (Besserer Park); Growing on slope; Broken branches; Leaning towards park; TREE TO BE PROTECTED
	13 Acer platanoides / Norway Maple 20	Good	Municipal tree (Besserer Park); Adjacent to existing stone wall to be removed; TREE TO BE REMOVED
	14 Acer platanoides / Norway Maple 15; 20	Good	Municipal tree (Besserer Park); 2 trunks; TREE TO BE REMOVED
	15 Ulmus americana / American Elm 20	Good	Municipal tree (Besserer Park); Adjacent on/in existing stone wall to be removed; TREE TO BE REMOVED
	16 Ulmus americana / American Elm 25	Good	Municipal tree (Besserer Park); Adjacent on/in existing stone wall to be removed; 2 trunks; TREE TO BE REMOVED

boy-0022 (II) 17 Ulmus americana / American Elm 25	Good	Municipal tree (Besserer Park); Adjacent on/in existing stone wall to be removed; TREE TO BE REMOVED
	25 STOREY NOTE: 18 Ulmus americana / American Elm 25 NOTE:	Good	Municipal tree (Besserer Park); Adjacent on/in existing stone wall to be removed; TREE TO BE REMOVED
	DATA RELATED TO BUTTERNUT TREES WERE PROVIDE BY ANDREW BOYD, CONSULTING REFER TO TREE CONSERVATION REPORT FOR BUTTERNUT TREE HEALTH ASSESSMEN 1. DATA RELATED TO BUTTERNUT TREE HEALTH ASSESSMENT 1. DATA RELATED TO BUTTERNUT TREE HEALTH ASSESSMENT 1. DATA RELATED TO BUTTERNUT TREE HEALTH ASSESSMENT 1. DATA RELATED TO BUTTERNUT		WITH IFS ASSOCIATES INC.
9> 1.04.04.04.04.04.04.04.04.04.04.04.04.04.	PROPOSE B BUYENIS BY STREET BY	A STATE OF THE STA	
120/12/16 4:54 PM By: Lalonde, Isabelle	PART 2 PART 2 PART 2 PART 2 PROBLEM TO THE ENGINE ONLY FILL PROBLEM TO THE ENGINE ONLY FIL	E. P.

19	Acer negundo / Manitoba Maple	50	Fair	250 Fountain Place; TO BE PROTECTED
20	Acer negundo / Manitoba Maple	35	Fair	250 Fountain Place; TO BE PROTECTED
21	Acer negundo / Manitoba Maple	20	Good	250 Fountain Place; TO BE PROTECTED
22	Acer negundo / Manitoba Maple	40	Good	250 Fountain Place; TO BE PROTECTED
23	Acer negundo / Manitoba Maple	25	Good	250 Fountain Place; TO BE PROTECTED
24	Acer platanoides / Norway Maple	35	G000	Municipal tree (Besserer Park); TREE TO BE PROTECTED
25	Acer platanoides / Norway Maple	40	Fair to Poor	Municipal tree (Besserer Park); Growing on slope; Cankered tree; TO BE REMOVED
26	Acer platanoides / Norway Maple	40	Dead	Municipal tree (Besserer Park); TO BE REMOVED
27	Acer platanoides / Norway Maple	11	Good	Municipal tree (Besserer Park); Growing on slope facing Fountain Place; TO REMAIN
28	Acer platanoides / Norway Maple	11	Good	Municipal tree (Besserer Park); Growing on slope facing Fountain Place; TO REMAIN

39	Acer platanoides / Norway Maple	10	Good	Municipal tree (Besserer Park); TO REMAIN
40	Acer platanoides / Norway Maple	20	Good	Municipal tree (Besserer Park); TO REMAIN
41	Ulmus americana / American Elm	15	Fair	Municipal tree (Besserer Park); Broken branches; TO B REMOVED DUE TO BESSERER STREET MODIFICATIONS
42	Ulmus americana / American Elm	15	Good	Municipal tree (Besserer Park); TO REMAIN
43	Acer rubrum / Red Maple	35	Good	Municipal tree (Besserer Park); TO REMAIN
44	Acer rubrum / Red Maple	60	Good	Municipal tree (Besserer Park); TO REMAIN
B1 to B3	Juglans cinerea / Butternut	n/a	Dead or Missing	Municipal trees (Besserer Park); Planted saplings; TO BE REMOVED.
B4	Juglans cinerea / Butternut	1	Poor	Municipal trees (Besserer Park); Planted saplings; Tree#2 of the Butternut Health Assessor's Report dated July 27, 2020; Excavation within 50m of tree; Category 1
B5 to B9	Juglans cinerea / Butternut	n/a	Dead or Missing	Municipal trees (Besserer Park); Planted saplings
