244 Fountain Place Tree Conservation Report

244 Fountain Place, Ottawa Proposed Apartment Building Project 160401234

Prepared for: TC United Group

Original Submission: October 19, 2016 Revised Report: October 16, 2020

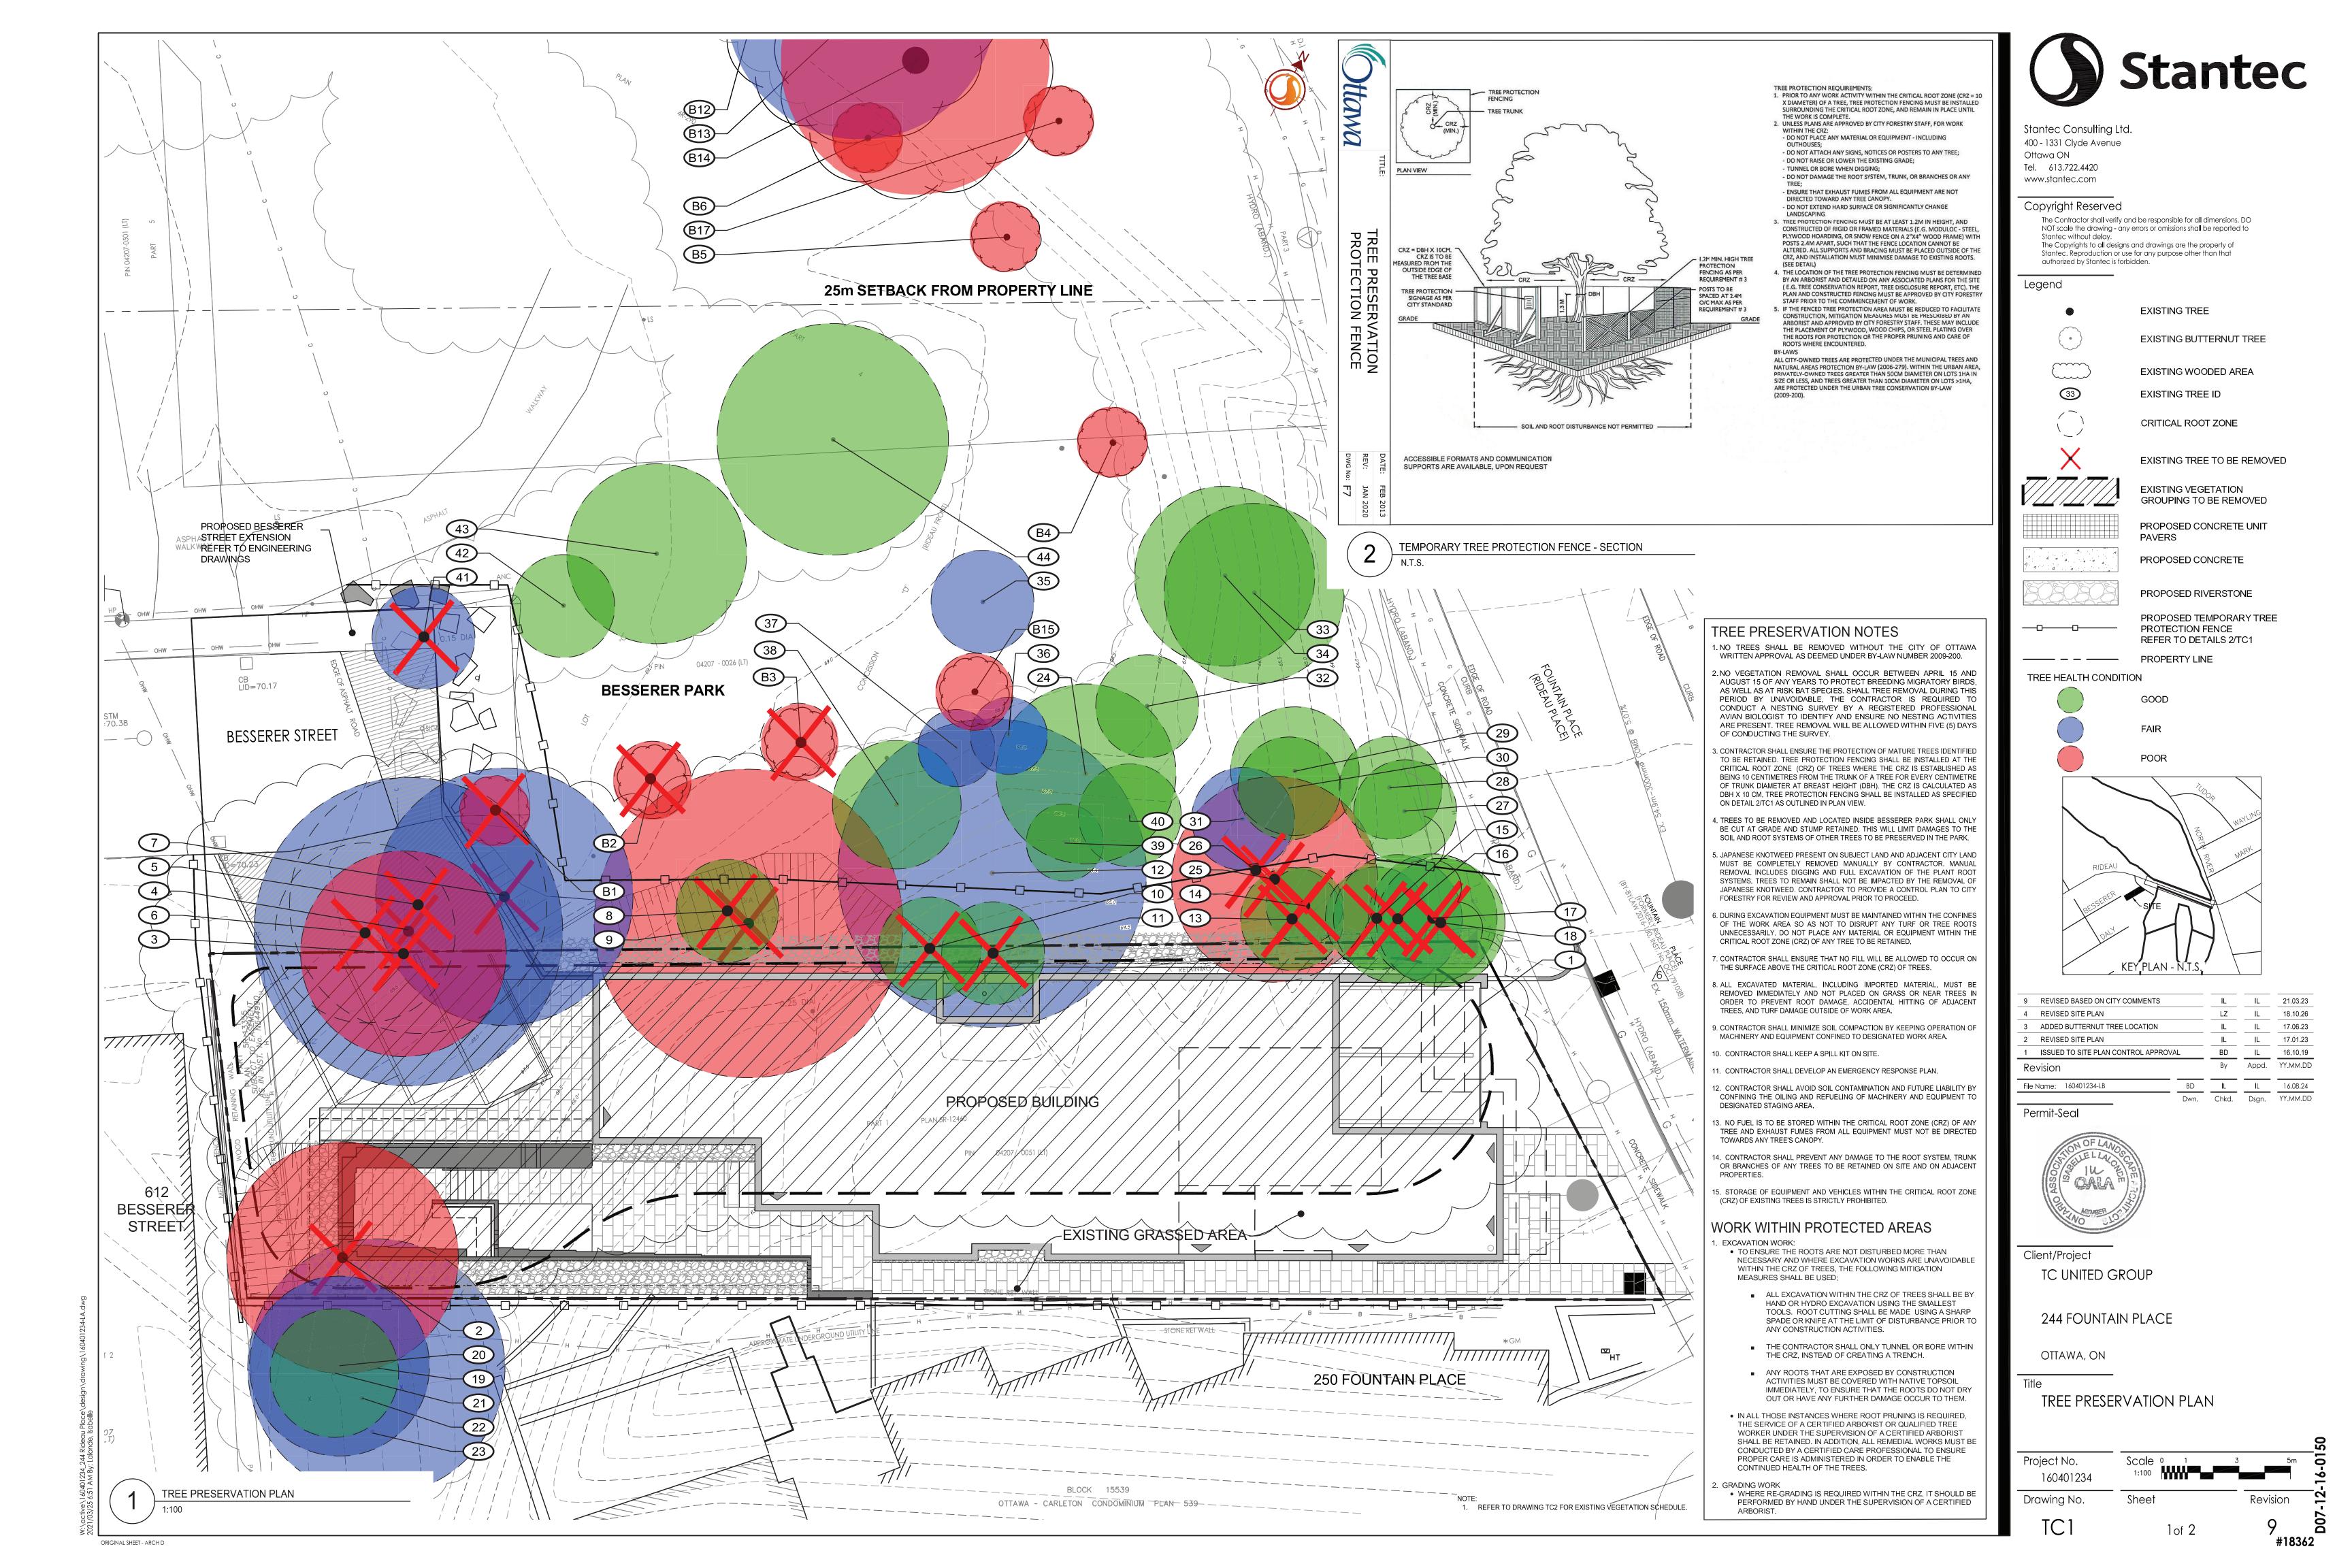
EXISTING VEGETA	TION	SC L	EDITE		50
		IION	ЗСП	EDULE	20 Acer negundo / Manitoba Maple	35
	TREE ASSESSMENTS CONDUCTED April 20, 2016, September 19, 2019, June 22,201	7 (Butternut tr	ees), Augu	st 9, 2019, and June 9, 2020.	21 Acer negundo / Manitoba Maple	20
	DI ANT	DIAMETER	HEALTH		22 Acer negundo / Manitoba Maple 23 Acer negundo / Manitoba Maple	40 25
EX. COMB (1200Ø) E INV=64.45		AT BREAST HEIGHT (cm)	CONDITIO	BEI/I/ABK >	24 Acer platanoides / Norway Maple	35
	Acer negundo / Manitoba Maple - 45%				25 Acer platanoides / Norway Maple	40
	Acer platanoides / Norway Maple - 45% 1 Populus grandidentata / Large tooth aspen - 1%	15-40	Good to Poor Dead	Grouping of trees; A number of trees are dead or in poor condition; GROUPING TO BE REMOVED TO ALLOW	26 Acer platanoides / Norway Maple	40
	Rhamnus cathartica / Buckthorn - 6% Ulmus americana / American Elm - 3%		Dead	FOR CONSTRUCTION OF BUILDING	27 Acer platanoides / Norway Maple	11

RIDEAU STREET	2 Acer negundo / Manitoba Maple	50	Fair to Poor	TO BE REMOVED	28 Acer platanoides / Norway Maple	11
	3 Acer negundo / Manitoba Maple	40	Poor	Growing on the slope; Tree is falling towards 244 Fountain Place with large crack in the trunk; TO BE REMOVED TO ALLOW CONSTRUCTION OF NEW	29 Ulmus americana / American Elm	25
				PARKING AREA	30 Ulmus americana / American Elm 31 Acer platanoides / Norway Maple	20
	4 Acer negundo / Manitoba Maple	60	Fair	Municipal tree (Besserer Park); Tree growing on top of slope; Tree is standing with some pruning; tree is leaning	32 Acer negundo / Manitoba Maple	20
The Course		00	i dii	towards Hydro Pole; TO BE REMOVED TO ALLOW CONSTRUCTION OF NEW PARKING AREA	33 Acer negundo / Manitoba Maple	35
	5 Acer negundo / Manitoba Maple	50	Dead	Municipal tree (Besserer Park); Tree fell inside the park (spring 2020); TO BE REMOVED	34 Acer negundo / Manitoba Maple	35

butterrut) appling				Municipal tree (Besserer Park); Growing on top of slope; Bark is pealing; Rotted; Damaged by wildlife; Leader was	35 Pinus strobus / White Pine	N/A
	6 Acer negundo / Manitoba Maple	40	Poor	pruned in the past approximately 6m above ground; TO BE REMOVED TO ALLOW CONSTRUCTION OF NEW	36 Ulmus americana / American Elm	15
DIA butternut				PARKING AREA Municipal tree (Besserer Park); Growing on top of slope;	37 Ulmus americana / American Elm 38 Ulmus americana / American Elm	15 30
	7 Acer negundo / Manitoba Maple	5 0	Fair	Tree is leaning towards 244 Fountain Place; Tree opens up into 2 leaders at approximately 2m above ground;	39 Acer platanoides / Norway Maple	10
EX. COMB (II) SE INV=	/ Acer negunao / Manitoba Mapie	50	Fair	large stem at 1m from base was pruned back in the past; TO BE REMOVED TO ALLOW CONSTRUCTION OF	40 Acer platanoides / Norway Maple	20
G WINV=		00		NEW PARKING AREA Municipal tree (Besserer Park); Growing on a slope; TO	41 Ulmus americana / American Elm	15

B10 Page 10 Pa	8 Ulmus americana / American Elm	20	Good	BE REMOVED DUE TO REGRADING	42 Ulmus americana / American Elm	15
50m SETBACK FROM PROPERTY LINE				Municipal tree (Besserer Park); Growing on a slope; Large 40cm branch broke naturally and fell inside 244 Fountain Place with lenght of branch extending entire width of property; Other	43 Acer rubrum / Red Maple 44 Acer rubrum / Red Maple	35 60
B1) B7	9 Acer negundo / Manitoba Maple	50	Fair to Poor	smaller branches are broken due to this failure; Other dead branches are visible at top of tree; TO BE REMOVED DUE TO	B1 to B3 Juglans cinerea / Butternut	n/a
PART 2	- A - A - A - A - A - A - A - A - A - A			REGRADING Tree on property line; Growing on a slope; TO BE		
	10 Acer platanoides / Norway Maple	20	Good	REMOVED Growing on slope adjacent to existing stone retaining	B4 <i>Juglans cinerea /</i> Butternut	1
× e ^{a1}	11 Acer platanoides / Norway Maple	20	Good	wall to be removed; TREE TO BE REMOVED	B5 to B9 Juglans cinerea / Butternut	n/a

12 Acer negundo / Manitoba Maple	60	Fair	Municipal tree (Besserer Park); Growing on slope; Broken branches; Leaning towards park; TREE TO BE PROTECTED	B10 Juglans cinerea / Butternut	6
	13 Acer platanoides / Norway Maple	20	Good	Municipal tree (Besserer Park); Adjacent to existing stone wall to be removed; TREE TO BE REMOVED	B11 Juglans cinerea / Butternut	3
× 69 ⁰⁶		15; 20	Good	Municipal tree (Besserer Park); 2 trunks; TREE TO BE	B12 Juglans cinerea / Butternut	25
Zin				REMOVED Municipal tree (Besserer Park); Adjacent on/in existing		
x 693 \ B12 x 9,15 butternut x ling	15 Ulmus americana / American Elm	20	Good	stone wall to be removed; TREE TO BE REMOVED	B13 Juglans cinerea / Butternut	17
B14	16 Ulmus americana / American Elm	25	Good	Municipal tree (Besserer Park); Adjacent on/in existing stone wall to be removed; 2 trunks; TREE TO BE	B14 Juglans cinerea / Butternut	11
58 X07-0022 (II) E 30 X 10 X	17 <i>Ulmus americana /</i> American Elm	25	Good	REMOVED Municipal tree (Besserer Park); Adjacent on/in existing	B15 Juglans cinerea / Butternut	1

PROPOSED TEMPORARY TREE PROTECTION FENCE REFER TO DETAILS 2/TC1
