### TREE CONSERVATION REPORT FOR 1010 DAIRY ROAD, OTTAWA(ORLEANS), ONTARIO

Report 21-007

Submitted  
September 9, 2021

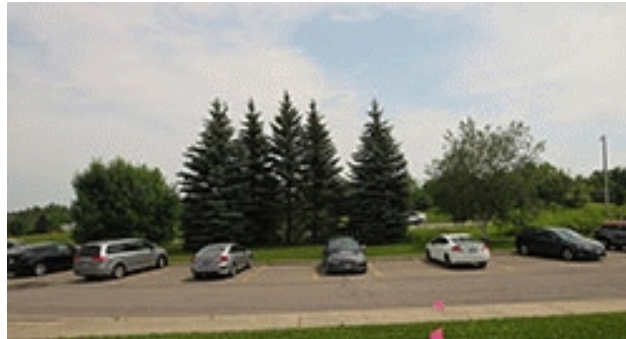
Table 1: Tree Inventory and Assessment						
ID	SPECIES	DBH (cm)	CANOPY (m)	COND RATING	PRESERV. RATING	COMMENT
1	White Birch <i>Betula papyrifera</i>	*	7	Good	Poor	dbh=10/10/9/8/8/5 MAINTENANCE: none PRESERVATION: remove (conflict with proposed parking area)
2	Colorado Blue Spruce <i>Picea pungens</i> var. <i>glauca</i>	25	5	Good	Poor	MAINTENANCE: none PRESERVATION: remove (conflict with proposed parking area)
3	Colorado Spruce <i>Picea pungens</i>	25	4	Good	Poor	MAINTENANCE: none PRESERVATION: remove (conflict with proposed parking area)
4	Colorado Spruce <i>Picea pungens</i>	25	4	Good	Poor	some needle cast MAINTENANCE: none PRESERVATION: remove (conflict with proposed parking area)
5	Colorado Blue Spruce <i>Picea pungens</i> var. <i>glauca</i>	30	6	Good	Poor	MAINTENANCE: none PRESERVATION: remove (conflict with proposed parking area)
6	Colorado Spruce <i>Picea pungens</i>	24	6	Good	Poor	MAINTENANCE: none PRESERVATION: remove (conflict with proposed parking area)

7	Green Ash <i>Fraxinus pennsylvanica</i>	*	8	Good	Poor	dbh=13/13/12/11/7/7/5; EAB signs MAINTENANCE: none PRESERVATION: remove (not expected to survive)
8	Colorado Blue Spruce <i>Picea pungens</i> var. <i>glauca</i>	32	8	Good	Poor	MAINTENANCE: none PRESERVATION: remove (conflict with proposed building envelope)
9	Colorado Spruce <i>Picea pungens</i>	25	6	Good	Poor	minor needle cast MAINTENANCE: none PRESERVATION: remove (conflict with proposed building envelope)

Photo 1: Trees 1 thru 7 (right to left).

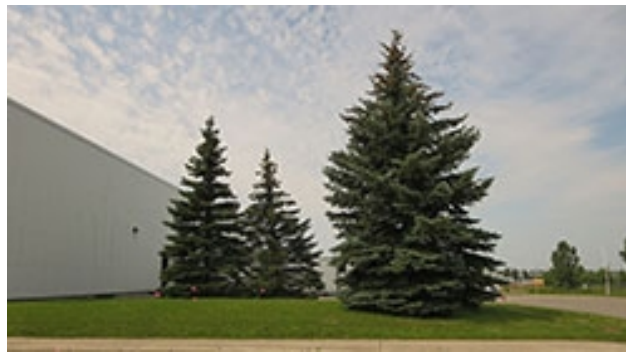
ID	SPECIES	DBH (cm)	CANOPY (m)	COND RATING	PRESERV. RATING	COMMENT
10	Colorado Spruce <i>Picea pungens</i>	31	8	Good	Poor	minor needle cast MAINTENANCE: none PRESERVATION: remove (conflict with proposed building envelope)

Photo 2: Trees 8, 9, and 10.

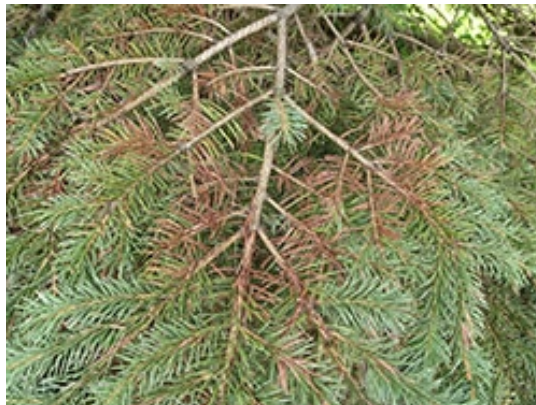
Photo 3: Signs of needle cast.

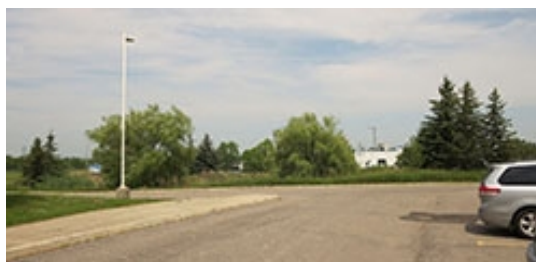
ID	TREES	DBH 10-30 cm	DBH >30 cm	COND RATING	PRESERV. RATING	COMMENT
A	8 coniferous 4 deciduous	8 3	1	Good	Good	MAINTENANCE: none PRESERVATION: CRZ
B	3 coniferous	3	0	Good	Good	MAINTENANCE: none PRESERVATION: CRZ
C	2 coniferous 1 deciduous	2 1	0	Good	Good	MAINTENANCE: none PRESERVATION: CRZ

Photo 4: Treed area A.
