Tim-O-Tree

Tree Retention Plan:

61 Pinehurst

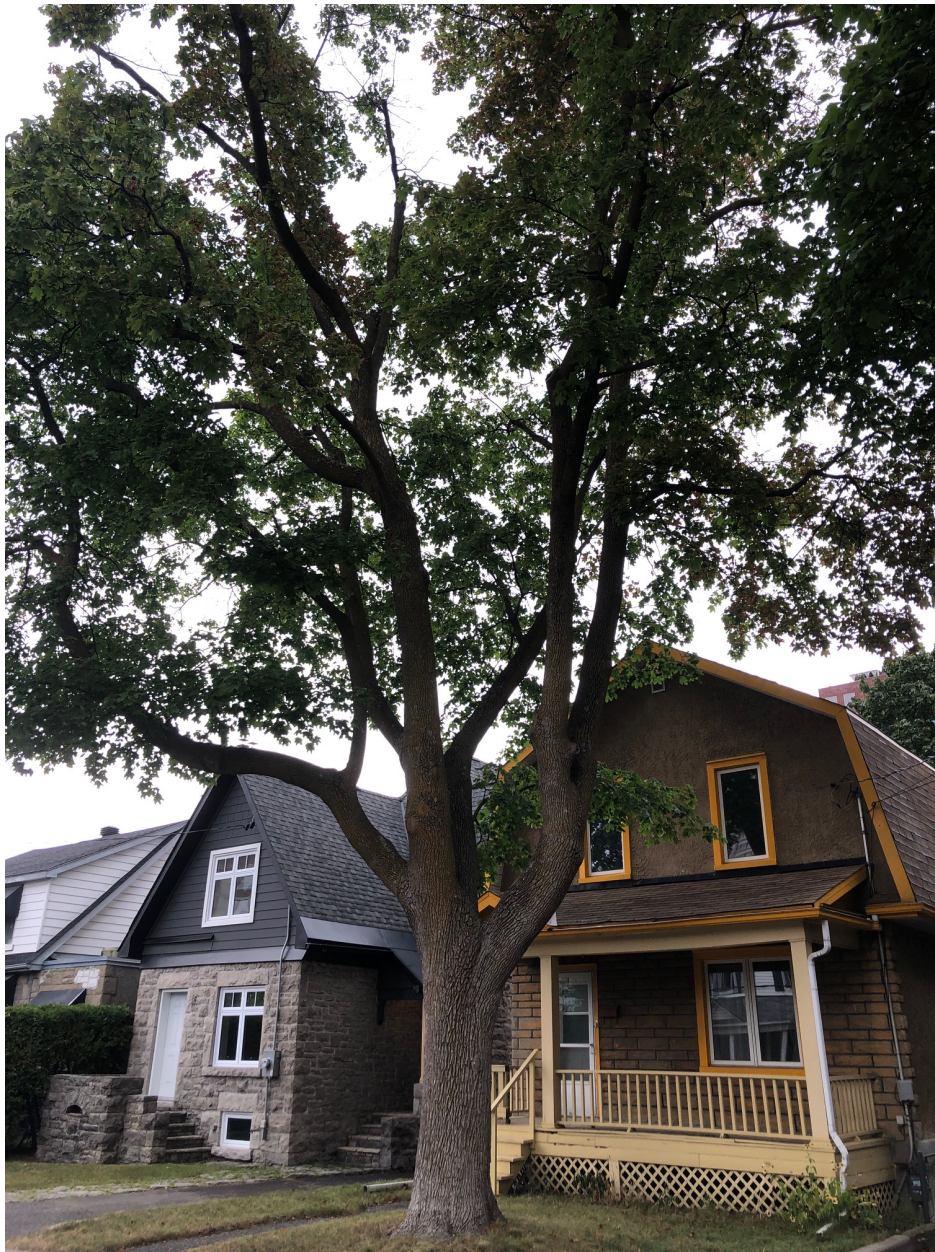
Tree 1: Municipal Black Maple

There is a black maple in the front yard of 61 Pinehurst. The site plan indicates that the tree is wholly owned by the city. The tree measures 70cm in diameter at breast height (DBH). According to the City of Ottawa's guidelines⁴⁵, the critical root zone (CRZ)⁶ of this tree measures 700cm.

The tree is in good condition, with a full canopy and no evident dieback. The tree has a strong trunk flare, and a sound structure with no evidence of included bark. One of the branches has a poor aspect ratio with the trunk, but the union doesn't look like it poses a hazard. Most pruning cuts are completely occluded, indicating good vigour and compartmentalization. There were no evident fruiting bodies or other signs of wood-decaying fungi.

According to the site plan, the foundation of the new building will be no closer to the tree than the current building (about 400cm). Even though excavation will be occurring within the CRZ as calculated based on trunk girth, realistically there are no roots past the outside of the foundation. Therefore, construction of a new foundation at the same distance from the tree as the current foundation will most likely not require root pruning.

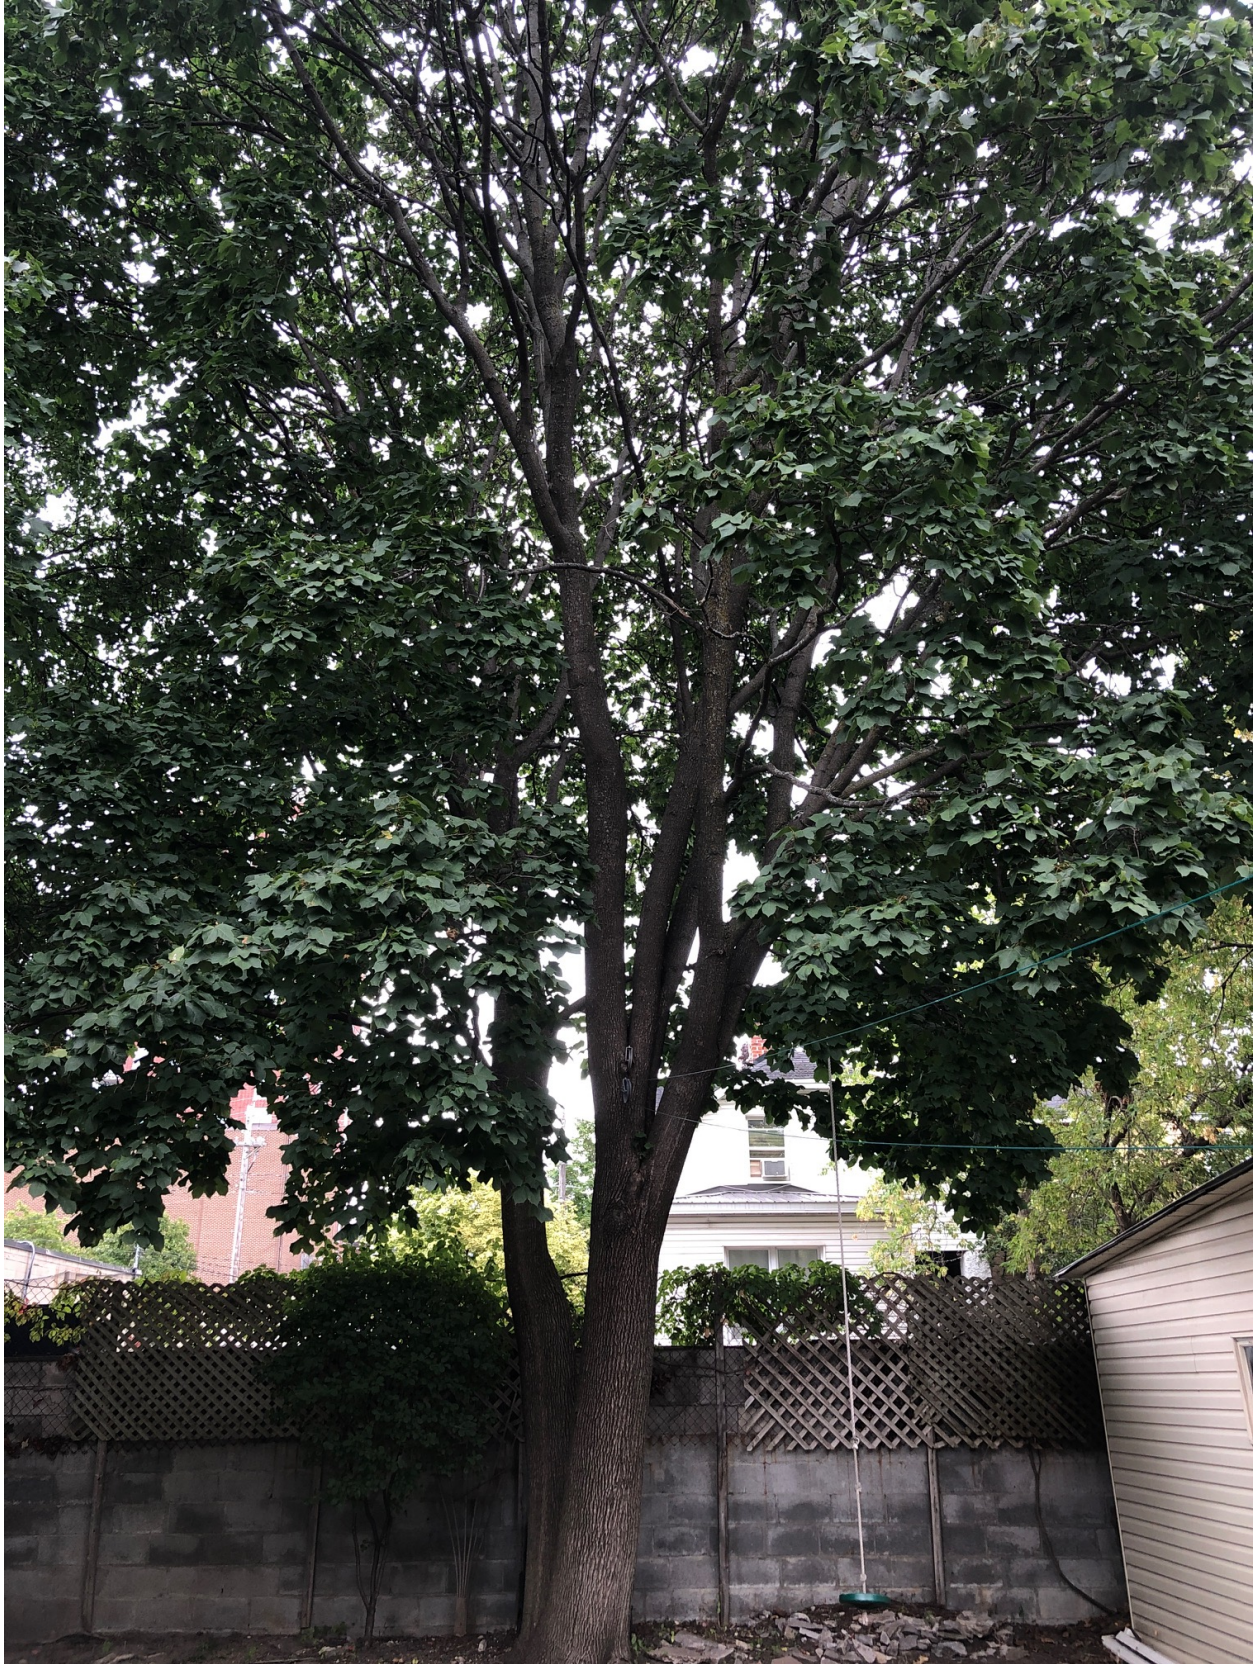
Tree 2 & 3: Norway Maples

There is a Norway maple in the back yard of 61 Pinehurst, next to the eastern edge of the property. It measures 46cm DBH⁷, meaning the critical root zone CRZ) measures 460cm.

The tree is in fair condition. It has a full canopy with few dead branches. It has multiple stems, some with included bark, but no signs of rot or tearing in these unions. The largest codominant stem has an included union with the trunk, but this inclusion is beginning to occlude via inosculation and this occlusion may progress, mitigating the mechanical weakness of the inclusion. The roots of the tree are likely girdled by the tree pressed up against its trunk, which reduces the structural stability of the buttress roots, but not enough to pose a significant hazard. There are two clothesline wheels embedded within the tree, at least one of which is too far gone to retrieve. While this poses a stress for the tree and interferes with potential occlusion of an included union, they do pose enough of a stress to the tree to affect its viability.

The smaller of the two trees measures 38cm DBH, meaning its CRZ is 380cm. The tree is in good condition, with a full canopy, a dominant central trunk and no signs of fungal infection. The tree's root structure is likely impeded by the presence of the adjacent Norway maple, but this does not pose a significant risk.

According to the site plan, at its closest, the foundation will be about 690cm from the trunks of these trees. That is well outside the CRZs of both trees.

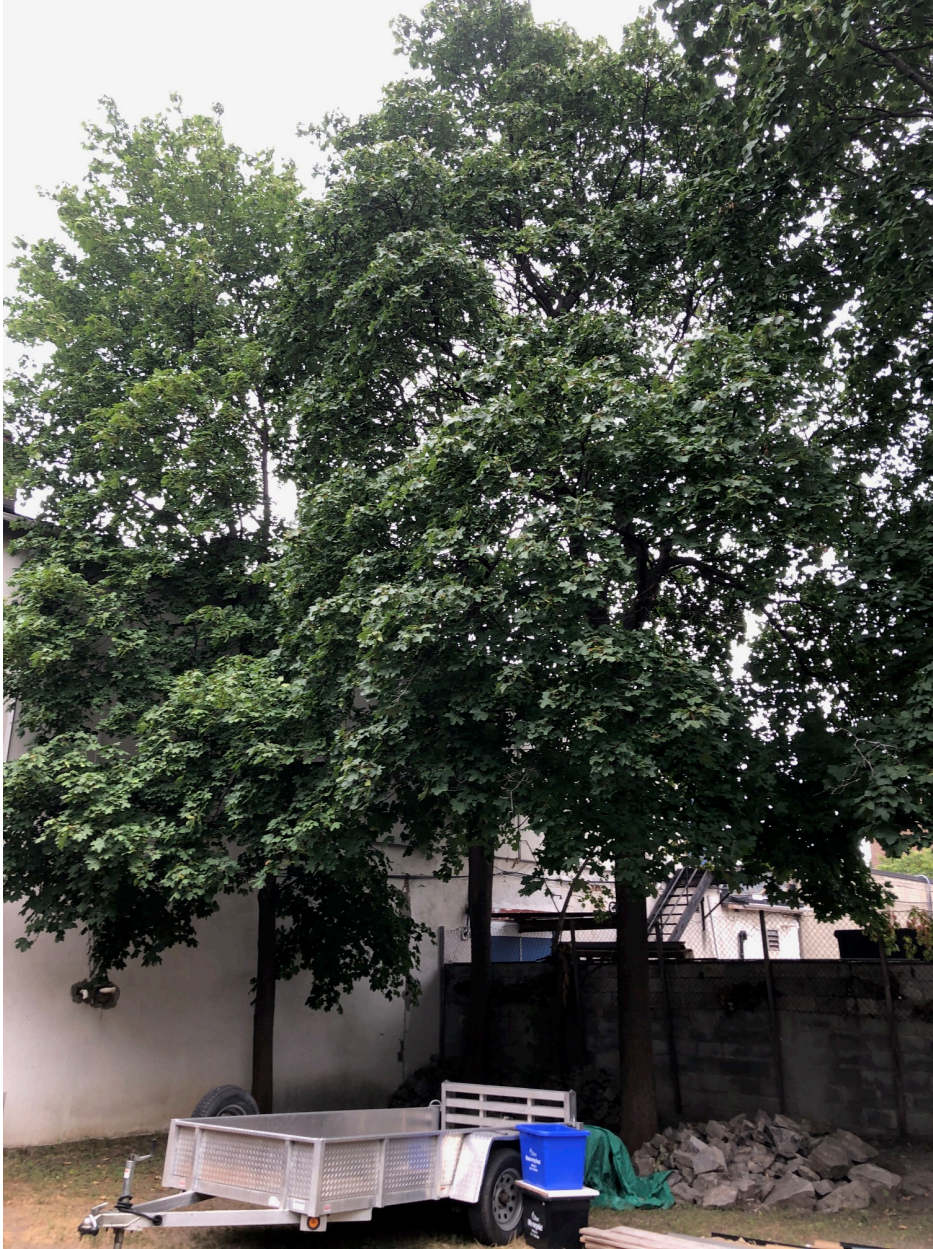
Tree 4 & 5: Norway Maples

In the adjacent back yard of 63 Pinehurst, there are three Norway maples. The smallest of these trees measures 24cm DBH and is therefore not distinctive. The middle tree measures 32cm, meaning its CRZ measures 320cm. The tree farthest to the south (right in photo below) measures 38cm, meaning its CRZ is 380cm.

The excavation, at its closest, will be well outside the CRZs of these trees. No root pruning will be necessary.
