TREE CONSERVATION REPORT

Preliminary report for 1983 Carling Ave

Address: 1983 Carling Ave

Date: January 22, 2022

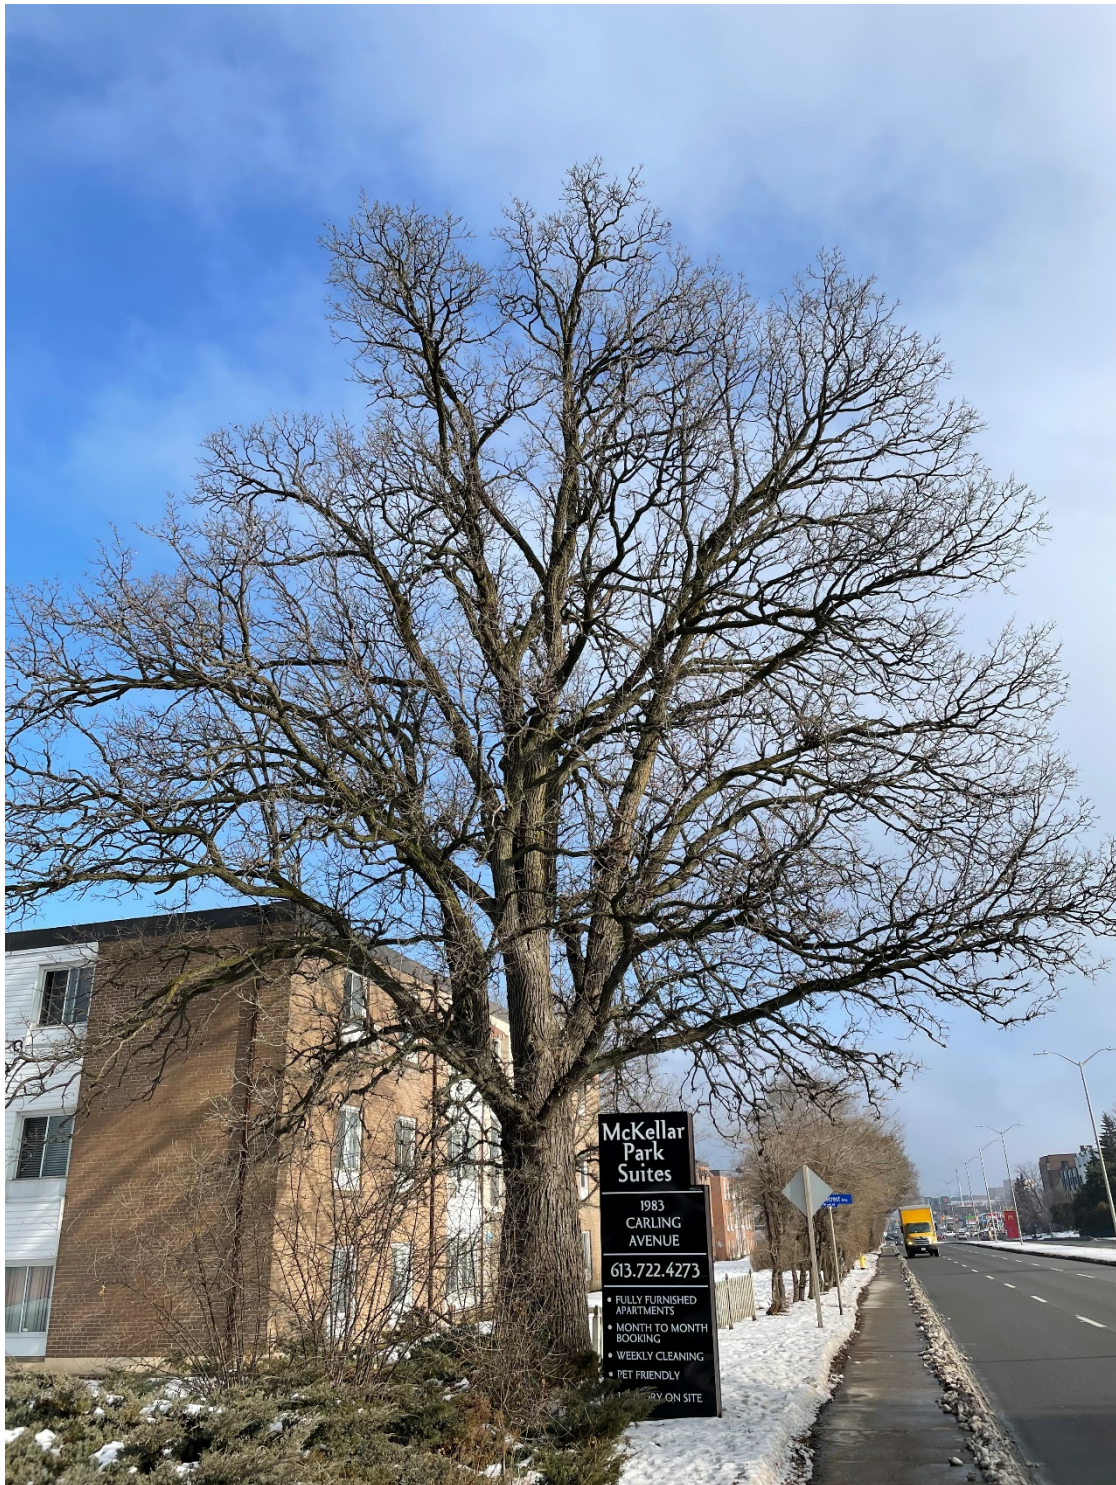
The large bur oak located close to the sidewalk and along Carling avenue is the tree of concern that will be most impacted by the proposed development. This tree has a diameter of 111 cm, and its root system likely extends at least 11 m in all directions, except for where there is infrastructure such as the road and building. Although the tree appears in good health, it does have some health concerns to note. The crown is extensive, but since this tree is overhanging a major thoroughfare, it has been damaged by salt spray which is visible along the south side. Also, there is a large cavity at the base of the tree that measures 80 cm long; 15 cm wide; and 40 cm deep. A metal rod was inserted and extended past the cavity wall an additional 30 cm. Therefore, the decay and cavity extend 70 cm into the trunk at the widest point. The extent of decay is over 1 m up the tree in the centre of the decay column – the 1 m rod did not reach the end. These observations on decay were made using tools for a basic assessment. To understand better the extent of internal decay in this tree, a Level 3 risk assessment would be required using an advanced technique such as sonic tomography or resistance drilling. These tools can map out the decay in the stem at different heights up the trunk and are relatively non-invasive. Combining these results with a good understanding of the dynamics of how internal decay impacts large oak trees would help to assess the structural integrity of the tree. Although extensive decay can give the impression of structural weakness, this may not always be the case. Trees can learn to adapt to weaknesses by refocusing their growth on strengthening their stem and reducing the crown weight naturally.

Based on the initial site plan provided by the client, the proposed building will be approximately 3.5 m from the trunk of the tree. When adding in the space required to construct this building, the excavation extends to approximately 2.5 m from the trunk. Looking at the existing critical root zone, approximately 30% of the potential rooting area would be removed as part of this development. However, most of this potential rooting area is currently covered by asphalt, and it is possible that there are not many roots under this surface, especially if it has been resurfaced. Mitigating any damage to the roots will be important to reducing the impact of the construction to the tree. Recommended mitigation measures include:

Figure 1: Large bur oak along Carling, facing east

- Avoid tearing of the roots prior to the excavation. If the roots do tear, they should be pruned with a clean cut to increase the likelihood of sealing properly and reduce the risk of pathogens from entering the tree.
- Roots should not be left exposed and be covered with soil as quickly as possible, or temporarily with a moist, organic material such as mulch and/or burlap
- The tree should be watered during dry summer months to reduce stress it will encounter from the construction

Those branches that are in conflict with the new building will also need to be pruned back. When pruning this tree, balancing the weight should be factored in while considering the root loss. Reducing the crown in response to root loss should be done only to improve stability and otherwise be kept at a minimum to reduce the stress response by the tree. Other mitigation factors could help to reduce the stress response by the tree including:

- Ensure the remaining root zone is well protected during all construction by following the protection measures below
- Mulching the rooting area with 5-10 cm of quick-decomposing mulch (e.g. hardwood)

Note that this tree should be assessed for structural stability once the excavation has begun to observe whether any structural roots have been severed. A Level 3 risk assessment would provide the best information to make conclusions around the risk of failure associated with this tree.

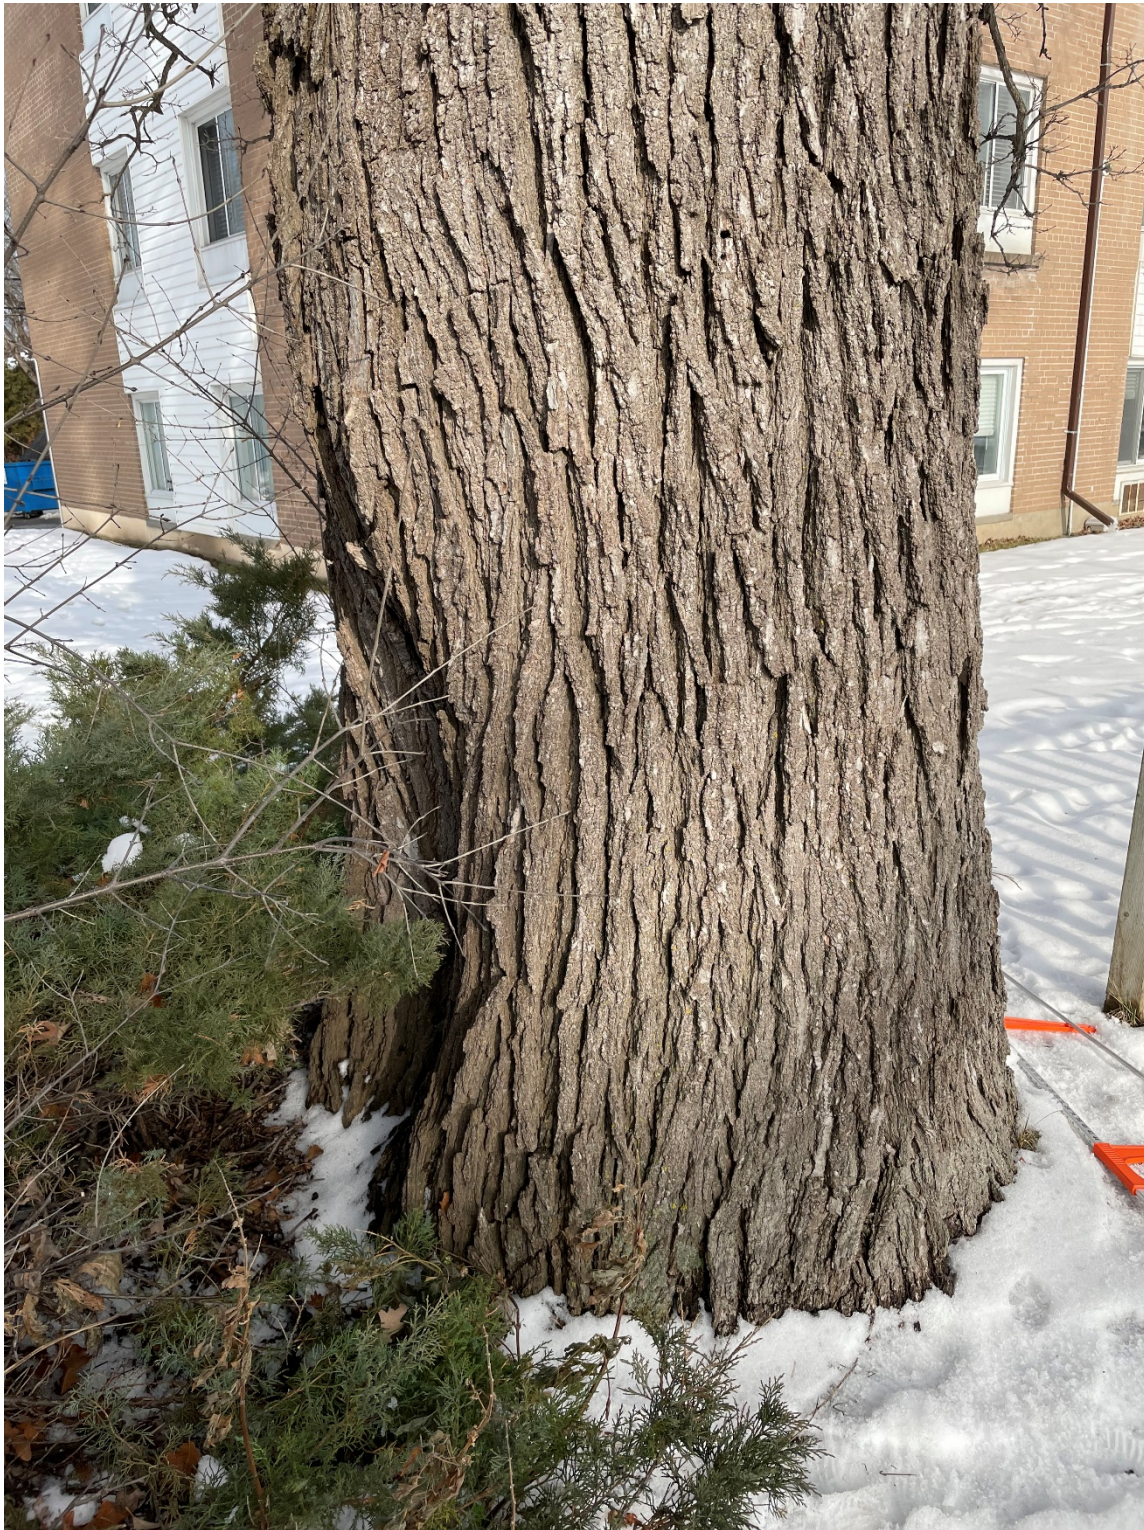
Figure 2: Wound at base of trunk along the west side

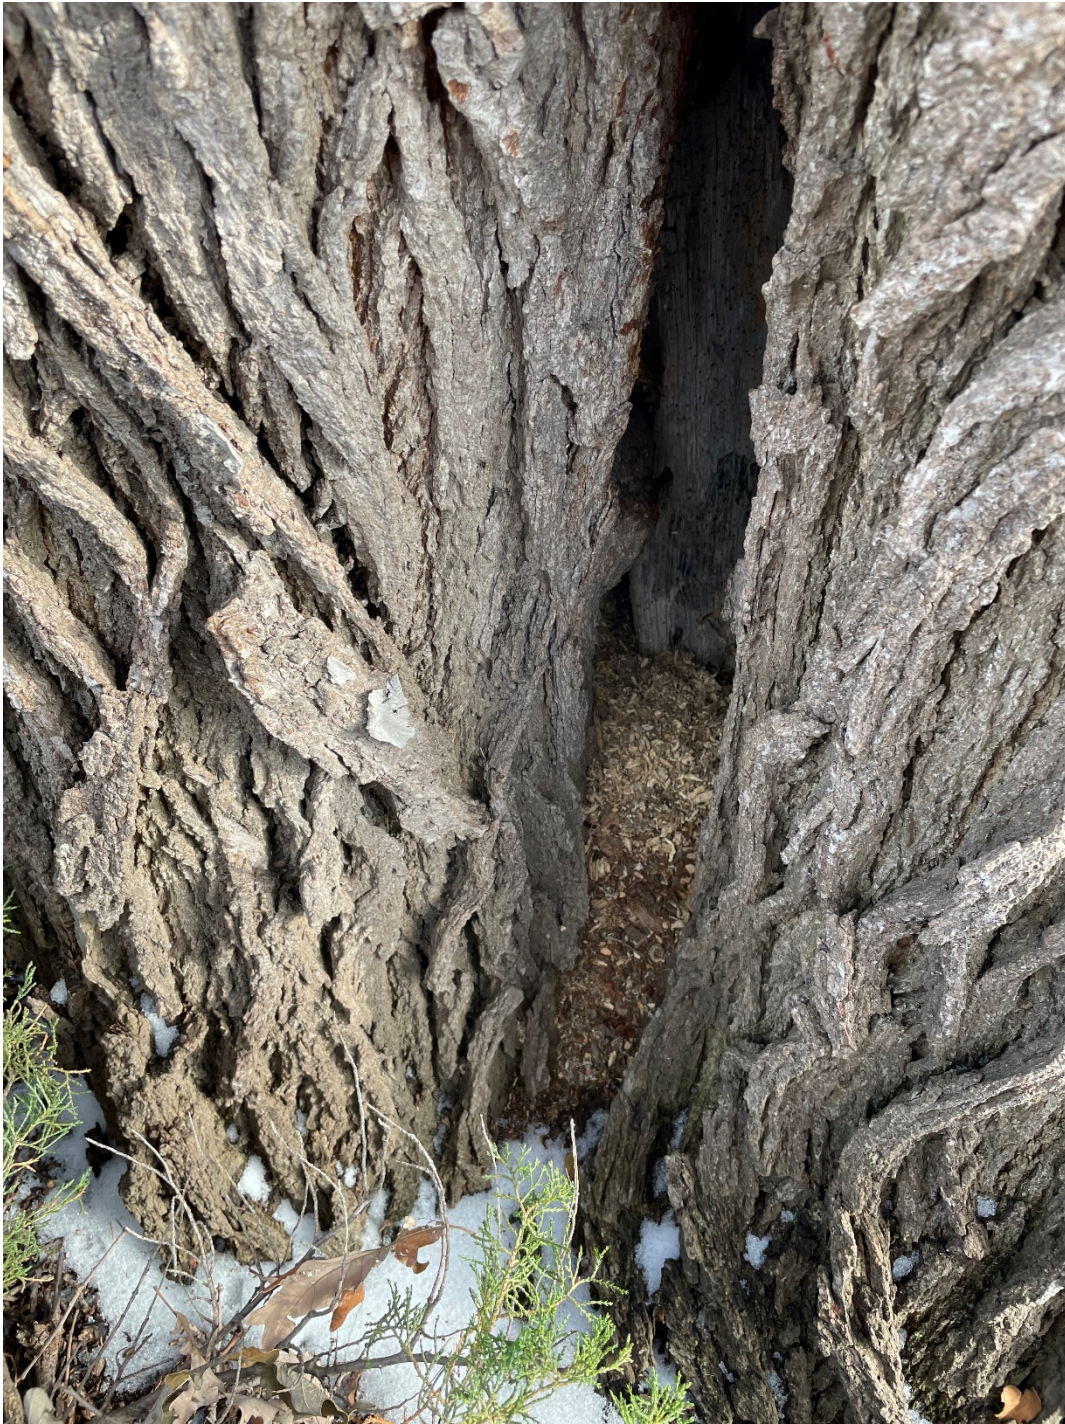
Figure 3: Picture showing cavity. Decay and cavity extend 70 cm into tree

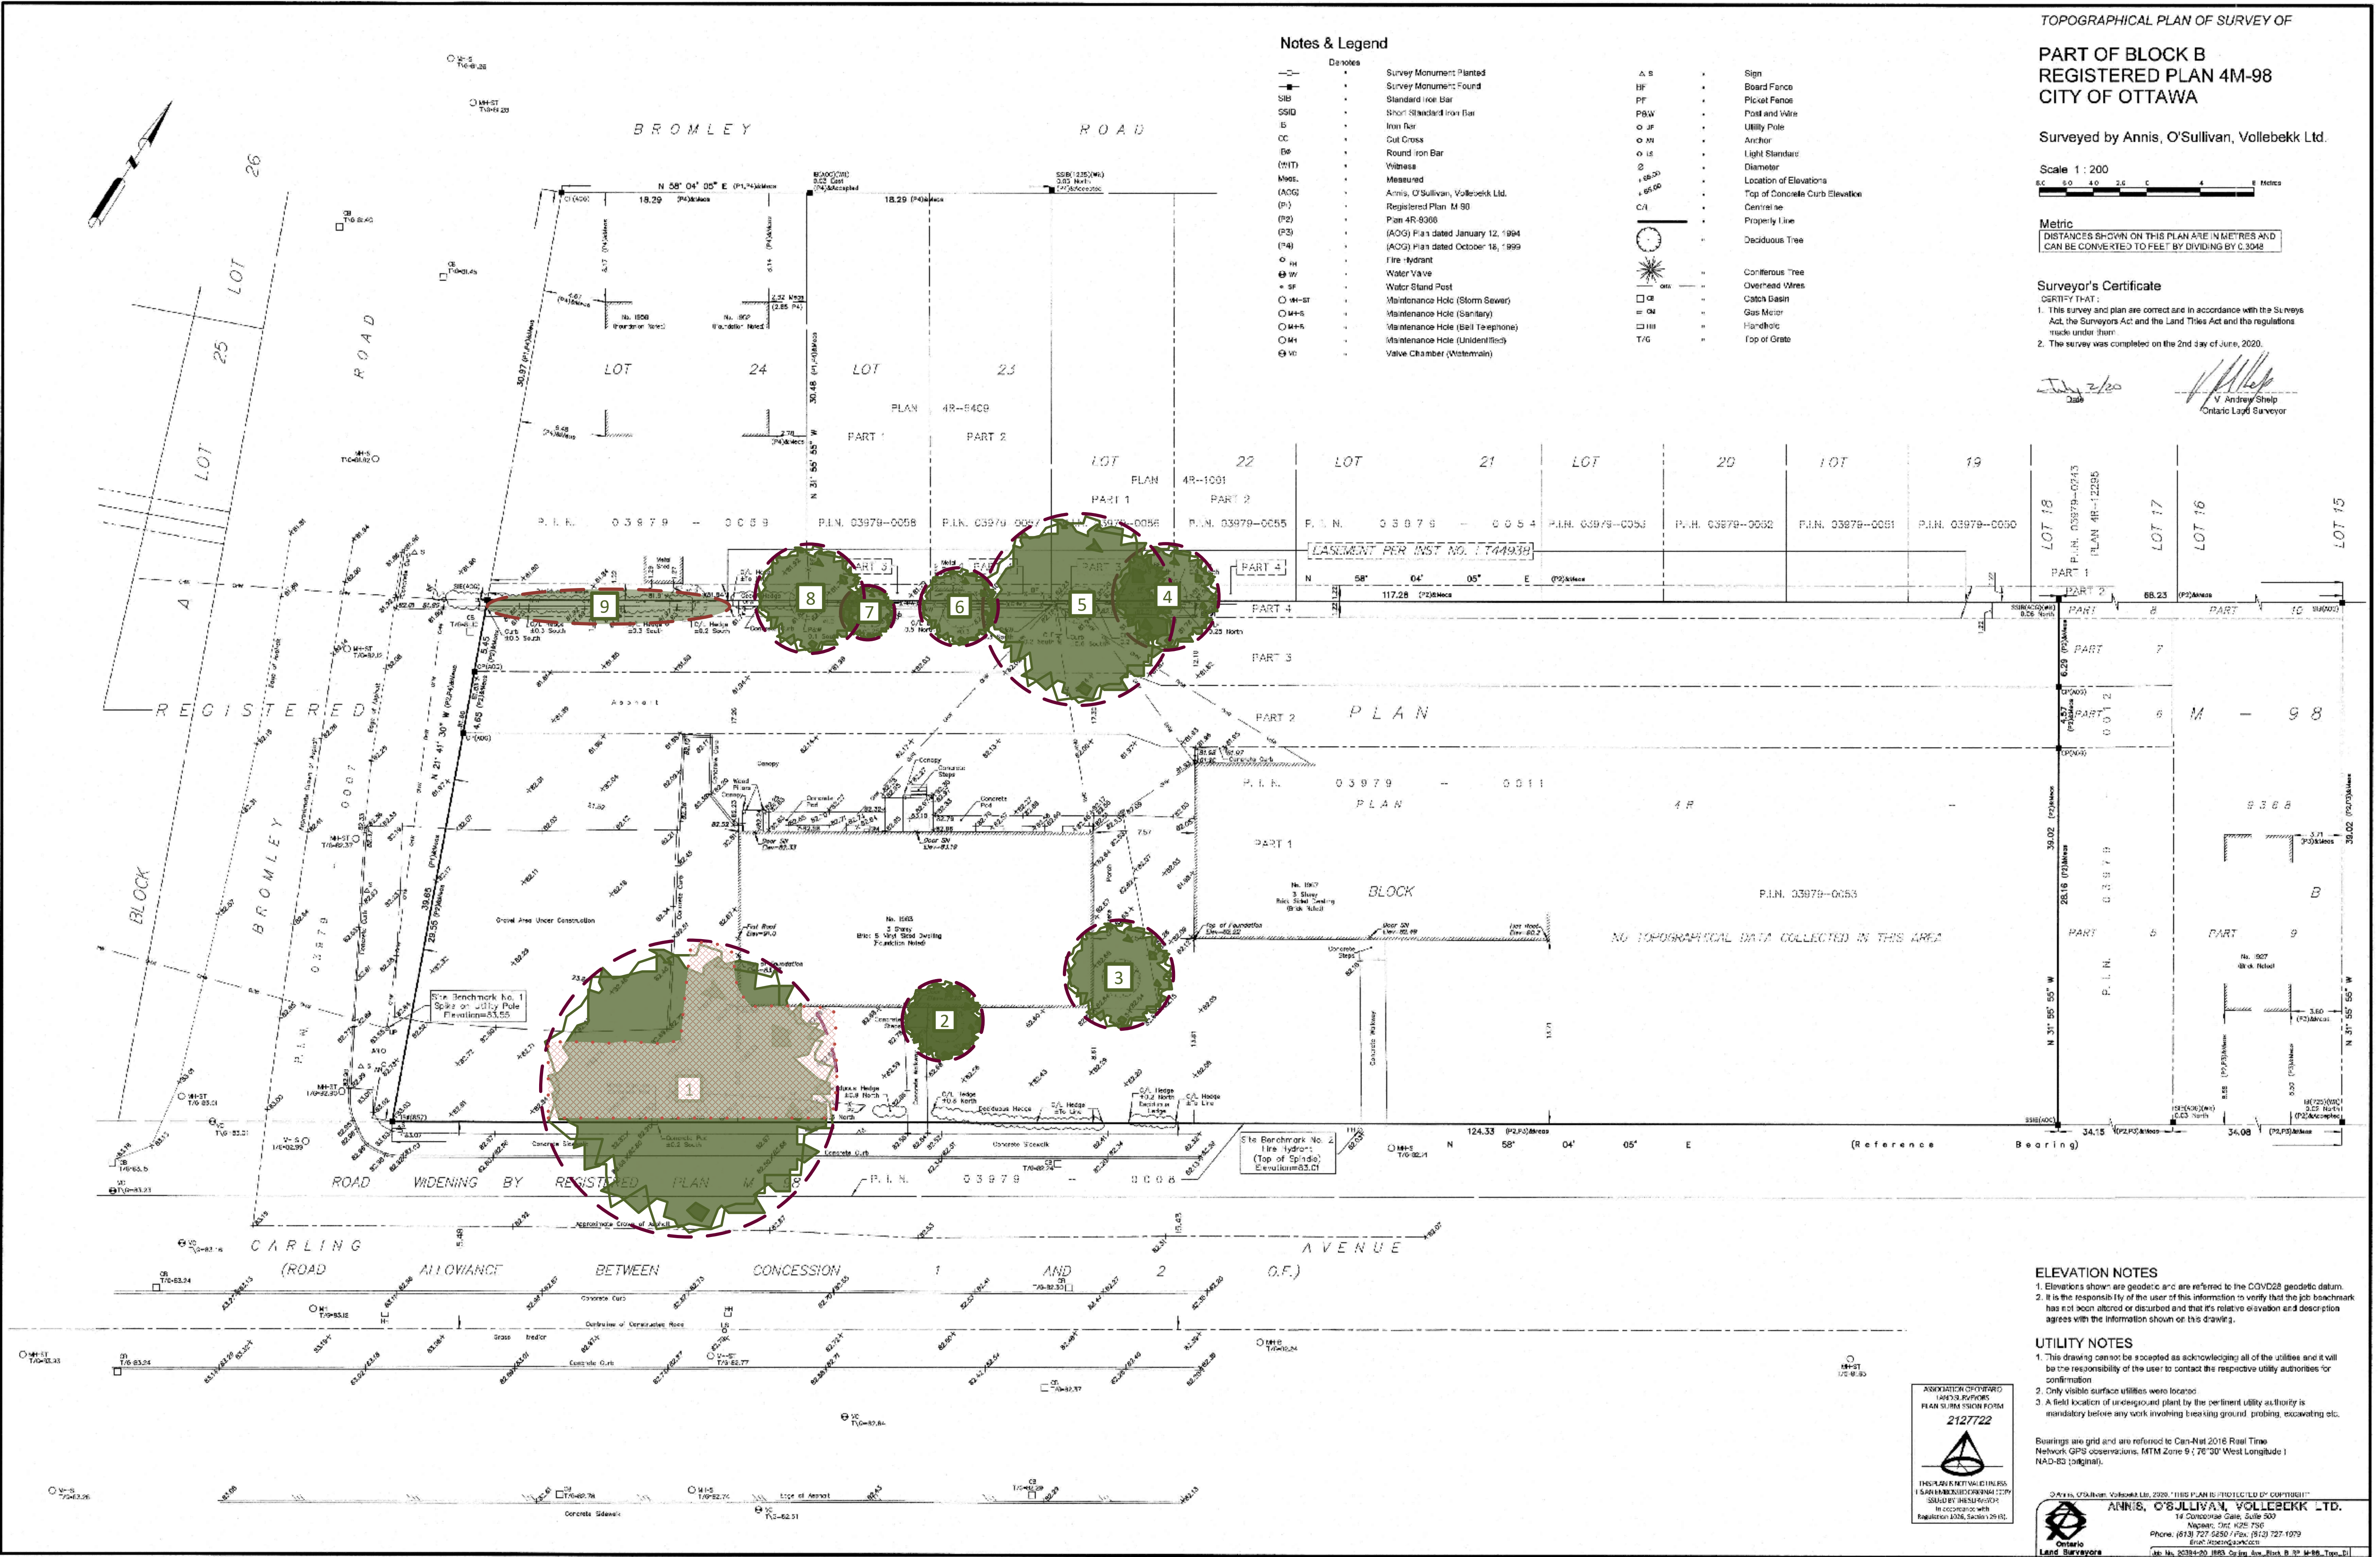
Recommended Tree Protection Fencing Area

Critical Root Zone

Prior to any site works, protective fencing should be installed around the trees as indicated in the attached Tree Disclosure Map and maintained until all construction on site has been completed as per the **City of Ottawa Tree Protection Specifications (April 2019)**. Within the fenced area, the following tree protection guidelines should be applied:

The tree protection fencing must be 1.2 m in height and constructed of a rigid or framed material (e.g. modulus – steel, plywood hoarding, or snow fence on a 2”X4” wood frame) with posts 2.4 m apart such that the fence location cannot be altered.
