September 14, 2021

**RE: TREE CONSERVATION REPORT FOR 949 NORTH RIVER ROAD**

949 NORTH RIVER ROAD AT ONTARIO STREET

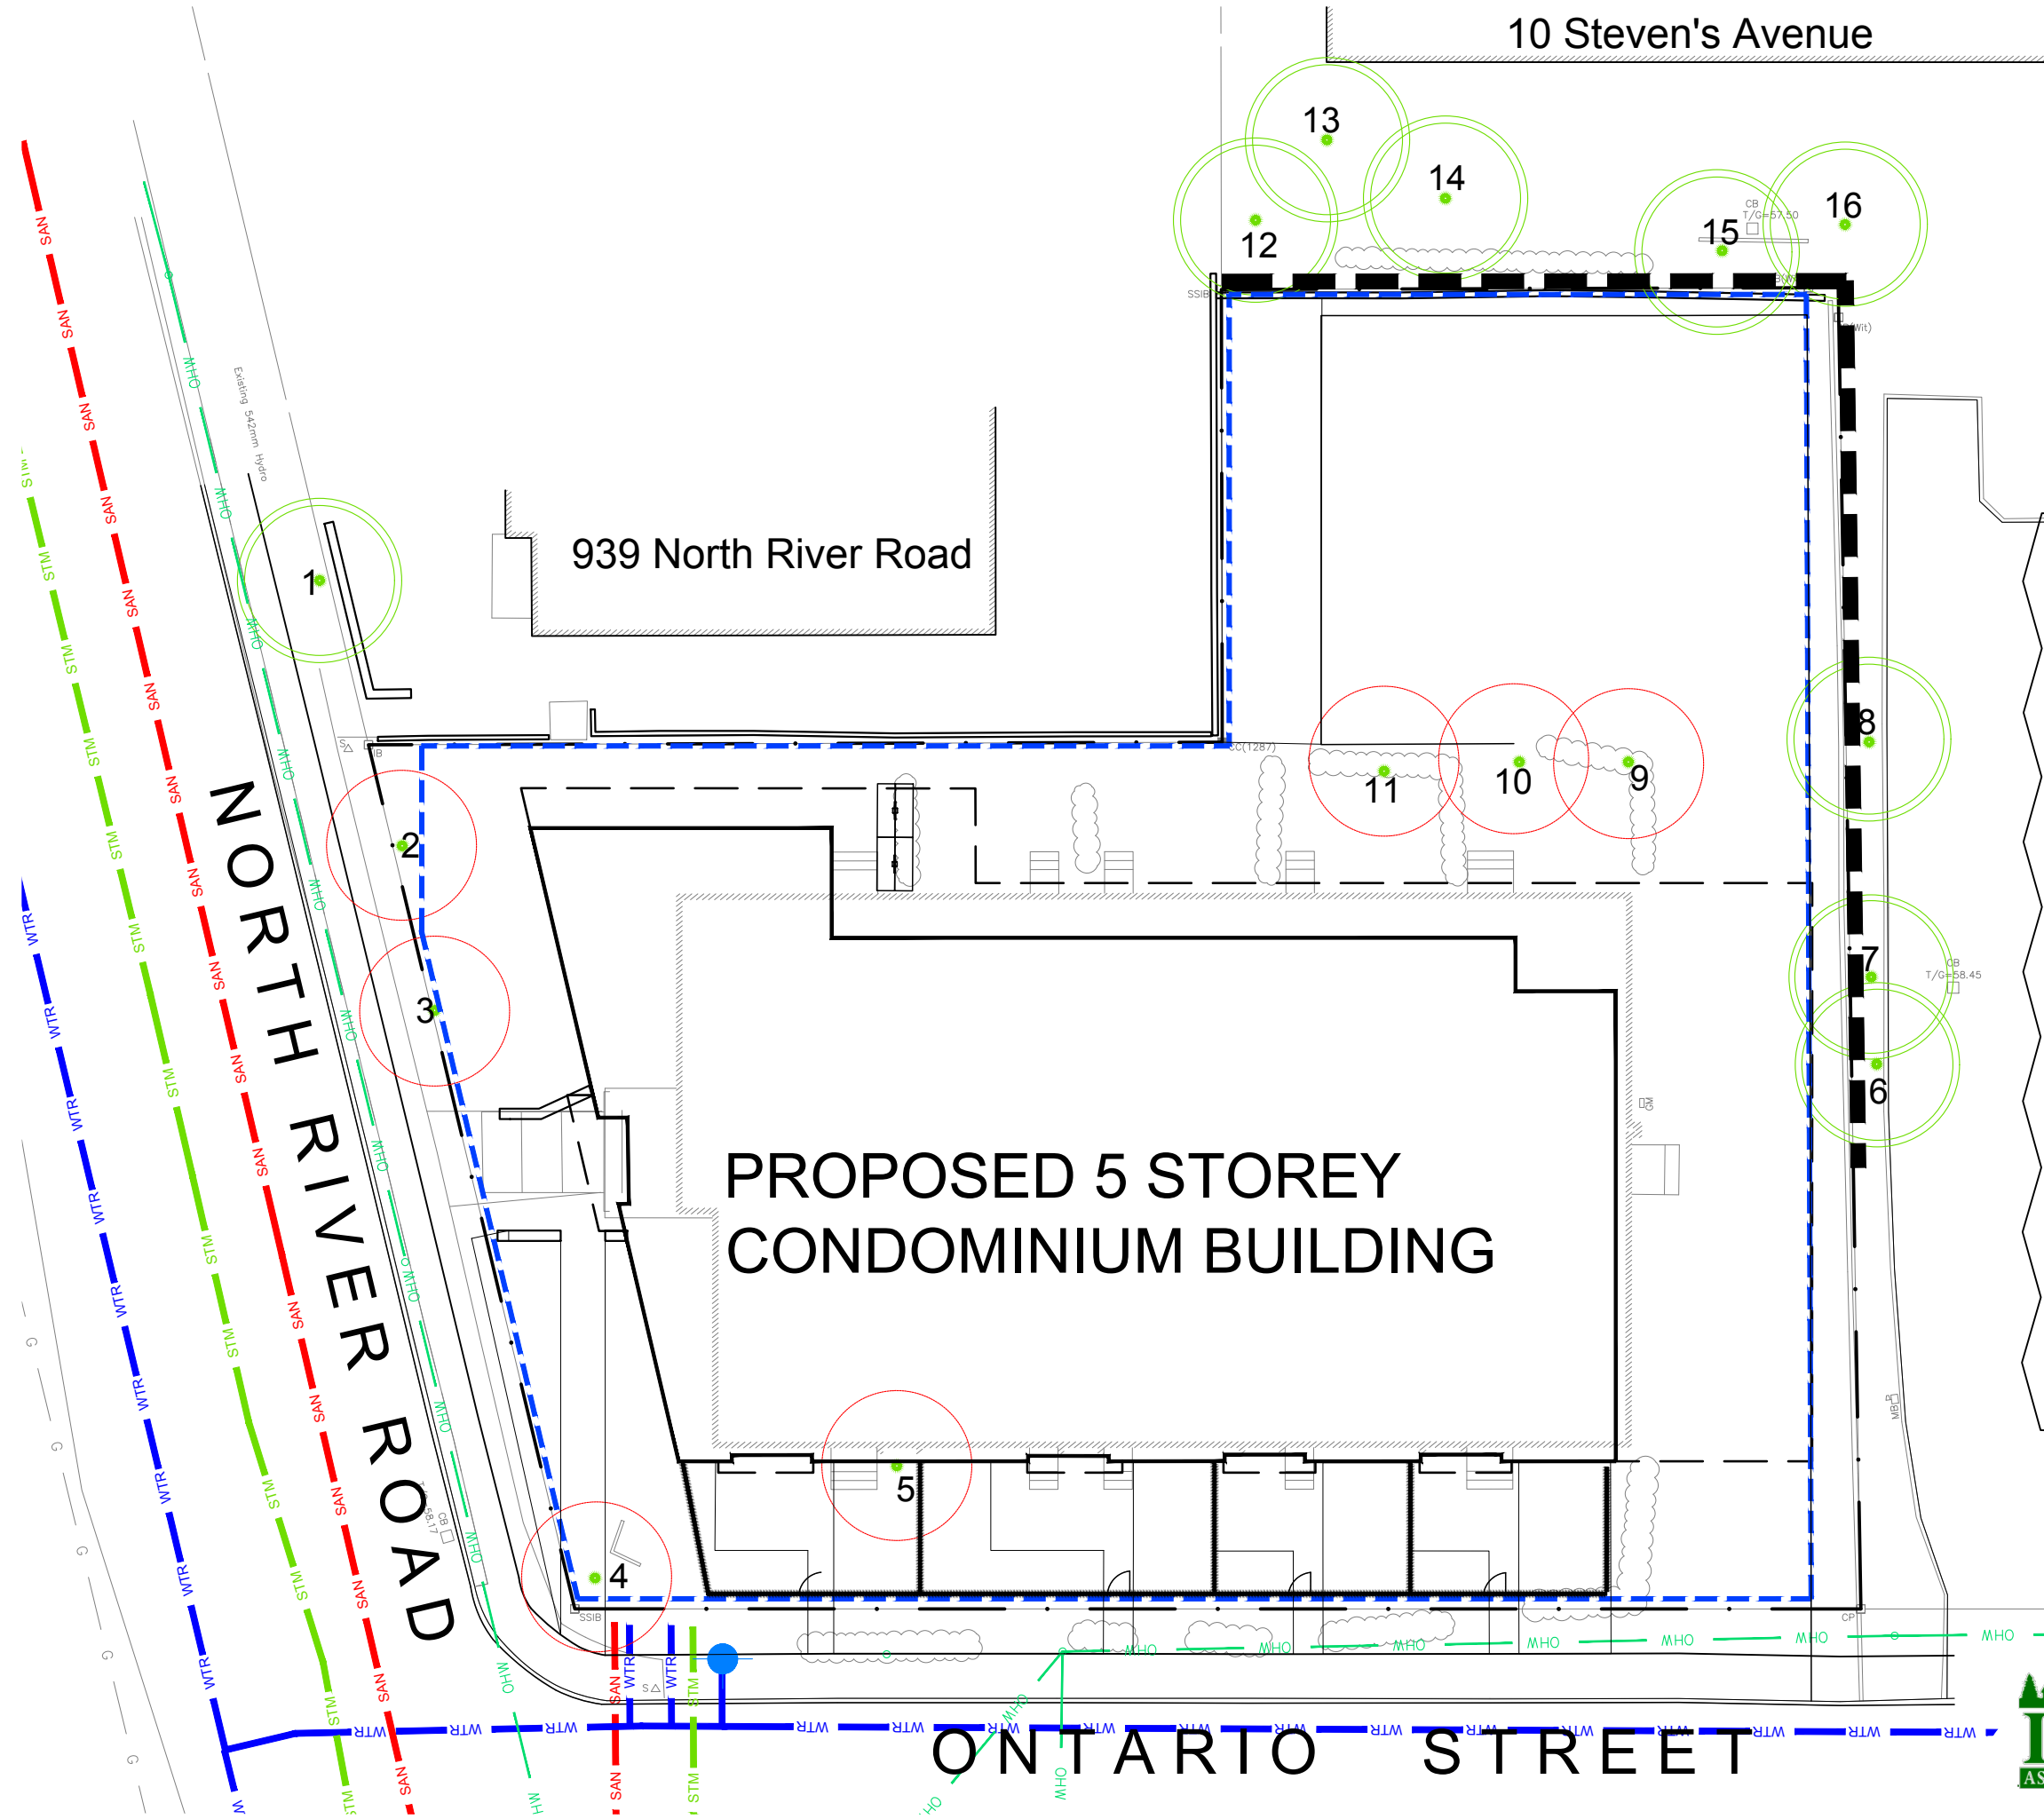
TCR TREE CONSERVATION REPORT

Table 1 on pages 2 and 3 of this report details the species, condition, size (diameter), ownership and status of the individual trees on and adjacent to the subject property. Each of these trees is referenced by the numbers plotted on the tree conservation plan included on page 4.

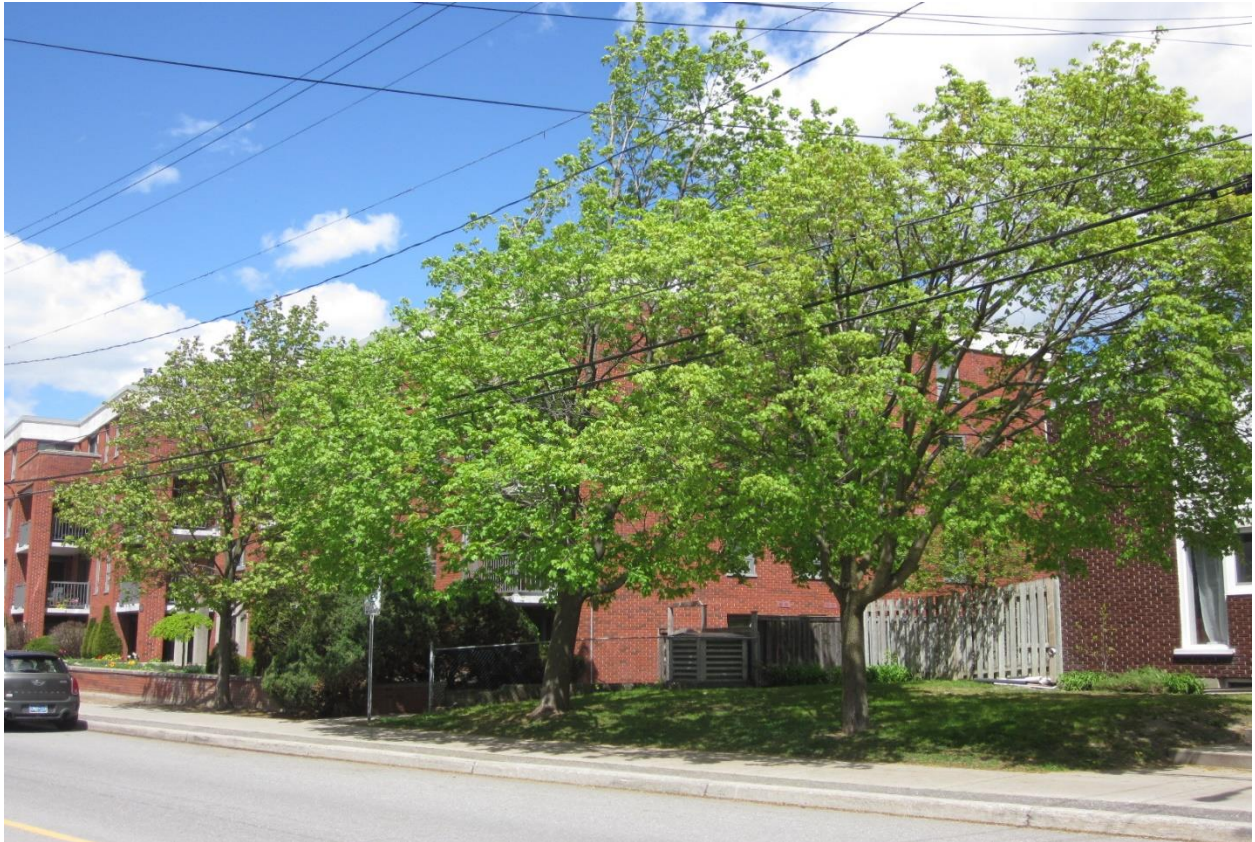
| Tree No. | Tree species | Condition (VP→E) | DBH <sup>1</sup> (cm) | Owner -ship | Age class, tree condition notes & <b>preservation status</b> (to be removed or preserved and protected) |
|---|---|---|---|---|---|
| 1 | Norway maple<br>( <i>Acer platanoides</i> ) | Fair | 24.0 | City | Maturing; central main stem with competing lateral on southeast at 1.75m from grade; major wound at 0.25-1.5m on east side of stem (plow damage); only visible root flare on east side of root collar – with two binding roots; introduced invasive species; <b>to be preserved and protected</b> |
| 2 | Norway maple | Good | 37.4 | City | Mature; co-dominant stems at 2.25m with strong union; broad crown – moderately pruned from overhead Hydro lines; good root collar; <b>to be removed</b> (conflicts with construction) |
| 3 | Norway maple | Fair | 27.8 | City | Mature; central stem with branch cluster at 2m; central stem suppressed, laterals now dominant; no flaring on root collar – girdling roots likely; minor pruning from overhead Hydro lines; <b>to be removed</b> (conflicts with construction) |

Picture 1. Trees #1, 2 and 3 (left to right) located adjacent to 949 North River Road

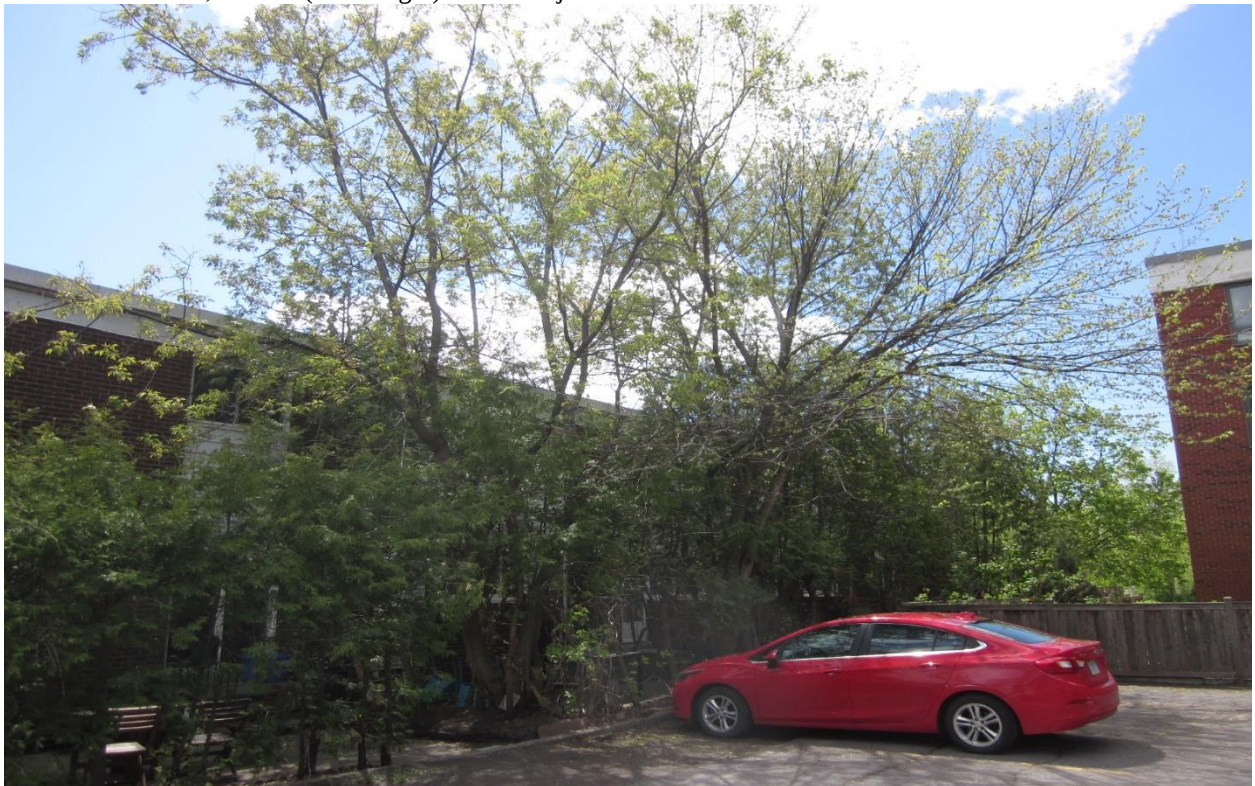
| Tree No. | Tree species | Condition (VP→E) | DBH <sup>1</sup> (cm) | Owner -ship | Age class, tree condition notes & <b>preservation status</b> (to be removed or preserved and protected) |
|---|---|---|---|---|---|
| 9 | Manitoba maple | Fair | 10.0, 19.2 & 23.5 | Private | Mature; tri-stemmed from grade – generally upright (stems only mildly divergent; fourth stem previously removed; <b>to be removed</b> (conflicts with construction) |
| 10 | White elm<br>( <i>Ulmus americana</i> ) | Good | 26.3 | Private | Mature; crown asymmetric towards north due to influence of trees #9 and 10; no outward signs of Dutch elm disease infection ( <i>Ophiostoma novo-ulmi</i> ); native species; <b>to be removed</b> (conflicts with construction) |
| 11 | Manitoba maple | Fair | 21.0 | Private | Mature; crown moderately divergent towards southeast due to influence of tree #10; <b>to be removed</b> (conflicts with construction) |

Picture 2. Trees #9, 10 and 11 (left to right) located at 949 North River Road

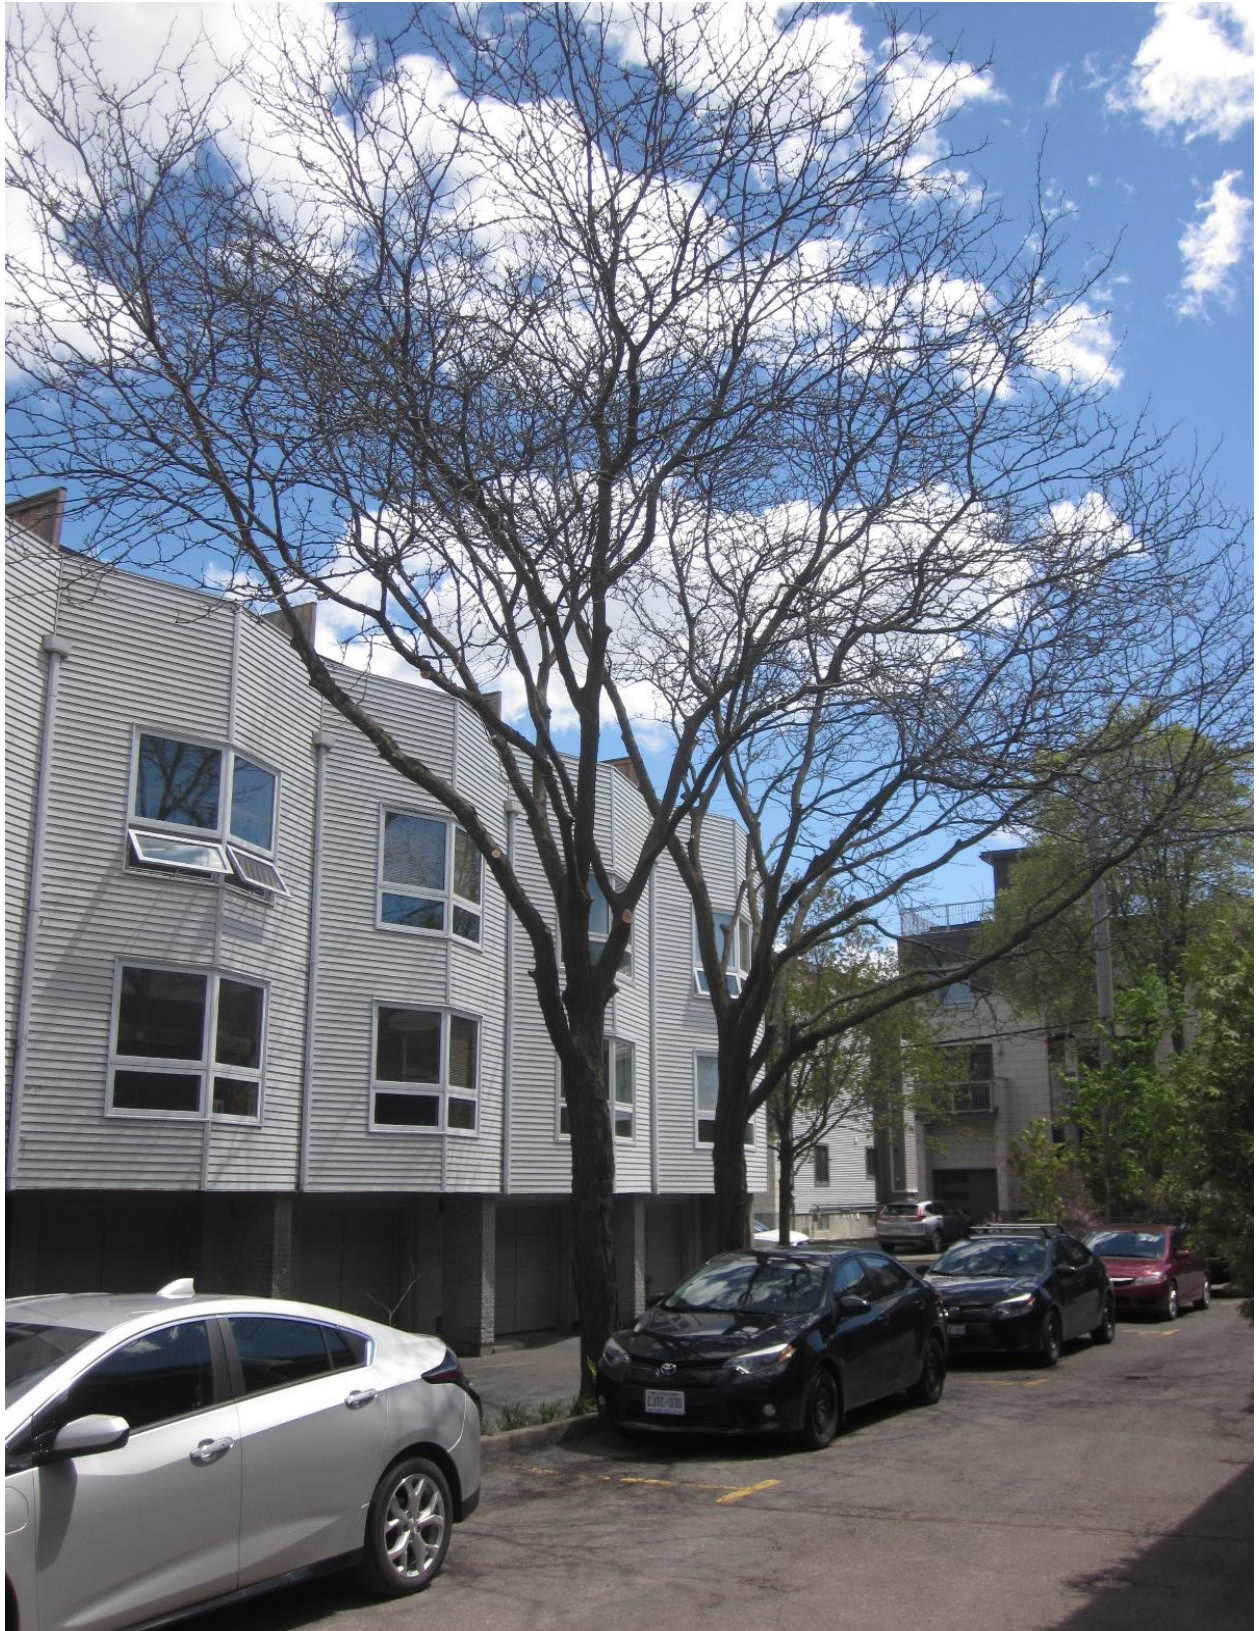
| Tree No. | Tree species | Condition (VP→E) | DBH <sup>1</sup> (cm) | Owner -ship | Age class, tree condition notes & <b>preservation status</b> (to be removed or preserved and protected) |
|---|---|---|---|---|---|
| 6 | Honey-locust<br>( <i>Gleditsia triacanthos</i> ) | Good | +/-40 | Neighbour | Mature; crown asymmetric towards south due to influence of tree #7; good growth increment even though located within a very limited rooting area; recently pruned; introduced species to Eastern Ontario; <b>to be preserved and protected</b> |
| 7 | Honey-locust | Good | +/-40 | Neighbour | Mature; crown asymmetric towards north due to influence of tree #6; good growth increment even though located within a very limited rooting area; recently pruned; introduced species to Eastern Ontario; <b>to be preserved and protected</b> |

Picture 3. Trees #6 and 7 (right to left) located adjacent to 949 North River Road

1. As per the City of Ottawa's tree protection barrier specification, erect a fence as close as possible to the CRZ of the tree(s);
2. Do not place any material or equipment within the CRZ of the tree(s);
3. Do not attach any signs, notices or posters to any tree;
4. Do not raise or lower the existing grade within the CRZ without approval;
5. Tunnel or bore instead of trenching within the CRZ of any tree;
6. Do not damage the root system, trunk or branches of any tree;
7. Ensure that exhaust fumes from all equipment are NOT directed towards any tree's canopy.

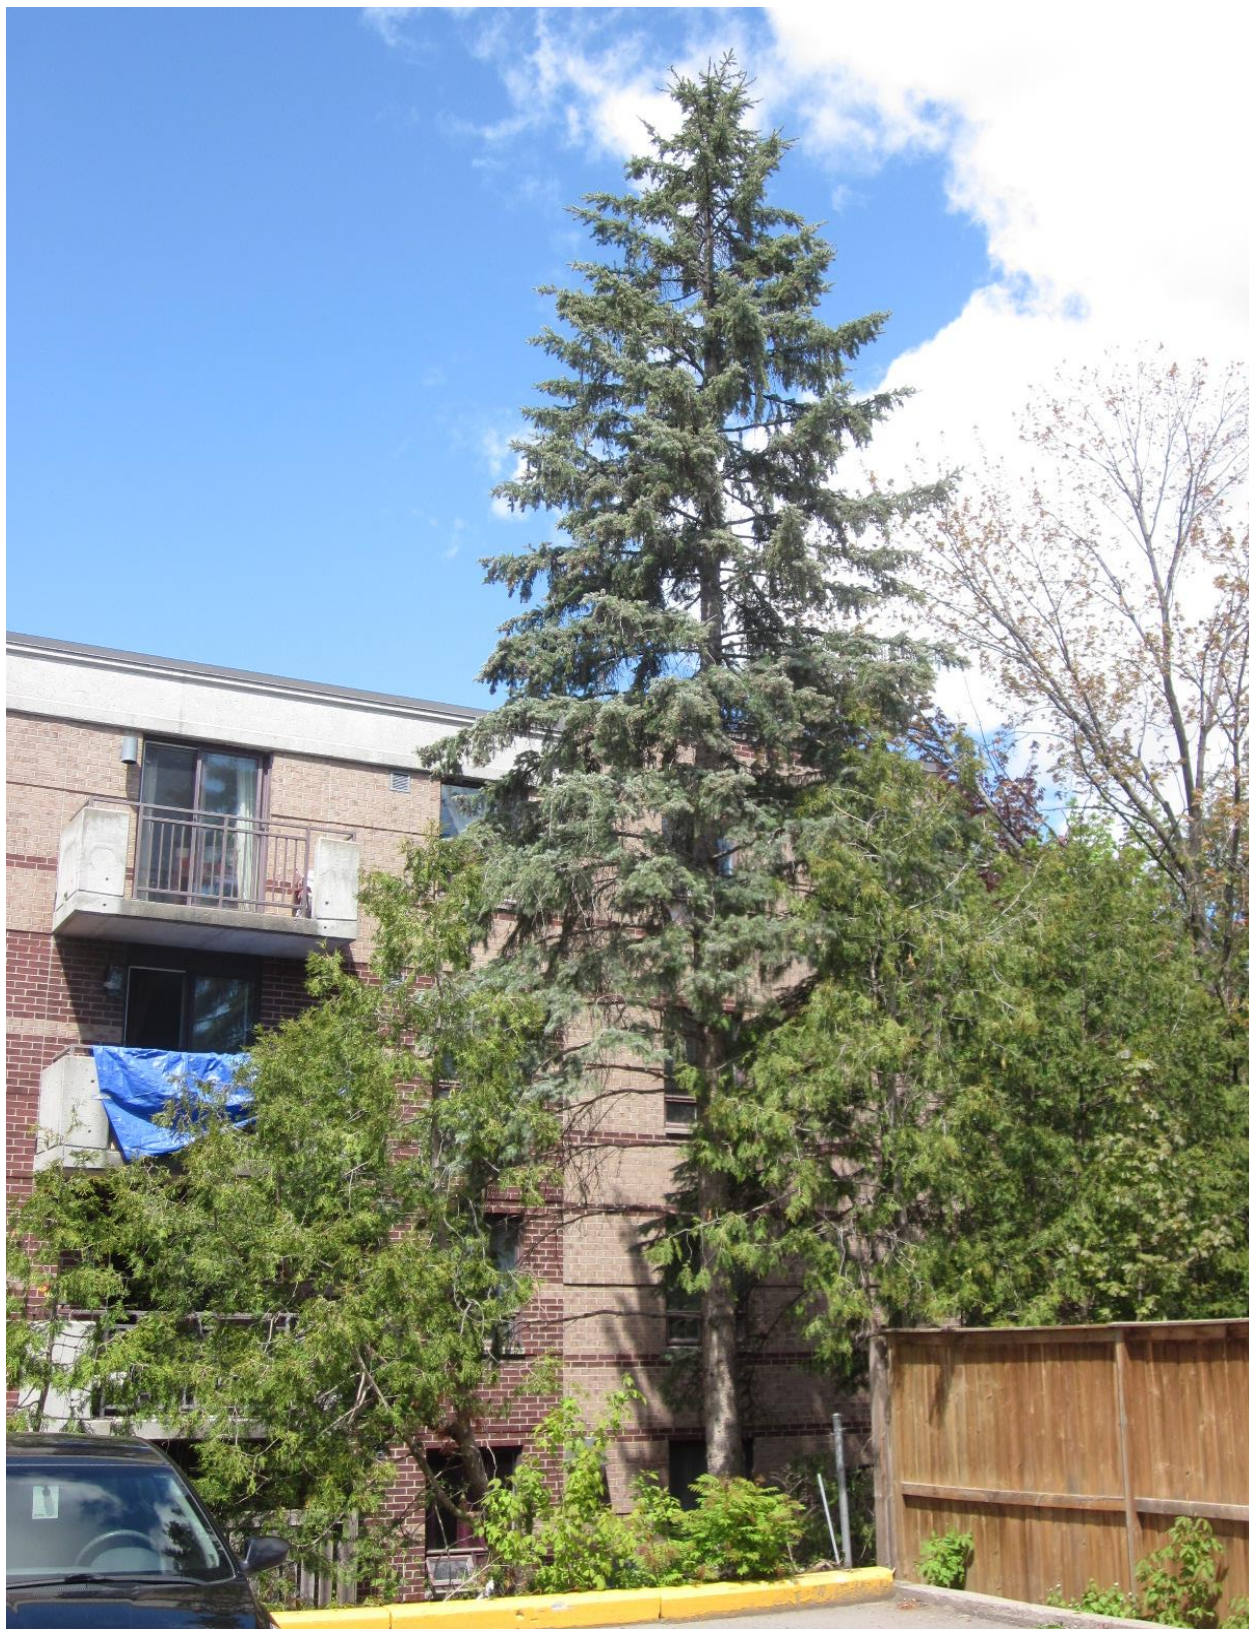
| Tree No. | Tree species | Condition (VP→E) | DBH <sup>1</sup> (cm) | Owner -ship | Age class, tree condition notes & <b>preservation status</b> (to be removed or preserved and protected) |
|---|---|---|---|---|---|
| 15 | White cedar<br>( <i>Thuja occidentalis</i> ) | Fair | +/-15 | Neighbour | Mature; moderately divergent towards northwest due to influence of tree #16; fair density, increment and colour native species; <b>to be preserved and protected</b> |
| 16 | Colorado spruce<br>( <i>Picea pungens</i> ) | Good | +/-30 | Neighbour | Mature; lower crown asymmetric and thin on inside due to influence of nearby cedar hedge; good density, increment and colour where directly exposed to sunlight; introduced species; <b>to be preserved and protected</b> |

Picture 4. Trees #15 and 16 (left to right) located adjacent to 949 North River Road
