**244 Fountain Place
Tree Conservation Report**

244 Fountain Place, Ottawa
Proposed Apartment Building
Project 160401234

Prepared for:
TC United Group

Original Submission: October 19, 2016
Revised:
October 13, 2021

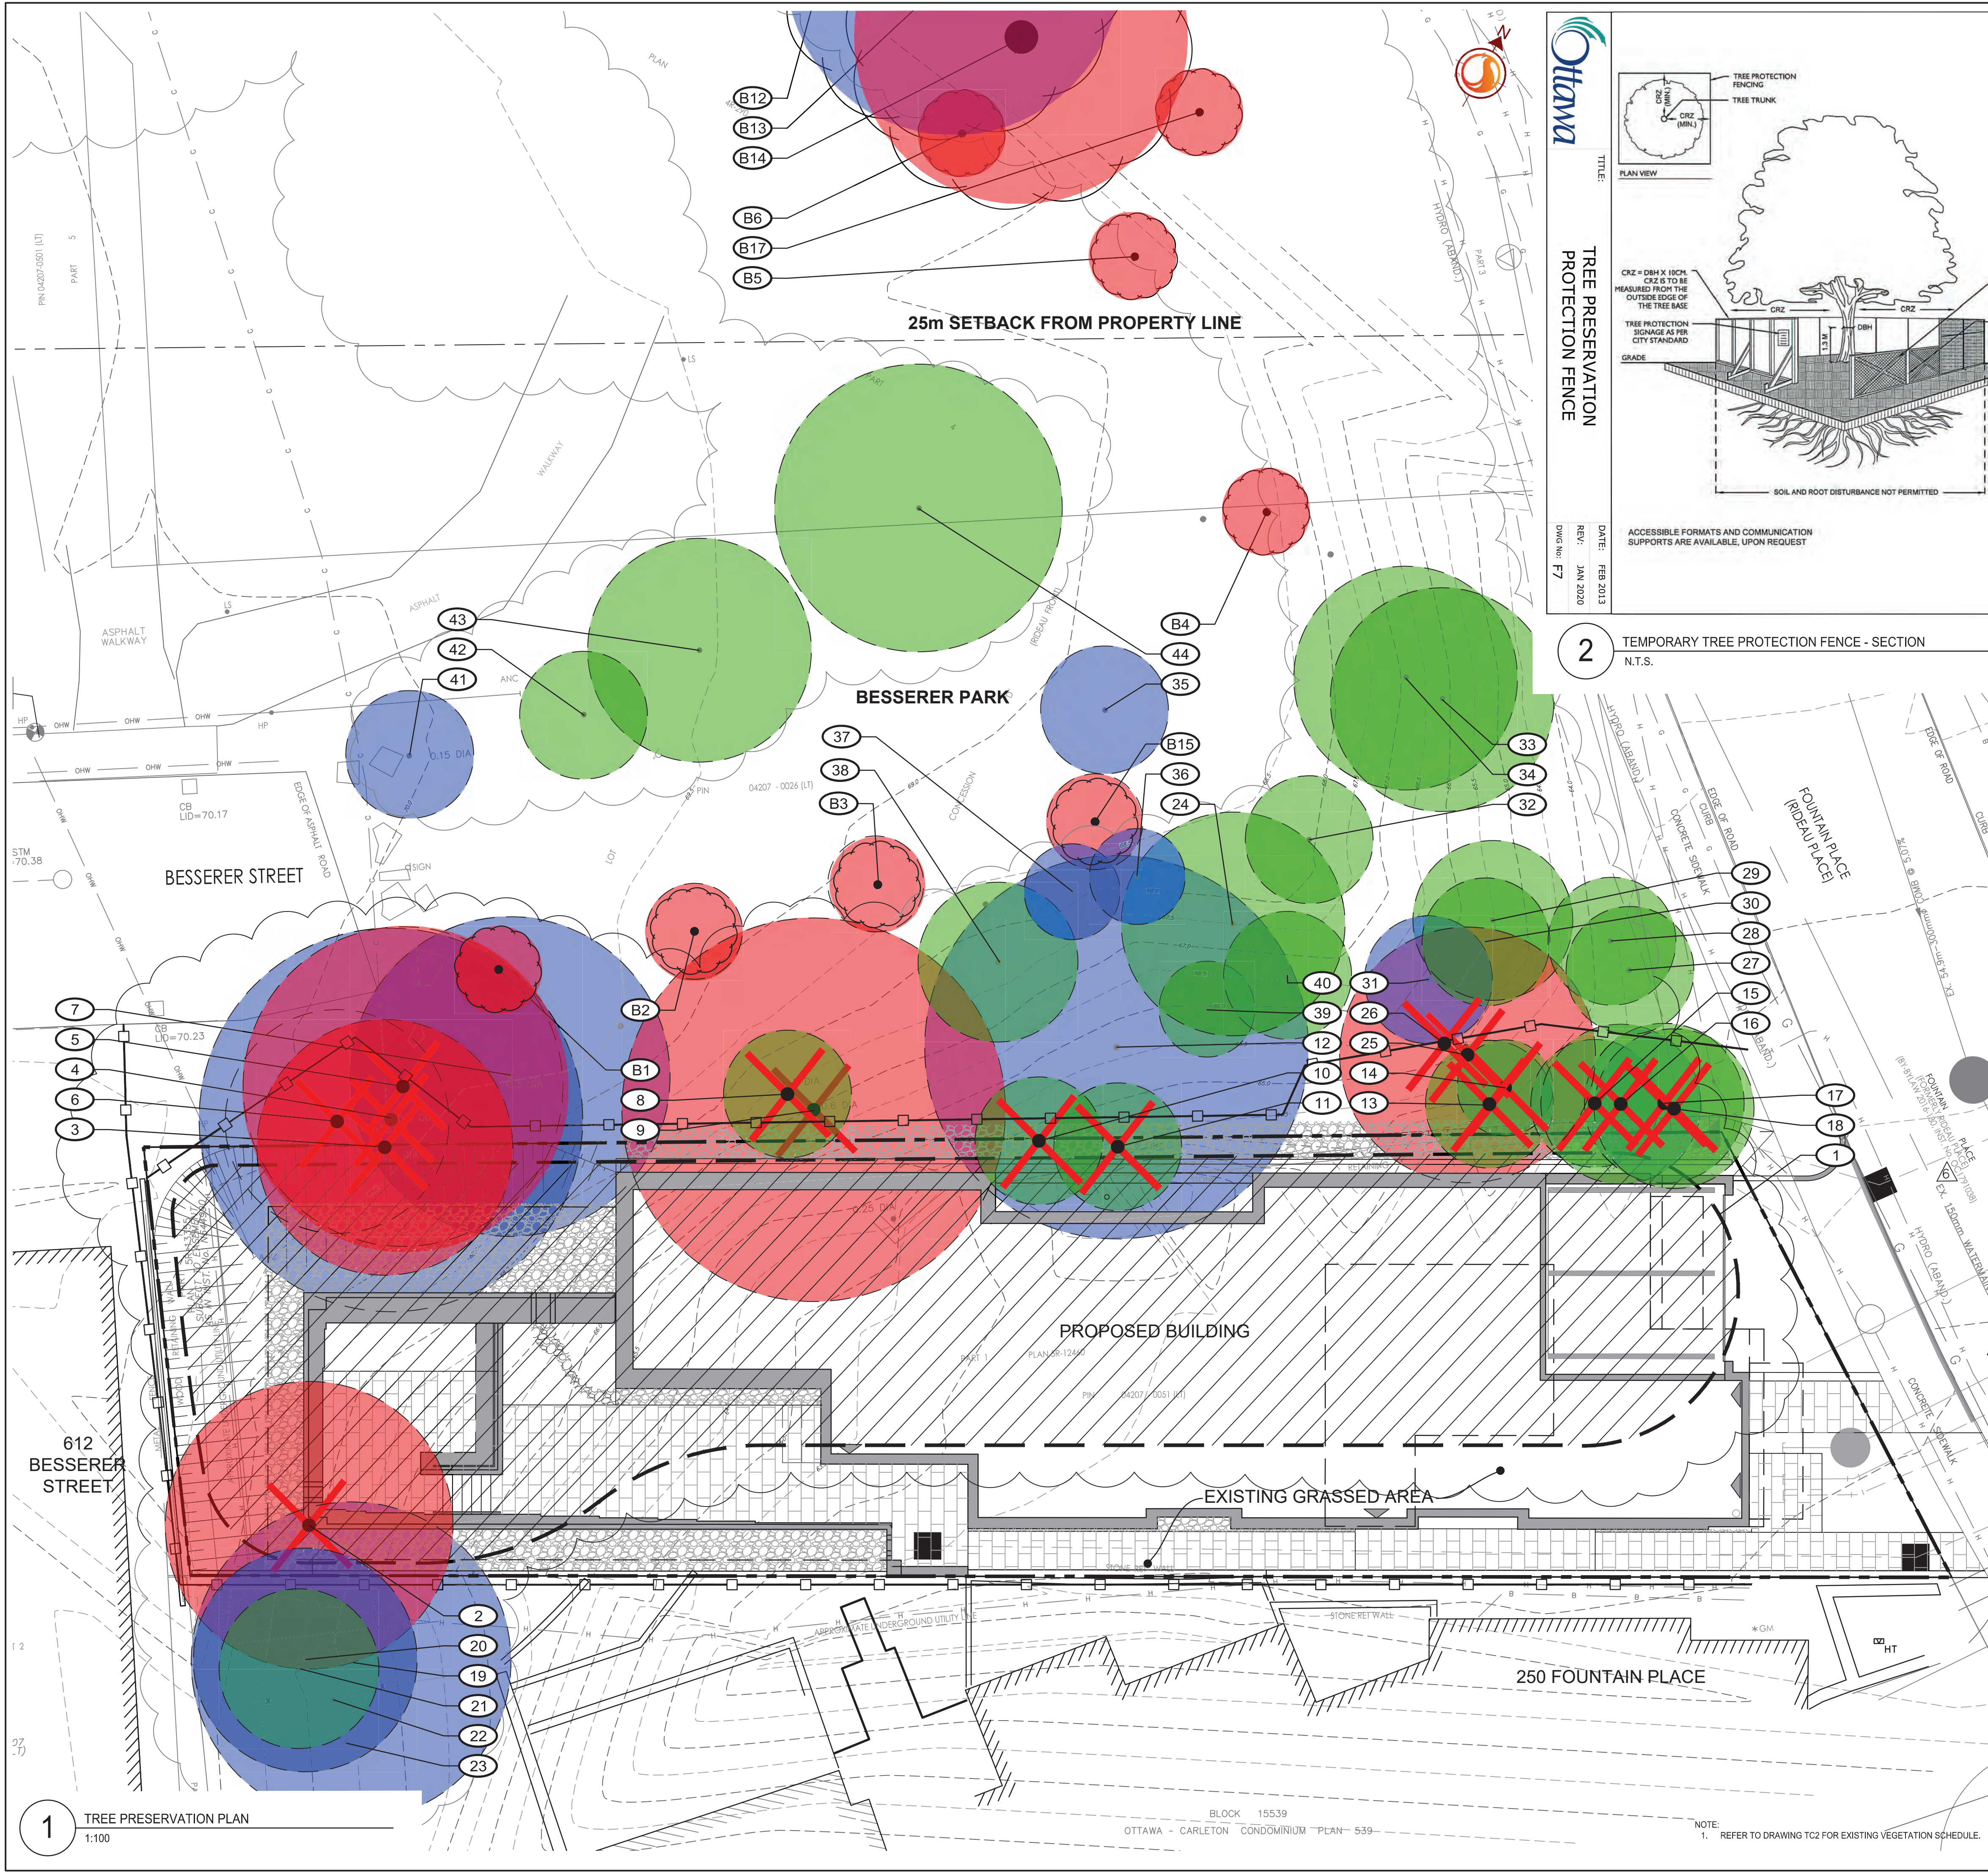
1 TREE PRESERVATION PLAN
1:100

5	<i>Acer negundo</i> / Manitoba Maple	50	Dead	Municipal tree (Besserer Park); Tree fell inside the park (spring 2020); TO BE REMOVED
6	<i>Acer negundo</i> / Manitoba Maple	40	Poor	Municipal tree (Besserer Park); Growing on top of slope; Bark is peeling, rotted; Damaged by wildlife; Leader was pruned in the past approximately 6m above ground; TO BE REMOVED DUE TO REGRADING WORKS
7	<i>Acer negundo</i> / Manitoba Maple	50	Fair	Municipal tree (Besserer Park); Growing on top of slope; Tree is leaning towards 244 Fountain Place; Tree opens up into 2 leaders at approximately 2m above ground; large stem at 1m from base was pruned back in the past; TO BE PROTECTED
8	<i>Ulmus americana</i> / American Elm	20	Good	Municipal tree (Besserer Park); Growing on a slope; TO BE REMOVED DUE TO REGRADING
9	<i>Acer negundo</i> / Manitoba Maple	50	Fair to Poor	Municipal tree (Besserer Park); Growing on a slope; Large 40cm branch broke naturally and fell inside 244 Fountain Place with length of branch extending entire width of property; Other smaller branches are broken due to this failure; Other dead branches are visible at top of tree; TO BE REMOVED DUE TO REGRADING

10	<i>Acer platanoides</i> / Norway Maple	20	Good	Tree on property line; Growing on a slope; TO BE REMOVED
11	<i>Acer platanoides</i> / Norway Maple	20	Good	Growing on slope adjacent to existing stone retaining wall to be removed; TREE TO BE REMOVED
12	<i>Acer negundo</i> / Manitoba Maple	60	Fair	Municipal tree (Besserer Park); Growing on slope; Broken branches; Leaning towards park; TREE TO BE PROTECTED
13	<i>Acer platanoides</i> / Norway Maple	20	Good	Municipal tree (Besserer Park); Adjacent to existing stone wall to be removed; TREE TO BE REMOVED
14	<i>Acer platanoides</i> / Norway Maple	15; 20	Good	Municipal tree (Besserer Park); 2 trunks; TREE TO BE REMOVED
15	<i>Ulmus americana</i> / American Elm	20	Good	Municipal tree (Besserer Park); Adjacent on/in existing stone wall to be removed; TREE TO BE REMOVED
16	<i>Ulmus americana</i> / American Elm	25	Good	Municipal tree (Besserer Park); Adjacent on/in existing stone wall to be removed; 2 trunks; TREE TO BE REMOVED

17	<i>Ulmus americana</i> / American Elm	25	Good	Municipal tree (Besserer Park); Adjacent on/in existing stone wall to be removed; TREE TO BE REMOVED
18	<i>Ulmus americana</i> / American Elm	25	Good	Municipal tree (Besserer Park); Adjacent on/in existing stone wall to be removed; TREE TO BE REMOVED
