October 12, 2021

**RE: TREE CONSERVATION REPORT FOR ST. THOMAS THE APOSTLE (2345 ALTA VISTA DRIVE)
AND ELLWOOD HOUSE (2270 BRAESIDE AVENUE), OTTAWA**

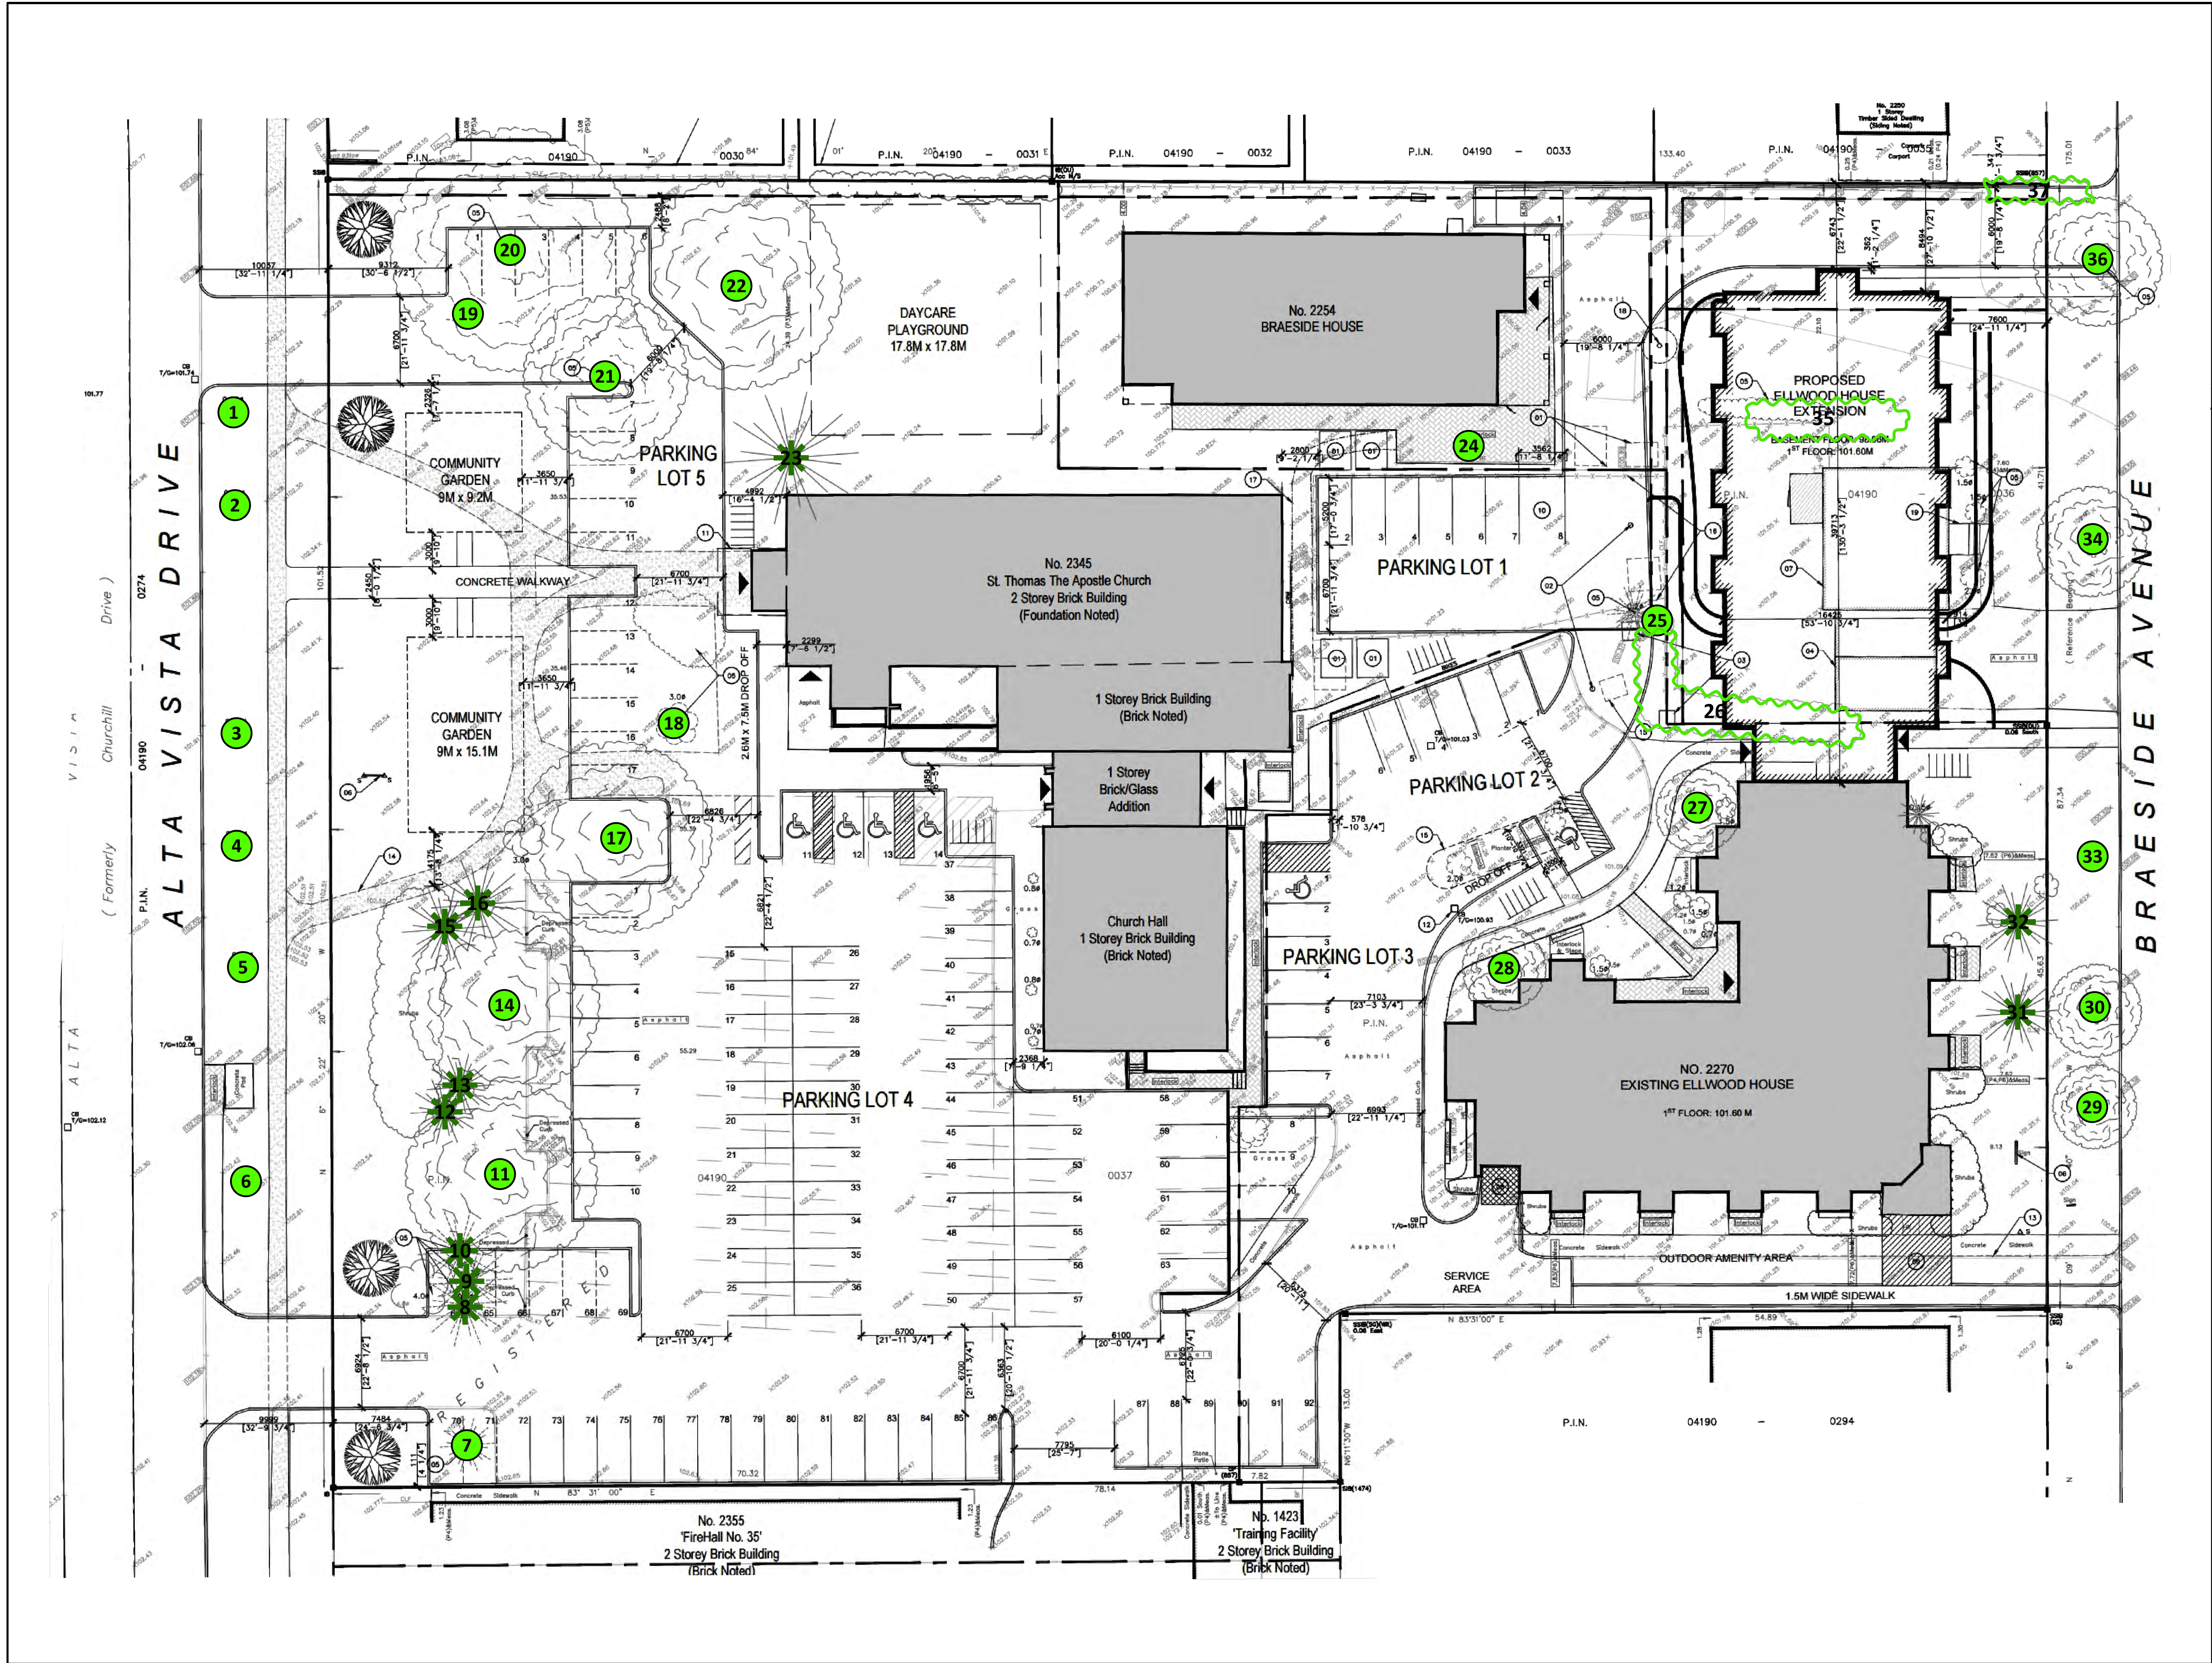
DRAWING: Tree Conservation Plan

All current vegetation is shown on the tree conservation plan included on page 8 of this report. By the numbers indicated on the plan, each tree and hedge is detailed below:

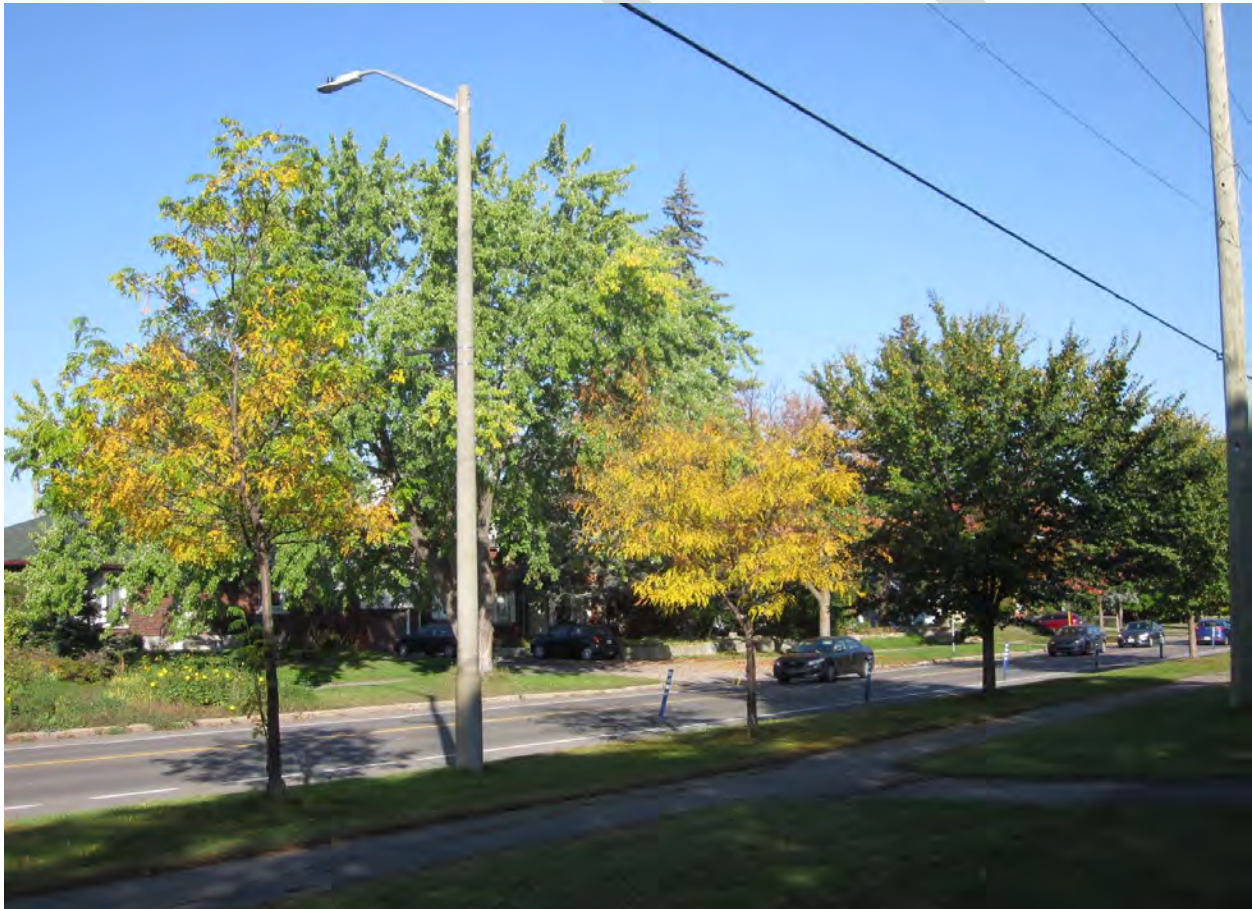
Tree No.	Tree species	Condition (VP→E)	DBH ¹ (cm)	Owner-ship	Age class, tree condition notes & preservation status (to be removed or preserved and protected)
1	White elm (<i>Ulmus americana</i>)	Good	20.4 (at 1m)	City	Maturing; central stem with suppressed laterals starting at 1.2m from grade; broad crown with good density and leaf size; cultivar; to be preserved and protected
2	White elm	Good	20.8	City	Maturing; central stem with competing lateral at 1.75m on southeast; good crown density and leaf size; cultivar; to be preserved and protected
3	White elm	Good	23.1	City	Maturing; central stem with competing laterals starting at 1.5m; broad crown with good density and leaf size; cultivar; to be preserved and protected
4	Honey-locust (<i>Gleditsia triacanthos</i>)	Good	11.1	City	Maturing; central stem with competing lateral at 1m and two suppressed laterals at 1.5m; crown asymmetric towards southwest; introduced species to Eastern Ontario; to be preserved and protected

5	Honey-locust	Fair	9.9	City	Maturing; central stem divergent towards northwest due to sweep at 2.5m; slight epicormic growth on lower bole; introduced species to Eastern Ontario; to be preserved and protected
6	Honey-locust	Fair	11.1	City	Maturing; central stem with three competing leaders at 2.5m; crown mildly asymmetric towards southwest; heavy epicormic growth on lower bole from 0.2m; introduced species to Eastern Ontario; to be preserved and protected
7	Norway maple (<i>Acer platanoides</i>)	Poor	25.2	Private	Maturing; lost lateral on southeast at 2m; barkless wound from grade to 3.5m with incipient decay; crown asymmetric towards northwest; introduced invasive species; to be removed

Picture 1. City trees #3, 4 and 5 (right to left) adjacent to 2345 Alta Vista Drive

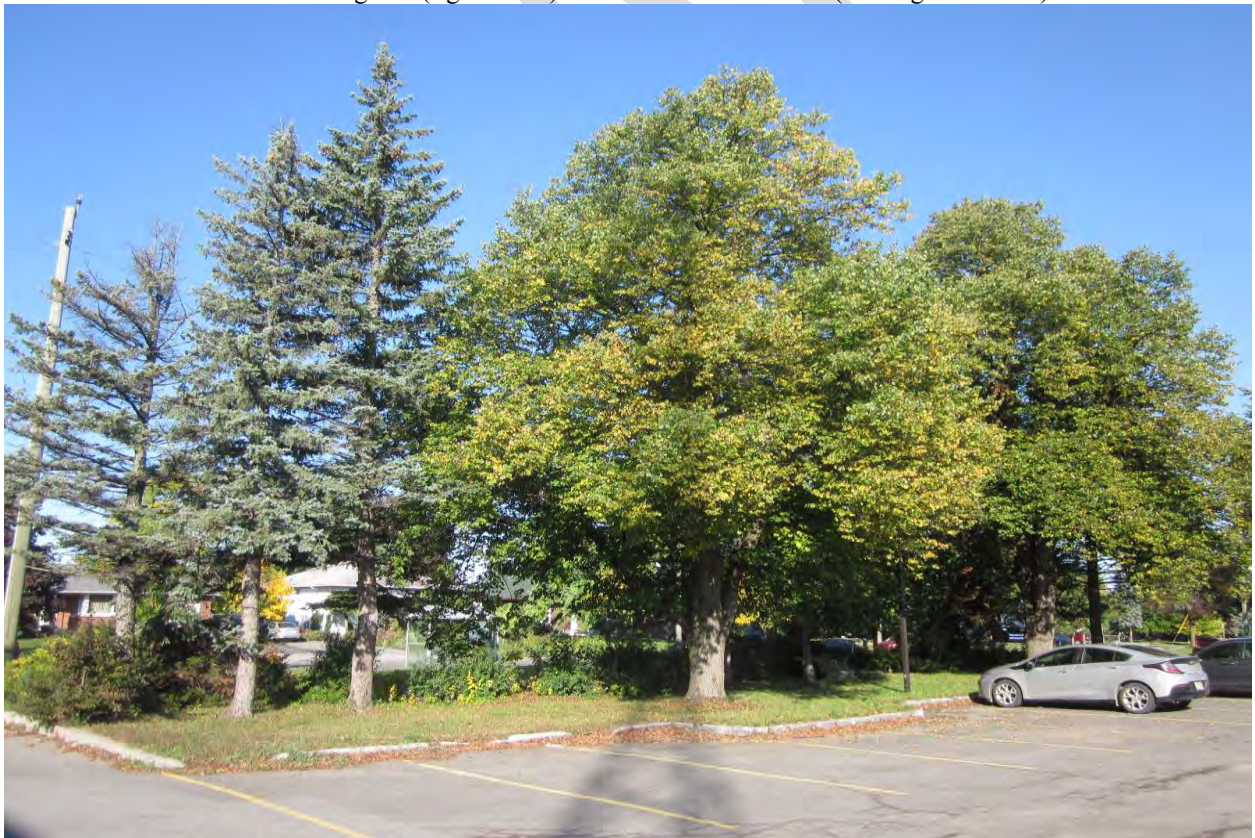
8	Colorado spruce (<i>Picea pungens</i>)	Poor	29.0	Private	Mature; three competing leaders – all dead; poor crown density and growth increment, fair needle colour on recent growth; introduced species; to be removed
9	Colorado spruce	Fair	30.5	Private	Mature; upright form due to influence of adjacent trees; leader dead; poor density, fair increment and colour; introduced species; to be removed
10	Colorado spruce	Good	36.5	Private	Mature; leader alive and intact; lower crown shaded by tree #11; good density, increment and colour; introduced species; to be removed
11	Little-leaf linden (<i>Tilia cordata</i>)	Good	61.7 (at 1m)	Private	Very mature; single dominant stem for most of height; suppressed laterals starting at 1.5m; very broad, dense crown with good leaf size; introduced species; to be preserved and protected
12	Colorado spruce	Good	28.6	Private	Mature; very asymmetric toward southwest due to influence of neighbouring trees; good density, increment and colour where exposed to direct sunlight; introduced species; to be preserved and protected

13	Colorado spruce	Poor	26.9	Private	Mature; leader missing; growth suppressed by adjacent trees – poor density, increment and colour; introduced species; to be preserved and protected
14	Little-leaf linden	Good	69.7 (at 1m)	Private	Very mature; competing stems 1.5m – mildly divergent; northwest stem dominant; very broad, dense crown with good leaf size; introduced species; to be preserved and protected
15	Colorado spruce	Fair	34.3	Private	Mature; leader dead; crown asymmetric towards west; good density, increment and colour where exposed to direct sunlight; introduced species; to be preserved and protected
16	Colorado spruce	Good	40.2	Private	Mature; crown asymmetric towards northwest; good density, increment and colour where exposed to direct sunlight; introduced species; to be preserved and protected

Picture 3. Private trees #8, 9, 10, 11 and 14 (left to right) at 2345 Alta Vista Drive (looking westward)

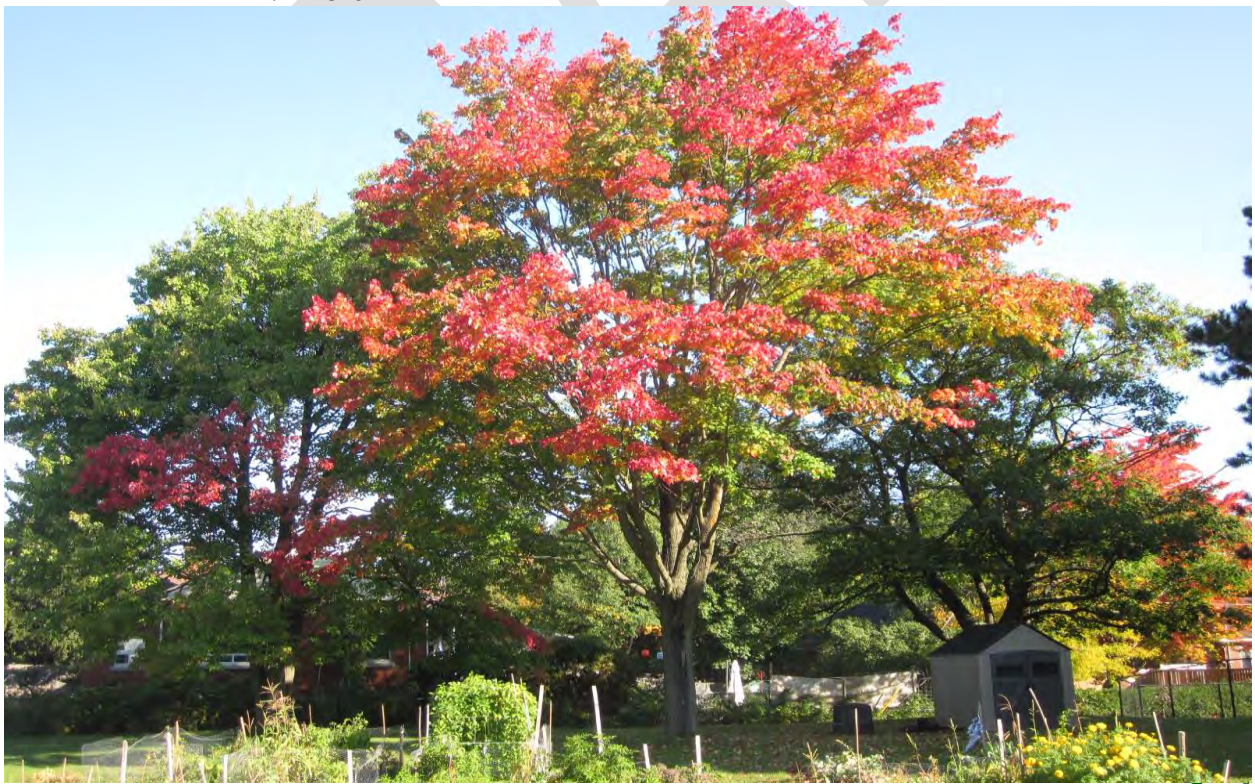
17	Little-leaf linden	Good	74.5	Private	Very mature; central stem to 7.5m with multiple leaders above (rounded crown apex); suppressed laterals starting at 2m – very broad, dense crown with good leaf size; good root collar; mildly restricted rooting area (parking median); introduced species; to be preserved and protected
18	Red maple (<i>Acer rubrum</i>)	Very good	12.5	Private	Maturing; central stem with competing leaders; lowest lateral at 1m; native species; to be removed (could possibly be transplanted for use elsewhere)
19	Hackberry (<i>Celtis occidentalis</i>)	Fair	10.4 (at 1m)	Private	Maturing; central stem with competing laterals at 1.3m on southeast and 2.25m on northwest; native species; to be removed (could possibly be transplanted for use elsewhere)
20	Red maple	Fair	81.2 (at 0.2m)	Private	Very mature; tri-stemmed at 0.5m from grade - moderately divergent; lower crown asymmetric towards south due to clearing from Hydro lines; good crown density and leaf size; native species; to be removed

21	Red maple	Good	60.2	Private	Mature; central stem with competing lateral at 2.25m on south and co-dominant leaders at 5m; crown asymmetric towards southwest due to influence of tree #22; native species; to be removed
22	Red oak (<i>Quercus rubra</i>)	Fair	95.2	Private	Very mature; tri-stemmed at 2m – dominant stem towards east with suppressed stem on west and heavily suppressed stem on north (strongly divergent); heavy buttressing in lower bole with opposing basal wounds (one with advanced decay); polypore fruiting body on ground near base present in October; native species; to be preserved and protected (must be decay tested to ensure integrity of bole)

Picture 5. Private tree #20, 21 and 22 (left to right) at 2345 Alta Vista Drive

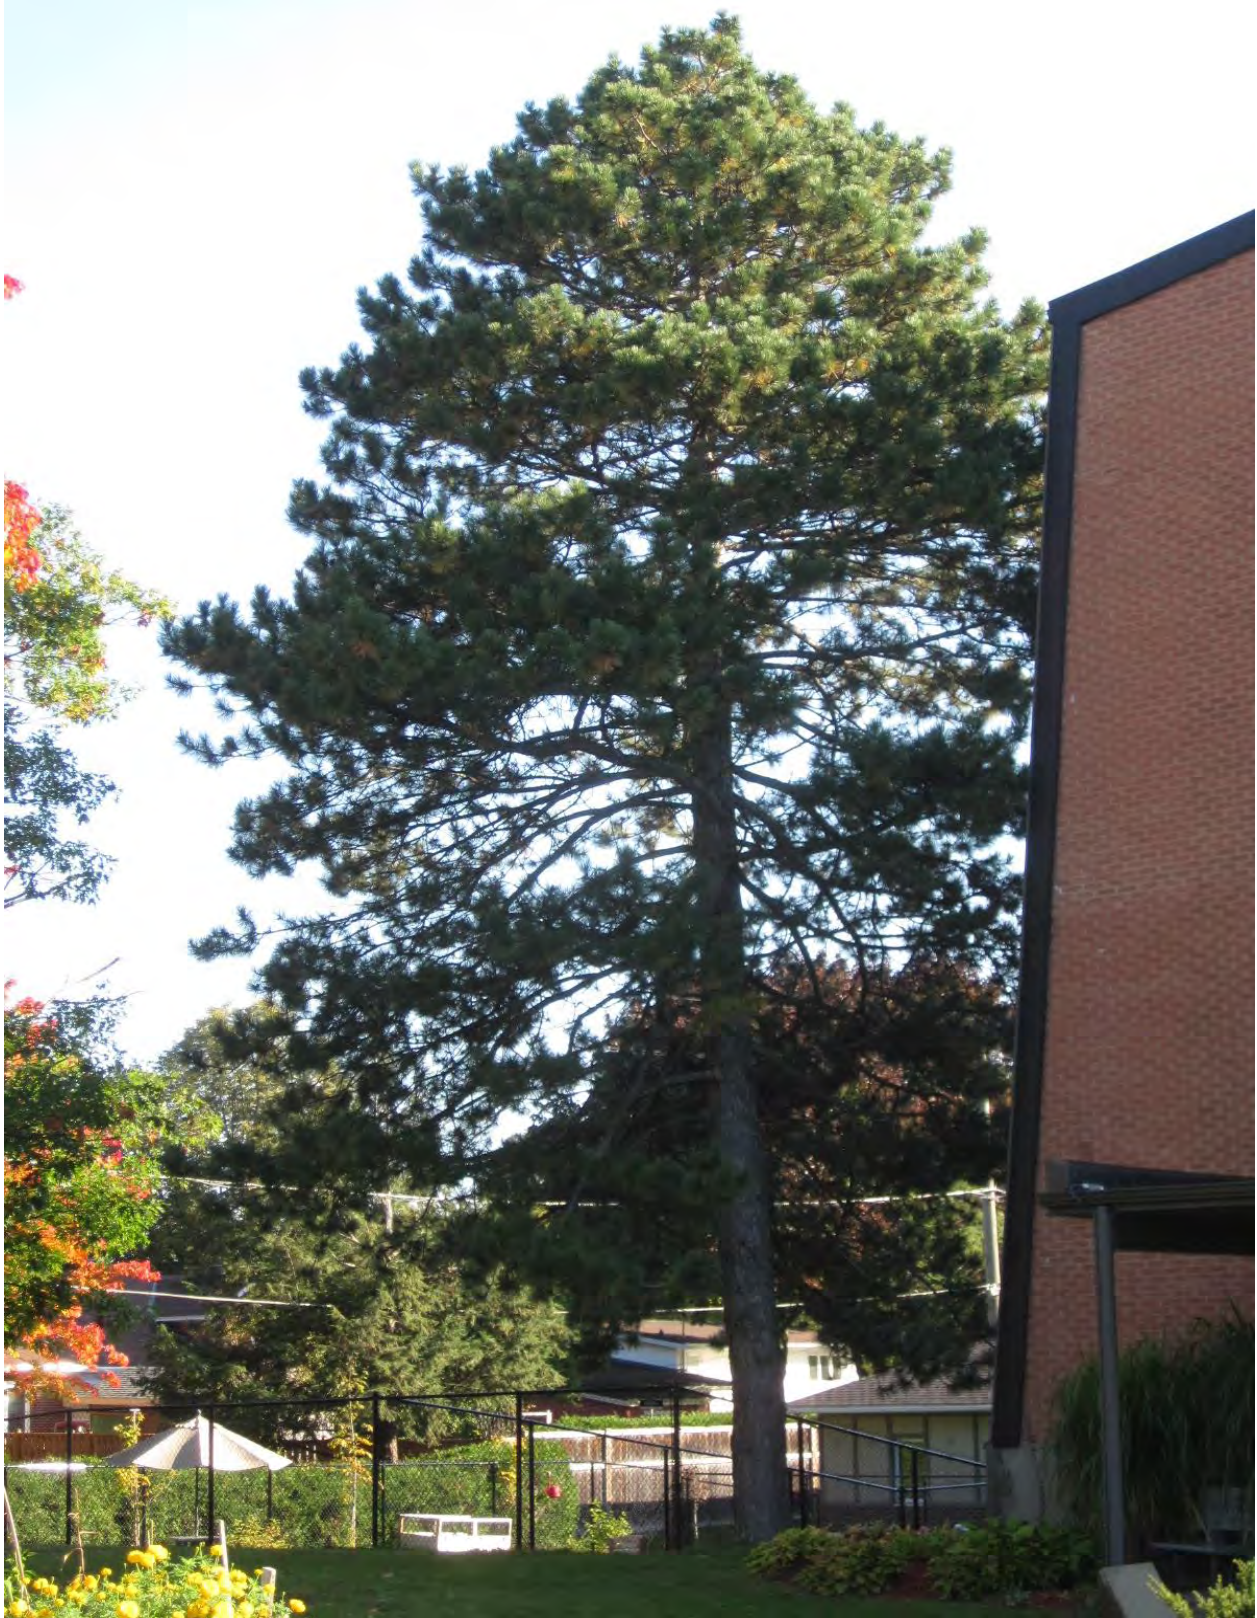
23	Austrian pine (<i>Pinus nigra</i>)	Good	55.9	Private	Very mature; central dominant stem mildly divergent towards northwest due to proximity of building; co-dominant leaders at 12m; crown generally symmetric; deep crown - held at 2m from grade; good density; increment and colour for age; introduced species; to be preserved and protected
24	Pin oak (<i>Quercus palustris</i>)	Good	+/-15	Private	Maturing; within fence playground; introduced species to Eastern Ontario; to be preserved and protected
25	Norway maple	Good	27.2	Private	Mature; lower stem divergent towards northwest, crown asymmetric in same direction due to influence of adjacent trees; likely originated from seed; introduced invasive species; to be removed
26	White cedar (<i>Thuja occidentalis</i>)	Fair	15 avg.	Private	Mature hedge with 11 stems in total; west section divergent with stem damage from snow piling - poor density, increment and colour with heavy cone crop in 2021; east section with fair density, increment and colour; located within a mildly restricted rooting area; native species; to be removed

Picture 6. Private tree #23 at 2345 Alta Vista Drive

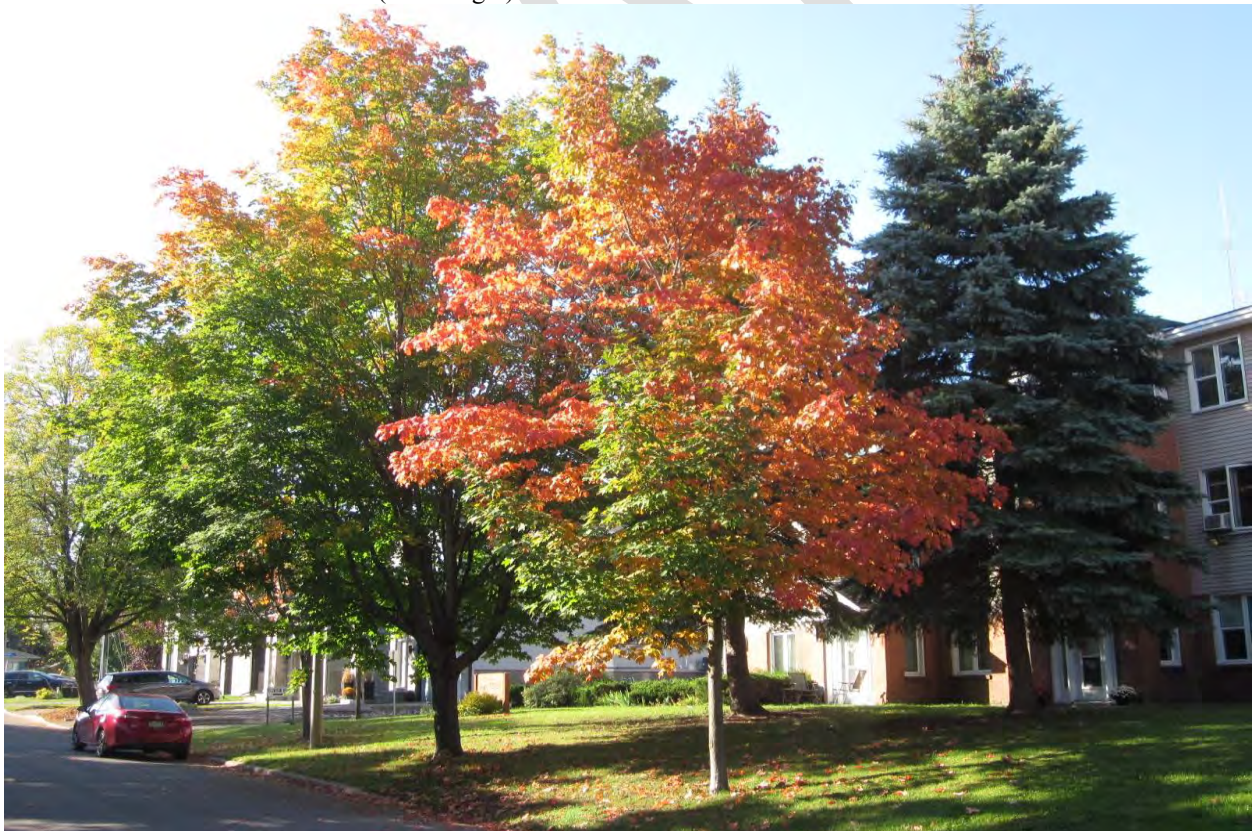
29	Sugar maple	Very poor	36.5	City	Mature; central stem with upright co-dominant leaders at 2.5m; suppressed laterals starting at 1.5m; in very advanced decline - holding less than 10% living foliage; major deadwood present; native variety; to be preserved and protected (though should be removed due to hazard potential)
30	Sugar maple	Fair	41.0	City	Mature; tri-dominant stems at 2m with competing laterals on northwest and northeast and a suppressed lateral on south – all at 1.5m from grade; broad, dense crown; good leaf size; native species; to be preserved and protected
31	Colorado spruce	Fair	40.3	Private	Mature; good form, density, increment and colour; lower crown shaded by tree #30; introduced species; to be preserved and protected
32	Colorado spruce	Very good	31.5	Private	Mature; good form, density, increment and colour; introduced species; to be preserved and protected
33	Sugar maple	Very good	16.5	City	Maturing; central dominant stem with suppressed laterals at 4m on east; native species; to be preserved and protected

Picture 8. City trees #30 and 33 and private tree #32 (left to right) at 2270 Braeside Avenue

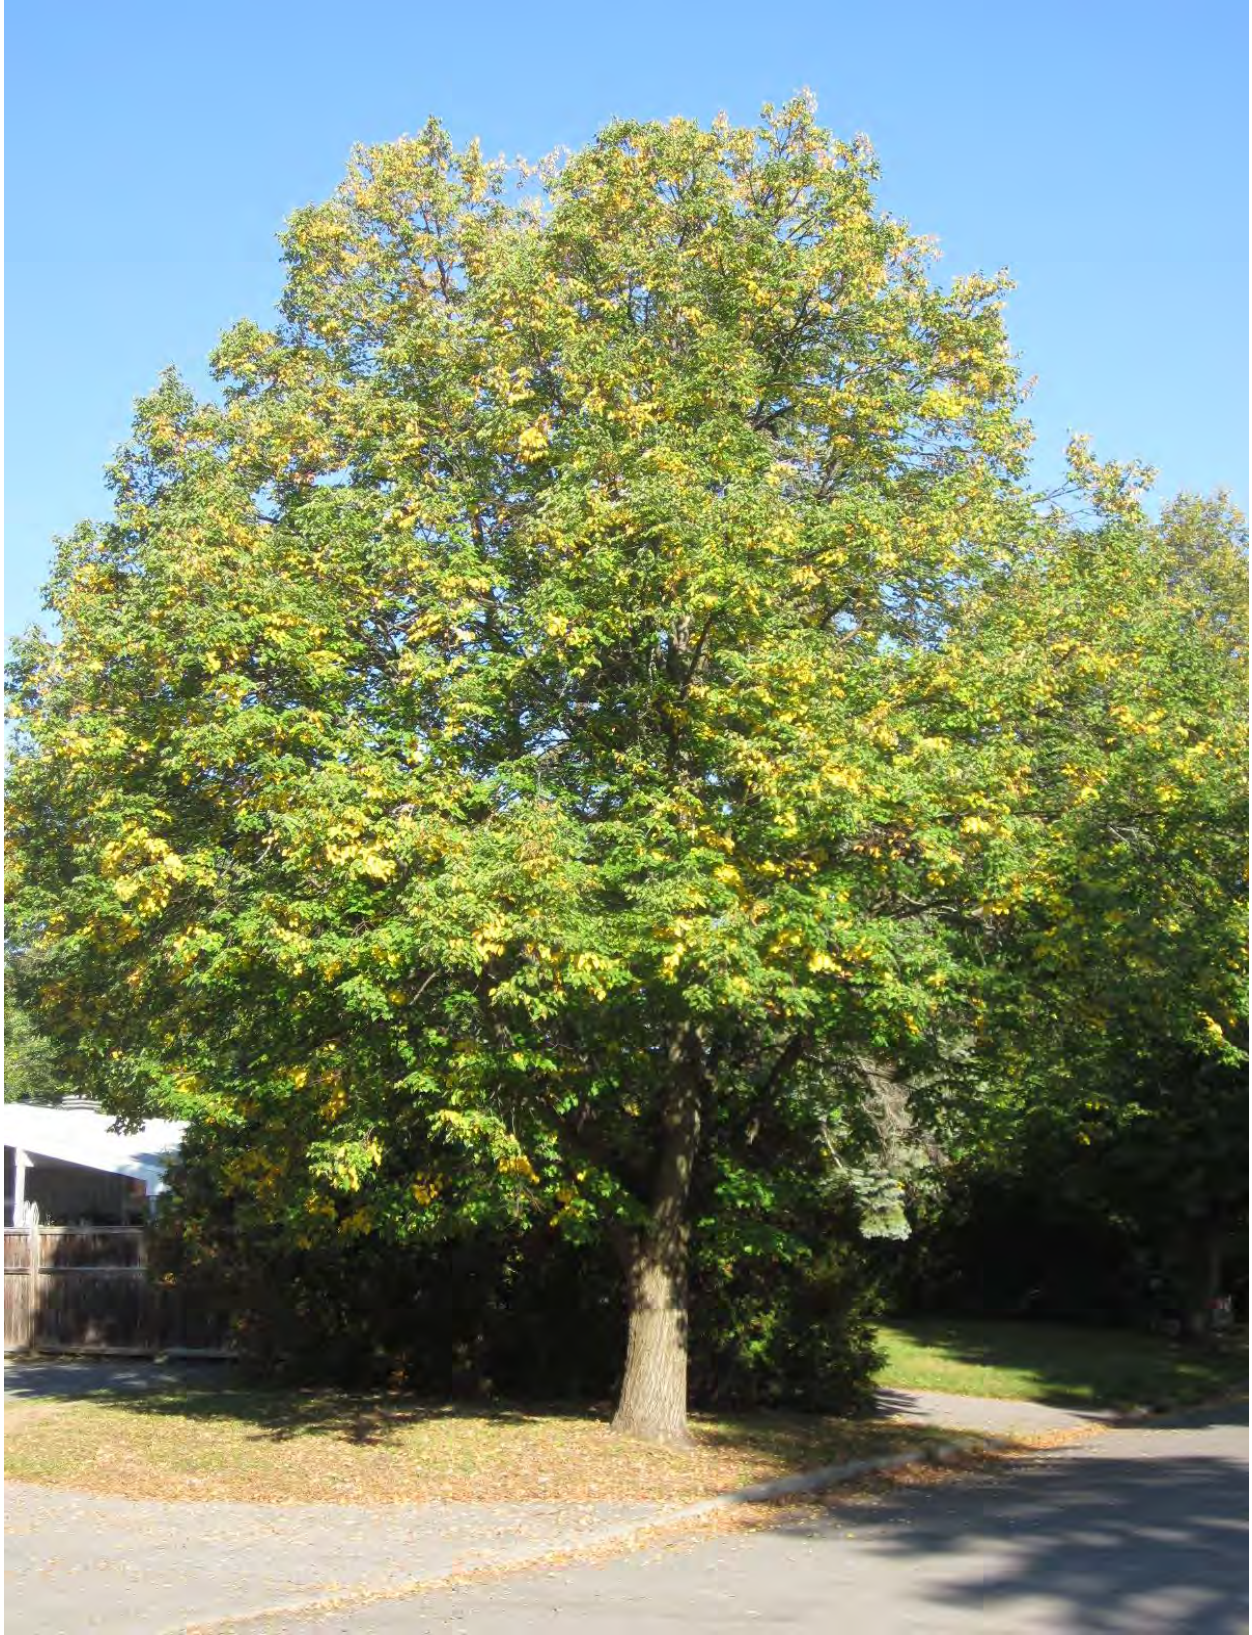
Picture 9. City tree #36 adjacent to 2270 Braeside Avenue (tree is to be removed for new driveway)
