URBAN FORESTRY & FOREST MANAGEMENT CONSULTING

November 29, 2021

RE: TREE CONSERVATION REPORT FOR 180 KANATA AVENUE, OTTAWA

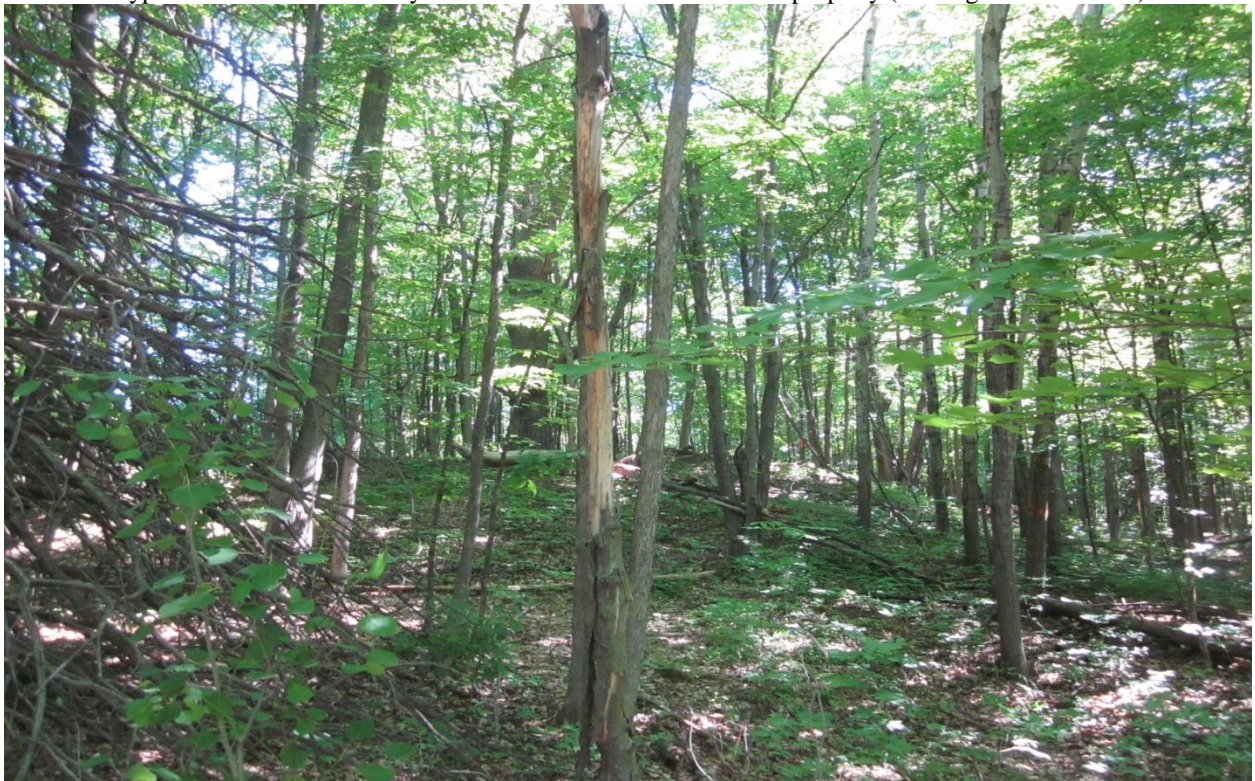
Picture 2. Typical over- and understory conditions at 180 Kanata Avenue property (looking northeastward)

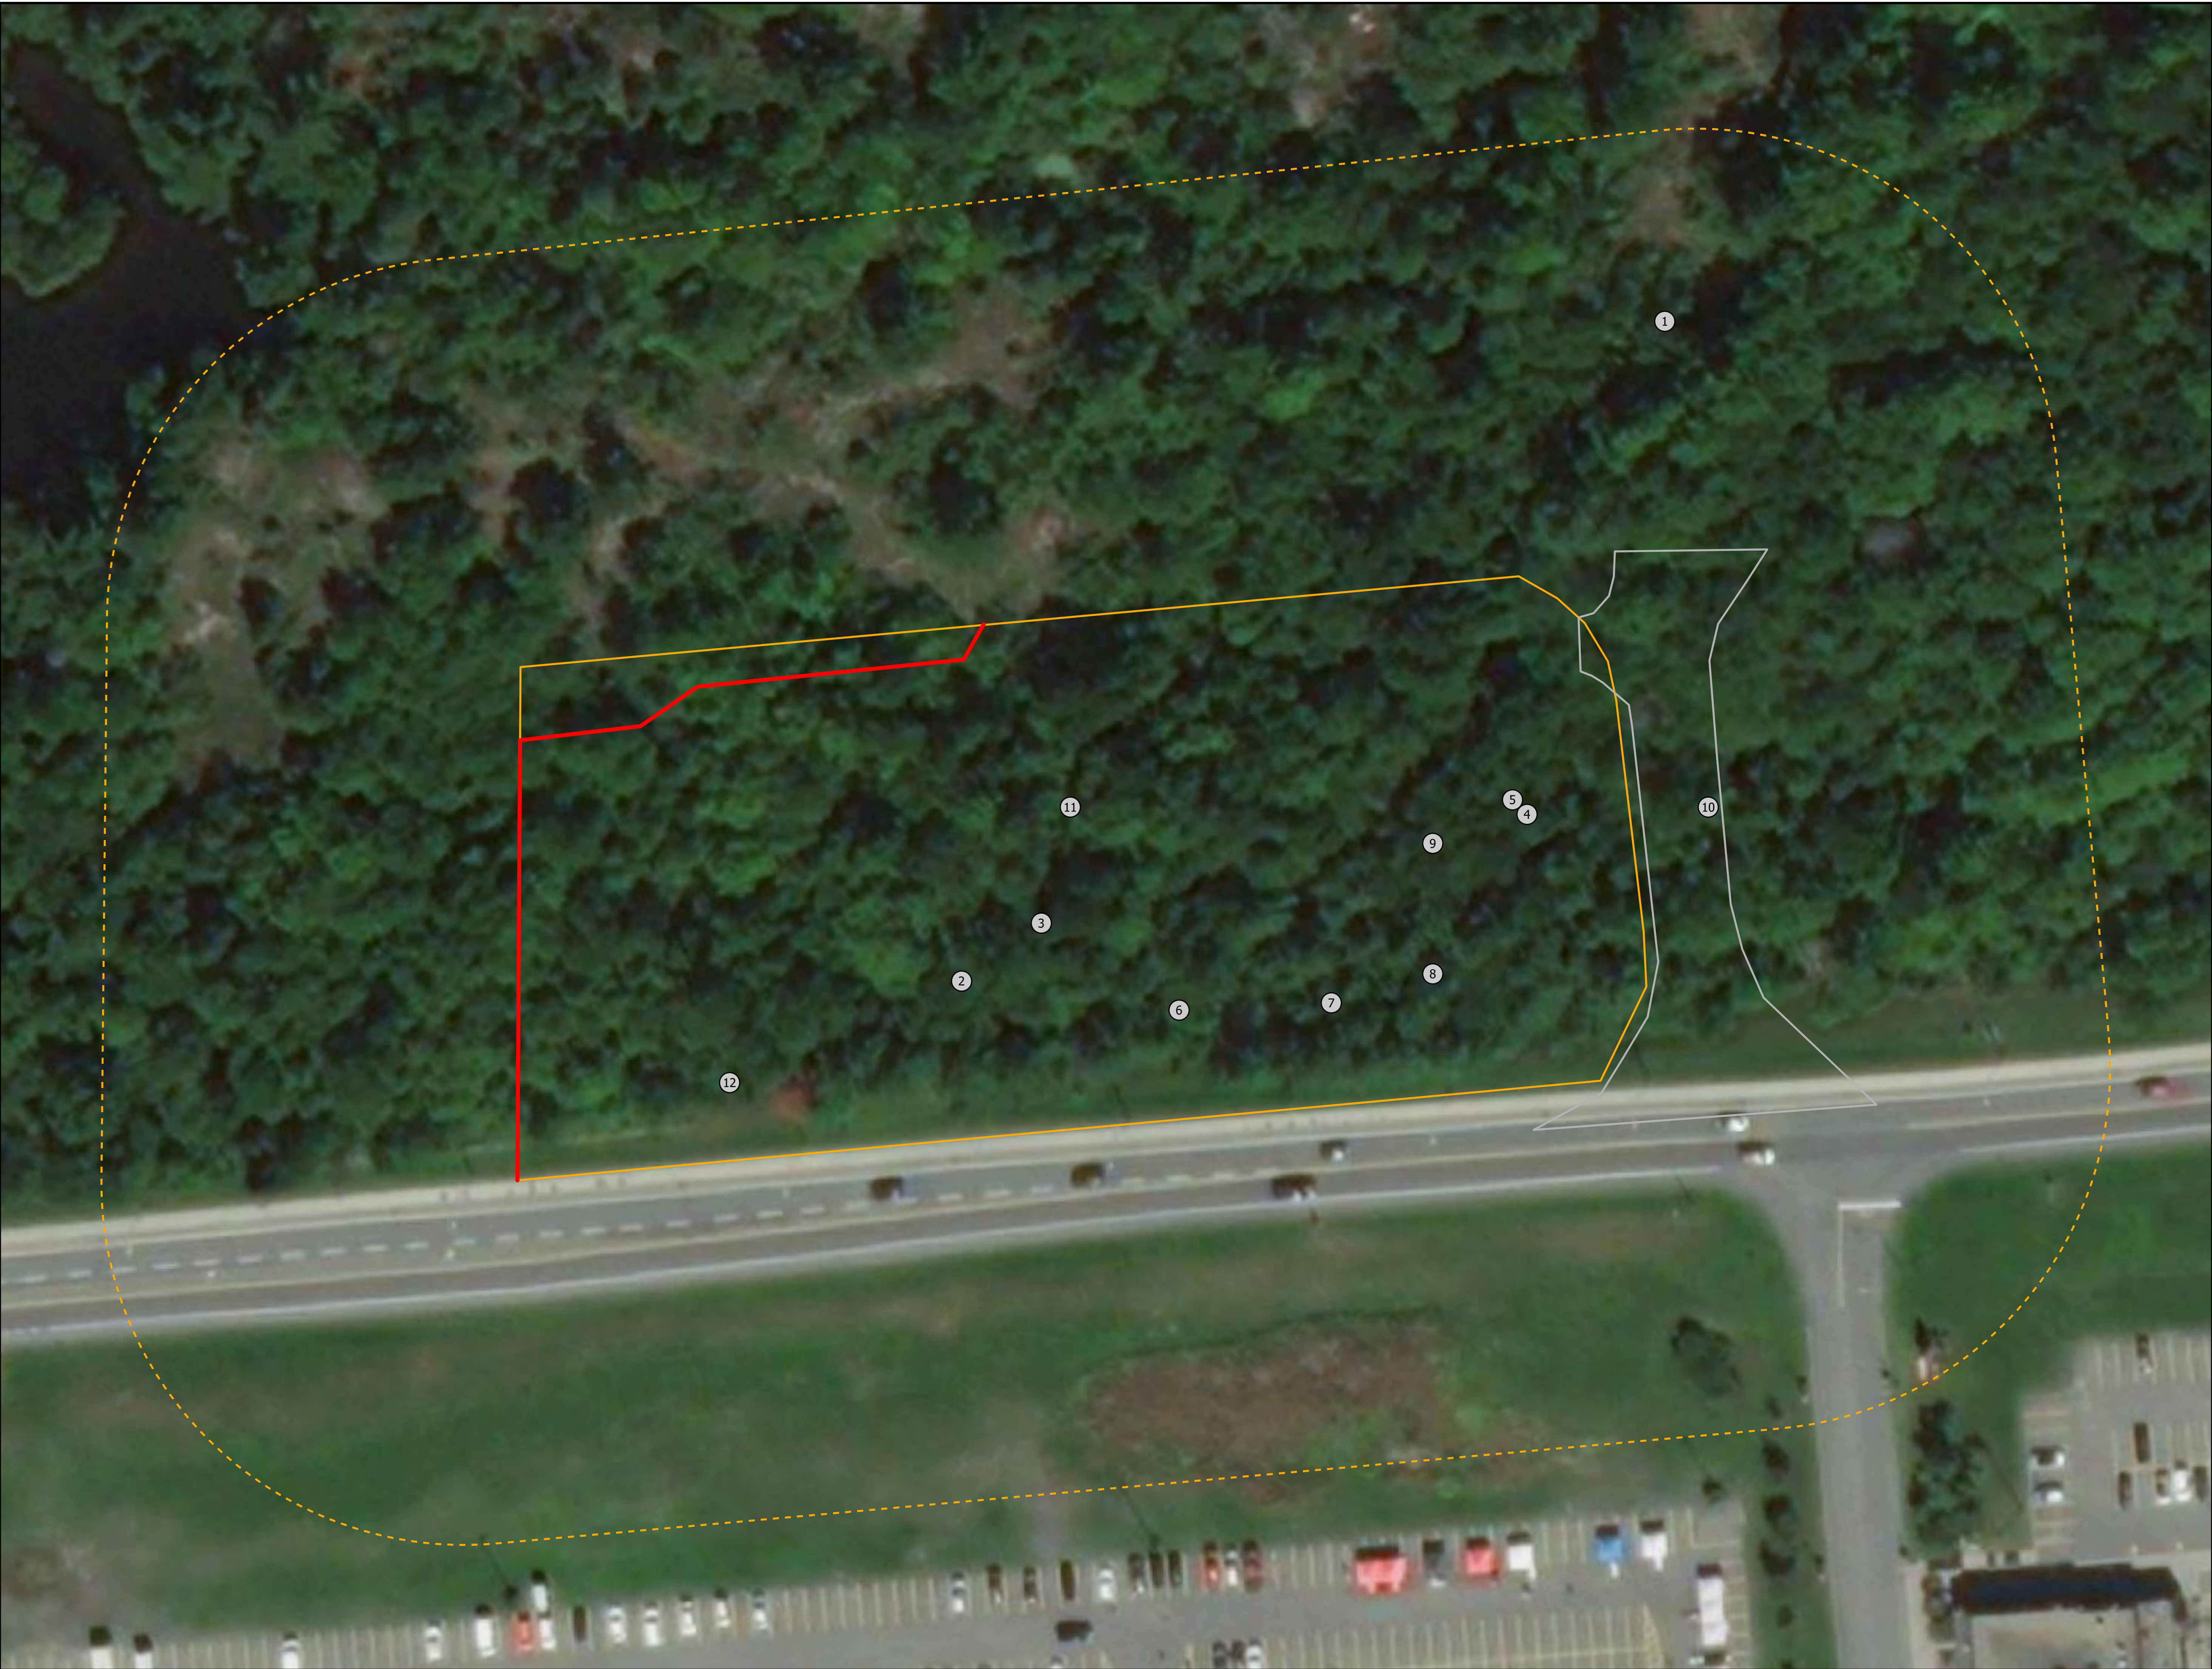
Locations of Butternut

A total of twelve butternuts (*Juglans cinerea*) were found on or within 50m of the subject property. This tree species is listed as endangered under the Province of Ontario's Endangered Species Act (2007) and so is protected from harm. Through the completion of a butternut health assessment all twelve trees were determined to be Category 1 (*i.e.* non-retainable). This assessment was sent to the Ontario Ministry of Environment, Conservation and Parks in June 2021.

Given the layout of the proposed development and parking below grade, and the relatively small area of the subject property, there are very limited opportunities for the conservation of existing trees. In particular, the need for substantial grade changes (via blasting due to the presence of extensive rock) precludes large scale tree conservation. Instead, tree retention will be limited to the margins of the property – in particular along the northern property line (see tree conservation plan included on page 9 of this report).

The presence of dying and dead mature trees at the perimeter of the property, aside from being an eyesore, will also be a factor in worker health and safety. It is a known fact that edge trees are also often destabilized. With this in mind, the preserved areas should be managed in such a way as to remove mature trees in proximity to the forest edge. As the distance increases from the edge so should the average diameter of the retained trees. Allowing limited sun and wind to enter the newly exposed edges will better help the remaining trees to adapt.

Prior to all clearing activities the property lines must be well marked. It is important that trees on adjacent public property, including those straddling property lines, be preserved and not harmed in any way.
