**244 Fountain Place
Tree Conservation Report**

244 Fountain Place, Ottawa
Proposed Apartment Building
Project 160401234

Original Submission: October 19, 2016
Revised:
January 17, 2022

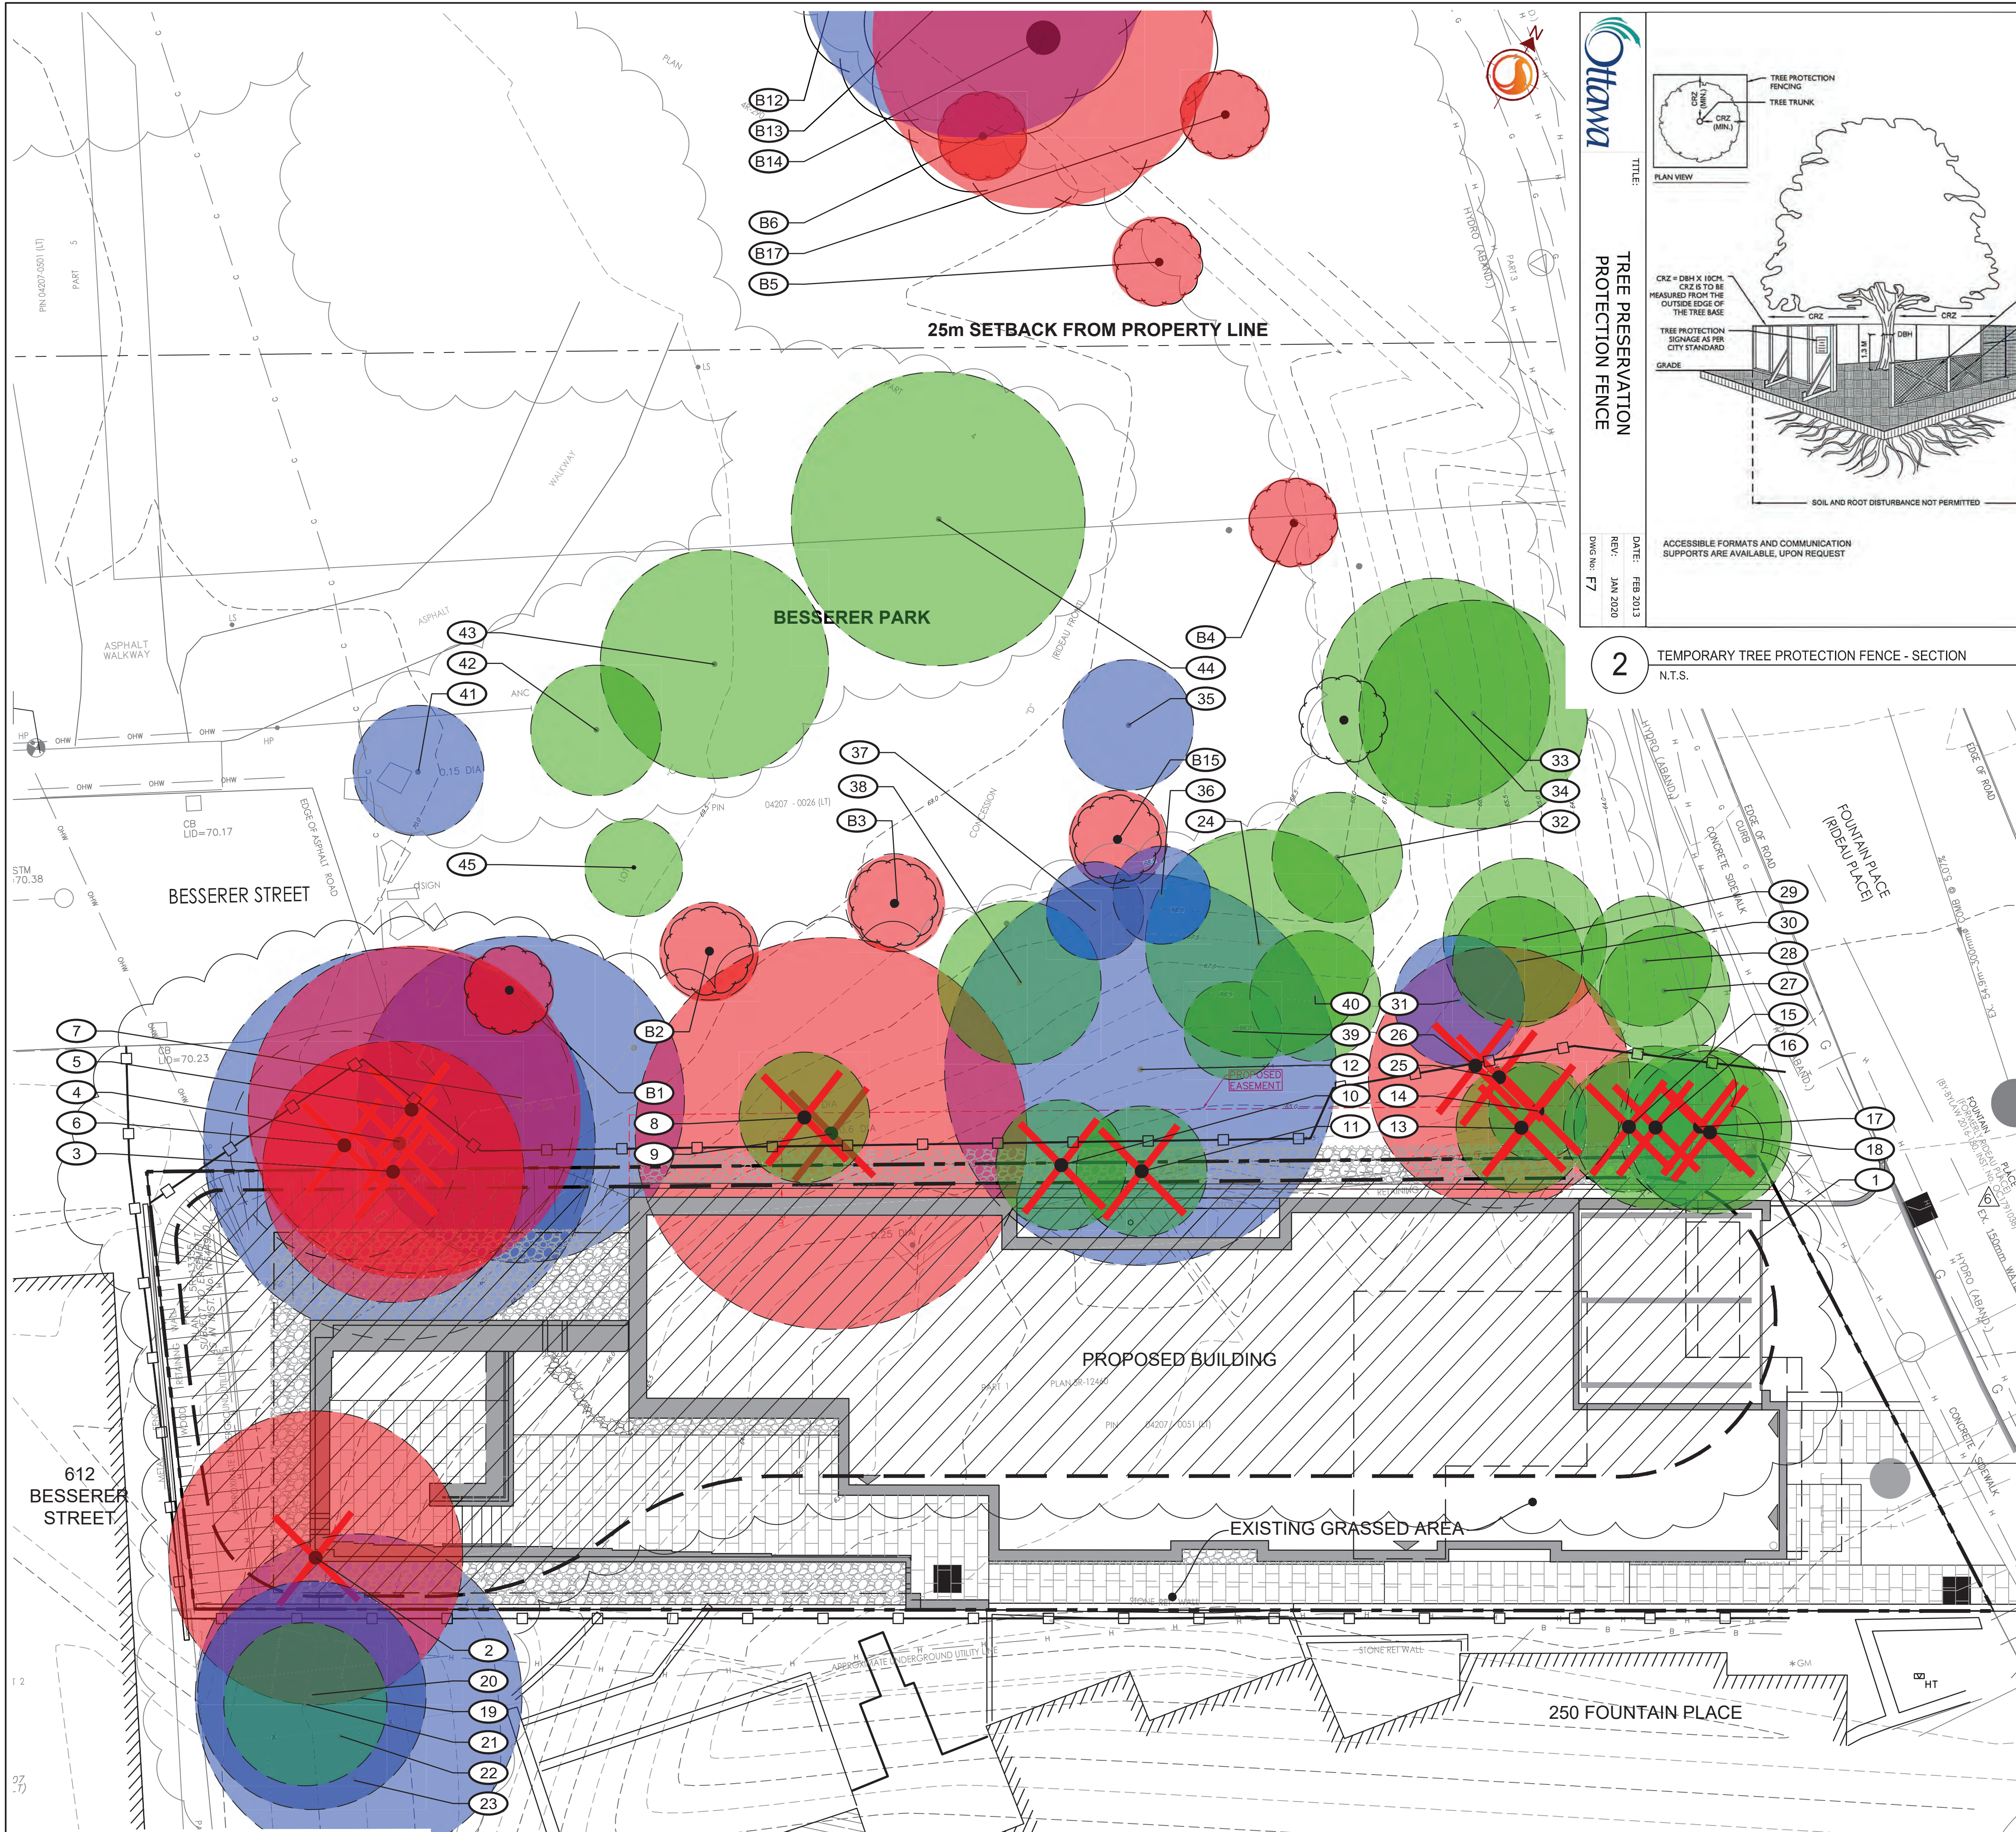
1 TREE PRESERVATION PLAN
1:100

PLANT ID	BOTANICAL NAME / COMMON NAME	DIAMETER AT BREAST HEIGHT (cm)	HEALTH CONDITION	REMARKS
1	<i>Acer negundo</i> / Manitoba Maple - 45% <i>Acer platanoides</i> / Norway Maple - 45% <i>Populus grandidentata</i> / Large tooth aspen - 1% <i>Rhamnus cathartica</i> / Buckthorn - 6% <i>Ulmus americana</i> / American Elm - 3%	15-40	Good to Poor to Dead	Grouping of trees; A number of trees are dead or in poor condition; GROUPING TO BE REMOVED TO ALLOW FOR CONSTRUCTION OF BUILDING
2	<i>Acer negundo</i> / Manitoba Maple	50	Fair to Poor	TO BE REMOVED DUE TO REGRADING WORKS
3	<i>Acer negundo</i> / Manitoba Maple	40	Poor	Growing on the slope; Tree is falling towards 244 Fountain Place with large crack in the trunk; TO BE REMOVED DUE TO REGRADING WORKS
4	<i>Acer negundo</i> / Manitoba Maple	60	Fair	Municipal tree (Besserer Park); Tree growing on top of slope; Tree is standing with some pruning; tree is leaning towards Hydro Pole; TO BE REMOVED DUE TO REGRADING WORKS

5	<i>Acer negundo</i> / Manitoba Maple	50	Dead	Municipal tree (Besserer Park); Tree fell inside the park (spring 2020); TO BE REMOVED
6	<i>Acer negundo</i> / Manitoba Maple	40	Poor	Municipal tree (Besserer Park); Growing on top of slope; Bark is peeling, rotted; Damaged by wildlife; Leader was pruned in the past approximately 6m above ground; TO BE REMOVED DUE TO REGRADING WORKS
7	<i>Acer negundo</i> / Manitoba Maple	50	Fair	Municipal tree (Besserer Park); Growing on top of slope; Tree is leaning towards 244 Fountain Place; Tree opens up into 2 leaders at approximately 2m above ground; large stem at 1m from base was pruned back in the past; TO BE PROTECTED
8	<i>Ulmus americana</i> / American Elm	20	Good	Municipal tree (Besserer Park); Growing on a slope; TO BE REMOVED DUE TO REGRADING
9	<i>Acer negundo</i> / Manitoba Maple	50	Fair to Poor	Municipal tree (Besserer Park); Growing on a slope; Large 40cm branch broke naturally and fell inside 244 Fountain Place with length of branch extending entire width of property; Other smaller branches are broken due to this failure; Other dead branches are visible at top of tree; TO BE REMOVED DUE TO REGRADING

10	<i>Acer platanoides</i> / Norway Maple	20	Good	Tree on property line; Growing on a slope; TO BE REMOVED
11	<i>Acer platanoides</i> / Norway Maple	20	Good	Growing on slope adjacent to existing stone retaining wall to be removed; TREE TO BE REMOVED
12	<i>Acer negundo</i> / Manitoba Maple	60	Fair	Municipal tree (Besserer Park); Growing on slope; Broken branches; Leaning towards park; TREE TO BE PROTECTED; CANOPY PRUNING MAY BE REQUIRED
13	<i>Acer platanoides</i> / Norway Maple	20	Good	Municipal tree (Besserer Park); Adjacent to existing stone wall to be removed; TREE TO BE REMOVED
14	<i>Acer platanoides</i> / Norway Maple	15; 20	Good	Municipal tree (Besserer Park); 2 trunks; TREE TO BE REMOVED
15	<i>Ulmus americana</i> / American Elm	20	Good	Municipal tree (Besserer Park); Adjacent on/in existing stone wall to be removed; TREE TO BE REMOVED
16	<i>Ulmus americana</i> / American Elm	25	Good	Municipal tree (Besserer Park); Adjacent on/in existing stone wall to be removed; 2 trunks; TREE TO BE REMOVED

31	<i>Acer platanoides</i> / Norway Maple	20	Fair	Municipal tree (Besserer Park); Dead branches; TO REMAIN
32	<i>Acer negundo</i> / Manitoba Maple	20	Good	Municipal tree (Besserer Park); Leaning towards Rideau; TO REMAIN
33	<i>Acer negundo</i> / Manitoba Maple	35	Good	Municipal tree (Besserer Park); TO REMAIN
34	<i>Acer negundo</i> / Manitoba Maple	35	Good	Municipal tree (Besserer Park); TO REMAIN
35	<i>Pinus strobus</i> / White Pine	N/A	Fair	Municipal tree (Besserer Park); 2.5m high; Signs of pine blister rust canker; TO REMAIN
36	<i>Ulmus americana</i> / American Elm	15	Fair	Municipal tree (Besserer Park); TO REMAIN
37	<i>Ulmus americana</i> / American Elm	15	Fair	Municipal tree (Besserer Park); TO REMAIN
38	<i>Ulmus americana</i> / American Elm	30	Good	Municipal tree (Besserer Park); TO REMAIN
39	<i>Acer platanoides</i> / Norway Maple	10	Good	Municipal tree (Besserer Park); TO REMAIN
40	<i>Acer platanoides</i> / Norway Maple	20	Good	Municipal tree (Besserer Park); TO REMAIN

41	<i>Ulmus americana</i> / American Elm	15	Fair	Municipal tree (Besserer Park); Broken branches; TO REMAIN
42	<i>Ulmus americana</i> / American Elm	15	Good	Municipal tree (Besserer Park); TO REMAIN
43	<i>Acer rubrum</i> / Red Maple	35	Good	Municipal tree (Besserer Park); TO REMAIN
44	<i>Acer rubrum</i> / Red Maple	60	Good	Municipal tree (Besserer Park); TO REMAIN
45	<i>Amelanchier canadensis</i> / Downy Serviceberry	5	Good	Information provided by City Forestry; Municipal tree (Besserer Park); Tree was planted in 2021 by City Forestry; TO REMAIN
B1 to B3	<i>Juglans cinerea</i> / Butternut	n/a	Dead or Missing	Municipal trees (Besserer Park); Planted saplings; DEAD TREES STILL ON SITE TO BE REMOVED; WIRE MESH ASSOCIATED TO TREE TO BE REMOVED AS WELL WHEN REMOVING DEAD TREES.
B4	<i>Juglans cinerea</i> / Butternut	1	Poor	Municipal trees (Besserer Park); Planted saplings; Tree#2 of the Butternut Health Assessor's Report dated July 27, 2020; Excavation within 50m of tree; Category 1

- TREES TO BE REMOVED AND LOCATED INSIDE BESSERER PARK SHALL ONLY BE CUT AT GRADE AND STUMP RETAINED. THIS WILL LIMIT DAMAGES TO THE SOIL AND ROOT SYSTEMS OF OTHER TREES TO BE PRESERVED IN THE PARK.

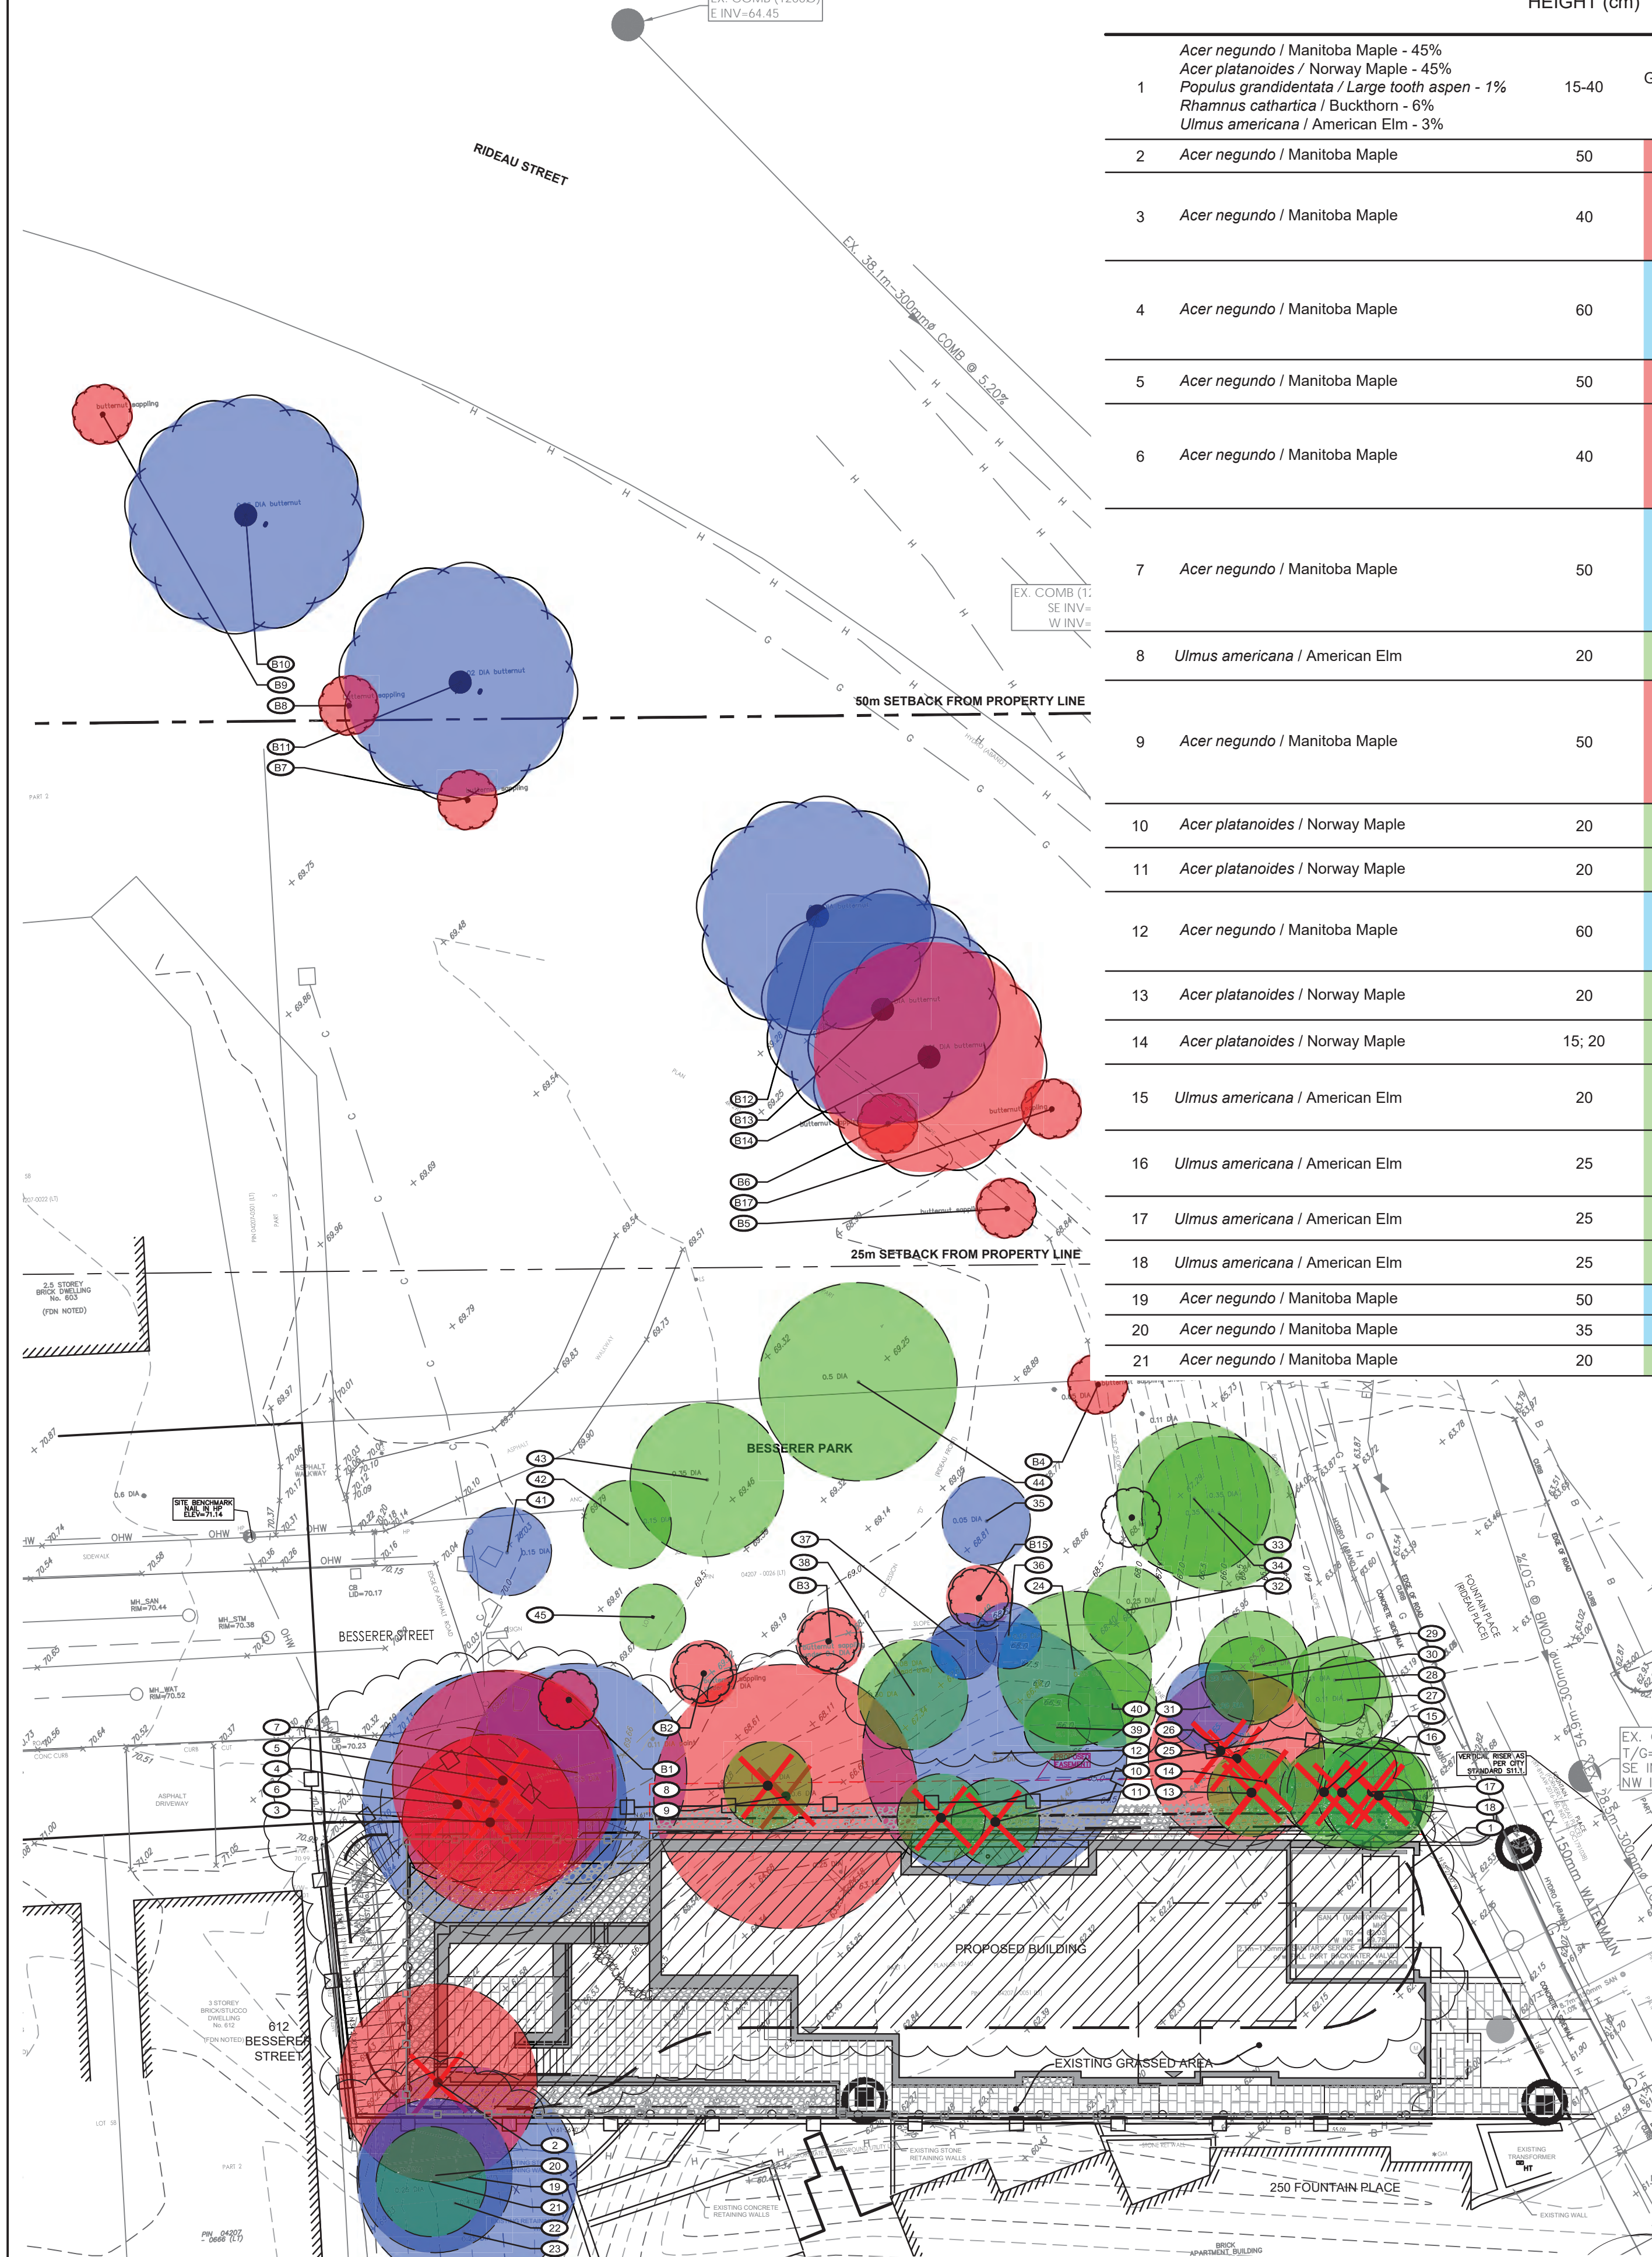
1 BUTTERNUT TREES IN BESSERER PARK
1:200

B5 to B9	<i>Juglans cinerea</i> / Butternut	n/a	Dead or Missing	Municipal trees (Besserer Park); Planted saplings; DEAD TREES STILL ON SITE TO BE REMOVED; WIRE MESH ASSOCIATED TO TREE TO BE REMOVED AS WELL WHEN REMOVING DEAD TREES.
B10	<i>Juglans cinerea</i> / Butternut	6	Fair	Municipal tree (Besserer Park); Located more than 50m from proposed development
B11	<i>Juglans cinerea</i> / Butternut	3	Fair	Municipal tree (Besserer Park); Located more than 50m from proposed development
B12	<i>Juglans cinerea</i> / Butternut	25	Fair	Municipal tree (Besserer Park); Tree #3 of the Butternut Health Assessor's Report dated July 27, 2020; Excavation within 50m of tree; Category 3
B13	<i>Juglans cinerea</i> / Butternut	17	Fair	Municipal tree (Besserer Park); Tree #4 of the Butternut Health Assessor's Report dated July 27, 2020; Excavation within 50m of tree; Category 1
B14	<i>Juglans cinerea</i> / Butternut	11	Dead	Municipal tree (Besserer Park); DEAD TREES STILL ON SITE TO BE REMOVED; WIRE MESH ASSOCIATED TO TREE TO BE REMOVED AS WELL WHEN REMOVING DEAD TREES.

B15	<i>Juglans cinerea</i> / Butternut	1	Poor	Municipal trees (Besserer Park); Planted saplings; Tree#1 of the Butternut Health Assessor's Report dated July 27, 2020; Excavation within 50m of tree; Category 1
B16 to B17	<i>Juglans cinerea</i> / Butternut	n/a	Dead or Missing	Municipal trees (Besserer Park); Planted saplings; DEAD TREES STILL ON SITE TO BE REMOVED; WIRE MESH ASSOCIATED TO TREE TO BE REMOVED AS WELL WHEN REMOVING DEAD TREES.
