# TREE CONSERVATION REPORT

**326-33 Wilbrod**

Tree Conservation Report submitted as Partial  
Requirements for a Site Plan Control Application,  
September 19, 2021

**Dendron Forestry Services**

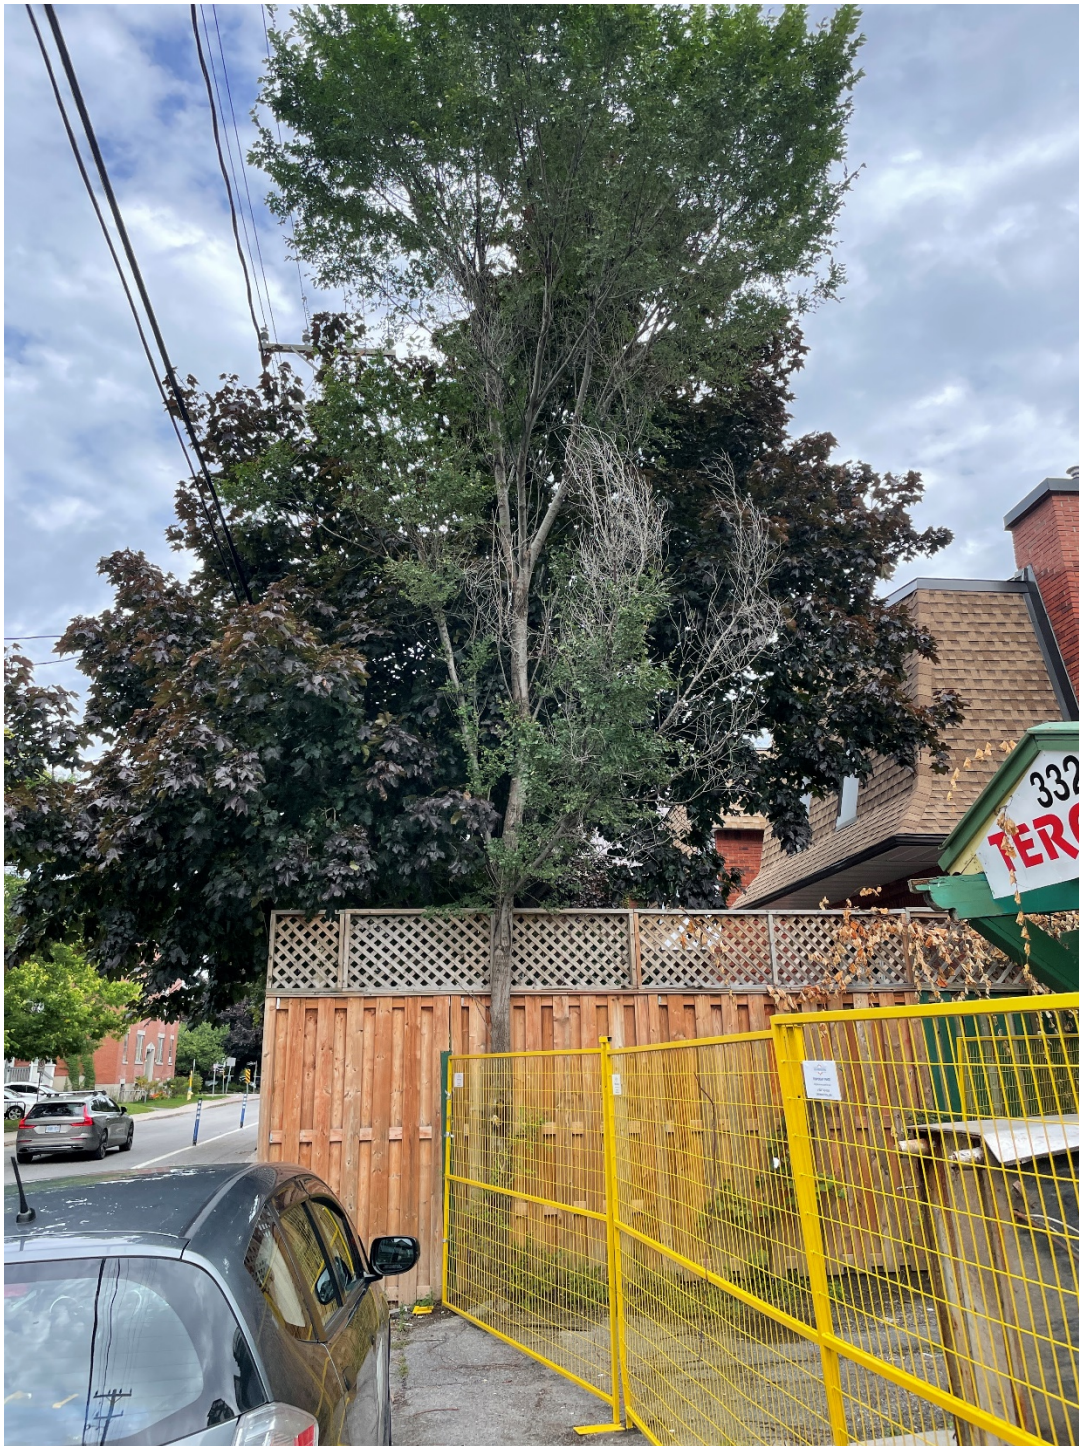
Tree <sup>1</sup>	Species	Diameter at breast height (dbh)	Ownership <sup>2,3</sup>	Condition	Action
1	Siberian elm ( <i>Ulmus pumila</i> )	20 cm	City	Fair	Remove; fair condition combined with unsuitable species, poor location, and impact by development
2	Manitoba maple ( <i>Acer negundo</i> )	46 cm (measured at 1.5 m)	City (based on survey and GeoOttawa)	Fair; growing into metal fence, backside has been pruned back to prevent overhanging on adjacent property	Removal and replacement of this tree is recommended; if retained, a further assessment should be conducted once material has been removed onsite to ensure viability and stability
3	Manitoba maple ( <i>Acer negundo</i> )	30 cm (estimate)	City (based on survey and GeoOttawa)	Poor; significant pruning for clearance on south side including topping of the dominant stem	Removal and replacement of this tree is recommended; if retained, a further assessment should be conducted once material has been removed onsite to ensure viability and stability

Figure 1: Tree 1, Siberian elm in the city right of way to be removed

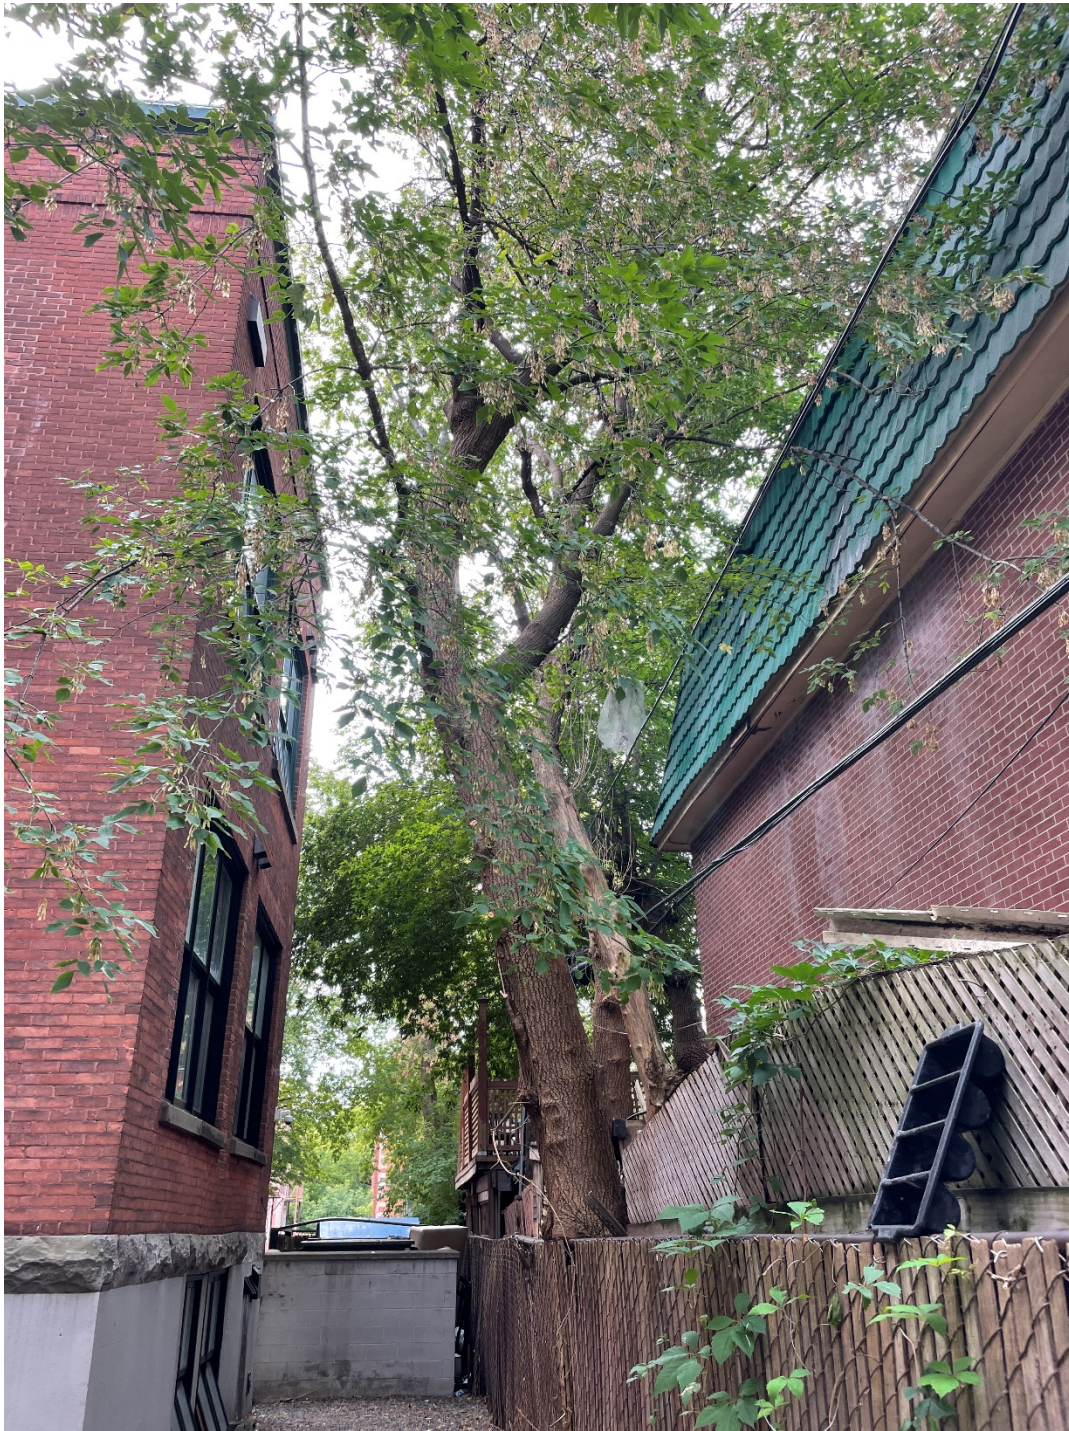
Figure 2: Tree 2, Manitoba maple, to be removed

Although trees 2 and 3 have been recommended for removal in this report, if the preference is to retain them, then it is highly recommended that a second health assessment be conducted once the site is more accessible and all the trees are fully visible. Manitoba maples are short-lived species and are more prone to failure than other species. Their viability for retention during construction taking into consideration their structural stability, should be re-assessed before any decision is made to retain them.

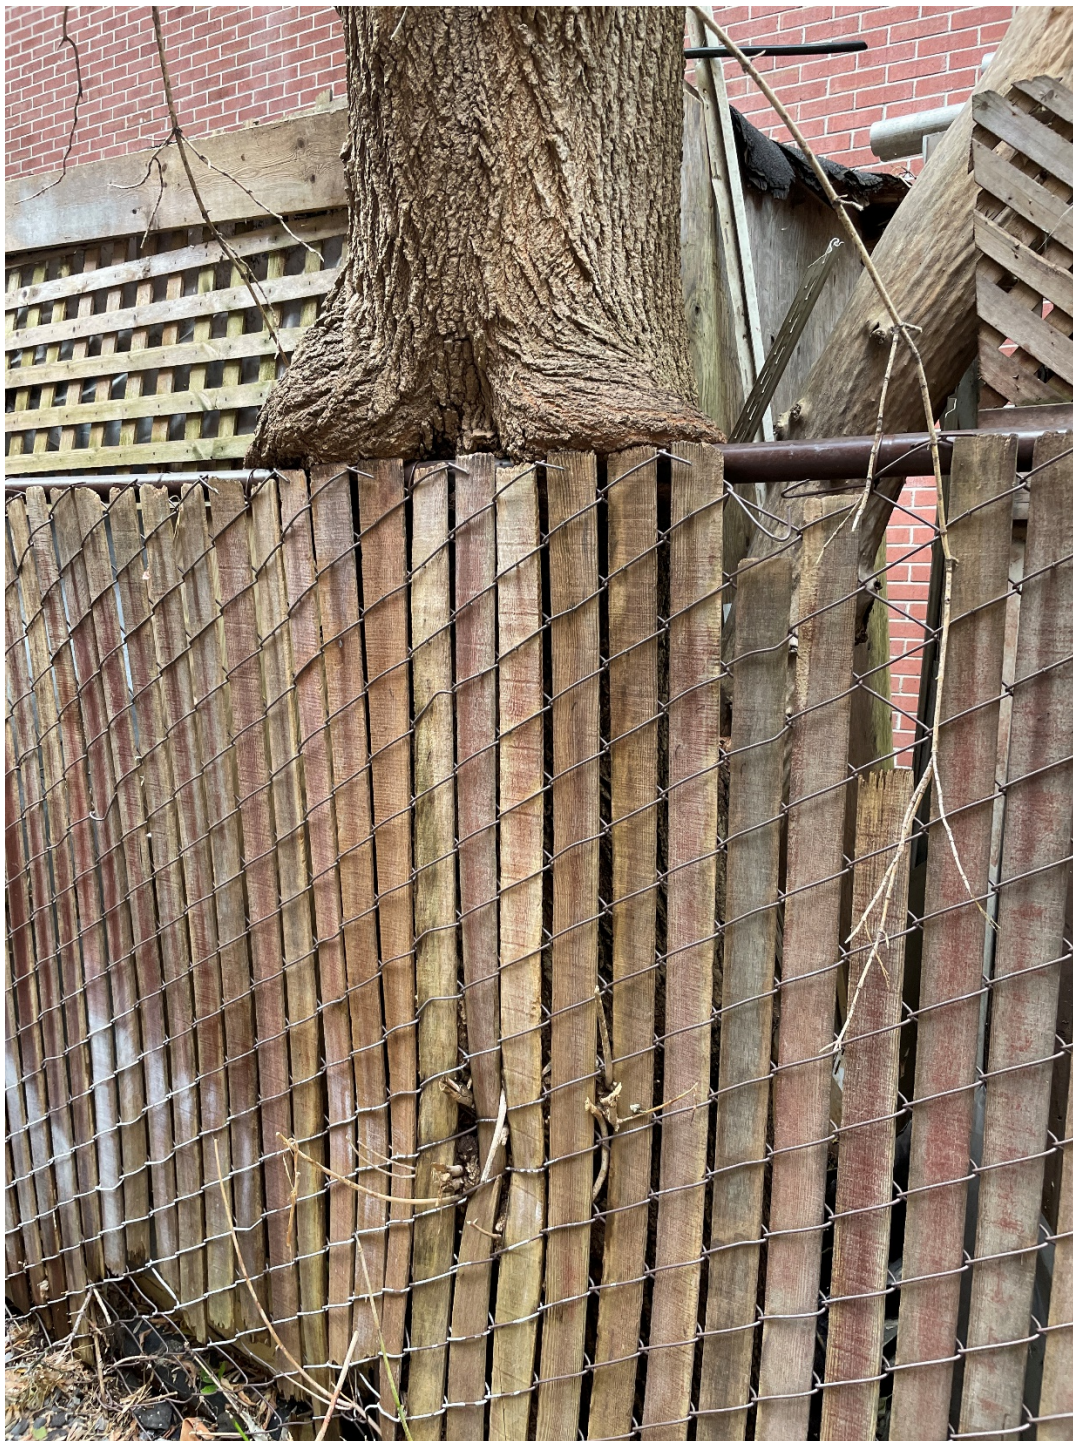
Figure 3: Tree 2, close-up of trunk growing into metal fence

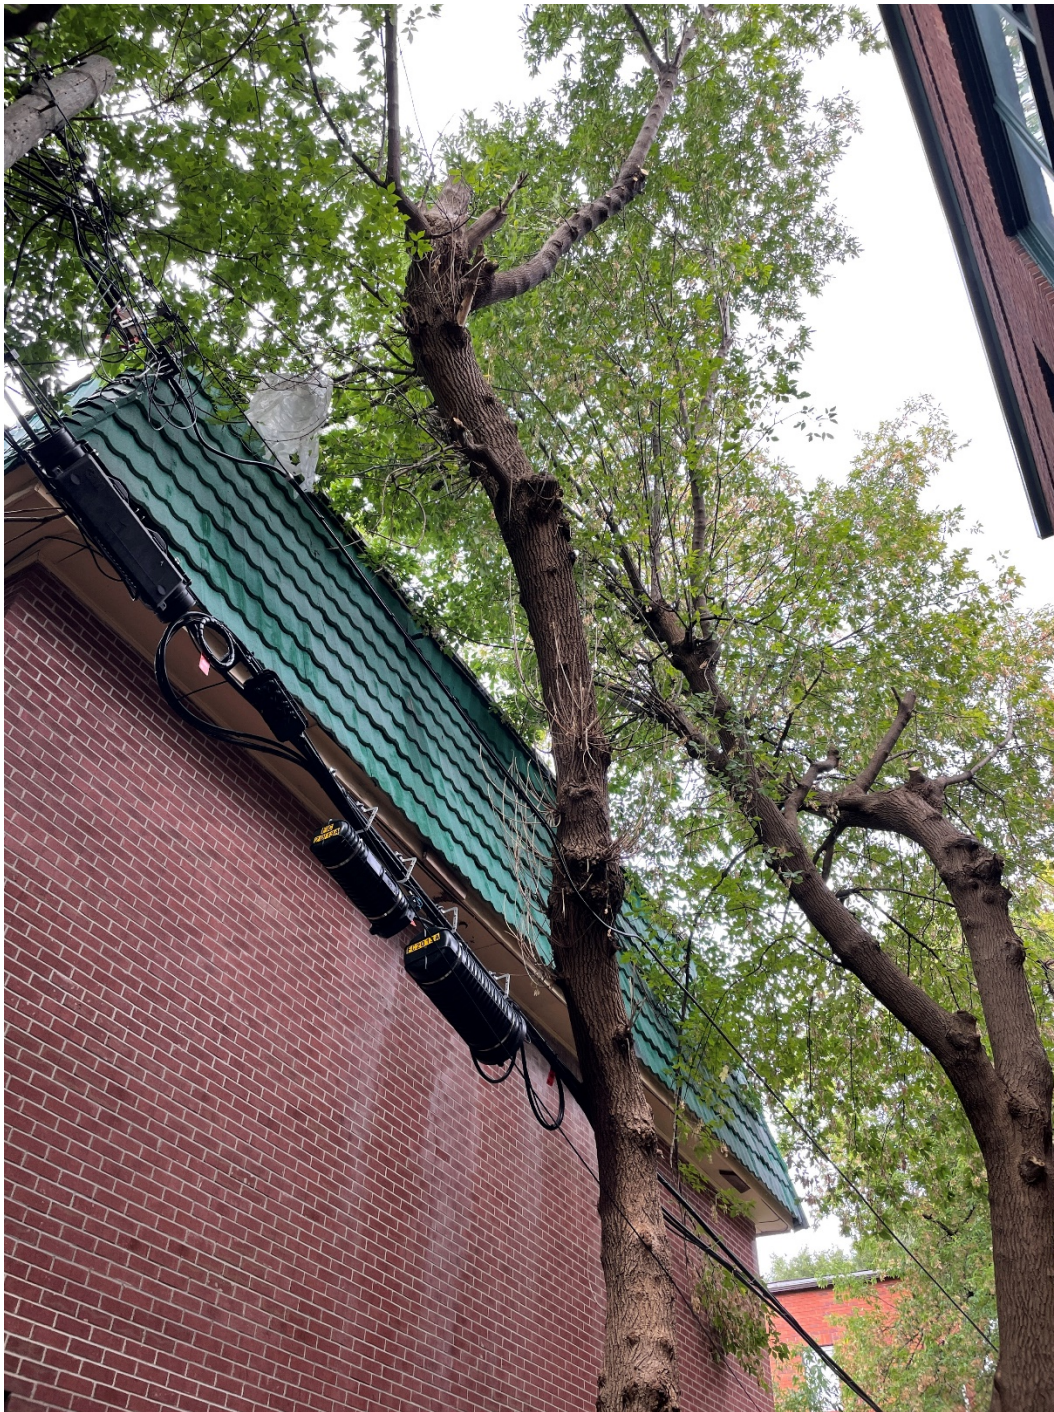
Figure 4: Tree 3 (left), Manitoba maple to be removed

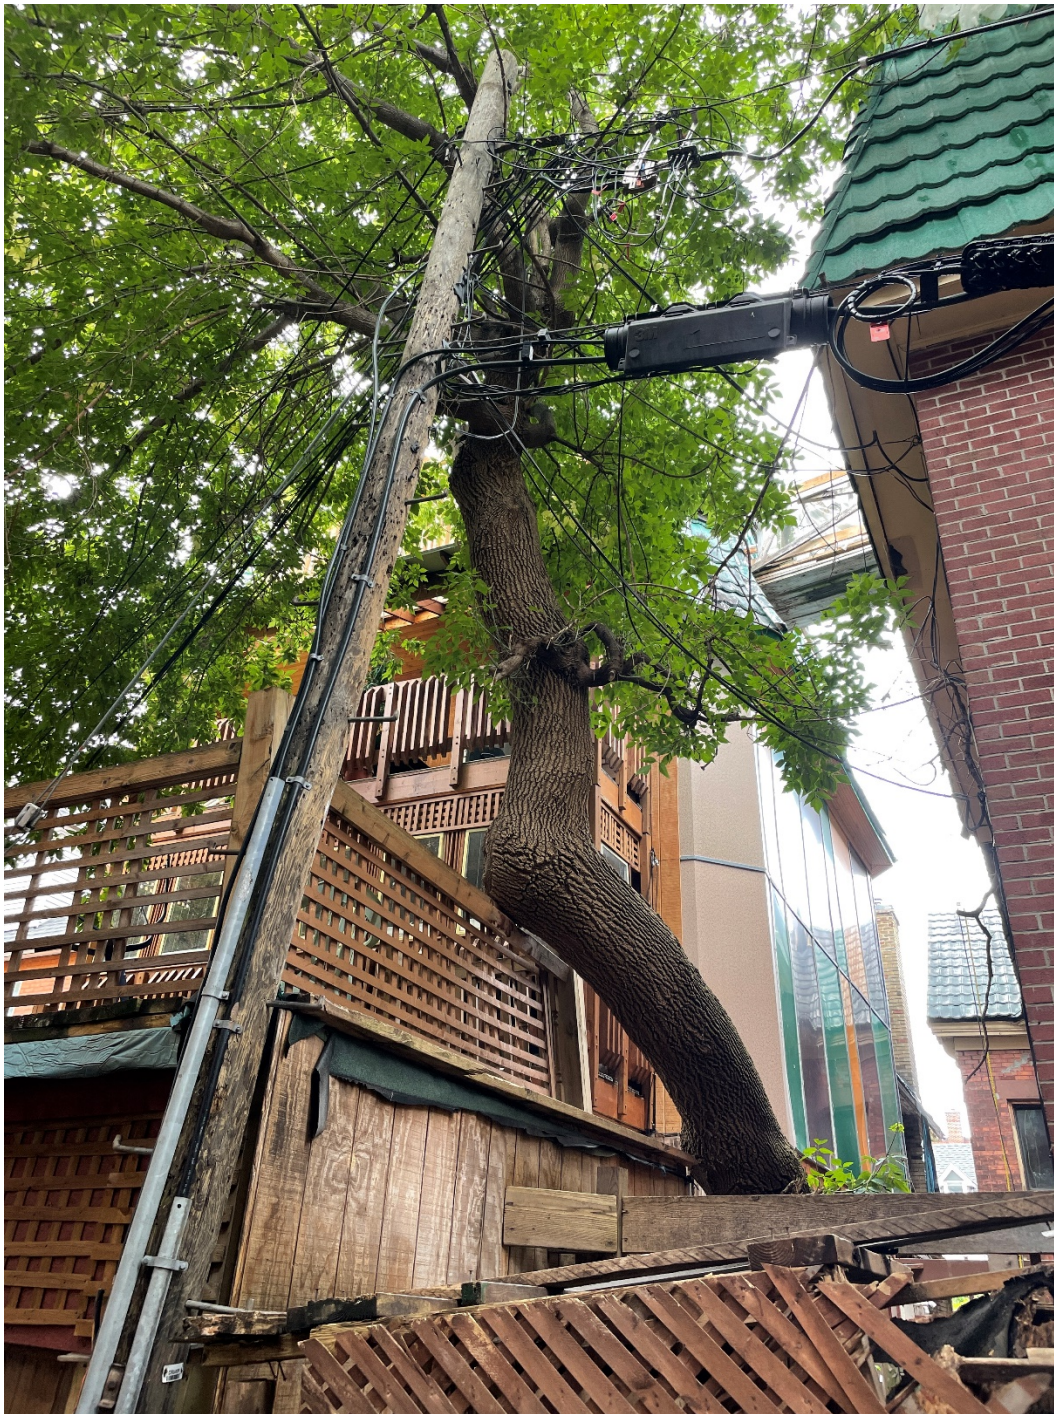
4	Manitoba maple ( <i>Acer negundo</i> )	55 cm (estimate)	Private	Poor; significant lean on main stem and pruning of branches overhanging adjacent property	Remove; in conflict with excavation for new building

Figure 5: Tree 4, Manitoba maple to be removed

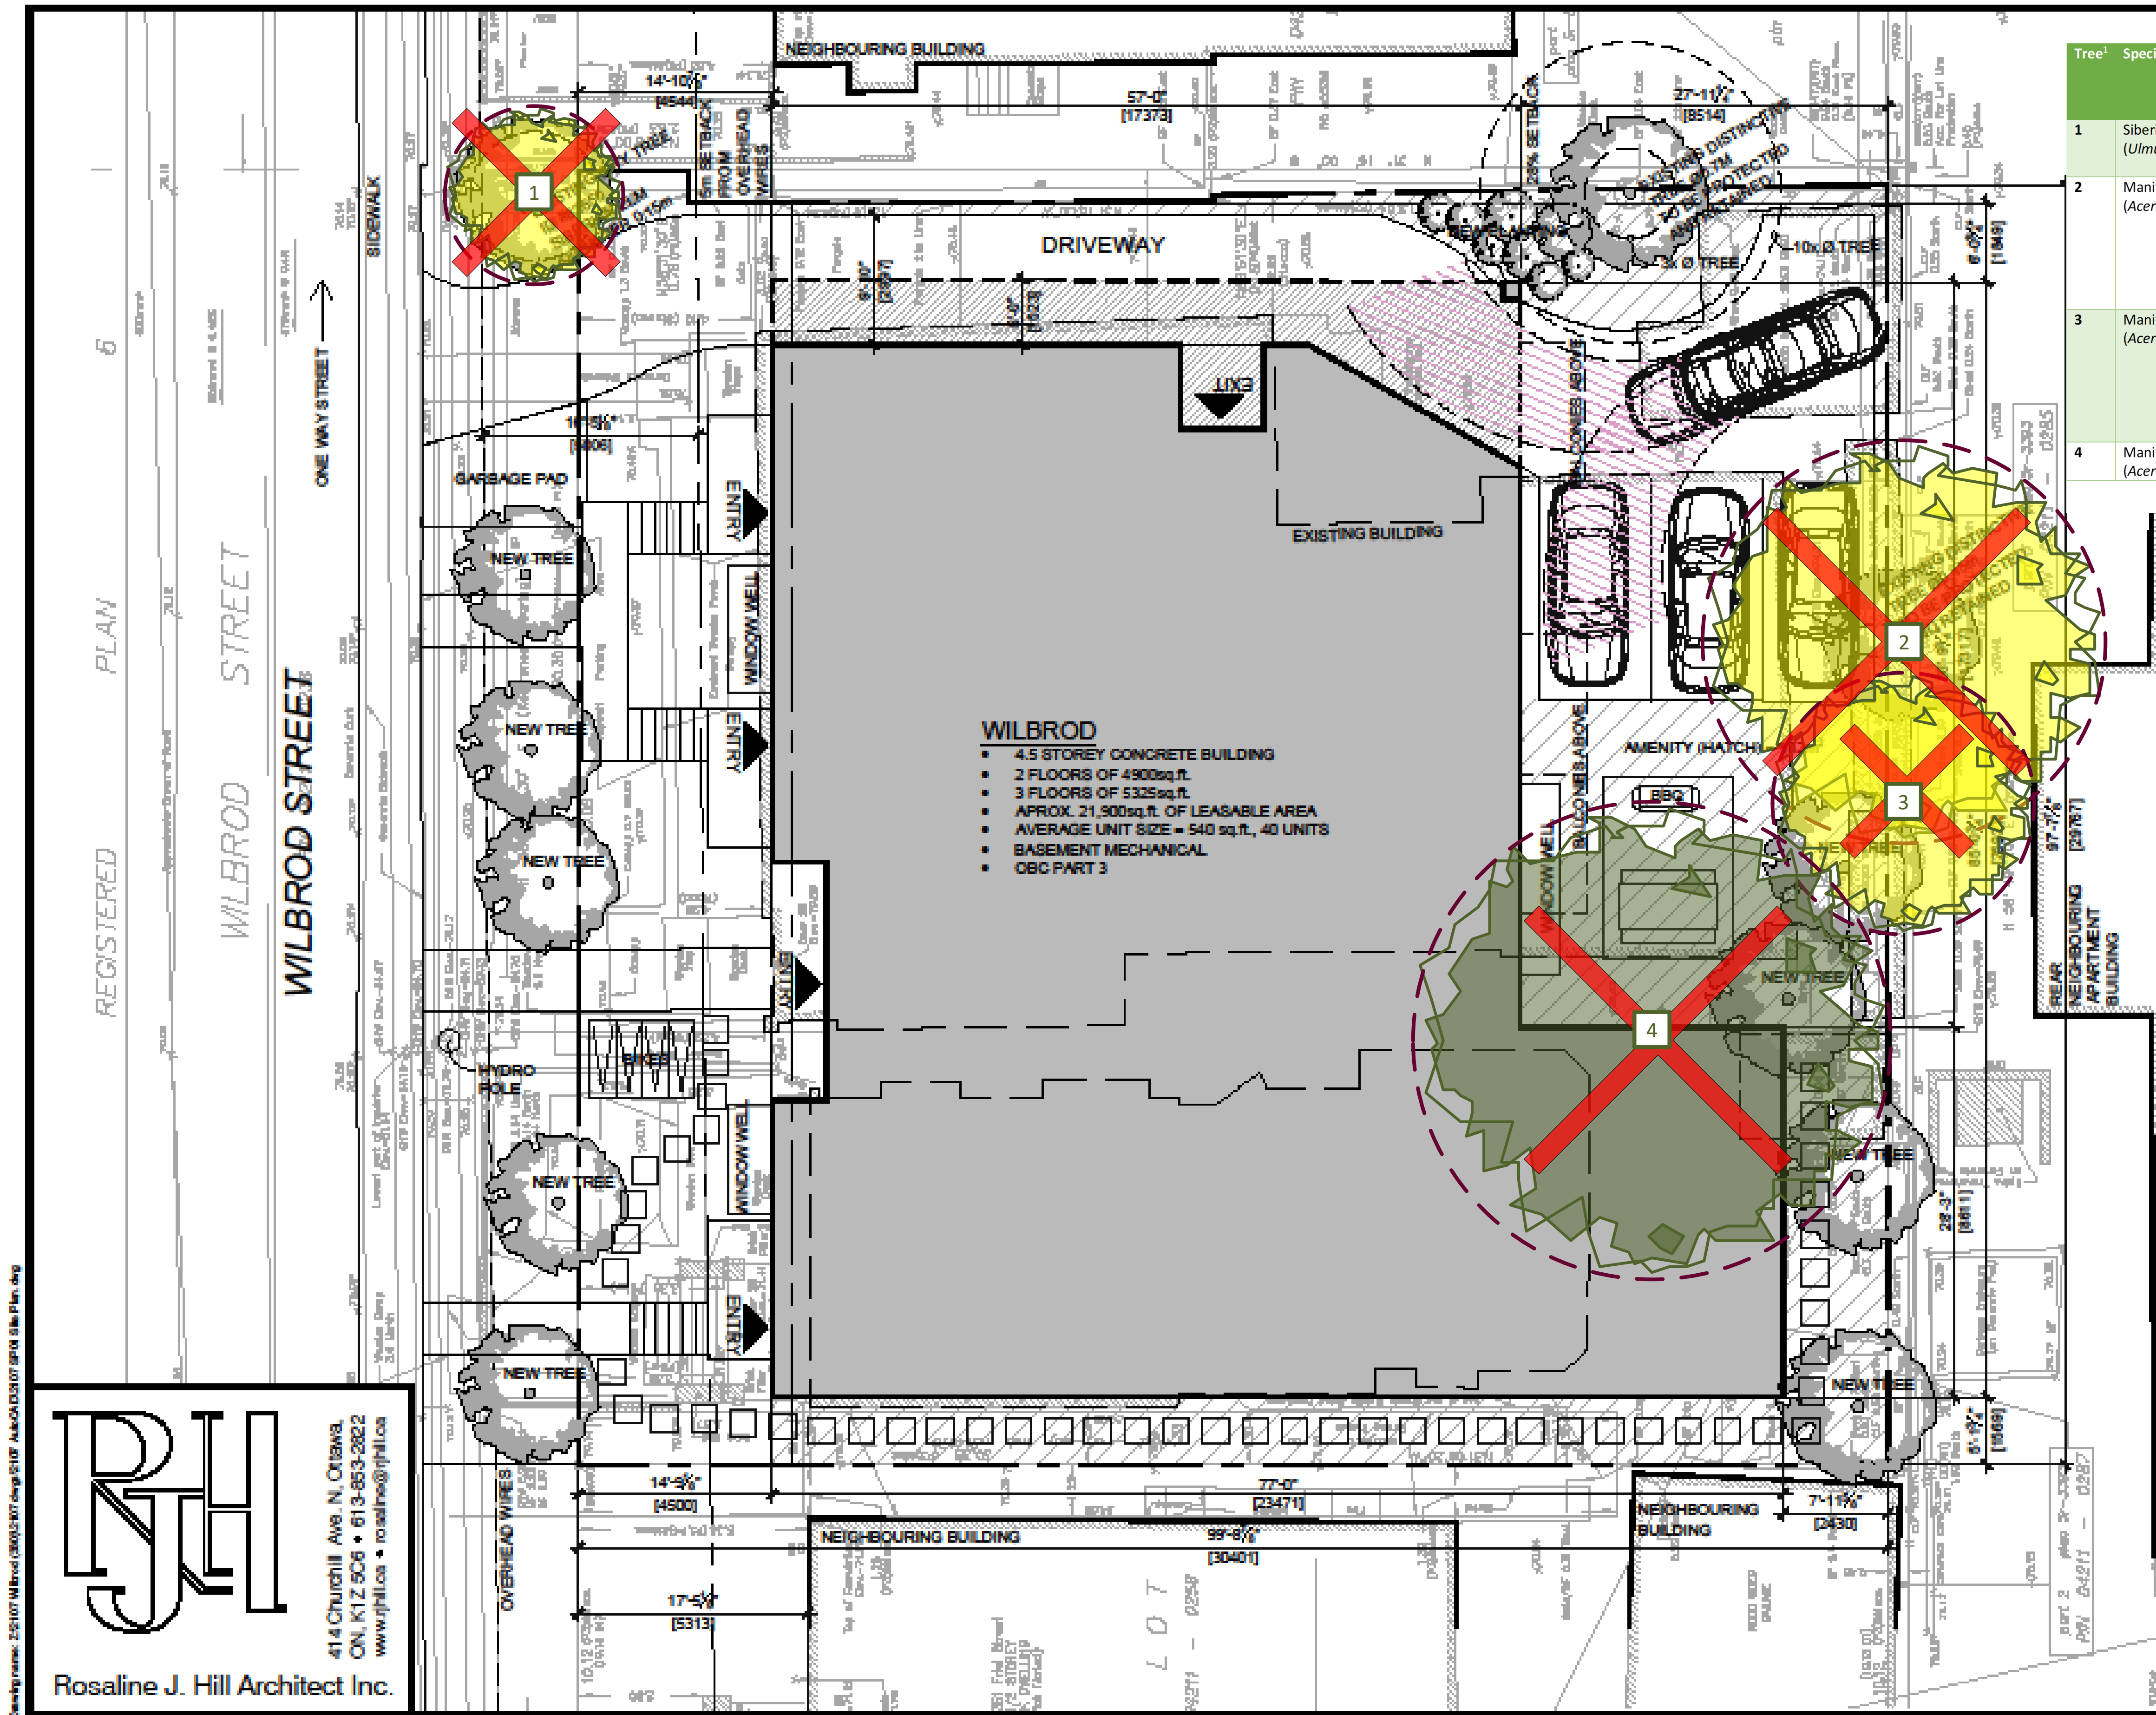
Tree Conservation Report – 326-330 Wilbrod  
 Tree layer prepared by Dendron Forestry Services  
 Version 1.0, Sept 18, 2021  
 For more information, please contact info@dendronforestry.ca

Tree #	Species	Diameter at breast height (dbh)	Ownership <sup>2,3</sup>	Action
1	Siberian elm ( <i>Ulmus pumila</i> )	20 cm	City	Remove; fair condition combined with unsuitable species, poor location, and impact by development
2	Manitoba maple ( <i>Acer negundo</i> )	46 cm (measured at 1.5 m)	City (based on survey and GeoOttawa)	Removal and replacement of this tree is recommended; if retained, a further assessment should be conducted onsite to ensure viability and stability; Permission from adjacent property owner required for removal
3	Manitoba maple ( <i>Acer negundo</i> )	30 cm (estimate)	City (based on survey and GeoOttawa)	Removal and replacement of this tree is recommended; if retained, a further assessment should be conducted onsite to ensure viability and stability; Permission from adjacent property owner required for removal
4	Manitoba maple ( <i>Acer negundo</i> )	55 cm (estimate)	Private	Remove; in conflict with excavation for new building
