URBAN FORESTRY & FOREST MANAGEMENT CONSULTING

September 30, 2021

**RE: TREE CONSERVATION REPORT FOR 1919 RIVERSIDE DRIVE, OTTAWA**

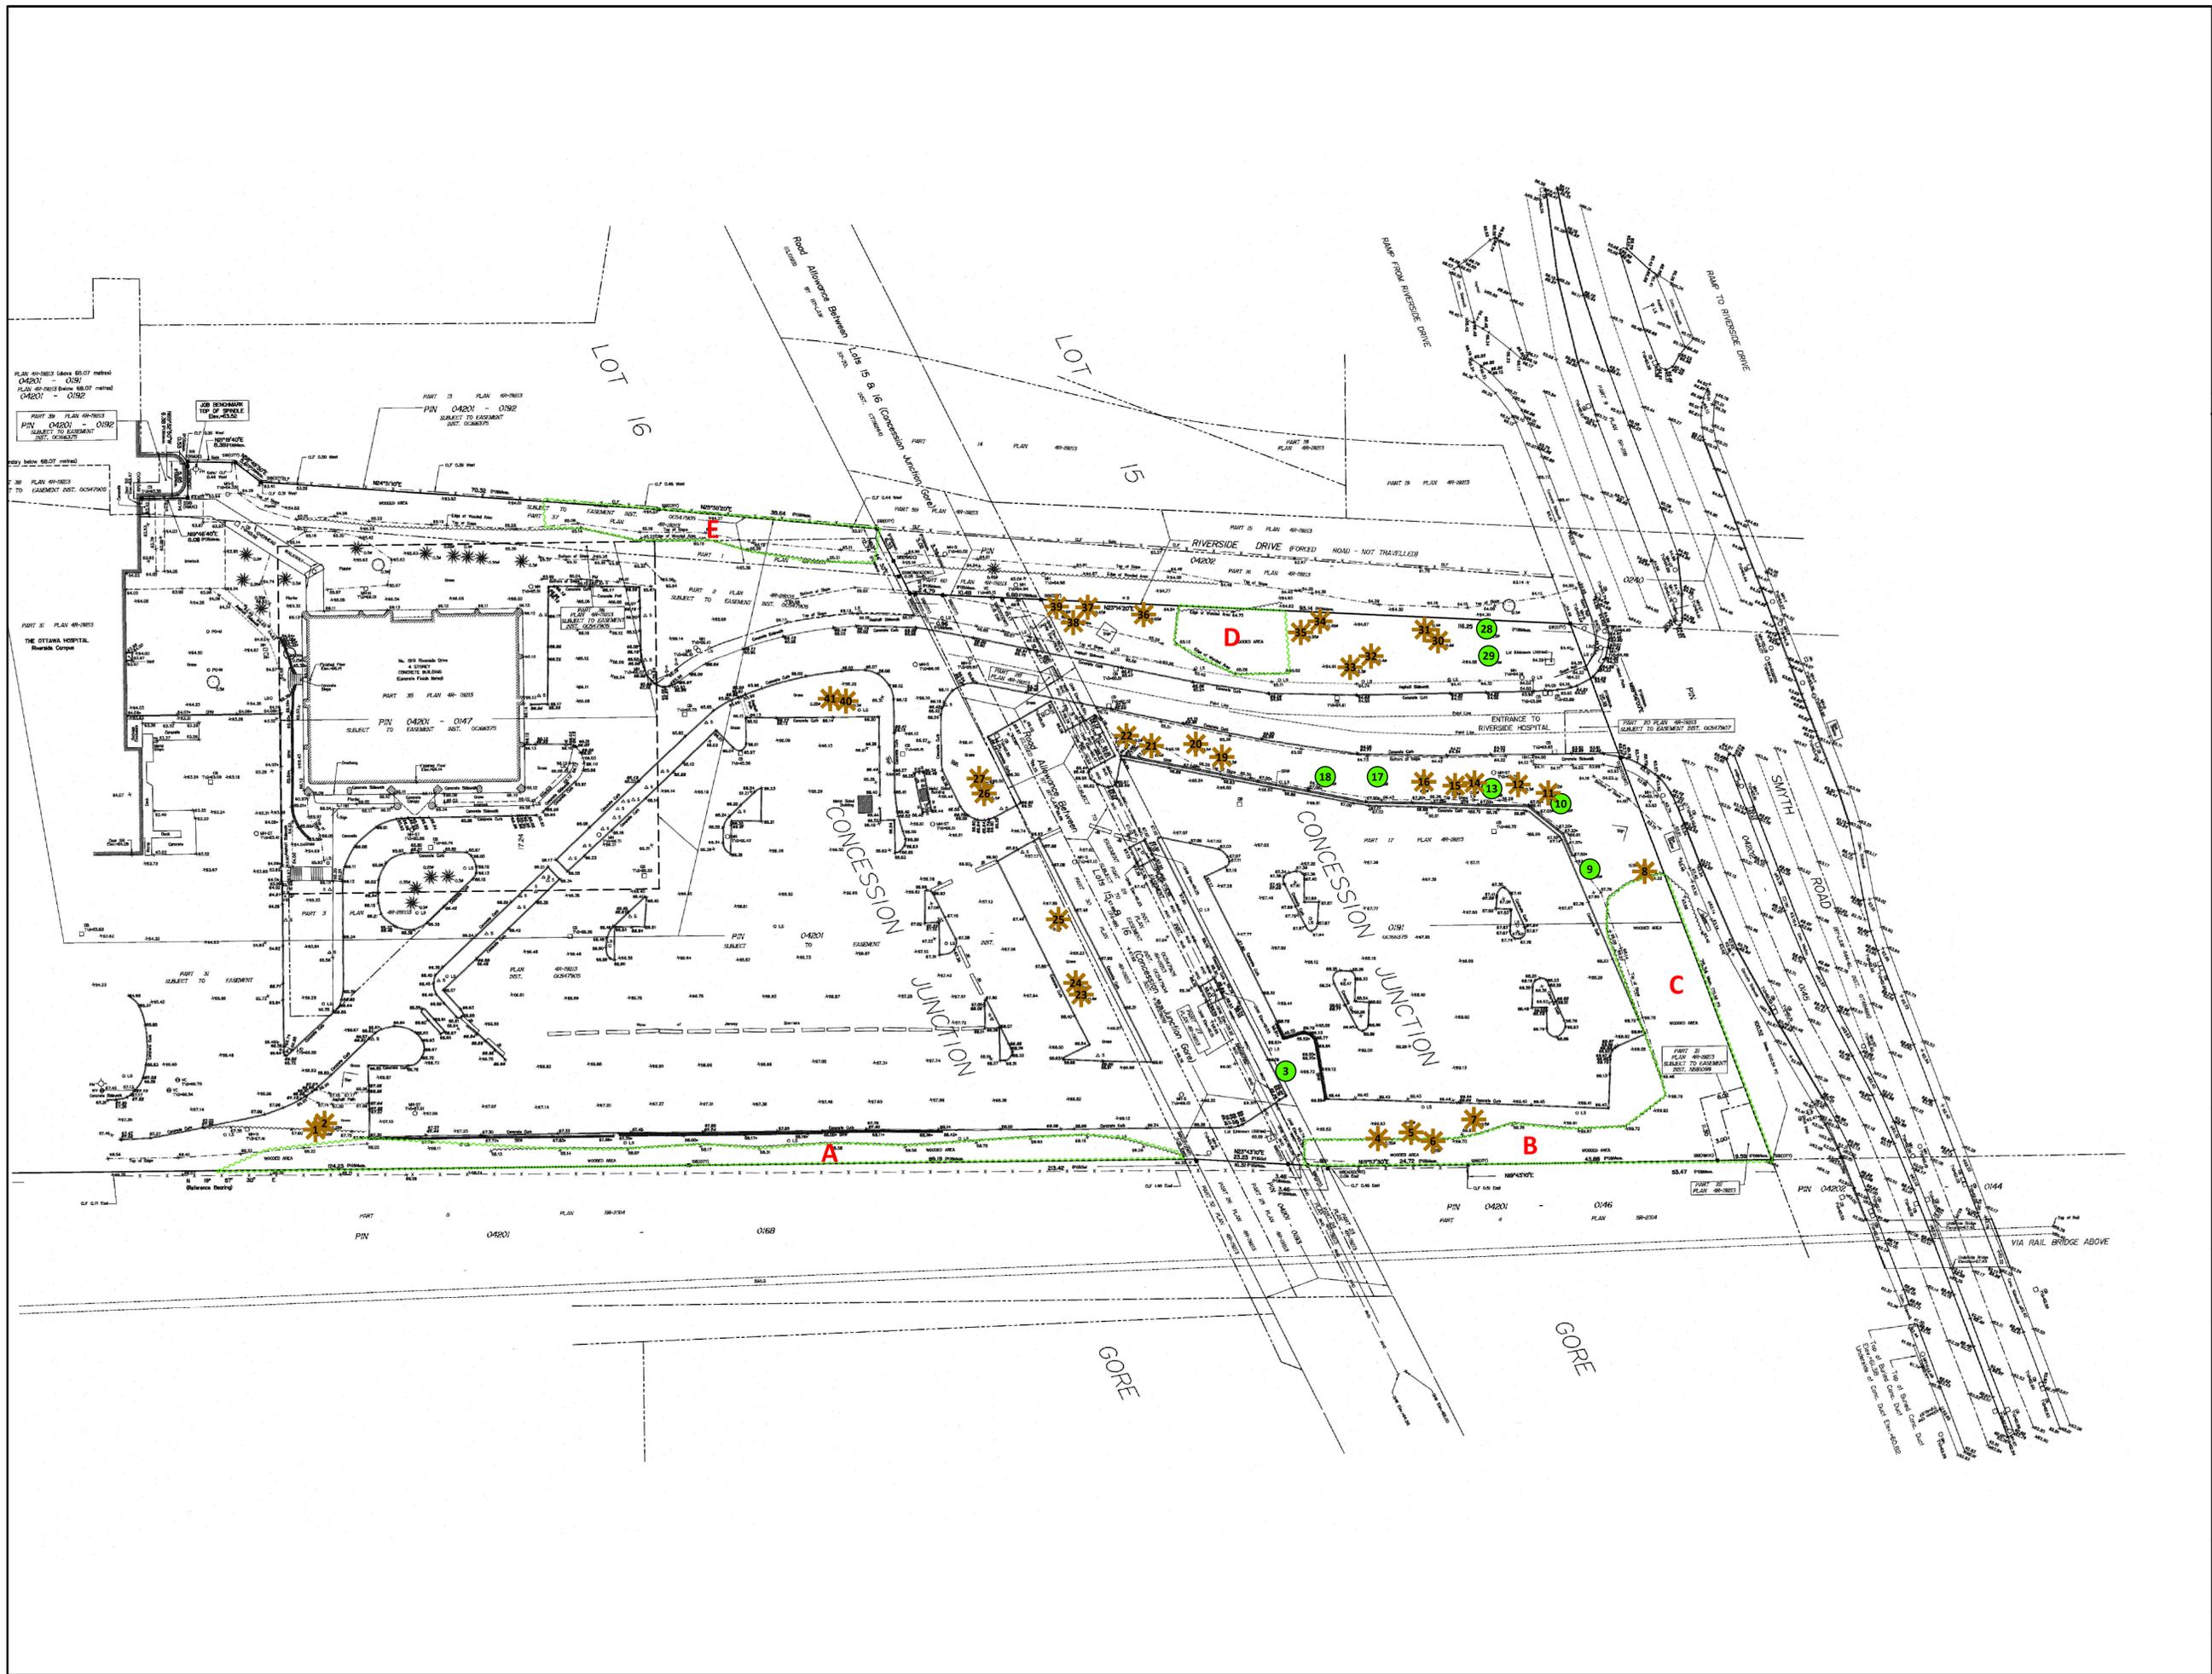
DRAWING: Tree Conservation Plan

All current vegetation is shown on the tree conservation plan included on page 7 of this report. By the numbers indicated on the plan, each tree and grouping of trees is detailed below:

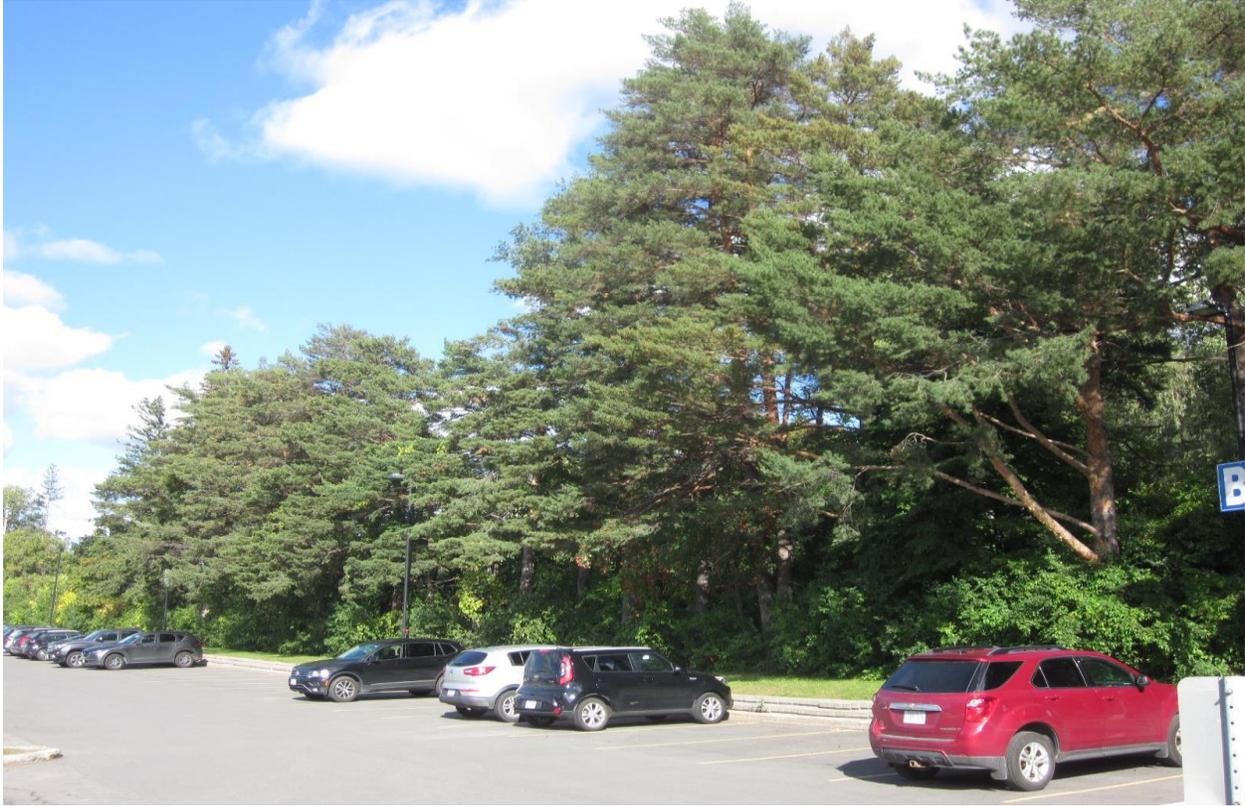
Tree grouping A: A line of twenty six mature Scots pine and five mature white spruce. All of these trees would have been planted. Generally they are in good condition – upright with good crown densities, growth increments and needle colour. Their crowns are held high above the understory and are often asymmetric towards the northwest due to intercompetition between trees. The understory is primarily introduced invasive buckthorn (*Rhamnus* spp.) and Norway maple (*Acer platanoides*) with scattered mountain-ash (*Sorbus* spp.), hawthorn (*Crataegus* spp.), bur oak and ash (*Fraxinus* spp.) – all of which are native species. All ash remaining on the property are either now dead or heavily infested with emerald ash borer (*Agilus planipennis*).

Picture 1. Tree grouping A at 1919 Riverside Drive

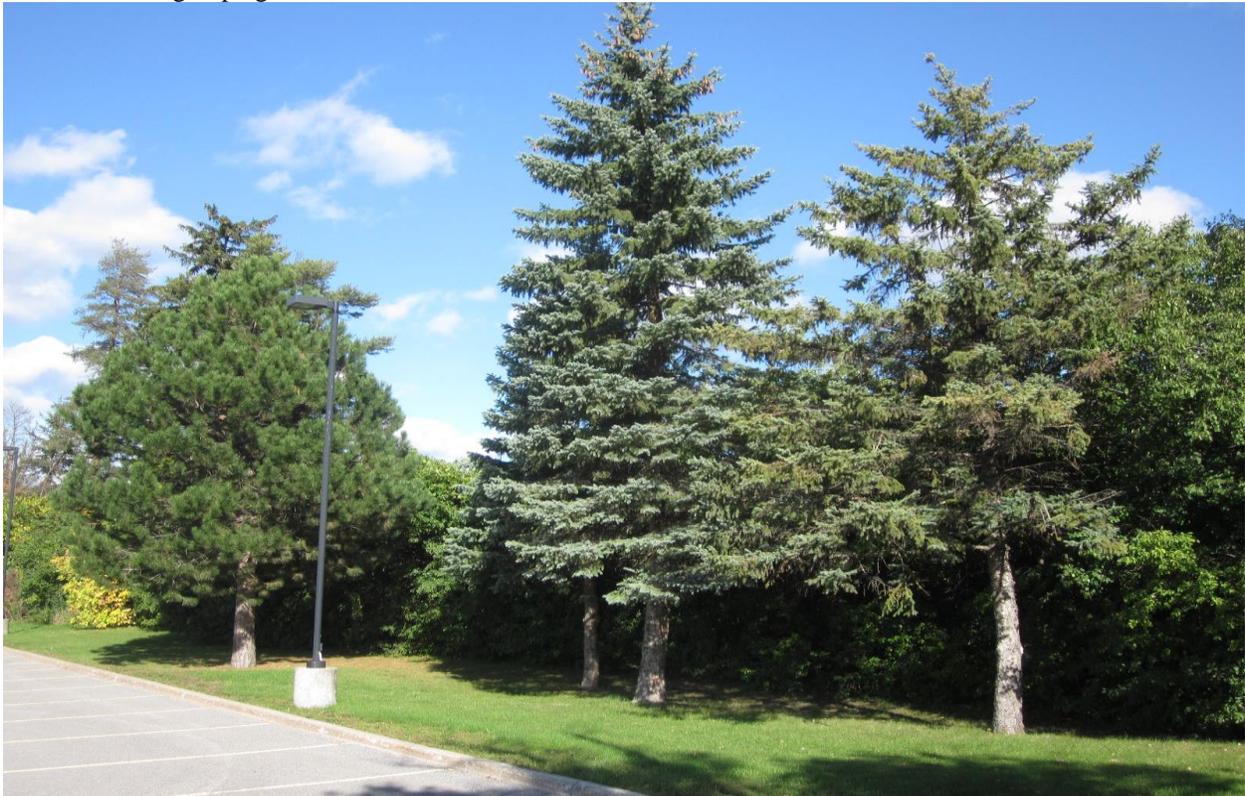
5	Colorado spruce	Very good	36.4	Mature; lower crown asymmetric; very good density, increment and colour; introduced species; <b>to be removed</b>
6	Colorado spruce	Good	24.7	Mature; lower crown asymmetric; good density, increment and colour; introduced species; <b>to be removed</b>
7	Austrian pine	Very good	40.9	Mature; very good density, increment and colour; introduced species; <b>to be removed</b>
8	European larch ( <i>Larix decidua</i> )	Fair	19.1	Maturing; salt spray damage to west side of crown – extensive dieback; fair density, increment and colour; introduced species; <b>to be removed</b>
9	Honey-locust ( <i>Gleditsia triacanthos</i> )	Good	22.6	Maturing; central stem with competing lateral at 1.5m on south side; good crown density, leaf size and colour; introduced species; <b>to be removed</b>
10	Honey-locust	Good	19.5	Maturing; multiple competing stems at 2m – broad crown; good crown density, leaf size and colour; introduced species; <b>to be removed</b>

Picture 2. Trees #4-7 (right to left) at 1919 Riverside Drive

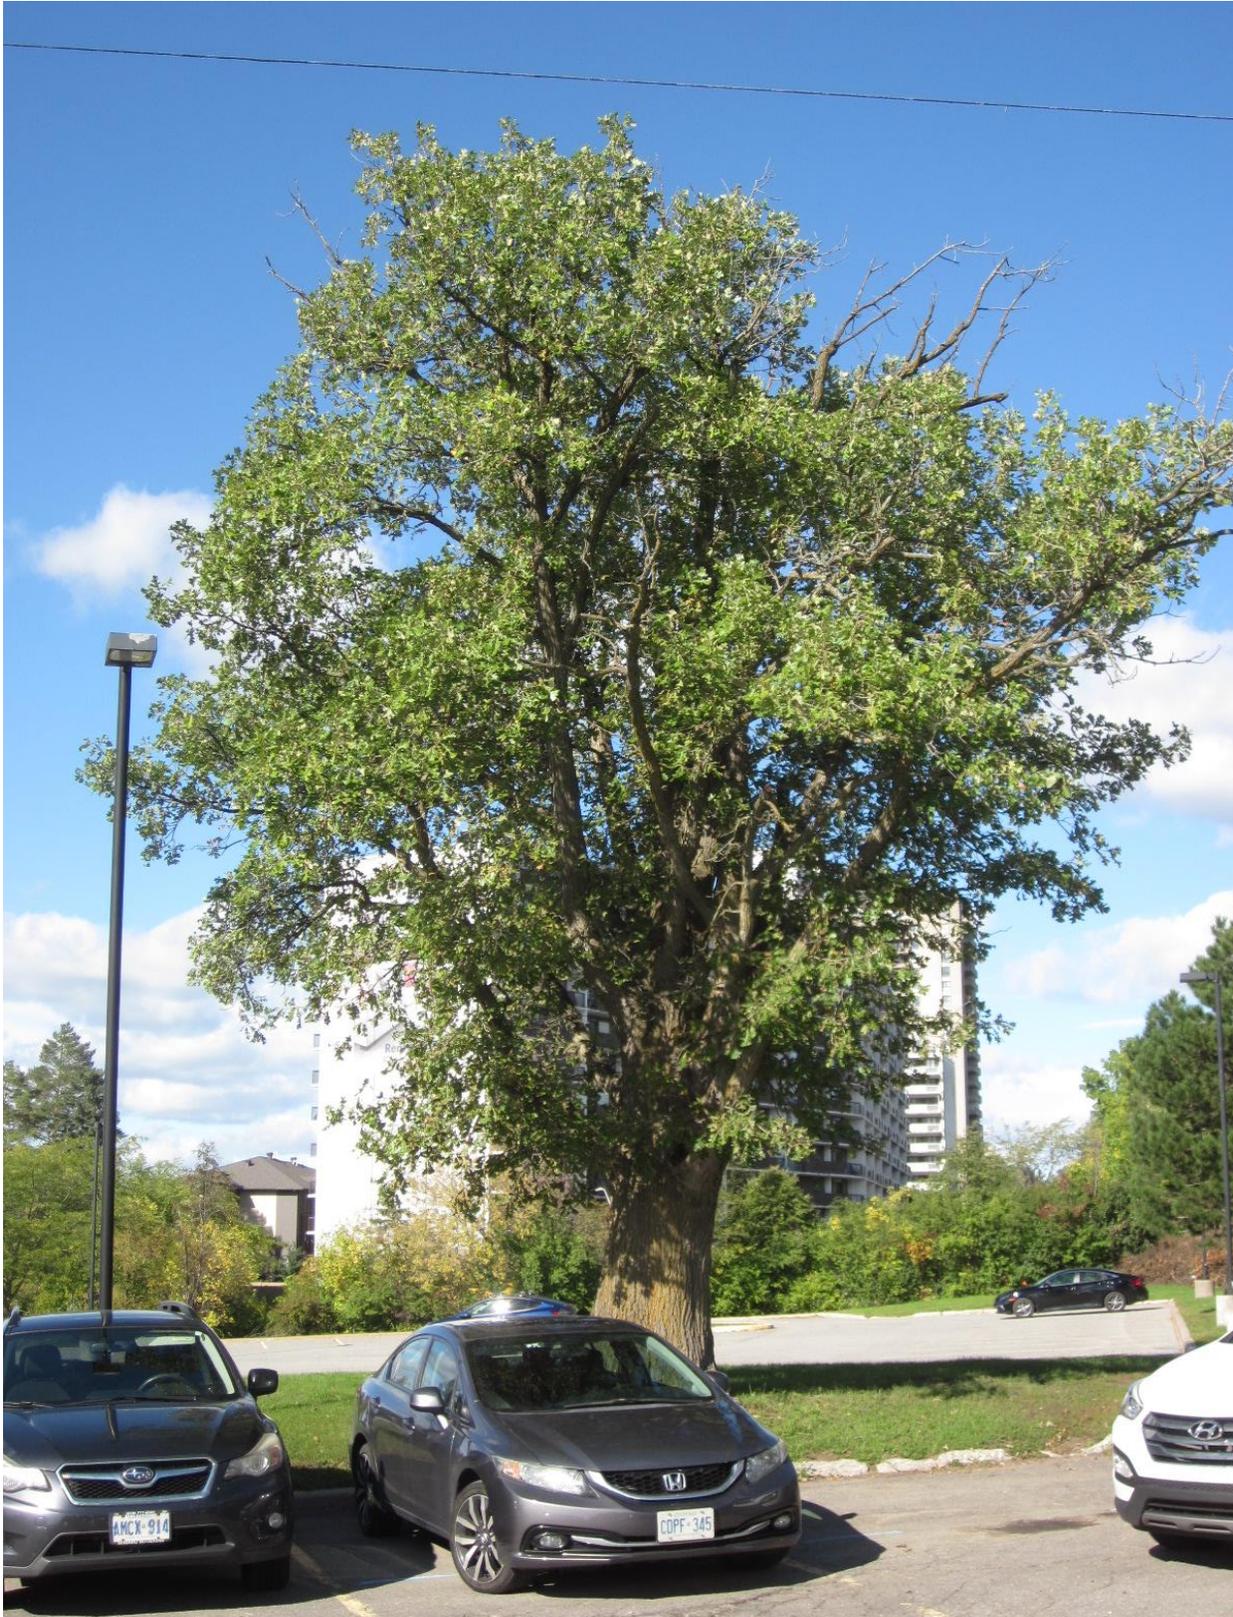
Picture 3. Tree #3 at 1919 Riverside Drive

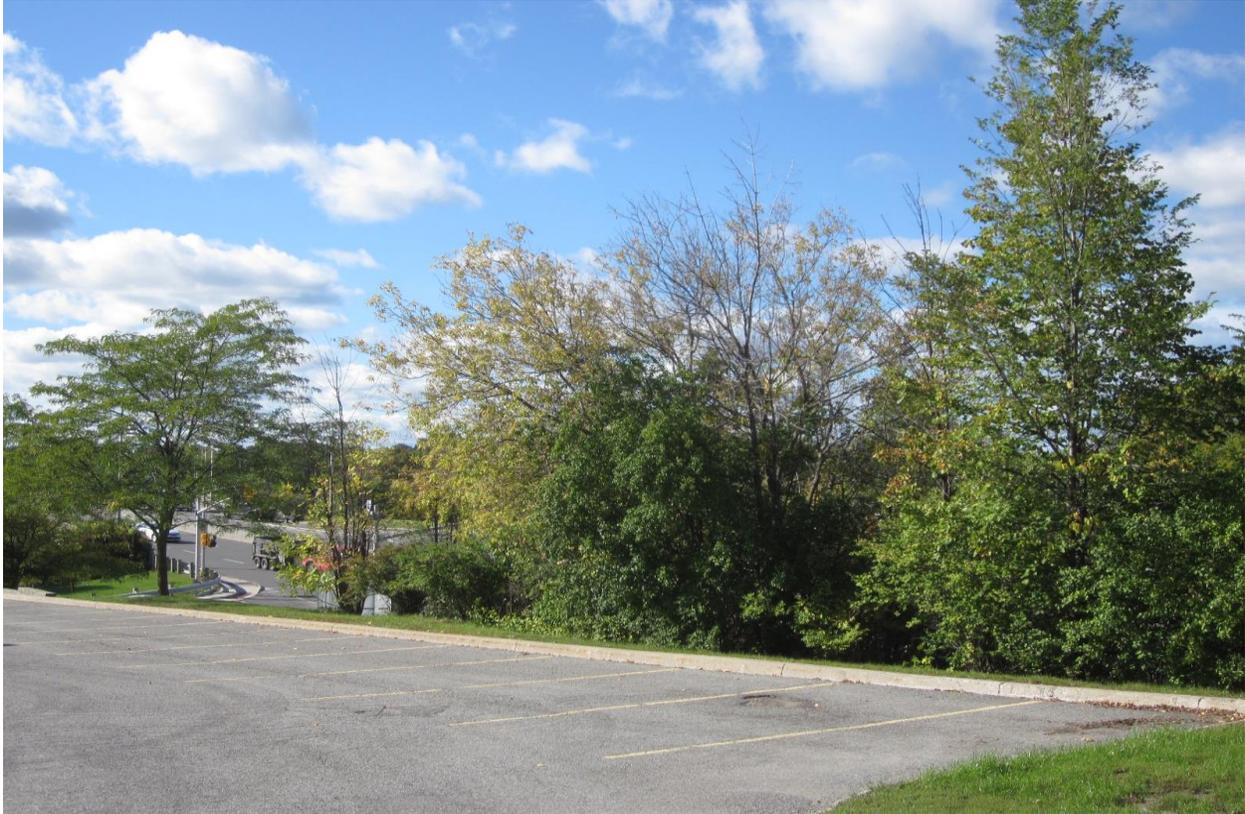
Tree grouping D: Three planted Scots pine and two American elms (*Ulmus americana*). The pines are mature, upright in form and hold their living crowns high above the buckthorn in the understory. They are in good condition, with good crown densities, growth increments and needle colour. The elms show no outward signs of Dutch elm disease (*Ophiostoma novo-ulmi*).

Picture 4. Tree grouping D (right) and trees #8 and 9 (left) at 1919 Riverside Drive

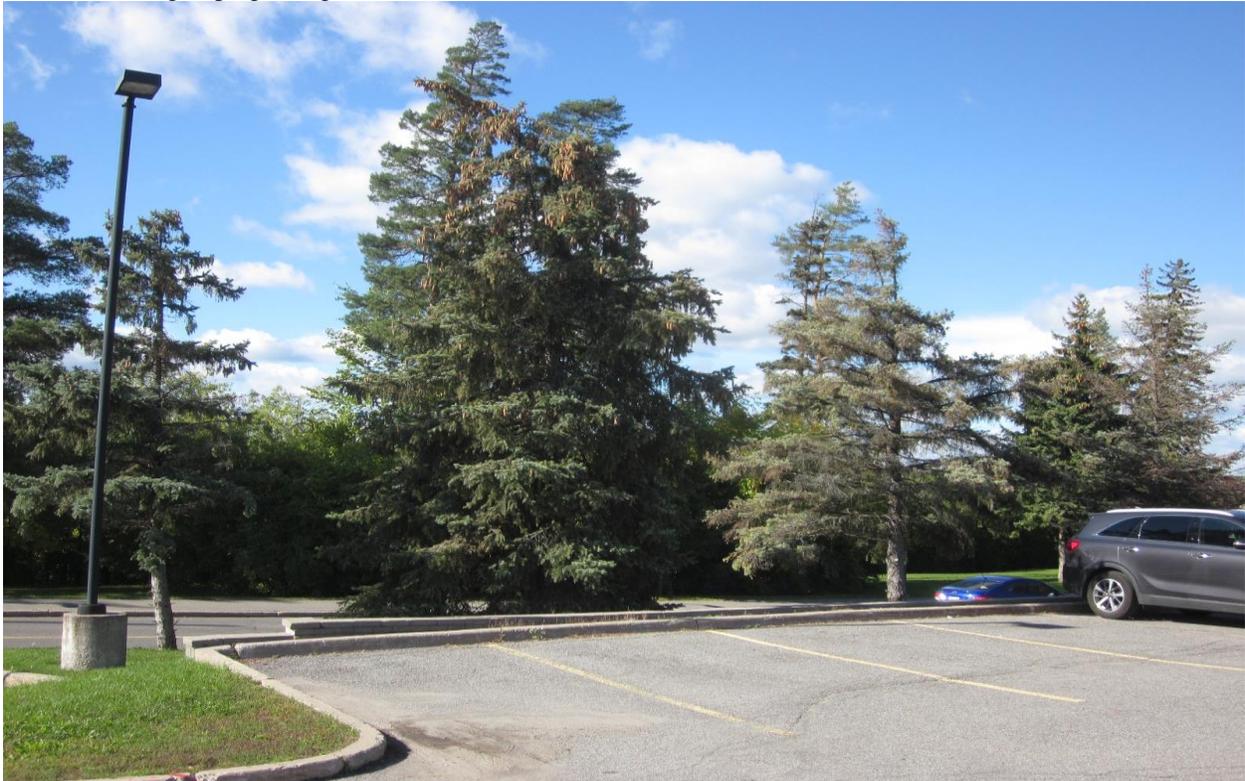
22	Colorado spruce	Fair	17.9	Maturing; fair density, increment and colour; scattered dead branches; introduced species; <b>to be removed</b>

Picture 5. Trees #19-22 (right to left) at 1919 Riverside Drive

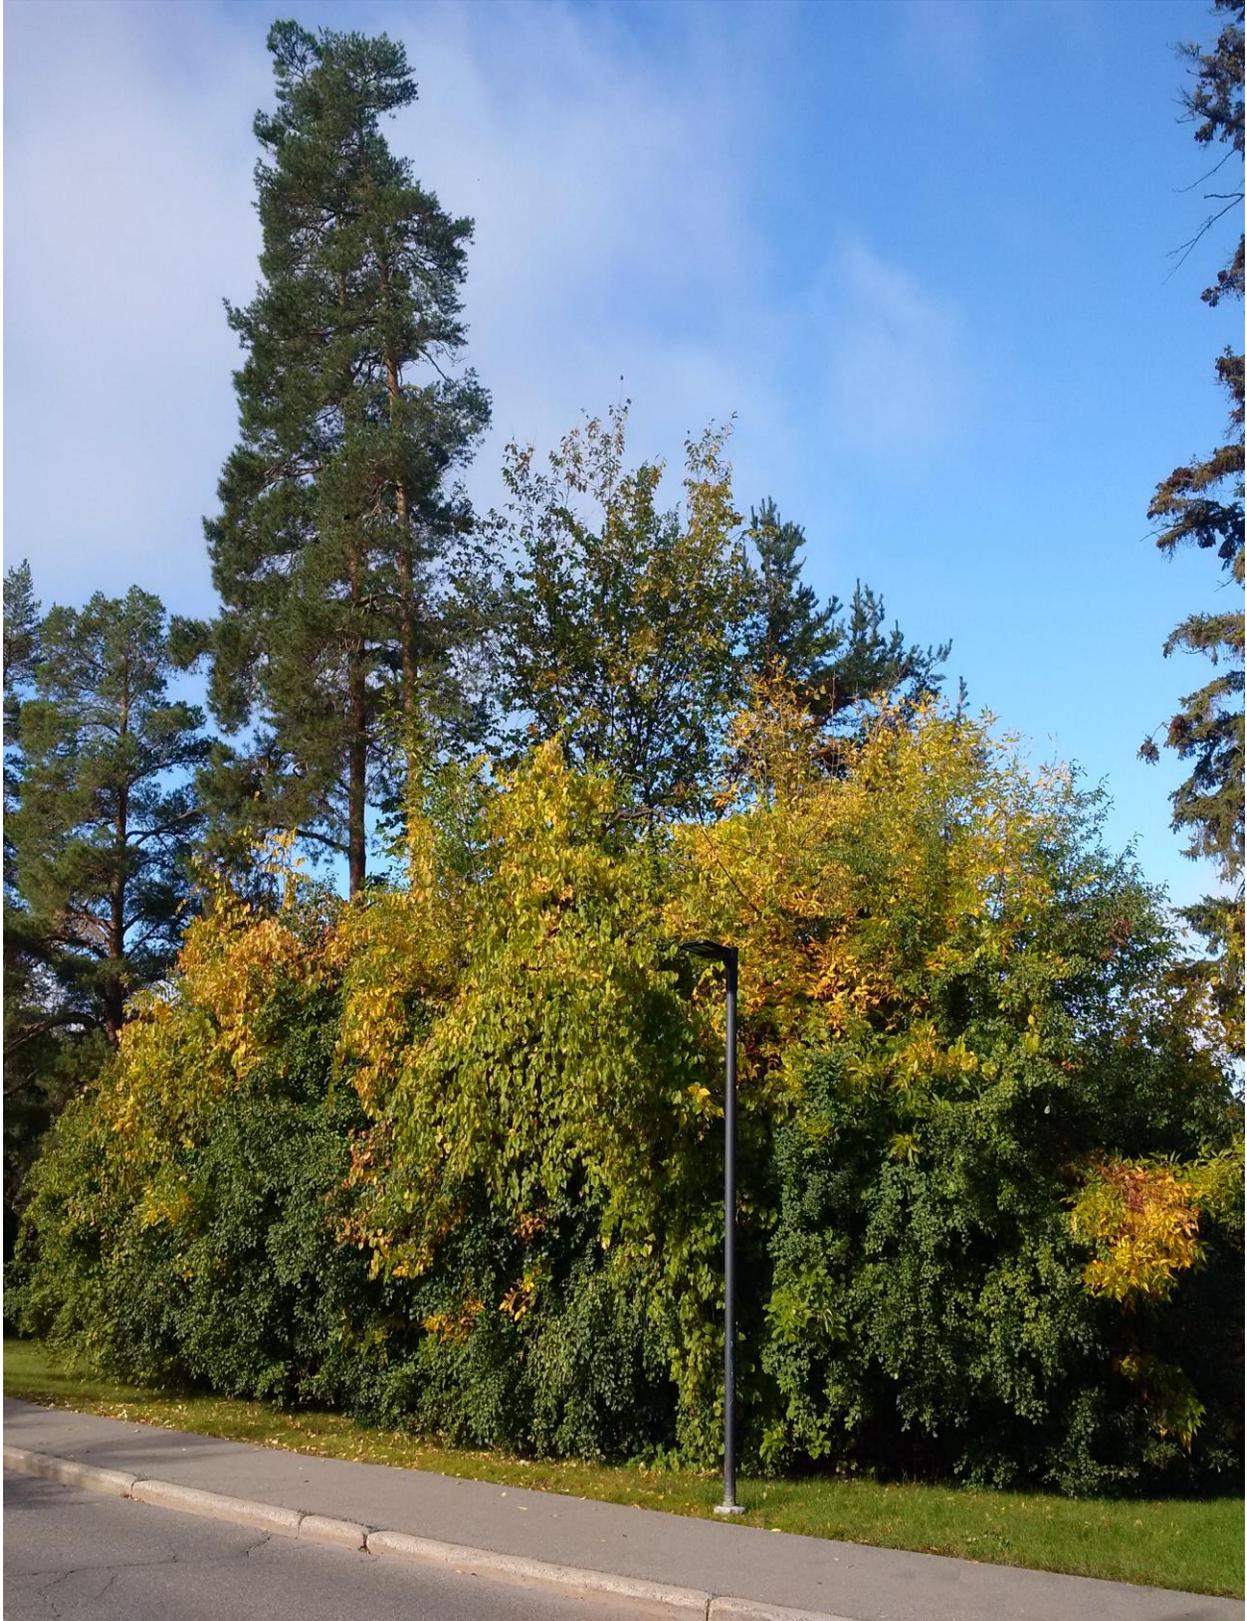
Picture 6. Tree grouping D at 1919 Riverside Drive

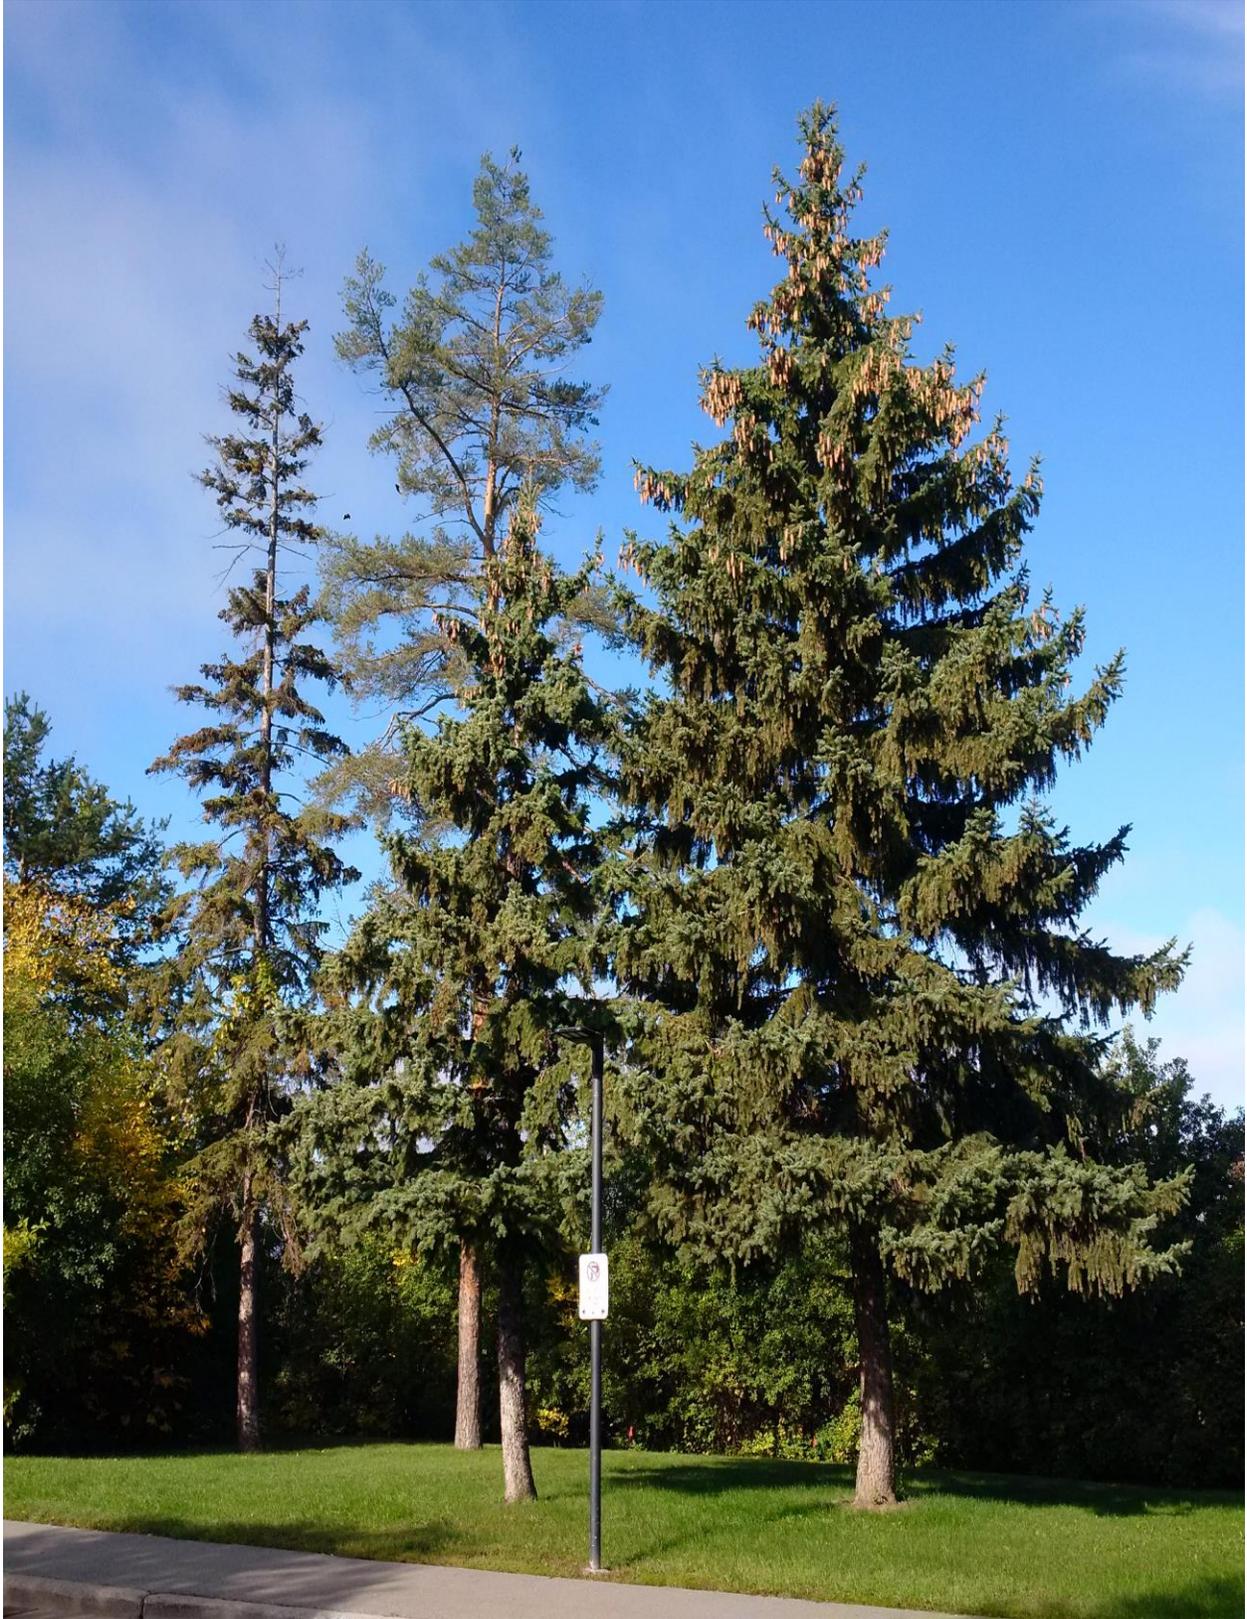
33	Colorado spruce	Good	28.2	Mature; good density, increment and colour; scattered dead branches; introduced species; <b>to be removed</b>

34	Scots pine	Good	41.4	Mature; upright stem, crown asymmetric towards southwest; good density, increment and colour; introduced invasive species; <b>to be removed</b>
35	White spruce	Fair	28.2	Mature; leader dead; scattered dead and dieback, especially near crown apex; fair density, increment and colour; native species; <b>to be removed</b>
36	Scots pine	Good	53.3	Mature; upright stem, crown asymmetric towards west; good density, increment and colour; introduced invasive species; <b>to be removed</b>
37	Scots pine	Good	37.8	Mature; upright stem, crown asymmetric towards northwest; good density, increment and colour; introduced invasive species; <b>to be removed</b>
38	Scots pine	Fair	47.4	Mature; upright narrow crown; sweep in main stem at 6m; fair density, increment and colour; introduced invasive species; <b>to be removed</b>
39	Scots pine	Fair	54.4	Mature; crown asymmetric towards west; sweep in main stem at 6m; good density, increment and colour; introduced invasive species; <b>to be removed</b>

Picture 7. Trees #32-35 (right to left) at 1919 Riverside Drive

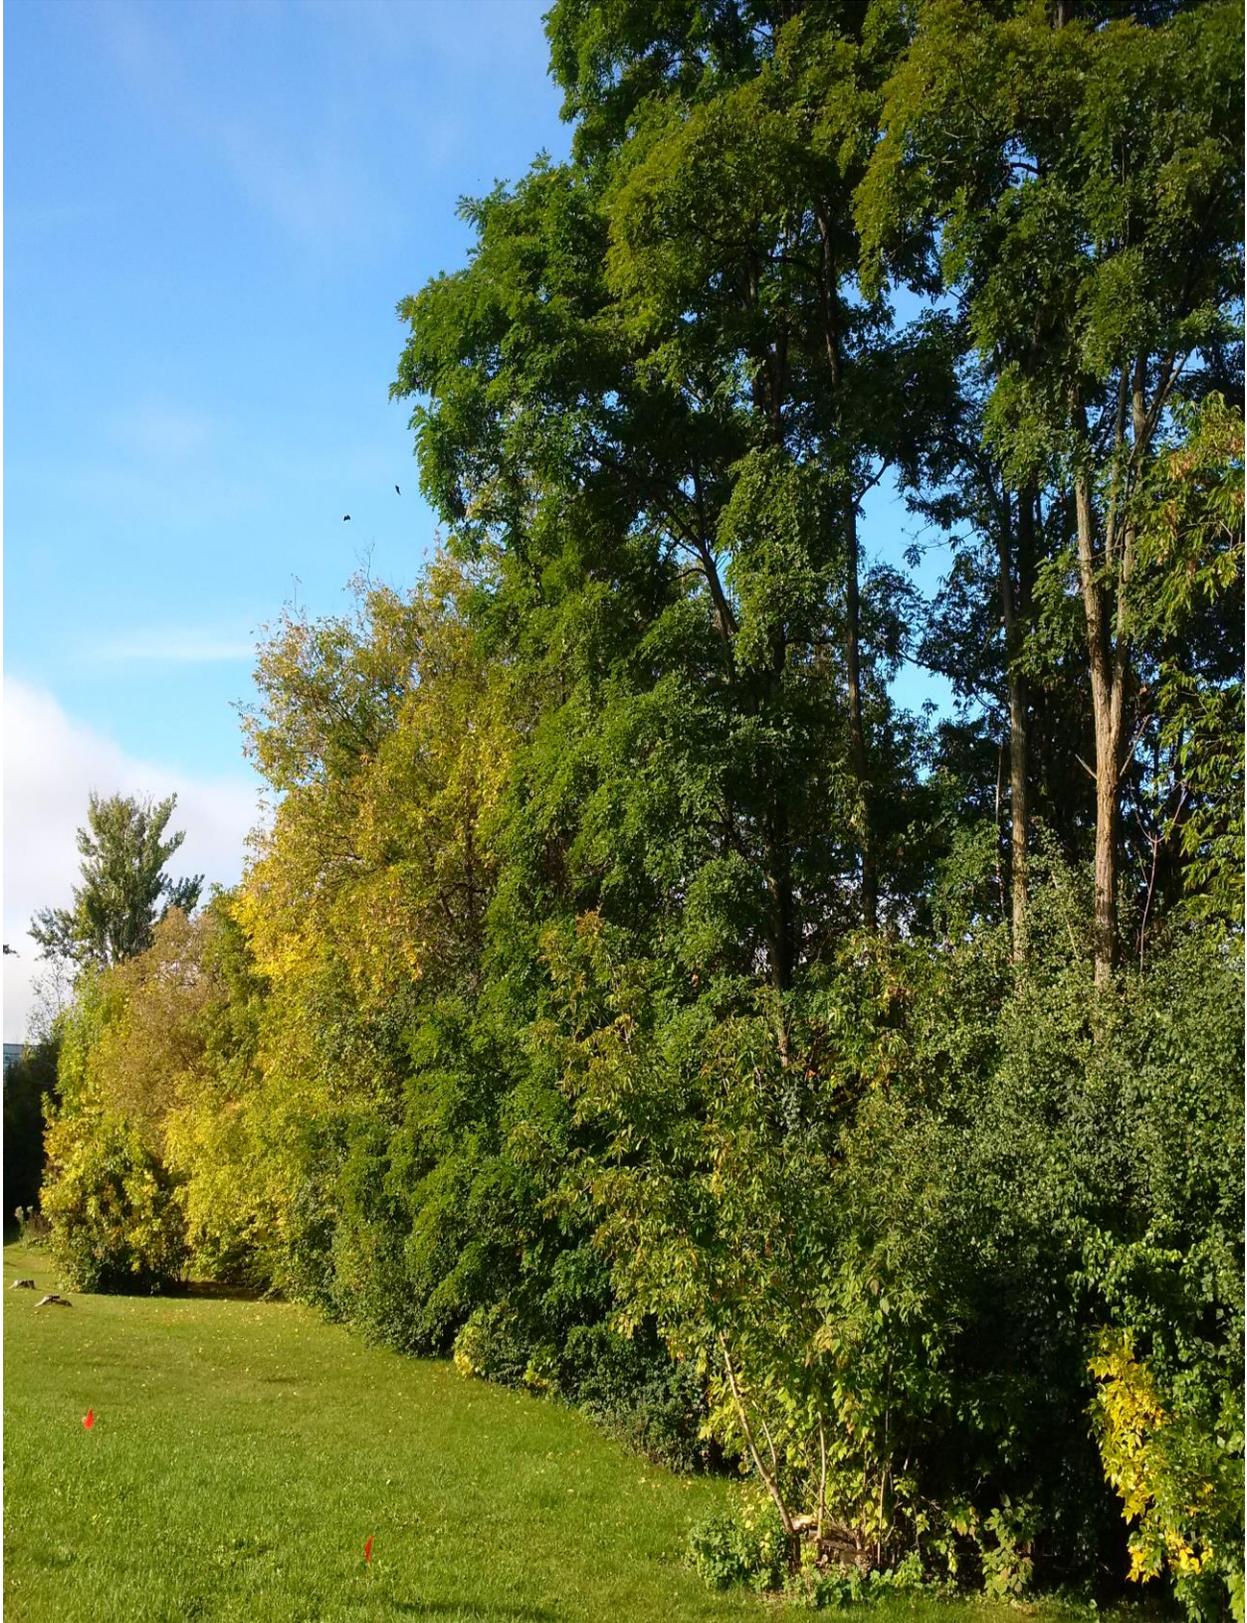
Tree grouping E: In the overstory are naturalized Manitoba maple from seed, naturally occurring trembling aspen (*Populus tremuloides*) spreading via root sprouts from the adjacent forest, naturalized black locust (*Robinia pseudoacacia*) spreading similarly and dead ash. Buckthorn once again dominates the understory.

Picture 8. Tree grouping E at 1919 Riverside Drive
