Tree Disclosure Information

Address: 216 McArthur Ave Date: November 21, 2021

Prepared by: Andrew Clifford, ISA Certified Arborist ON-1997A

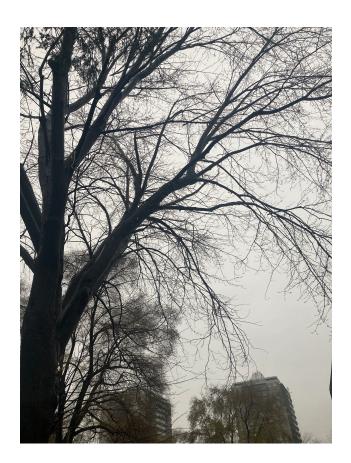
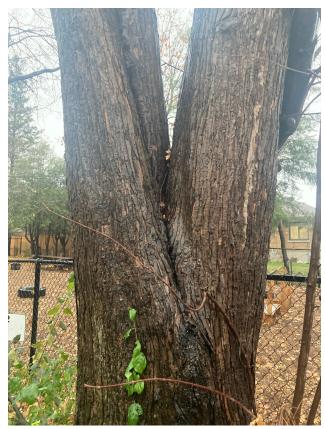
Tree no.1Silver Maple

Tree no. 1 is a 99cm Silver Maple located along the South end of the property. The tree is in fair condition with co-dominant leaders and included bark between main stems. The critical root zone is 9.9m with at least half the root zone within the excavation site, the canopy would also be impacted by the new build. Removal is required as the tree will be severely impacted by construction.

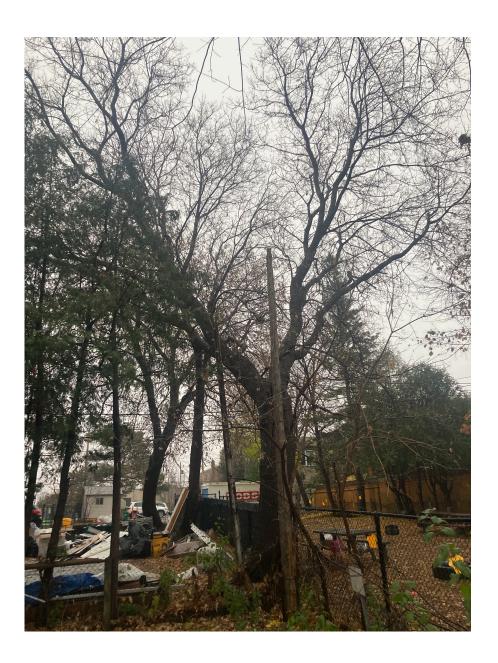
Tree no. 2Norway Maple

Tree no. 2 is a 59cm Norway Maple located at the South West corner of 218 McArthur Ave. The canopy does not impact the site, therefore no pruning is necessary. The tree has a critical root zone of 5.9 meters and may suffer minor impacts from excavation. Tree protection is necessary to protect from compaction around the root zone.

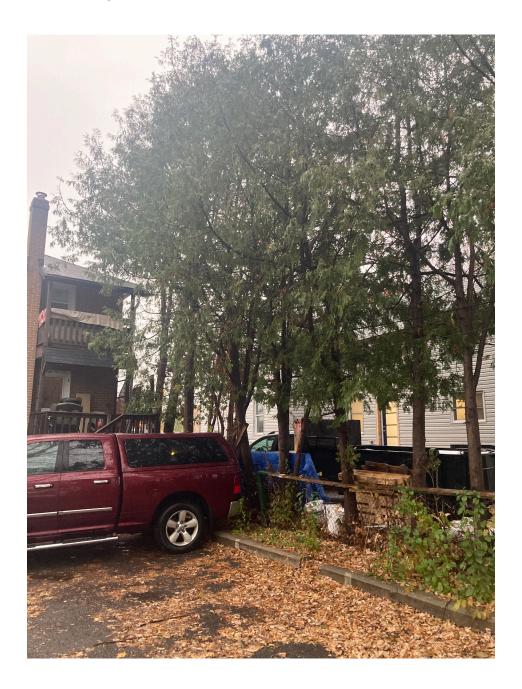
Tree no. 3Cedar Hedge

Tree no. 3 is a Cedar hedge along the North East side of 212 McArthur Ave. Hedges will be impacted by the new build and will therefore have to be removed.

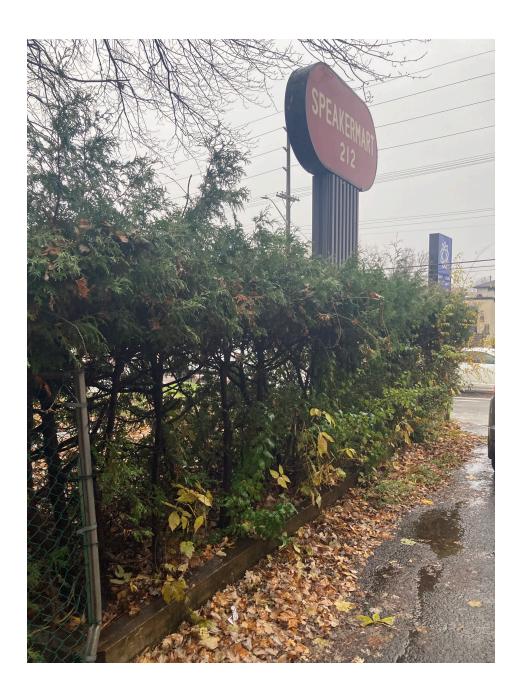
Tree no. 4 Cedar Hedge

Tree no. 4 is a row of Cedar trees ranging from 8cm-28cm DBH. Trees are within the new build and will therefore need to be removed.
