February 14, 2022

## **RE: TREE CONSERVATION REPORT FOR 180 KANATA AVENUE, OTTAWA**

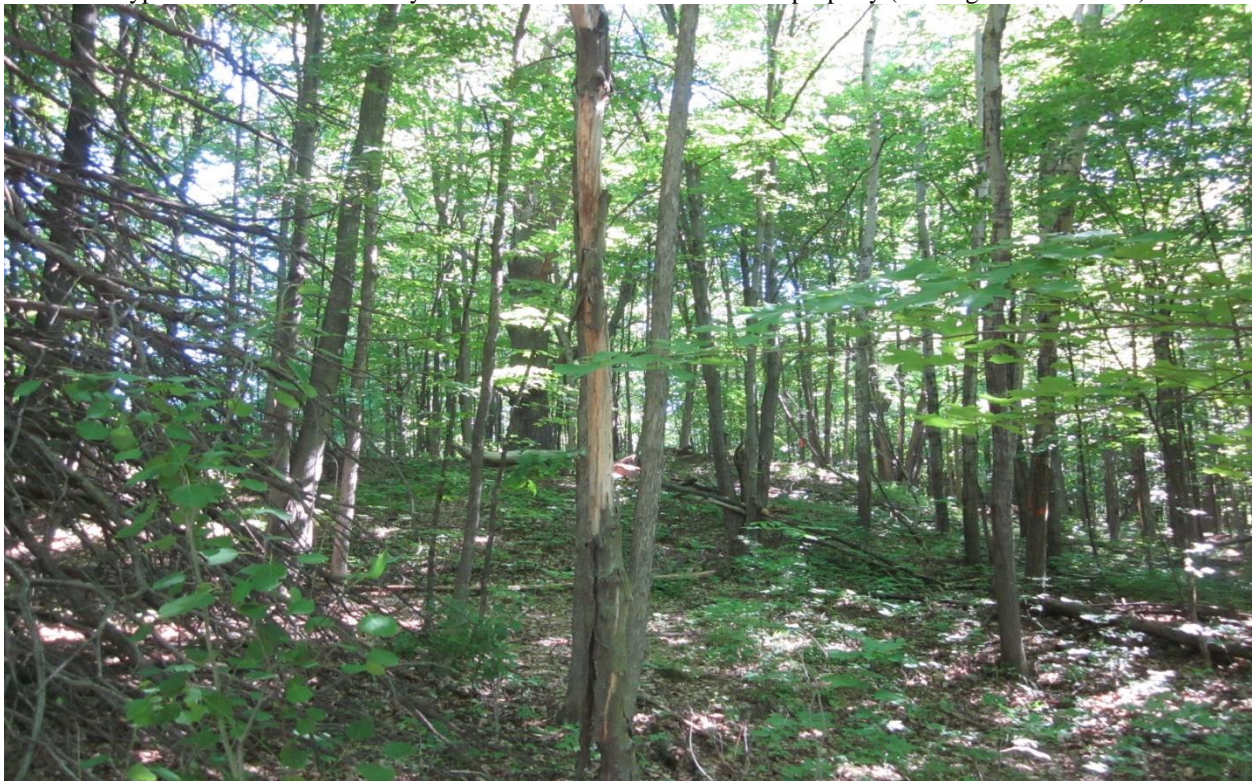
Picture 2. Typical over- and understory conditions at 180 Kanata Avenue property (looking northeastward)
