Tree Conservation Report

1600 James Naismith Drive

May 10, 2022

TREE CONSERVATION REPORT

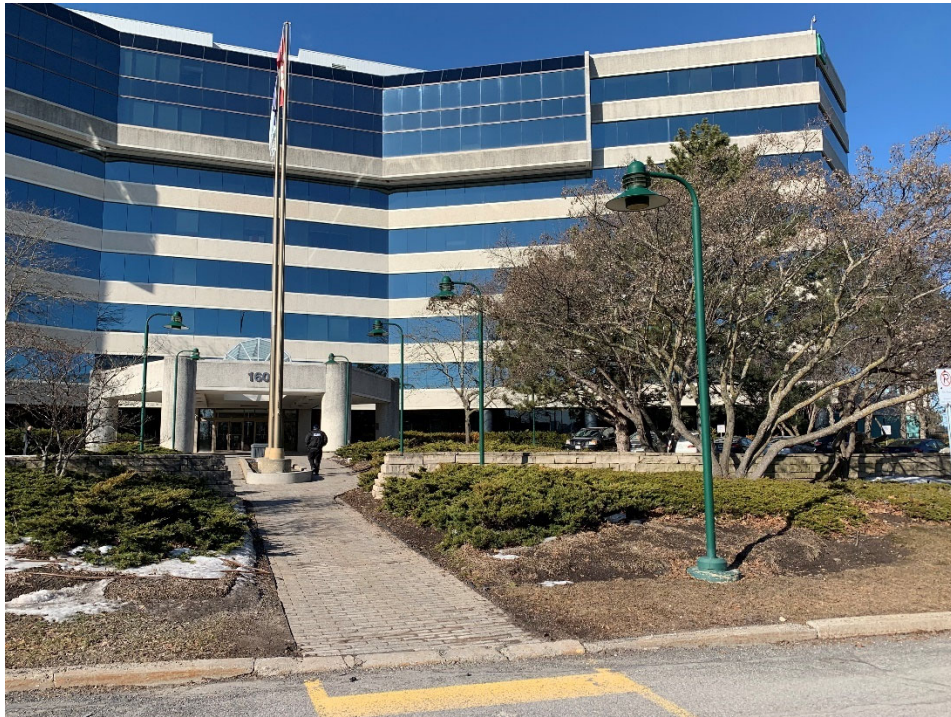
Photograph 1 – Main walkway leading to East Entrance

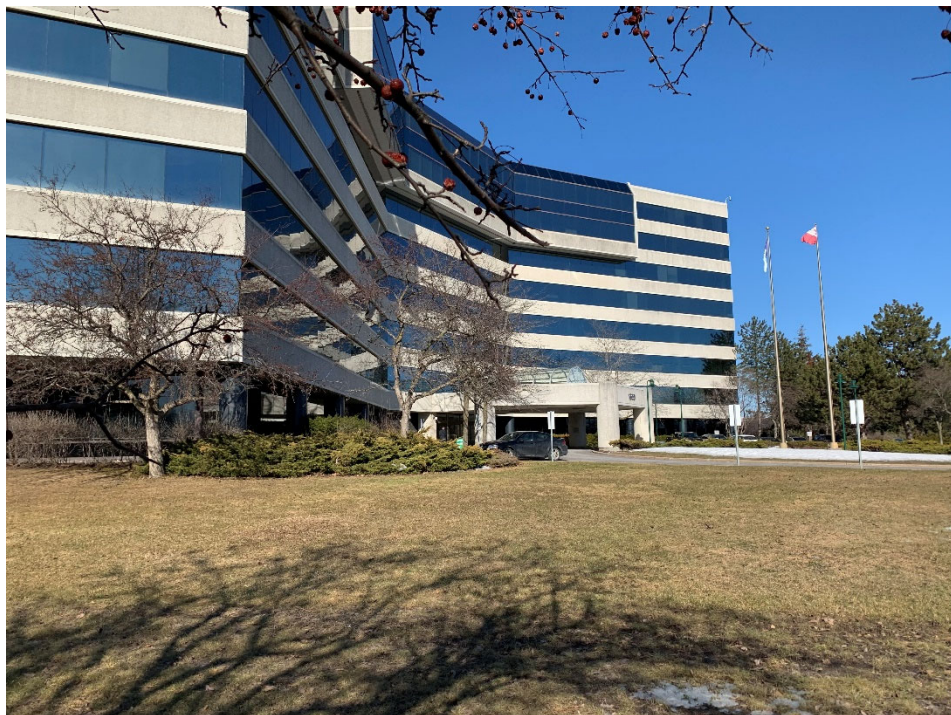
Photograph 2 – Trees and planting beds to the south

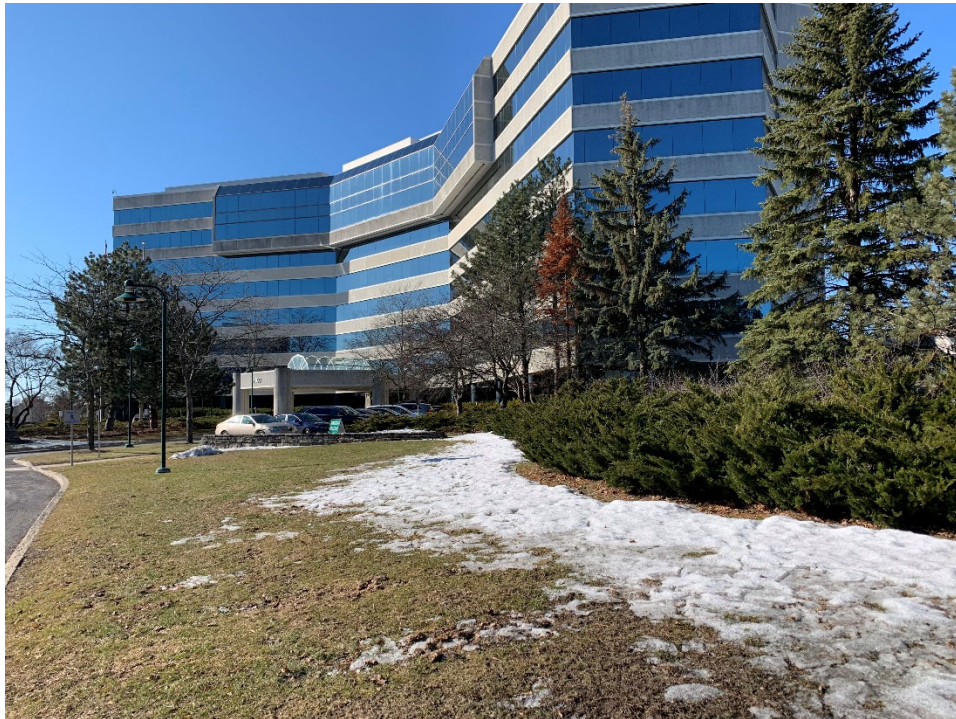
Photograph 3 – Trees and planting beds to the north

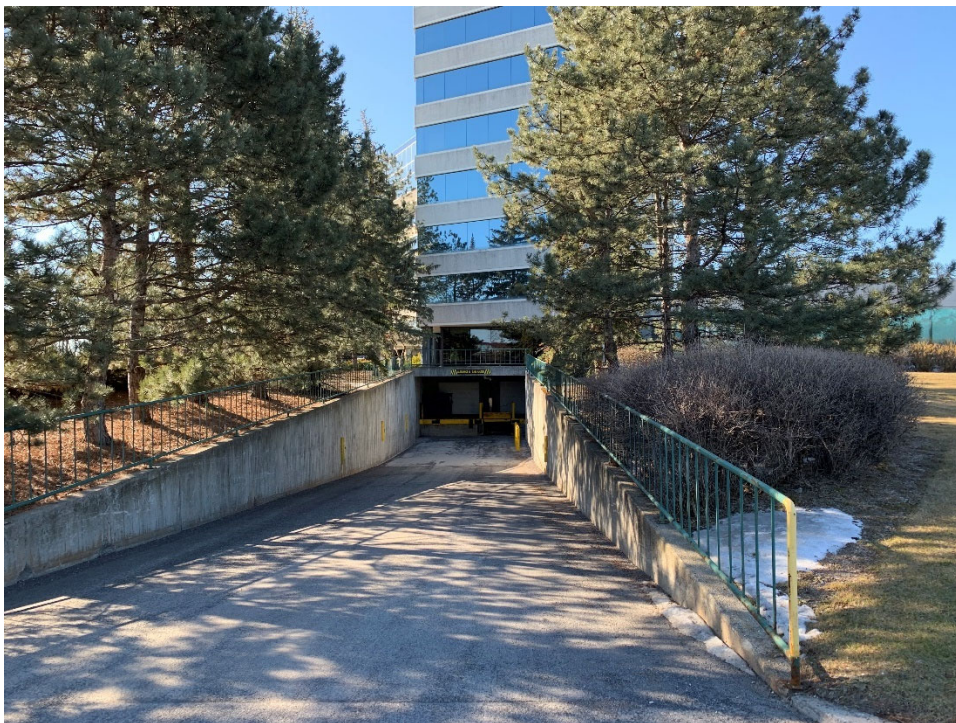
Photograph 4 – Trees and plantings beds bordering the loading ramp

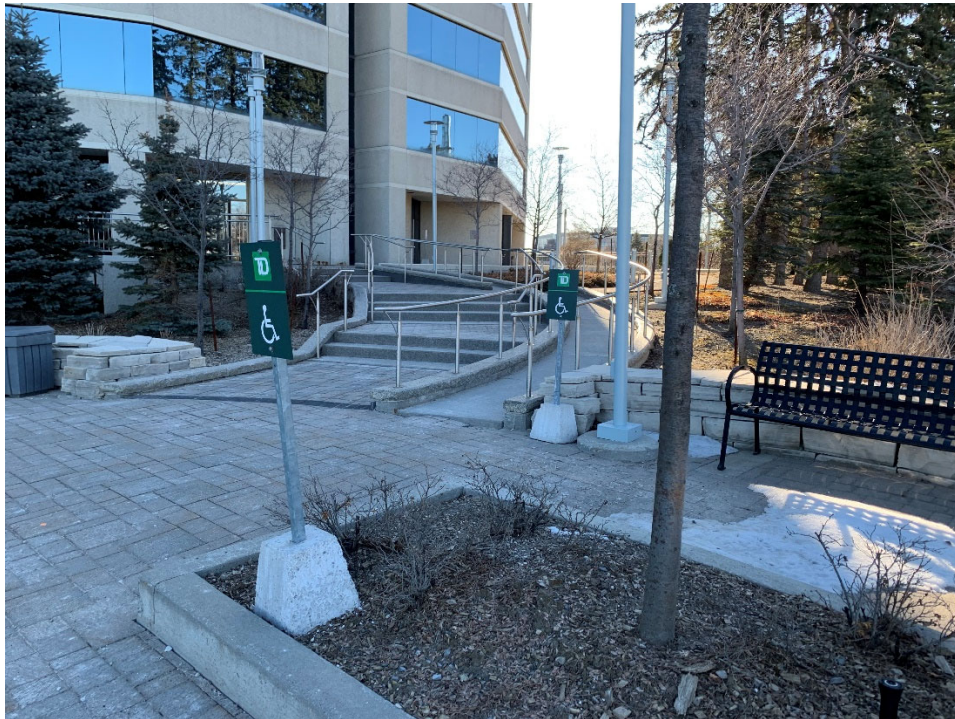
Photograph 5 – West entrance and ramp

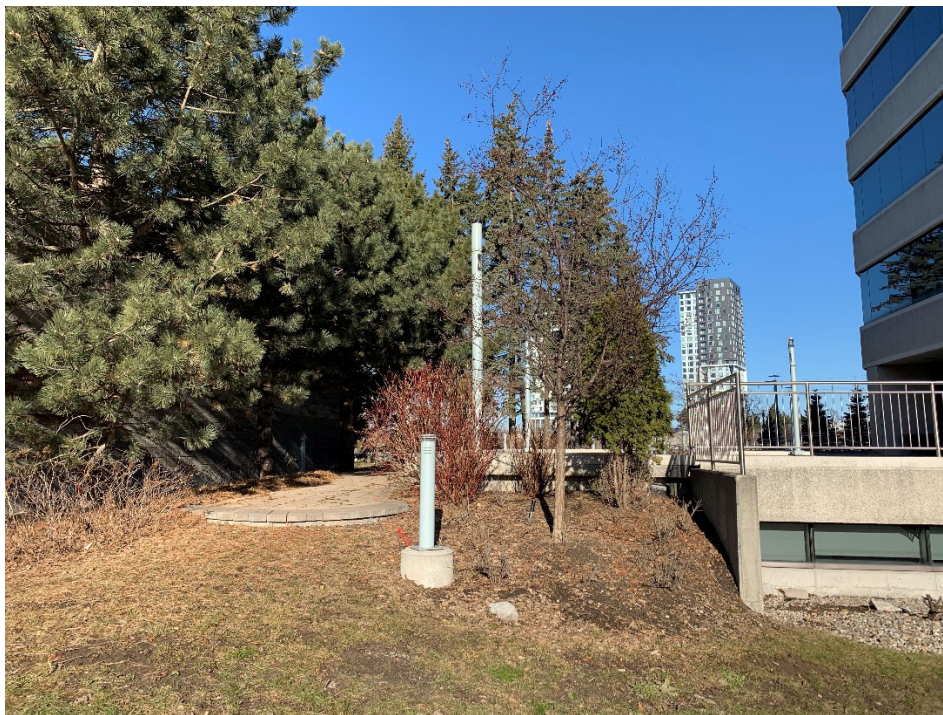
Photograph 6 – Plantings at the western terrace
