May 18, 2022

RE: TREE CONSERVATION REPORT FOR 1209 ST. LAURENT BOULEVARD, OTTAWA

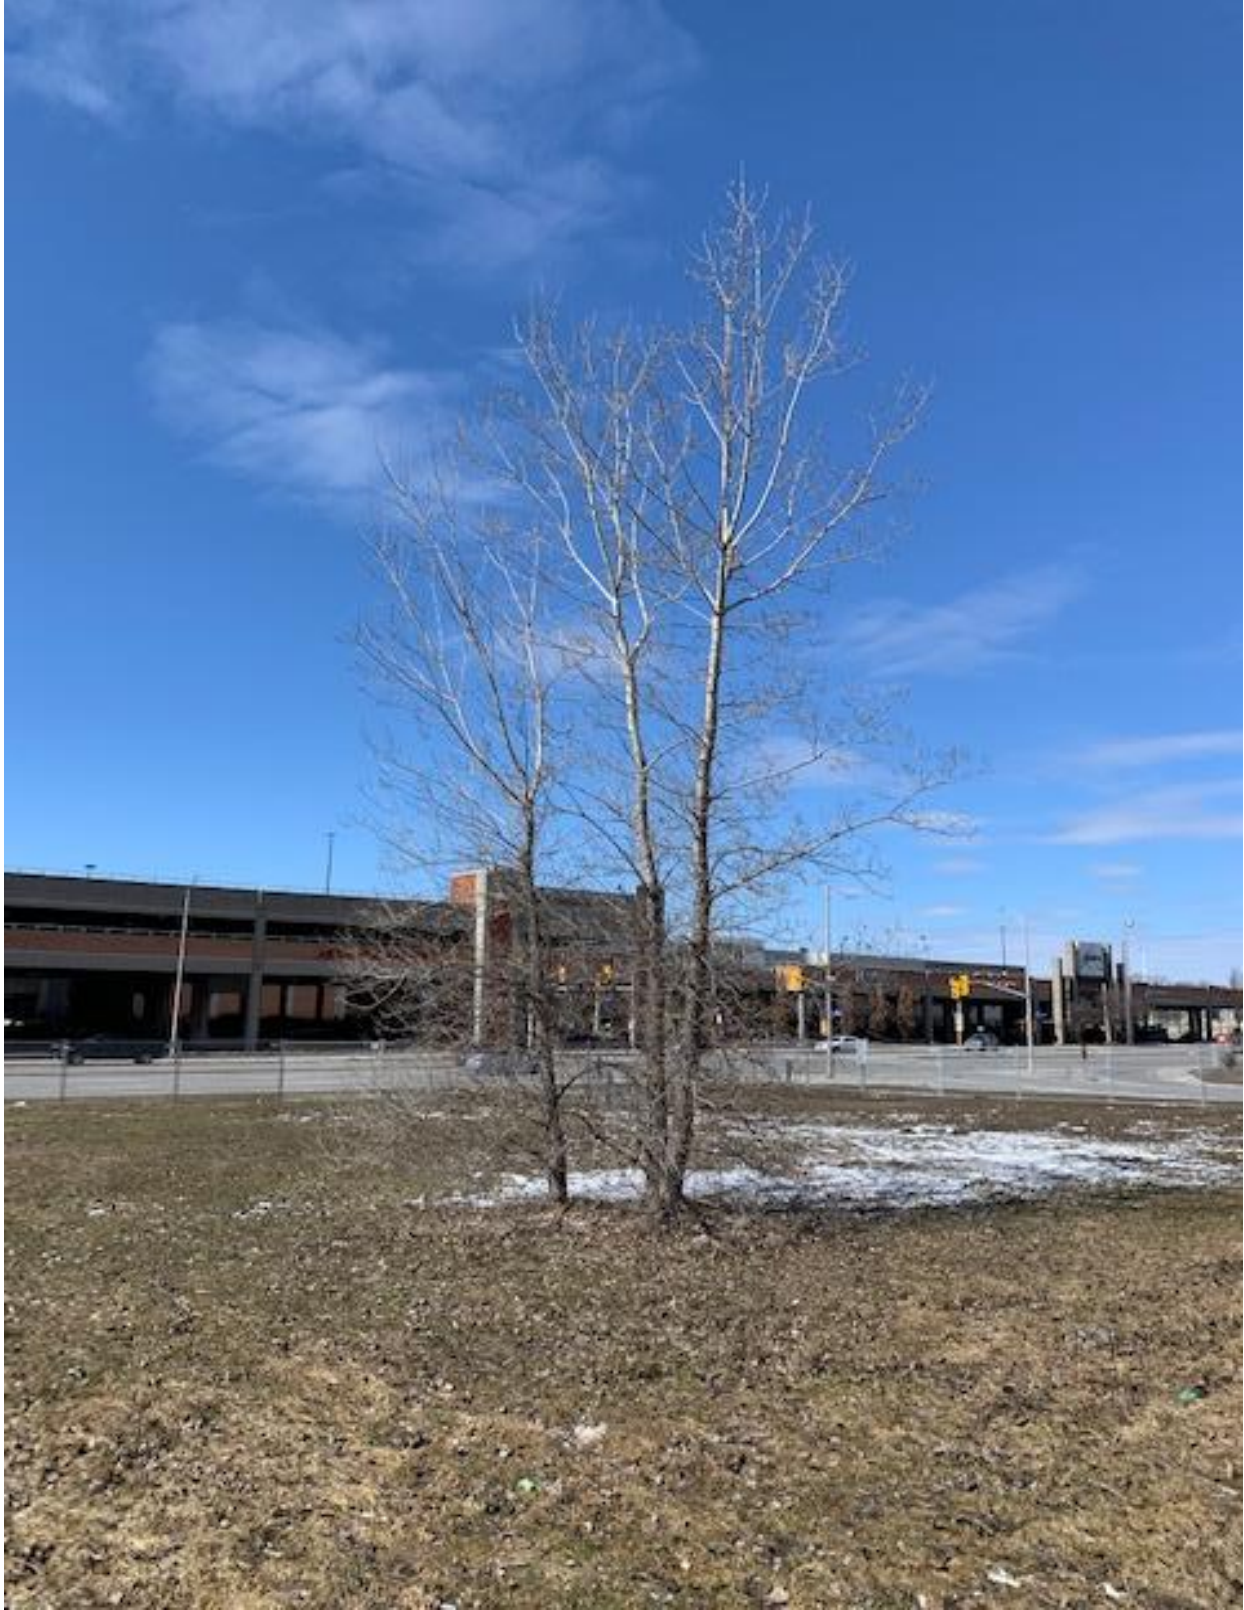
Tree No.	Tree species /Tolerance to Construction ¹	DBH ² (cm)	CRZ ³	Condition, age class, tree condition notes & preservation status (to be removed or preserved and protected)
1	Cottonwood (<i>Populus deltoides</i>)/ Moderate-Good	20 avg.	-	Good; three maturing trees; likely originated from wind-borne seed; native species; to be removed (conflicts with proposed development)
2	Austrian pine (<i>Pinus nigra</i>)	39	-	Standing dead; mature; marked for removal by City; to be removed (dead)
3	Austrian pine (<i>Pinus nigra</i>)	28	-	Standing dead; mature; to be removed (dead)
4	Austrian pine (<i>Pinus nigra</i>)	31	-	Standing dead; mature; to be removed (dead)
5	Austrian pine (<i>Pinus nigra</i>)/ Moderate-Good	38	-	Fair; mature; crown asymmetric towards north due to influence of adjacent trees; fair crown density, growth increment and needle colour; no distinct dominant leader; introduced species; to be removed (conflicts with proposed development)

Picture 1. Tree #1, poplar at 1209 St. Laurent Boulevard

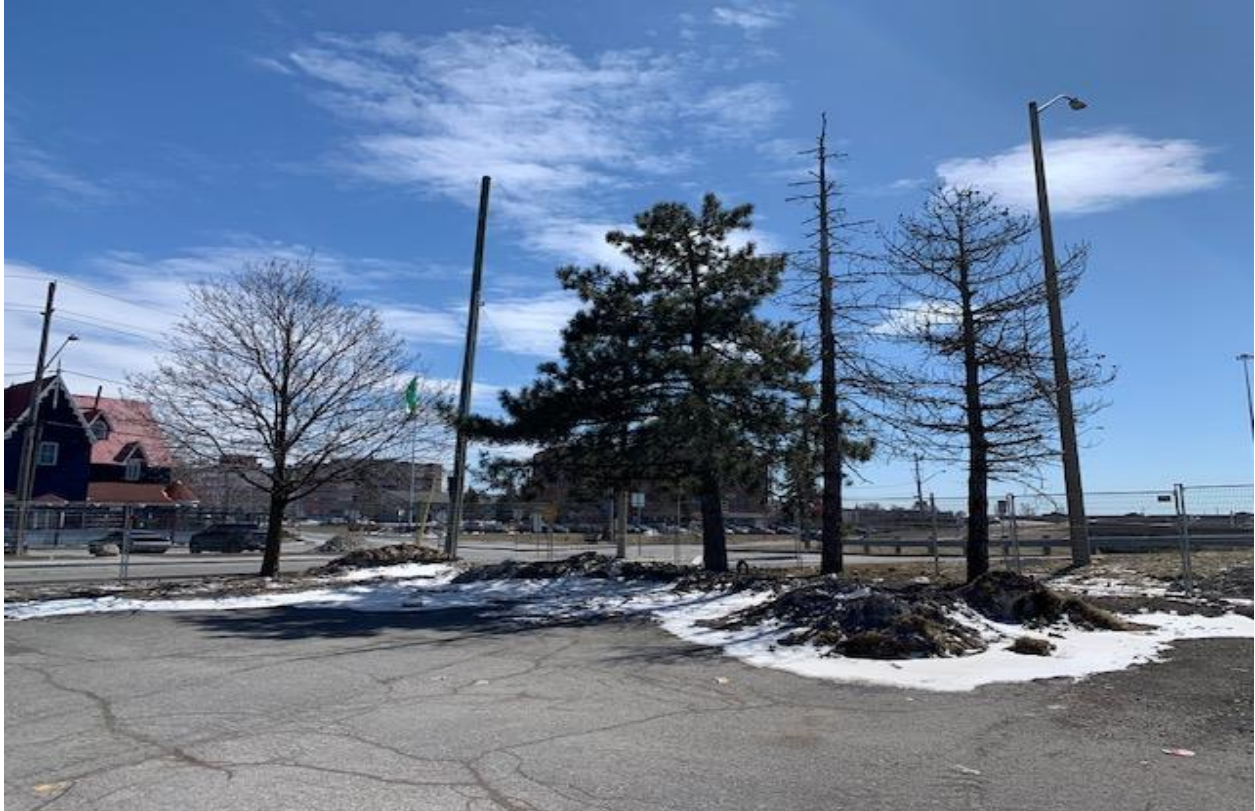
6	Norway maple (<i>Acer platanoides</i>)/ Moderate-Good	25	2.5	Good; mature; central dominant stem with competing leaders at 4m from grade; suppressed laterals starting at 1.5m; dense, compact crown; introduced invasive species; to be preserved and protected
7	Austrian pine (<i>Pinus nigra</i>)/ Moderate-Good	41	-	Good; mature; dominant central stem; crown asymmetric due to influence of nearby trees; good crown density, growth increment and needle colour; introduced species; to be removed (will not survive root loss)
8	Austrian pine (<i>Pinus nigra</i>)/ Moderate-Good	26	-	Fair; mature; dominant central stem; crown asymmetric due to influence of nearby trees; good crown density, growth increment and needle colour; introduced species; to be removed (will not survive root loss)
9	Austrian pine (<i>Pinus nigra</i>)/ Moderate-Good	31	-	Fair; mature; dominant central stem; crown asymmetric due to influence of nearby trees; good crown density, growth increment and needle colour; introduced species; to be removed (will not survive root loss)

Picture 2. Trees #3-6 (right to left) at 1209 St. Laurent Boulevard

Preservation and protection measures intended to mitigate damage during construction will be applied for the two trees to be retained. The following measures are the minimum required by the City of Ottawa to ensure tree survival during and following construction:

1. Erect a fence at the critical root zone (CRZ¹) of trees;
2. Do not place any material or equipment within the CRZ of the tree;
3. Do not attach any signs, notices or posters to any tree;
4. Do not raise or lower the existing grade within the CRZ without approval;
5. Tunnel or bore when digging within the CRZ of a tree;
6. Do not damage the root system, trunk or branches of any tree;
7. Ensure that exhaust fumes from all equipment are NOT directed towards any tree's crown.

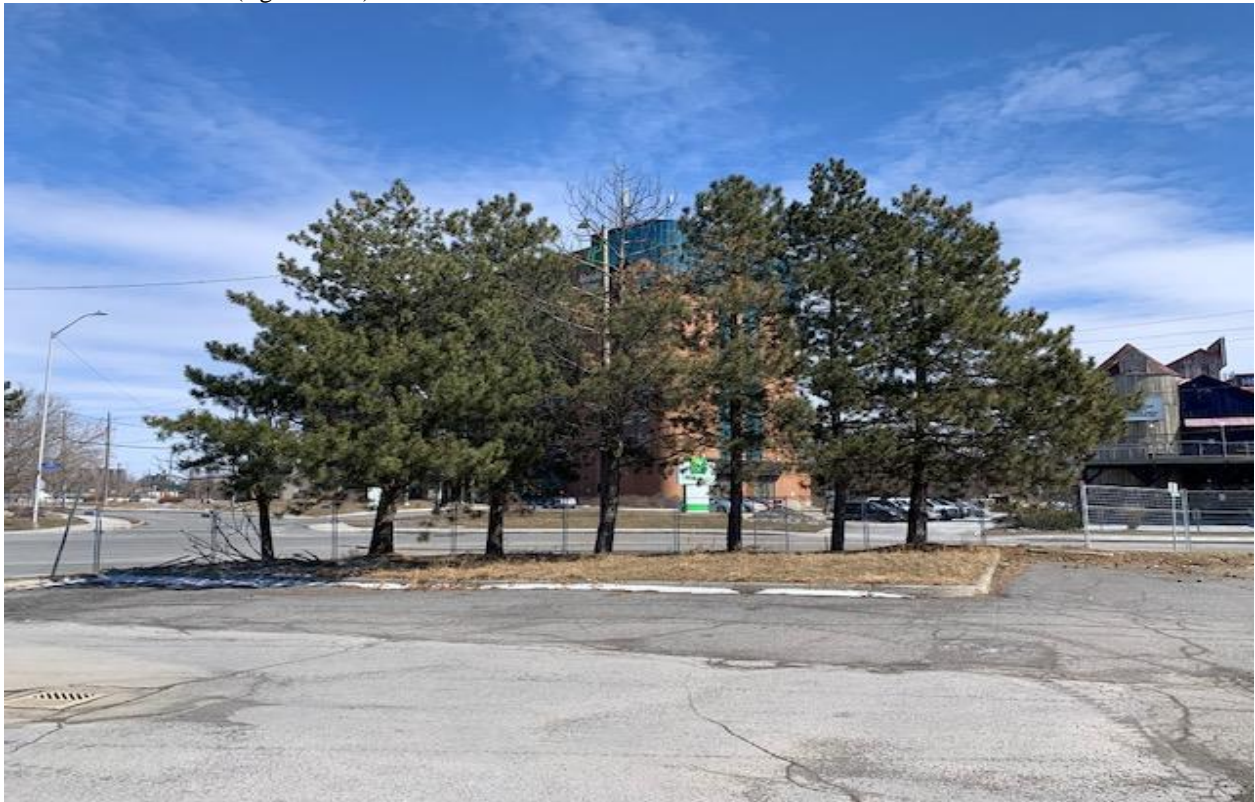
Tree No.	Tree species /Tolerance to Construction ¹	DBH ² (cm)	CRZ ³	Condition, age class, tree condition notes & preservation status (to be removed or preserved and protected)
10	Austrian pine (<i>Pinus nigra</i>)/ Moderate-Good	31	-	Very poor; mature; top half of crown dead, bottom with poor crown density, growth increment and needle colour; introduced species; to be removed (very poor condition and will not survive root loss)
11	Austrian pine (<i>Pinus nigra</i>)/ Moderate-Good	33	-	Fair; mature; crown moderately asymmetric due to influence of nearby trees; good crown density, growth increment and needle colour; introduced species; to be removed (will not survive root loss)
12	Austrian pine (<i>Pinus nigra</i>)/ Moderate-Good	43	-	Fair; mature; lower crown dead due to influence of nearby pine and maple trees; good crown density, growth increment and needle colour; introduced species; to be removed (will not survive root loss)

13	Norway maple (<i>Acer platanoides</i>)	22	-	Dead; mature; broken in two; to be removed (dead)
14	Austrian pine (<i>Pinus nigra</i>)	33	-	Dead; mature; seeded Siberian elm (<i>Ulmus pumila</i>) growing at base; to be removed (dead)
15	Austrian pine (<i>Pinus nigra</i>)/ Moderate-Good	26	-	Poor; mature; stunted growth form; poor crown density, growth increment and needle colour; introduced species; to be removed (poor condition)
16	Austrian pine (<i>Pinus nigra</i>)/ Moderate-Good	29	-	Poor; mature; stunted growth form; heavy vine (<i>Vitis</i> spp.) growth into crown; very poor crown density, growth increment and needle colour; introduced species; to be removed (poor condition)
17	Austrian pine (<i>Pinus nigra</i>)/ Moderate-Good	34	3.4	Fair; mature; crown asymmetric due to influence of nearby trees; vine (<i>Vitis</i> spp.) growth into crown; fair crown density and needle colour, good growth increment; hydro line runs through crown apex; introduced species; to be preserved and protected

Picture 3. Trees #7-13 (right to left) at 1209 St. Laurent Boulevard

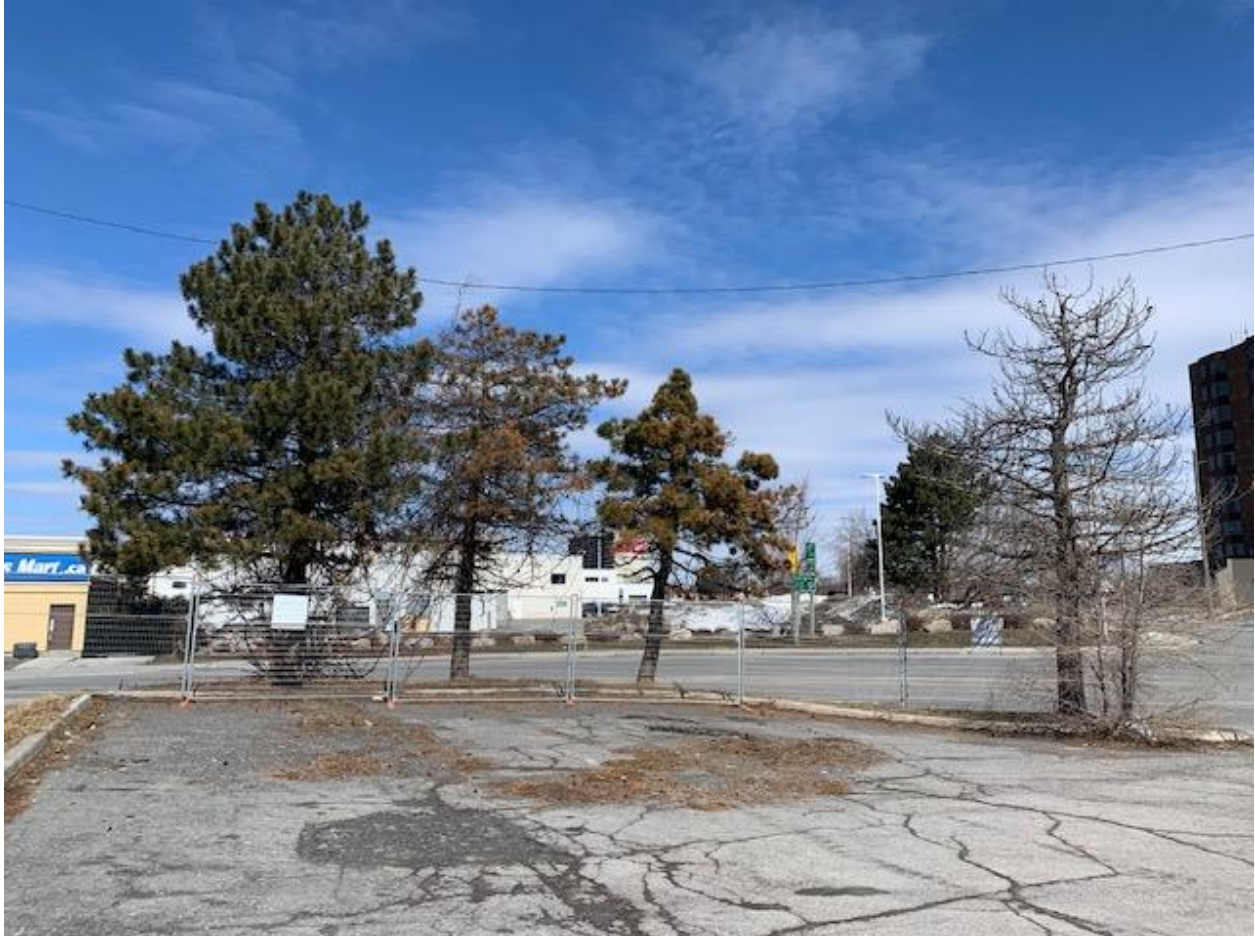
Picture 4. Trees #14-17 (right to left) at 1209 St. Laurent Boulevard
