TREE CONSERVATION REPORT

2920 Sheffield Rd

Tree Conservation Report submitted as
Partial Requirements for a Site Plan
Control Application, December 14, 2021

Date: December 14, 2021

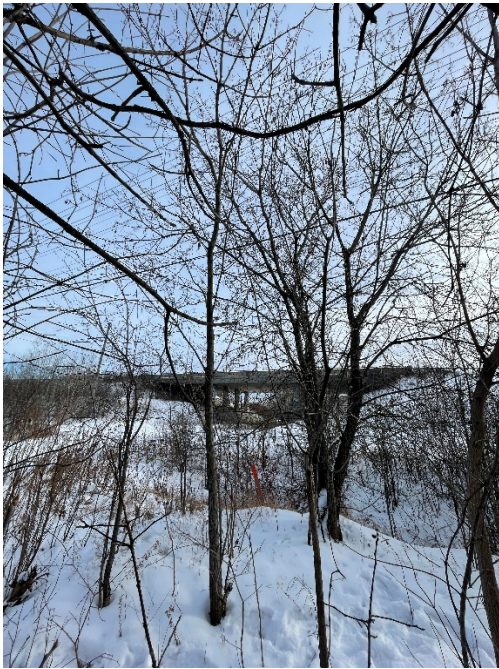
Figure 1: Tree 3, Manitoba maple on the southwestern tip on adjacent property

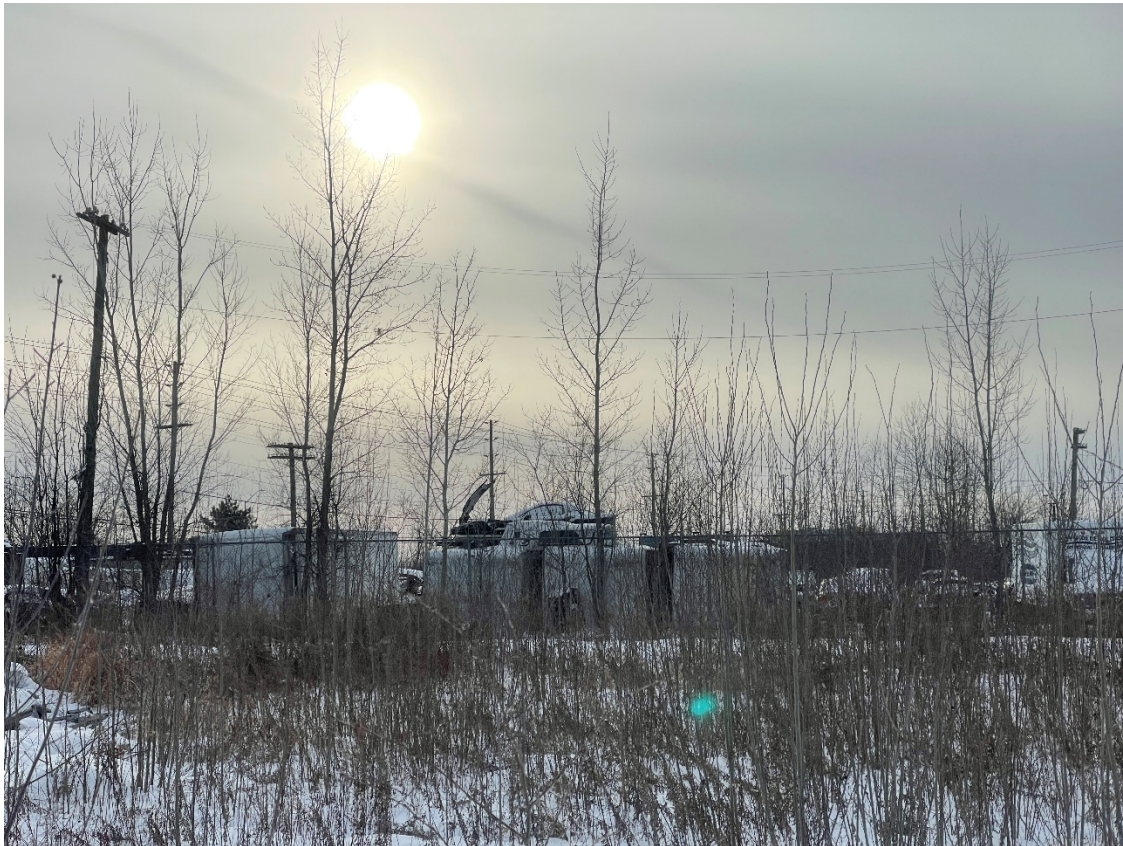
The property line along the west side runs along the ditch, approximately 1-2 metres east of the fence on the adjacent property at 2629 Walkley (Ottawa Metro Towing). There are some trees that are lining the fence, many of which have grown into the fence. Made up of trembling aspen, Manitoba maple, and ash, these trees are in poor health and have low suitability for retention. If the ditch is graded, this will impact the tree roots, and they should be removed. The only trees that would be suitable for retention are those along the southern tip of this west side. Note that all the trees along this site are on the adjacent property, and permission would be required from the adjacent property owner for removal.

Figure 2: Trees along the west property line, on adjacent property

All trees will be removed from this site due to poor health and conflict with the proposed development. Removal of any trees along the west side on adjacent property requires permission from the adjacent property owner at 2629 Walkley.

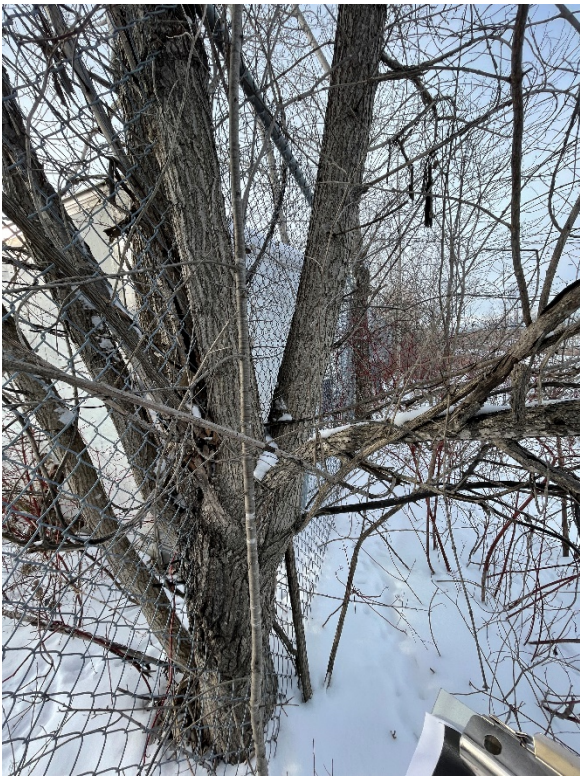
Figure 3: Tree 8, multi-stemmed poplar growing in fence

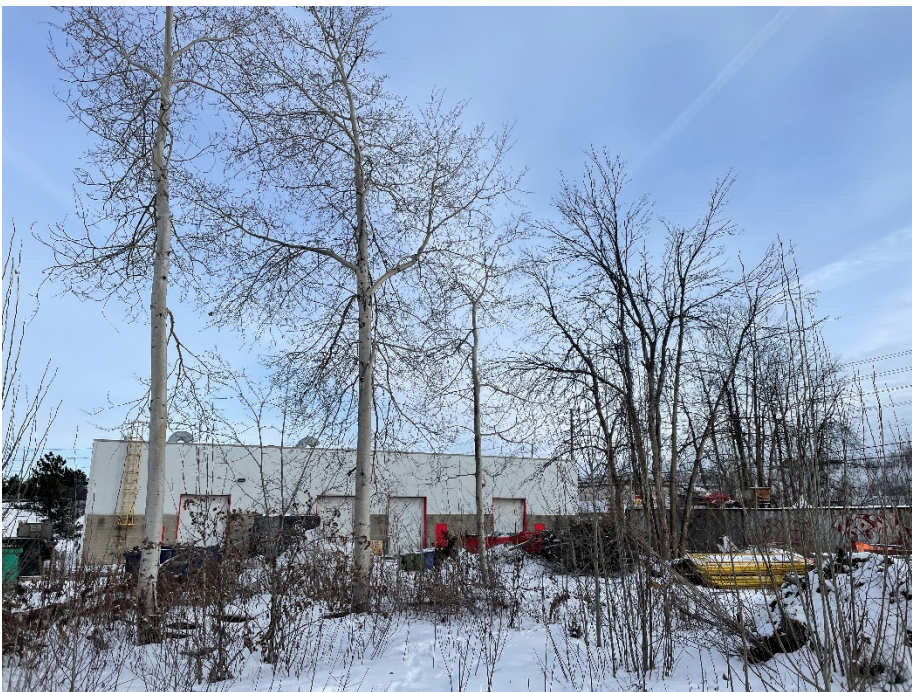
have seeded in naturally, and are either in fair/poor condition, or dead. Along the east, there is a clump of trembling aspen, just north of where the proposed new building will be. These trees are in fair/poor condition. The remaining trees to the south along this east side are ash, most of which have been killed by the Emerald Ash Borer.

Figure 4: Facing east, clump of poplars on left (trees 9-11) and dead ash on the right

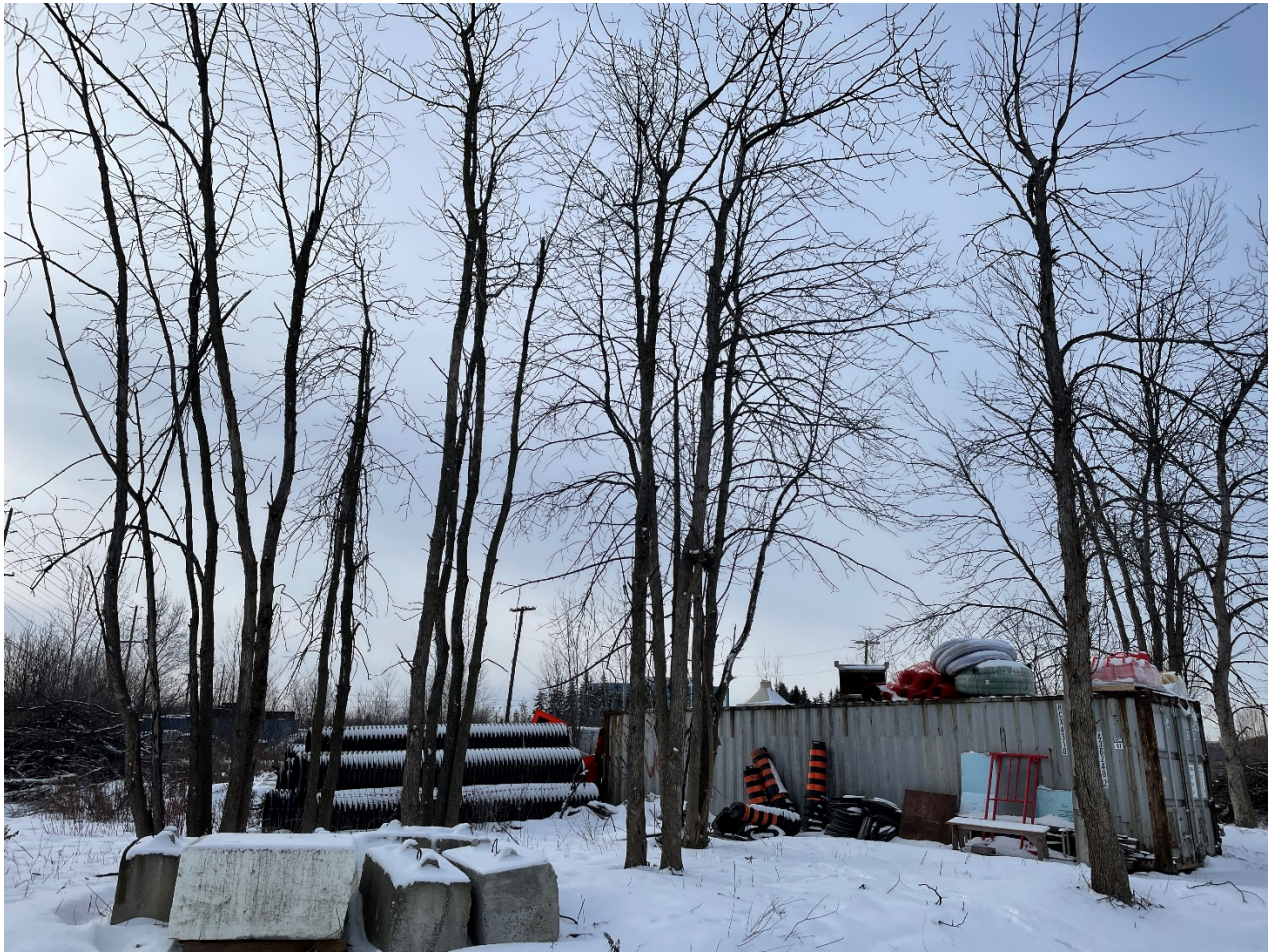
11	Trembling aspen (<i>Populus tremuloides</i>)	13 cm	2920 Sheffield	Poor: slight lean and decay all the way up the trunk	Remove; in conflict with new building and fire route and poor health
12	Ash (<i>Fraxinus spp</i>)	21 trees ranging 15-25 cm in diameter	2920 Sheffield	Dead	Remove; no permit required

Figure 5: Taken from the SE corner, facing west, clump of ash trees (number 12 on map)
