May 17, 2022

RE: TREE CONSERVATION REPORT FOR 3150 WOODROFFE AVENUE, OTTAWA

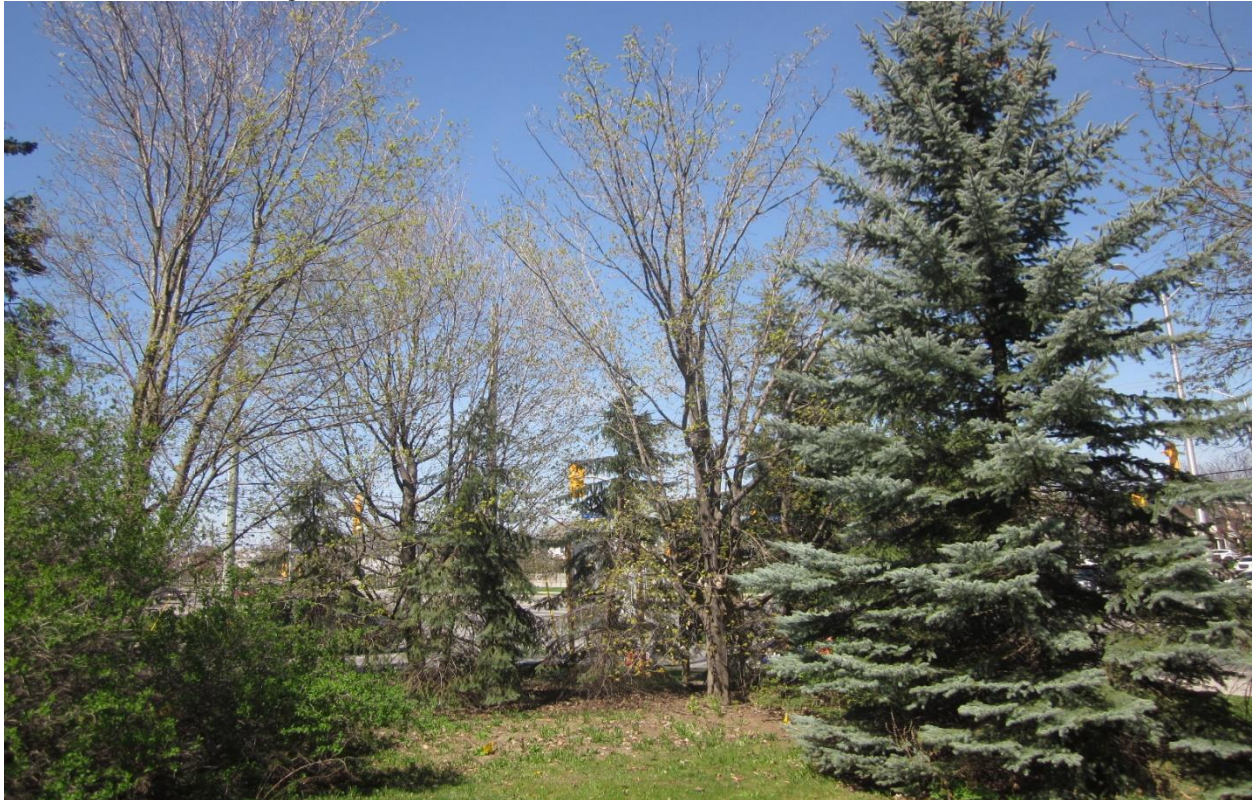
40	Balsam fir (<i>Abies balsamea</i>) / Moderate-Good	15.6cm /1.6m	Private	Poor; maturing; crown very asymmetric due to influence of tree #39; leader suffering abrasion damage; fair crown density, annual growth increment and needle colour; native species; to be preserved and protected
41	Colorado spruce (<i>Picea pungens</i>) / Moderate-Good	15.1cm /1.5m	Private	Poor; maturing; crown very asymmetric due to influence of tree #39; good crown density, annual growth increment and needle colour; introduced species; to be preserved and protected
42	Colorado spruce (<i>Picea pungens</i>) / Moderate-Good	12.3cm /1.2m	Private	Poor; maturing; crown very asymmetric due to influence of tree #39; sweep at 2m from previously lost leader; good crown density, annual growth increment and needle colour; introduced species; to be preserved and protected
43	Colorado spruce (<i>Picea pungens</i>) / Moderate-Good	12.7cm /1.3m	Private	Poor; maturing; crown very asymmetric due to influence of tree #44; sweep at 2m from previously lost leader; good crown density, annual growth increment and needle colour; introduced species; to be preserved and protected

Tree No.	Tree species /Tolerance to Construction ¹	DBH ² / CRZ ³	Ownership ⁴	Condition, age class, tree condition notes; species origin & preservation status (to be removed or preserved and protected)
44	Sugar maple (<i>Acer saccharum</i>)/ Poor-Moderate	38.6cm (at 0.5m)/ 3.9m	Private	Fair; mature; central stem with competing lateral at 1m on east; co-dominant leaders at 2.5m – both bisect at 3.5m with inclusion ridges at unions; native species; to be preserved and protected
45	Sugar maple (<i>Acer saccharum</i>)/ Poor-Moderate	35.5cm /3.6m	Private	Fair; mature; central stem with co-dominant leaders at 5.5m – both bisect within 2m of primary union; suppressed and competing laterals starting at 1.5m - broad, dense crown; native species; to be preserved and protected
46	Ash (<i>Fraxinus</i> spp.)	-	Private	Dead due to emerald ash borer (<i>Agrilus planipennis</i>); broken at 1m; to be removed
47	White spruce (<i>Picea glauca</i>)/ Moderate-Good	53.3cm /5.3m	City	Fair; mature; single upright main stem and leader; scattered dead branches due to <i>Cytospora kunzei</i> ; fair crown density, annual growth increment and needle colour; native species; to be preserved and protected

Picture 7. Trees #38-44 (right to left) at 3150 Woodroffe Avenue

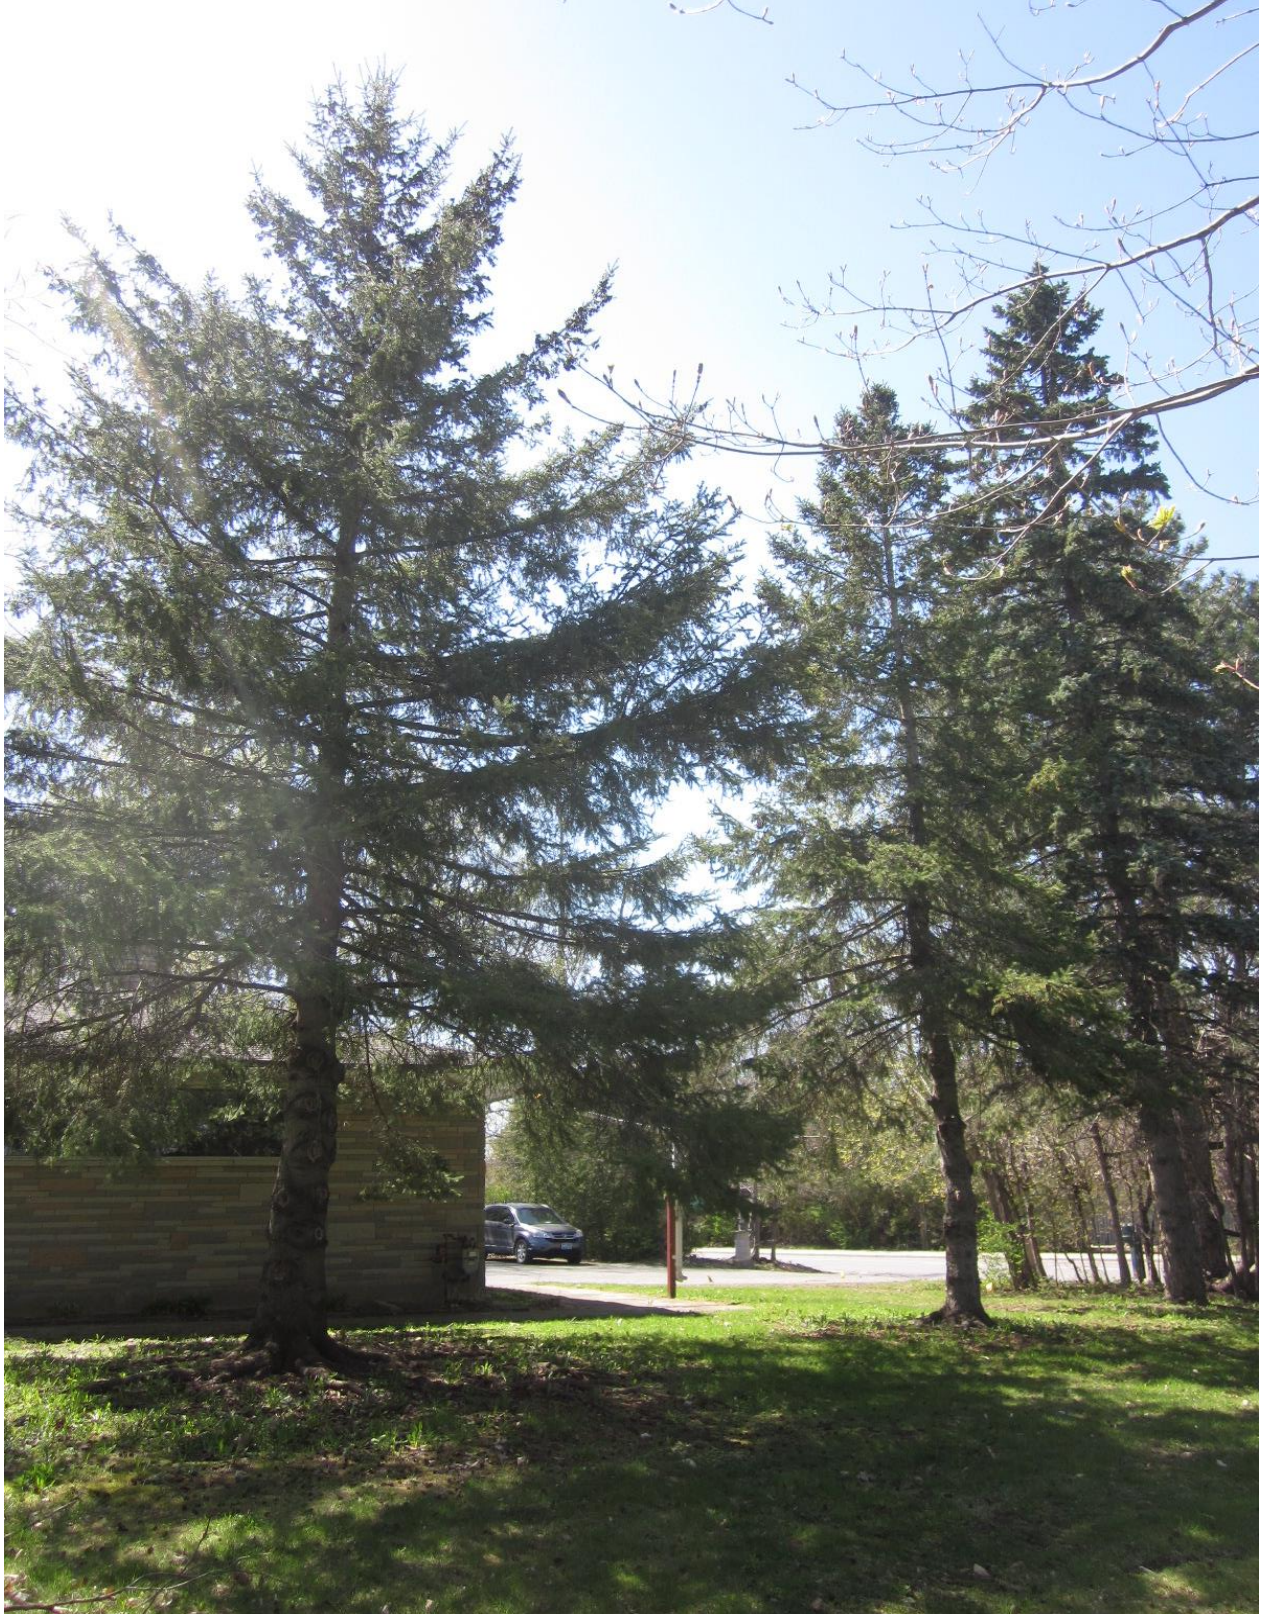
Tree No.	Tree species /Tolerance to Construction ¹	DBH ² / CRZ ³	Owner-ship ⁴	Condition, age class, tree condition notes; species origin & preservation status (to be removed or preserved and protected)
37	Colorado spruce (<i>Picea pungens</i>) / Moderate-Good	47.1cm /4.7m	Private	Good; mature; single upright main stem and leader; crown generally symmetric; lower crown thin due to influence of tree #48; good crown density, annual growth increment and needle colour elsewhere; introduced species; to be removed (conflicts with parking)
38	Colorado spruce (<i>Picea pungens</i>) / Moderate-Good	22.3cm /2.2m	Private	Very good; maturing; generally symmetric crown; good crown density, annual growth increment and needle colour elsewhere; introduced species; to be preserved and protected
39	Sugar maple (<i>Acer saccharum</i>) / Poor-Moderate	29.1cm /2.9m	Private	Good; maturing; co-dominant stems at 2.5m with competing lateral at 2m on east; native species; to be preserved and protected

Picture 8. Trees #35, 36 and 37 (left to right) at 3150 Woodroffe Avenue
