## **Tree Conservation Report**

1600 James Naismith Drive

September 28, 2022

Stantec Consulting Ltd.  
1331 Clyde Avenue  
Ottawa ON K2C 3G4  
Project No. 160410414

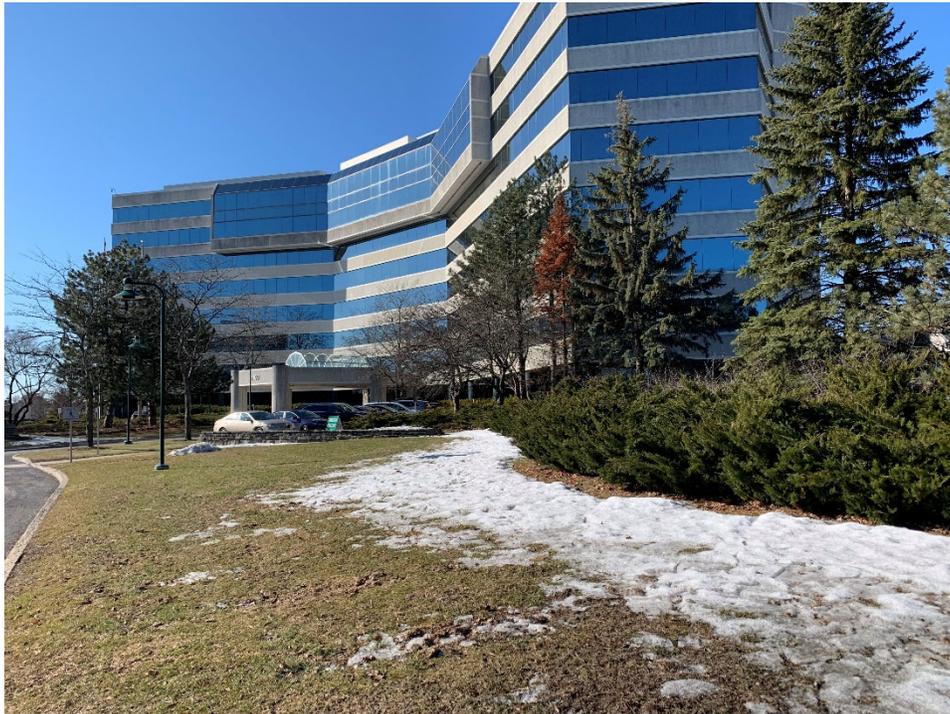
**Photograph 3 – Trees and planting beds to the north**

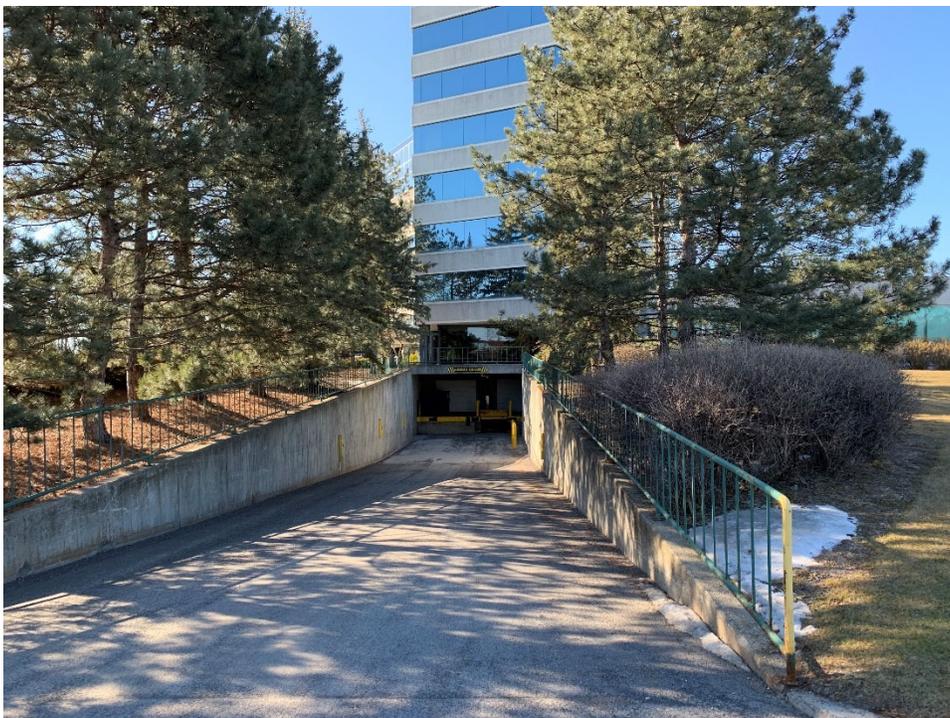
**Photograph 4 – Trees and plantings beds bordering the loading ramp**

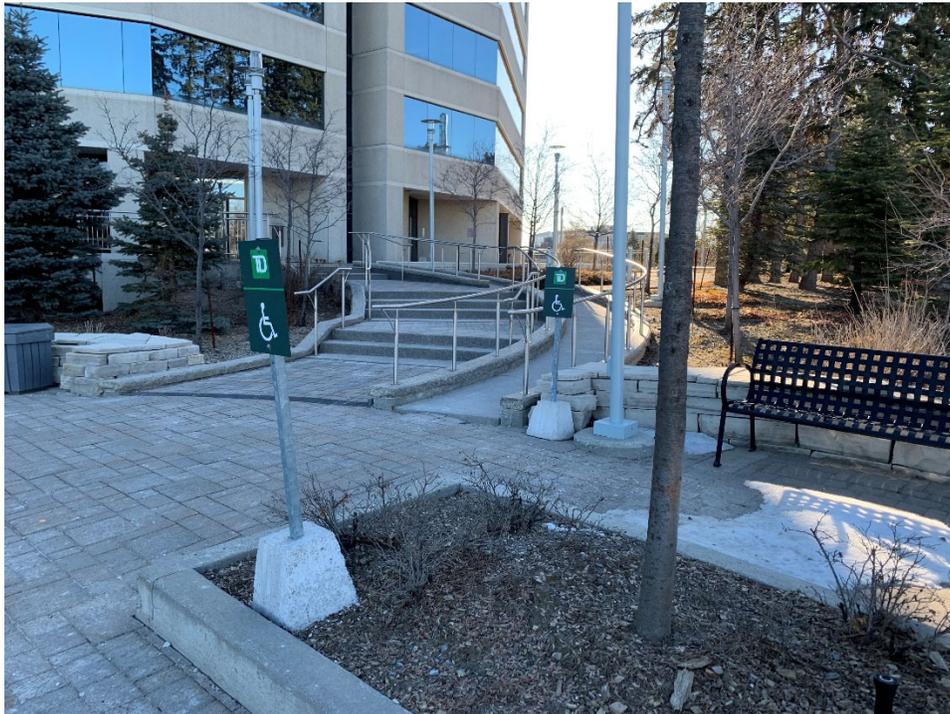
**Photograph 5 – West entrance and ramp**

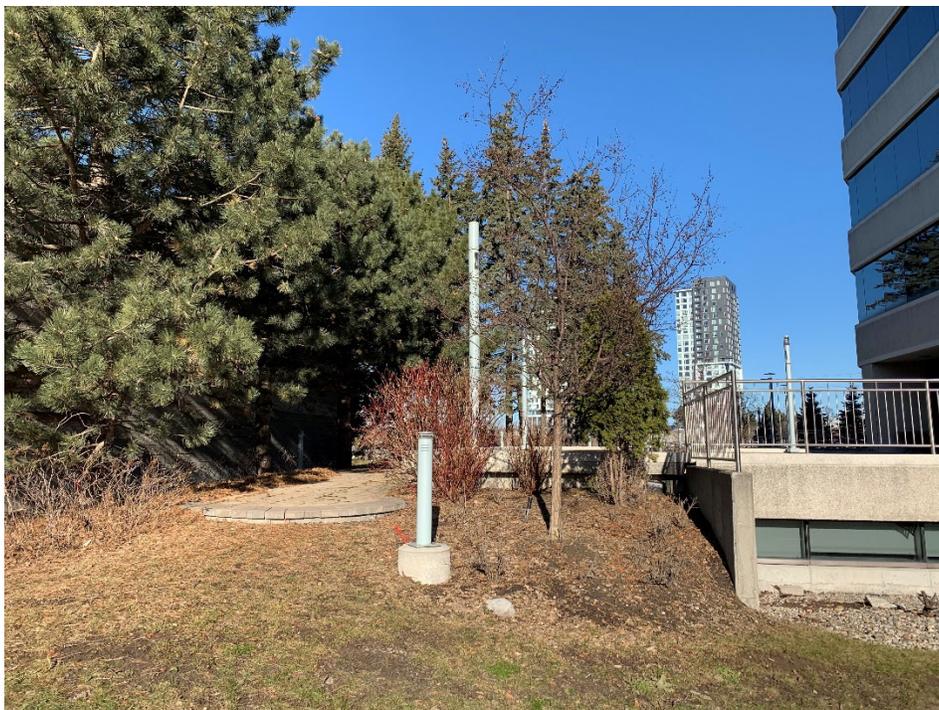
**Photograph 6 – Plantings at the western terrace**
