**ARBORIST REPORT FOR  
401 SMYTH ROAD,  
CITY OF OTTAWA, ONTARIO**

**CHILDREN'S HOSPITAL OF EASTERN ONTARIO-OTTAWA  
CHILDREN'S TREATMENT CENTRE (CHEO)  
1DOOR4CARE INTEGRATED TREATMENT CENTRE**

Date: August 2022  
File: C21114

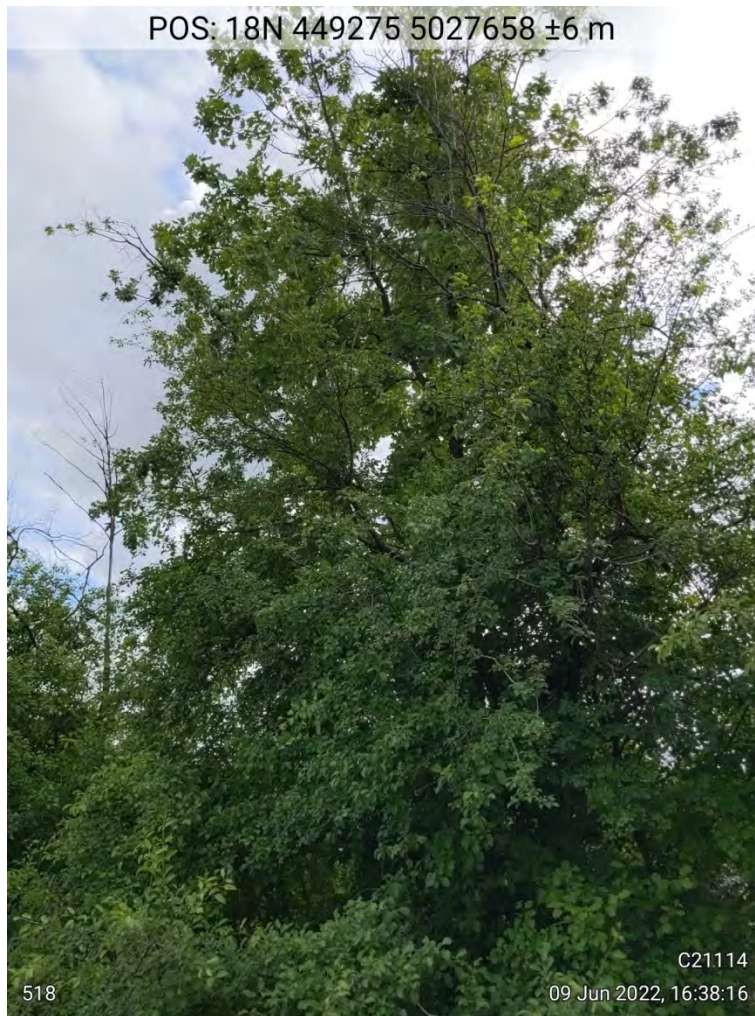
Of the trees to be retained, eight (8) are invasive common buckthorn. A significant amount of smaller common buckthorn was also observed within the hedgerows adjacent to Ring Road. Removal of these invasive specimens is strongly recommended.

**Photo 7 :** White Oak #518 at northeast corner of parking lot, surrounded by buckthorn

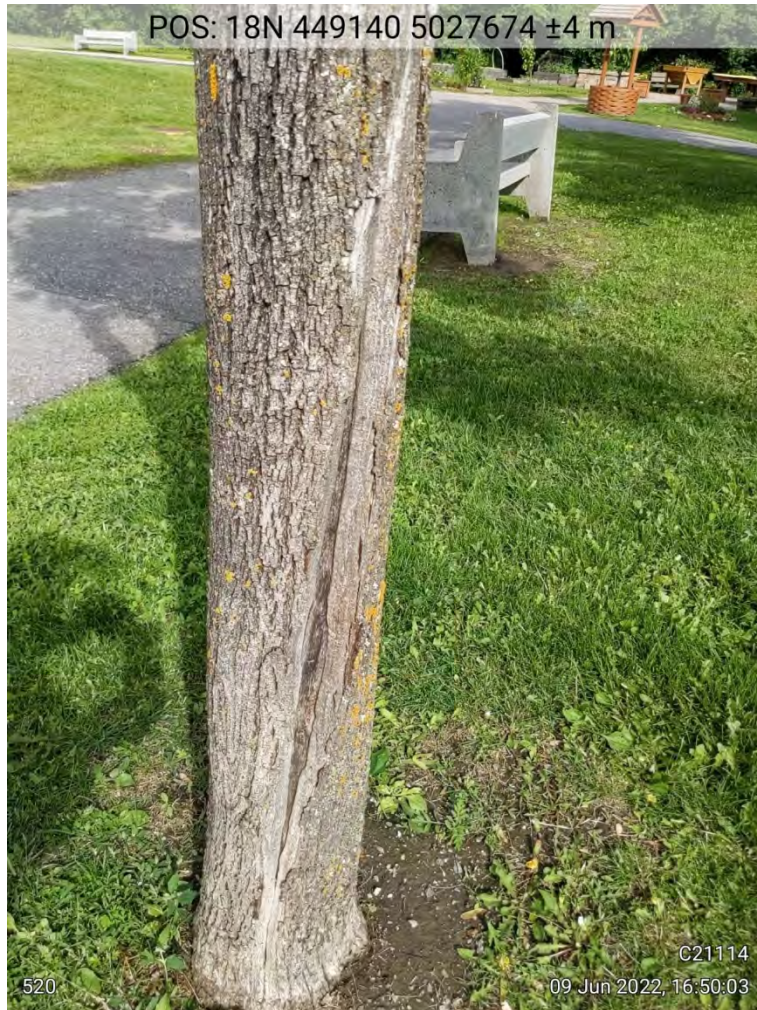
**Photo 9:** Frost crack on tree #520.

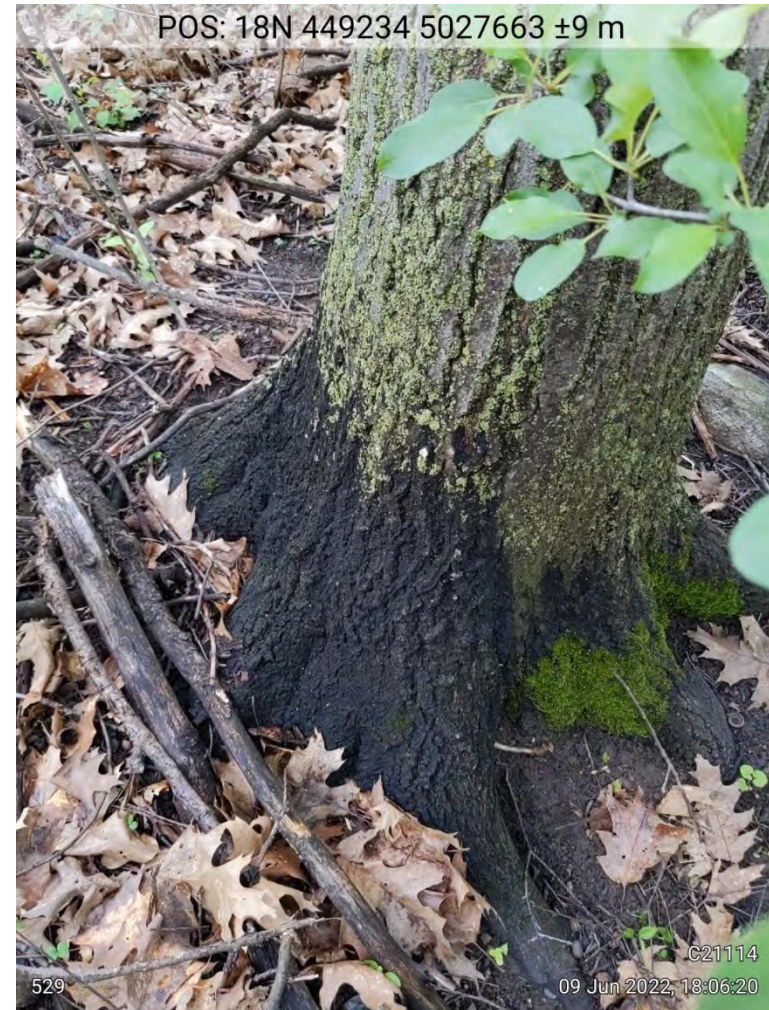
**Photo 10:** Possible slime flux or other disease on Tree #529 root collar. Tree located in woodland north of existing parking area.

- ◆ Further risk assessment of trees located north of the proposed parking structure (Trees #525-530) is recommended to better determine overall tree health and assess if selective tree removal should be completed.

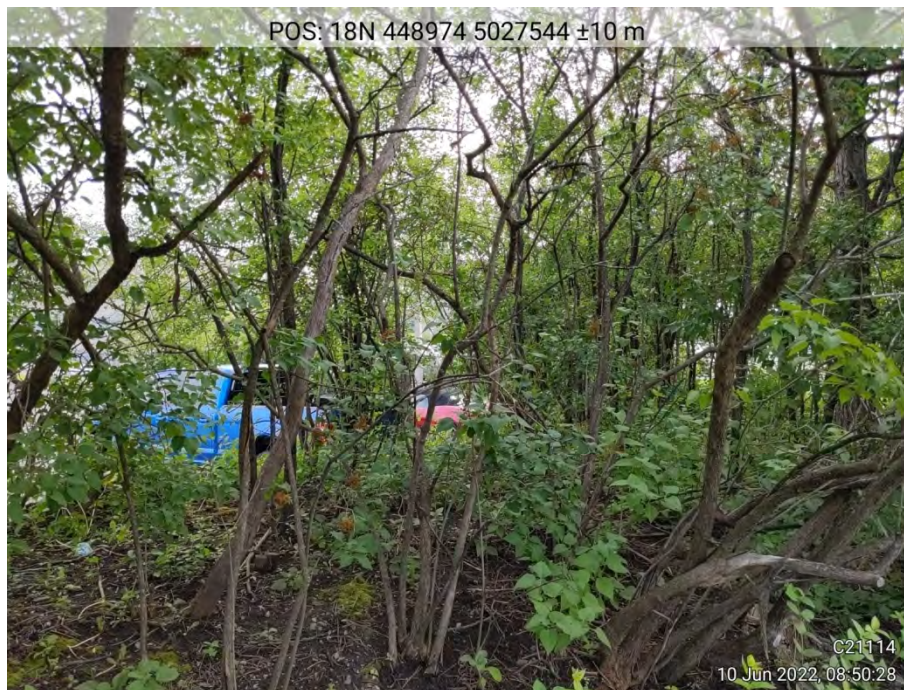
**Photo 2:** Example of vegetation conditions within hedgerow along Ring Road.

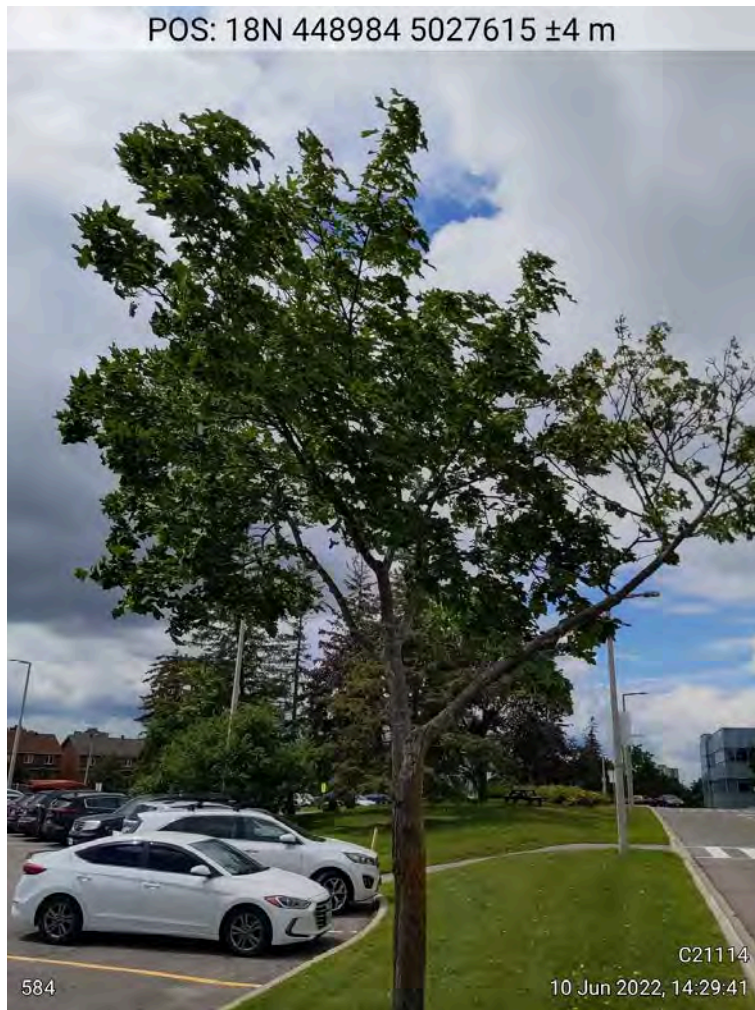
**Photo 7:** Norway Maple #584 adjacent parking, reduced canopy.

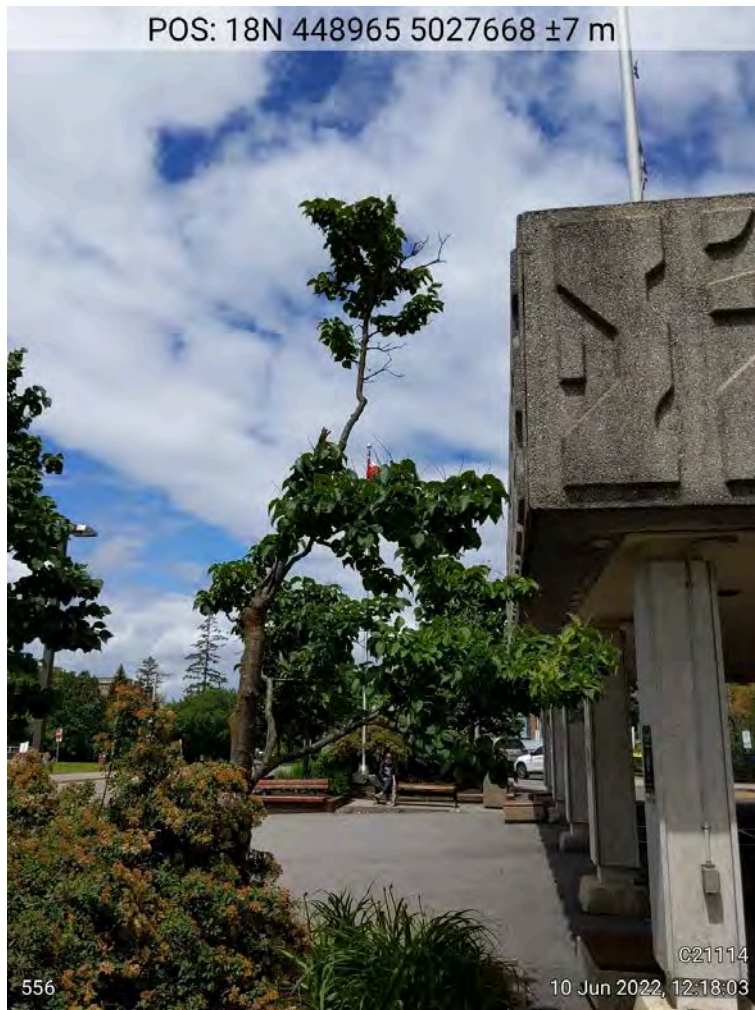
**Photo 11:** Tree #556 adjacent CHEO main entrance, fair condition with reduced canopy.

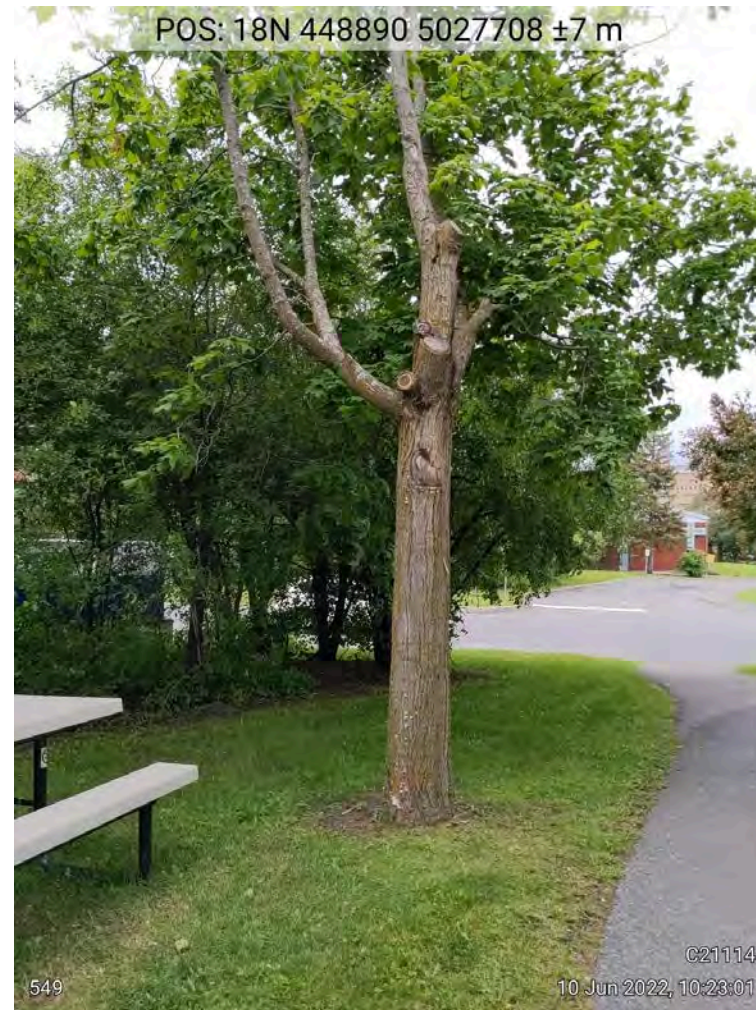
**Photo 12:** Tree #549 adjacent foot path, branches previously removed.

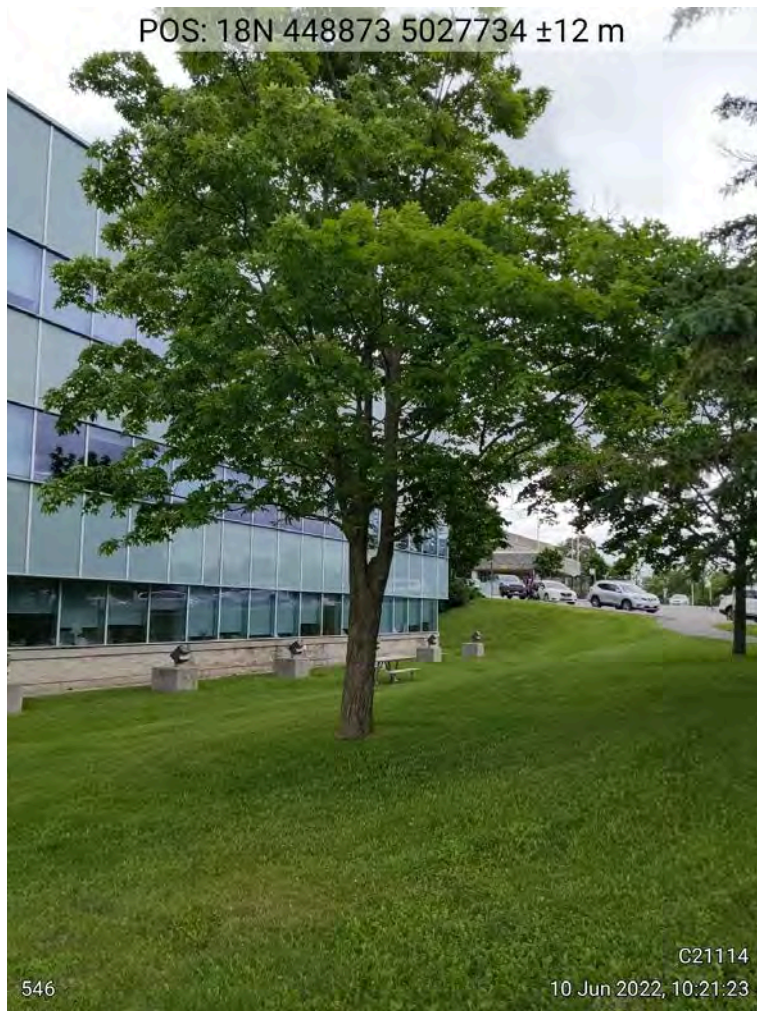
**Photo 13:** Tree #546, weak union at 1.5 metres.

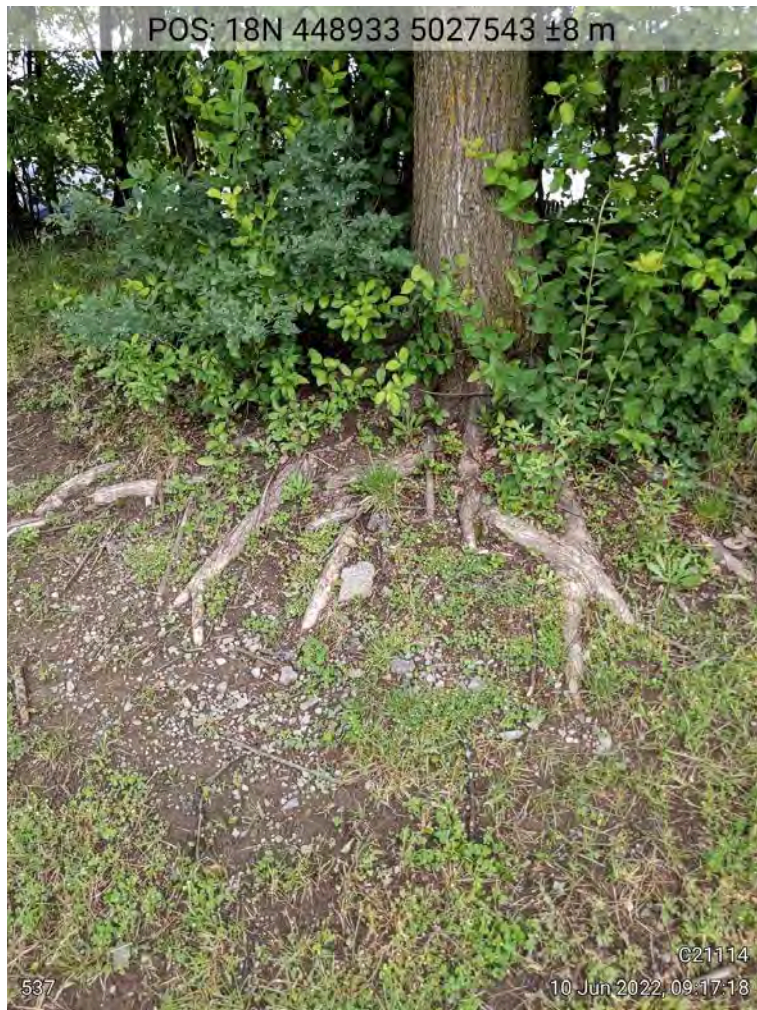
**Photo 15:** Tree #537 adjacent Ring Road, roots exposed at surface, compacted soil present on site

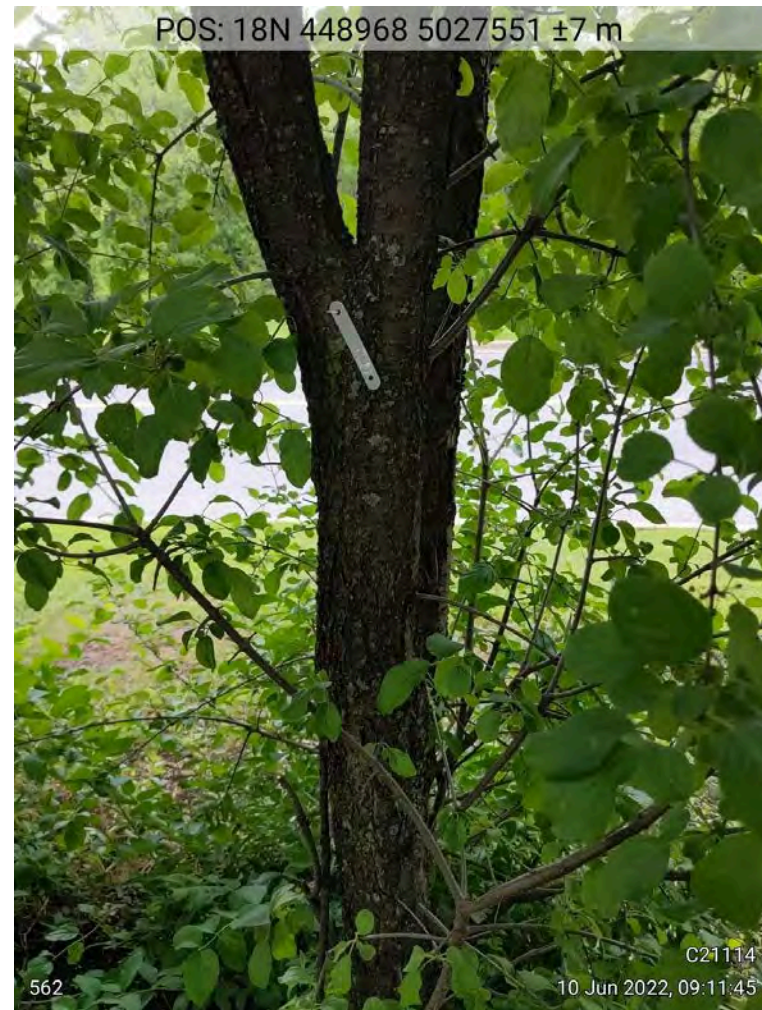
**Photo 16:** Tree #562, example of larger DBH Common Buckthorn present in hedgerows around parking area.
