Project:  
**RONALD MCDONALD HOUSE**  
 407 SMYTH ROAD  
 OTTAWA., ONTARIO

Drawing:  
**TREE CONSERVATION REPORT**

Scale: 1:400	Date: 20 NOV, 2020
Design By: PG	Drawn By: PG
Project Number: 2060-01	Sheet Number: TCR 1.1

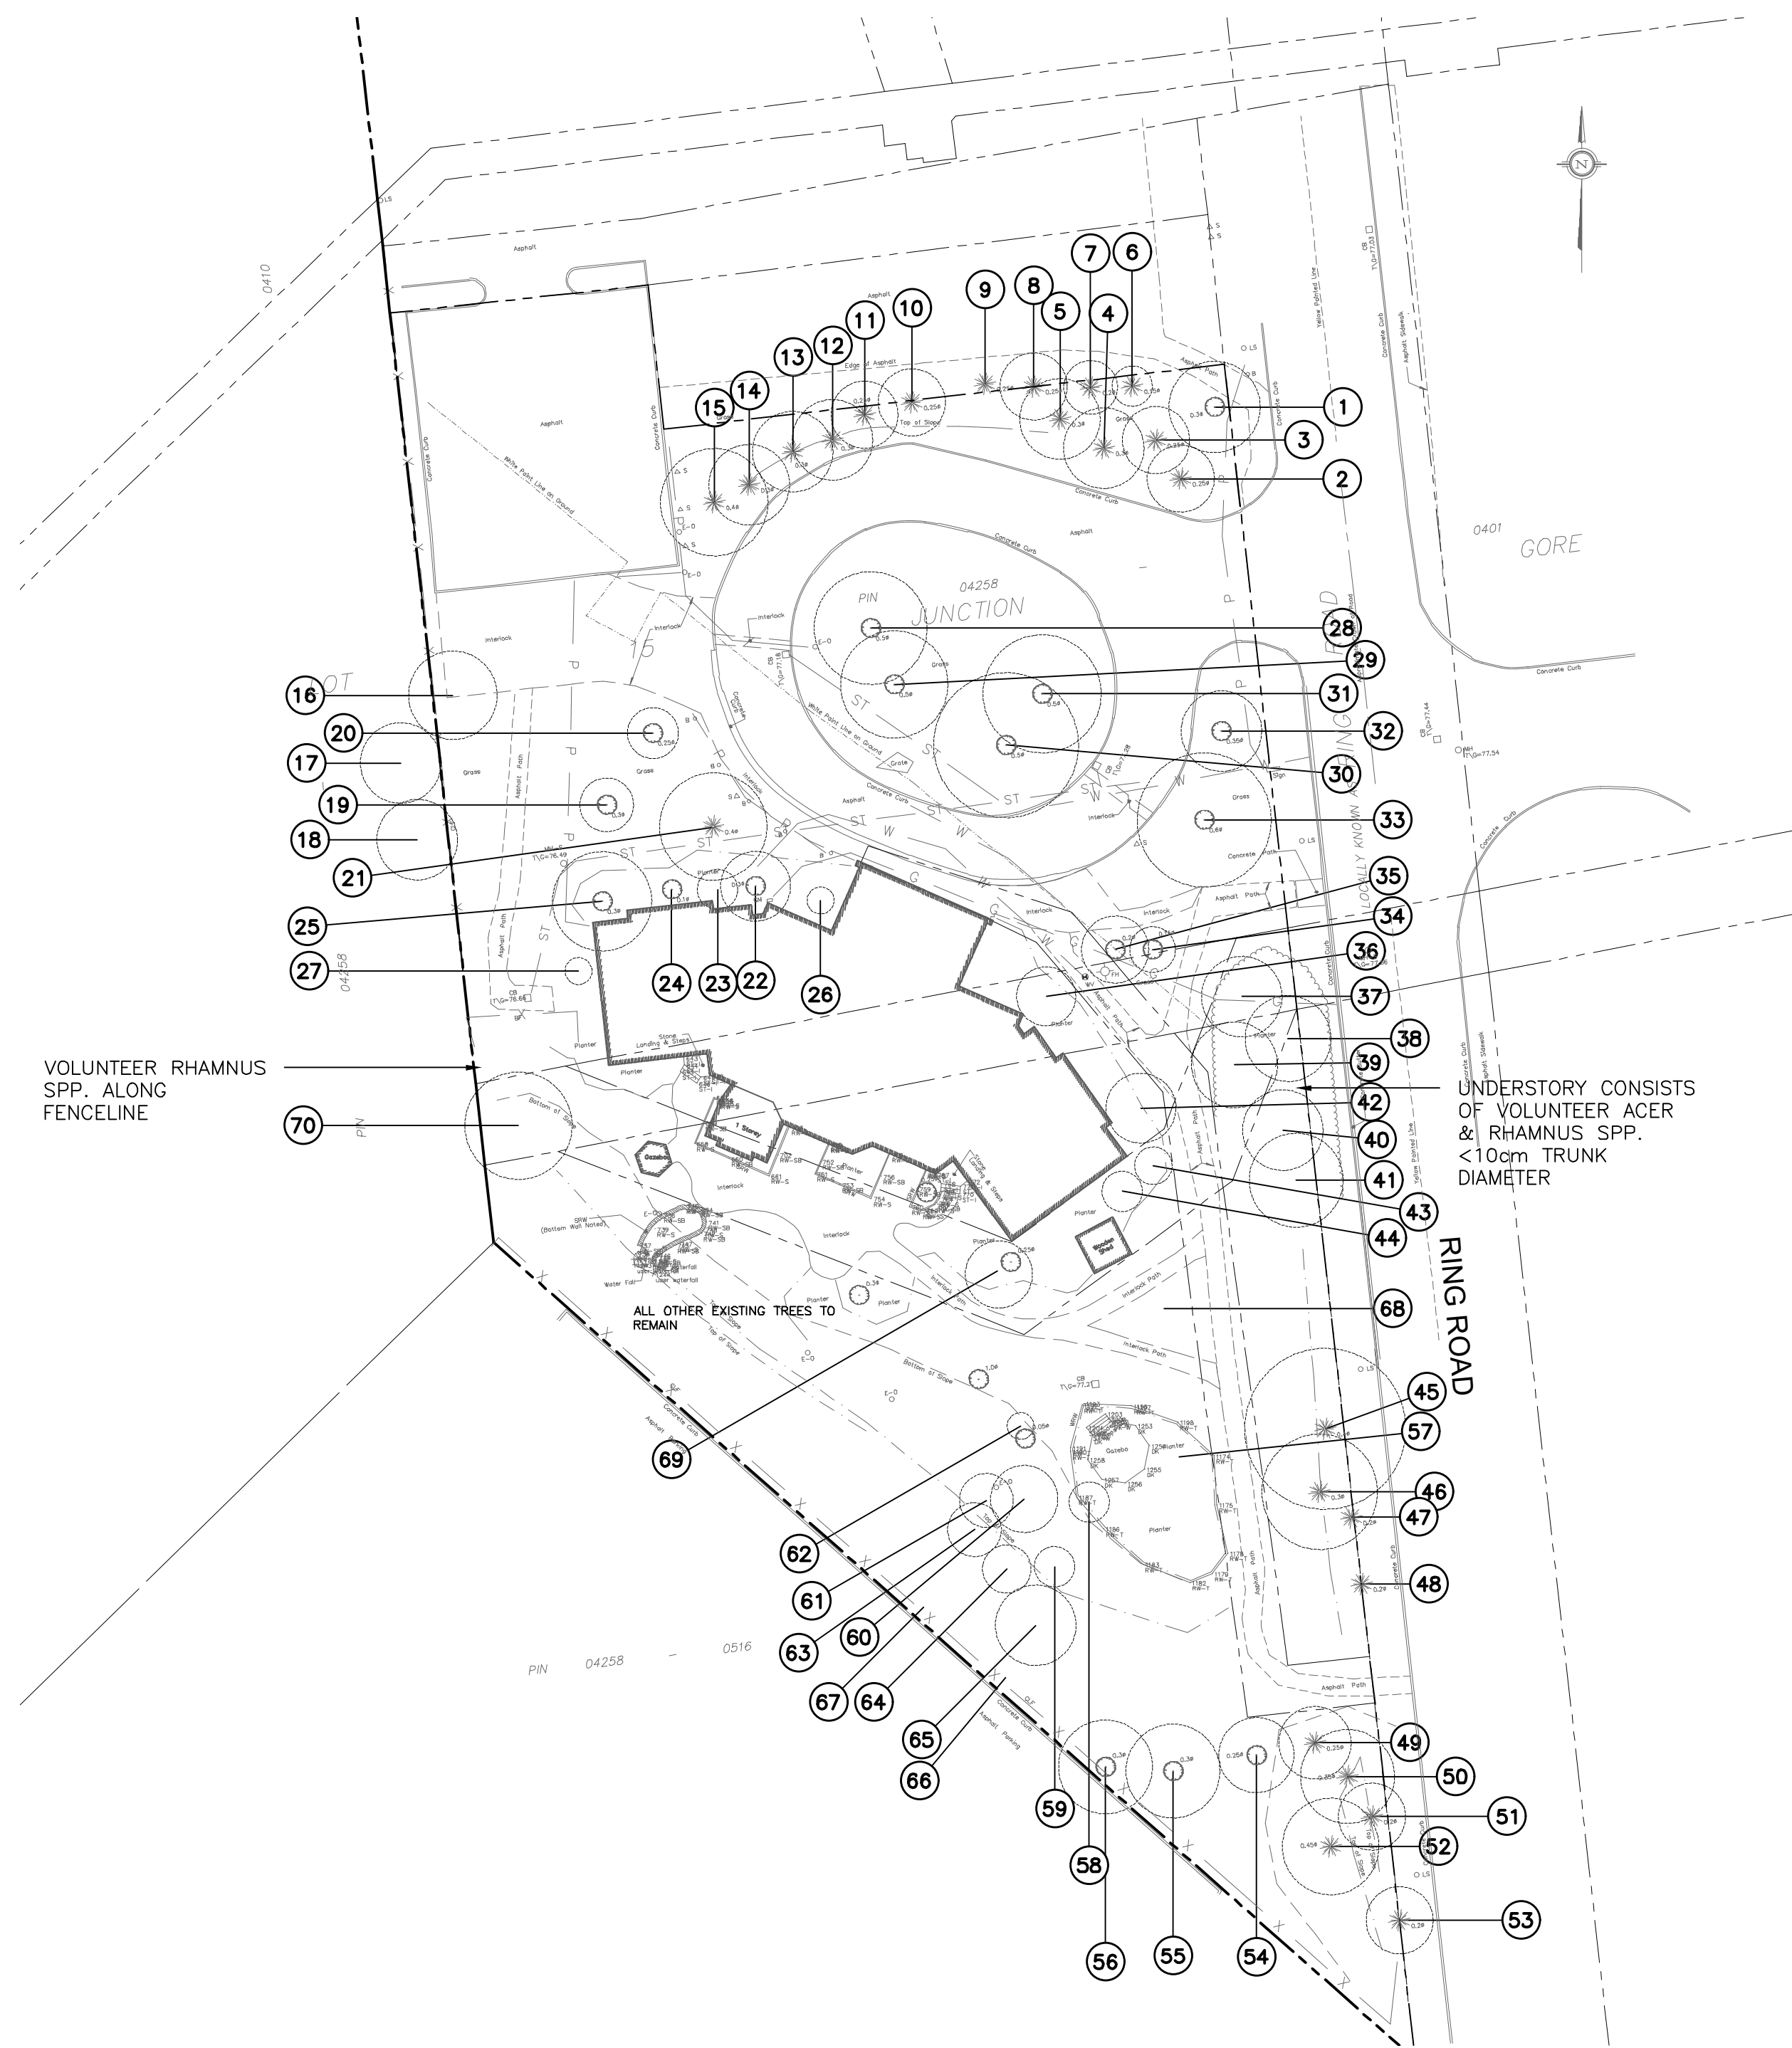
1 EXISTING VEGETATION Scale: 1:400

**NOTES:**  
 1.0 THE EXISTING PROPERTY CONTAINS A 2-STOUREY BUILDING, SURFACE PARKING, AND OUTDOOR AMENITY SPACE. EXISTING VEGETATION CONSISTS OF PLANTED TREES, VOLUNTEER TREES (SUCH AS MAPLE AND BUCKTHORN SPECIES), SHRUBS, PERENNIALS, AND TURFGRASS. THE SITE IS FLAT IN PROXIMITY TO THE EXISTING BUILDING, WHEREAS THE EXTERIOR OF THE SITE HAS GENTLY SLOPED BERMS.

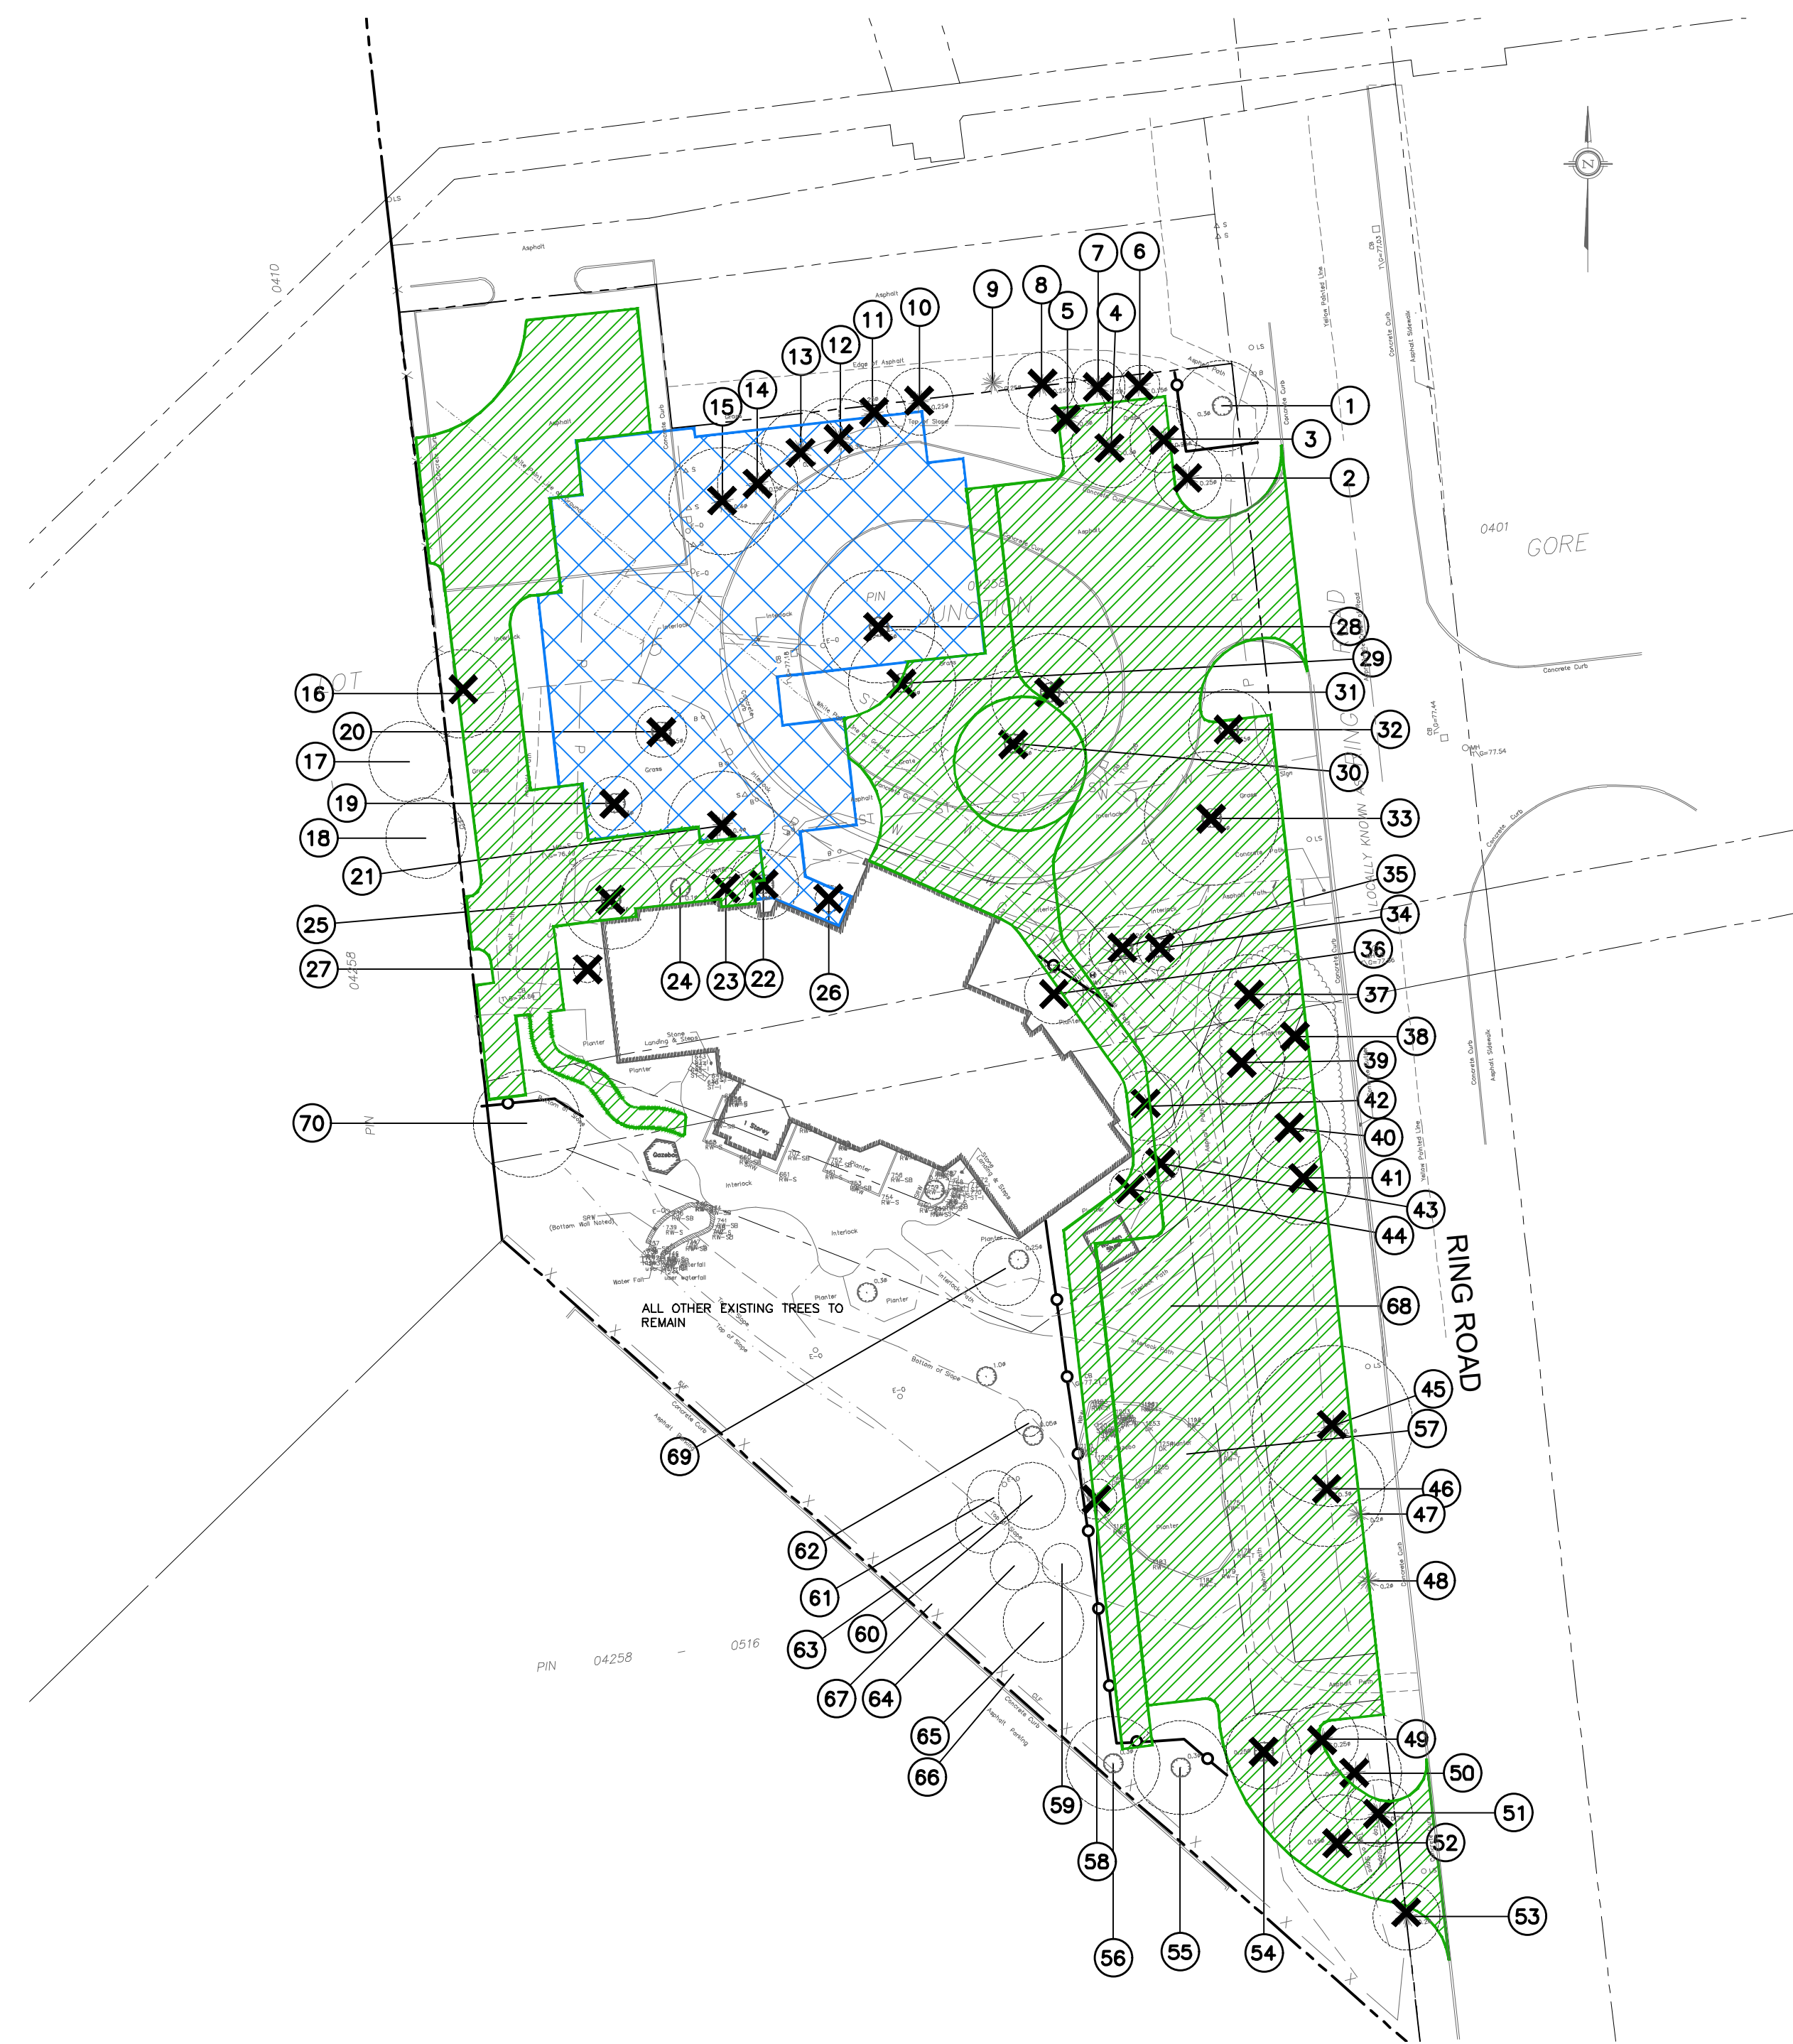
2 PROPOSED DEVELOPMENT Scale: 1:400

2.0 THE PROPOSED DEVELOPMENT REQUIRES THE REMOVAL OF FORTY-FOUR (48) TREES

- 12 ARE DUE TO THE PROPOSED BUILDING.
- 26 ARE DUE TO REQUIRED PARKING AREA.
- 10 ARE DUE TO PROPOSED LANDSCAPING.

- ERECT A FENCE AT THE CRITICAL ROOT ZONE (CRZ) OF TREES;
- DO NOT PLACE ANY MATERIAL OR EQUIPMENT WITHIN THE CRZ OF THE TREE;
- DO NOT ATTACH ANY SIGNS, NOTICES OR POSTERS TO ANY TREE;
- DO NOT RAISE OR LOWER THE EXISTING GRADE WITHIN THE CRZ WITHOUT APPROVAL;
- TUNNEL OR BORE WHEN DIGGING WITHIN THE CRZ OF A TREE
- DO NOT DAMAGE THE ROOT SYSTEM, TRUNK OR BRANCHES OF ANY TREE;
- ENSURE THAT EXHAUST FUMES FROM ALL EQUIPMENT ARE NOT DIRECTED TOWARDS ANY TREE'S CANOPY.
