July 11, 2022

RE: TREE CONSERVATION REPORT FOR 2700 SWANSEA CRESCENT, OTTAWA

Table 1. Species, condition, size (diameter) and status of trees at 2700 Swansea Crescent

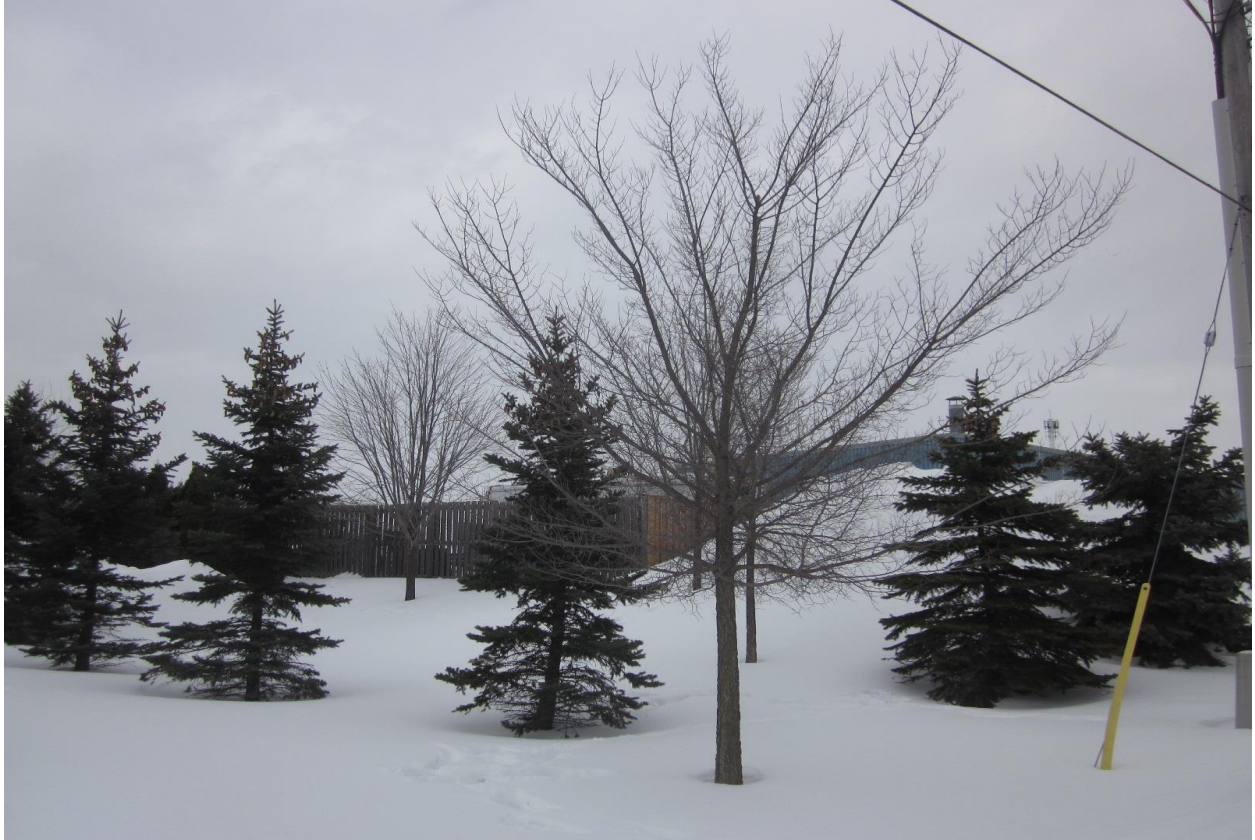
Tree No.	Tree species	Condition (VP→E)	DBH ¹ (cm)	Age class, tree condition notes, species origin & preservation status (to be removed or preserved and protected)
1	Hackberry (<i>Celtis occidentalis</i>)	Good	13	Maturing; good form and vigour; native species to be preserved
2	Colorado spruce (<i>Picea pungens</i>)	Good	10 avg.	Maturing; six trees in total; generally good form and vigour; introduced species; to be preserved
3	Hackberry (<i>Celtis occidentalis</i>)	Good	12	Maturing; good form and vigour; native species; to be preserved
4	Freeman maple (<i>Acer x. freemanii</i>)	Fair	14 & 19	Maturing; two trees in total; co-dominant leaders; very good vigour; cultivar; to be preserved
5	Freeman maple (<i>Acer x. freemanii</i>)	Poor to Fair	7, 12 & 12	Maturing; three trees in total; co-dominant leaders; poor to fair vigour; cultivar; to be preserved
6	Honey-locust (<i>Gleditsia triacanthos</i>)	Fair	8 & 12	Maturing; two trees in total; typical open crown forms; fair vigour; restricted rooting; introduced species to Eastern Ontario; both trees to be removed (conflict with construction)

Picture 1. Trees/groupings #1-4 at 2700 Swansea Crescent

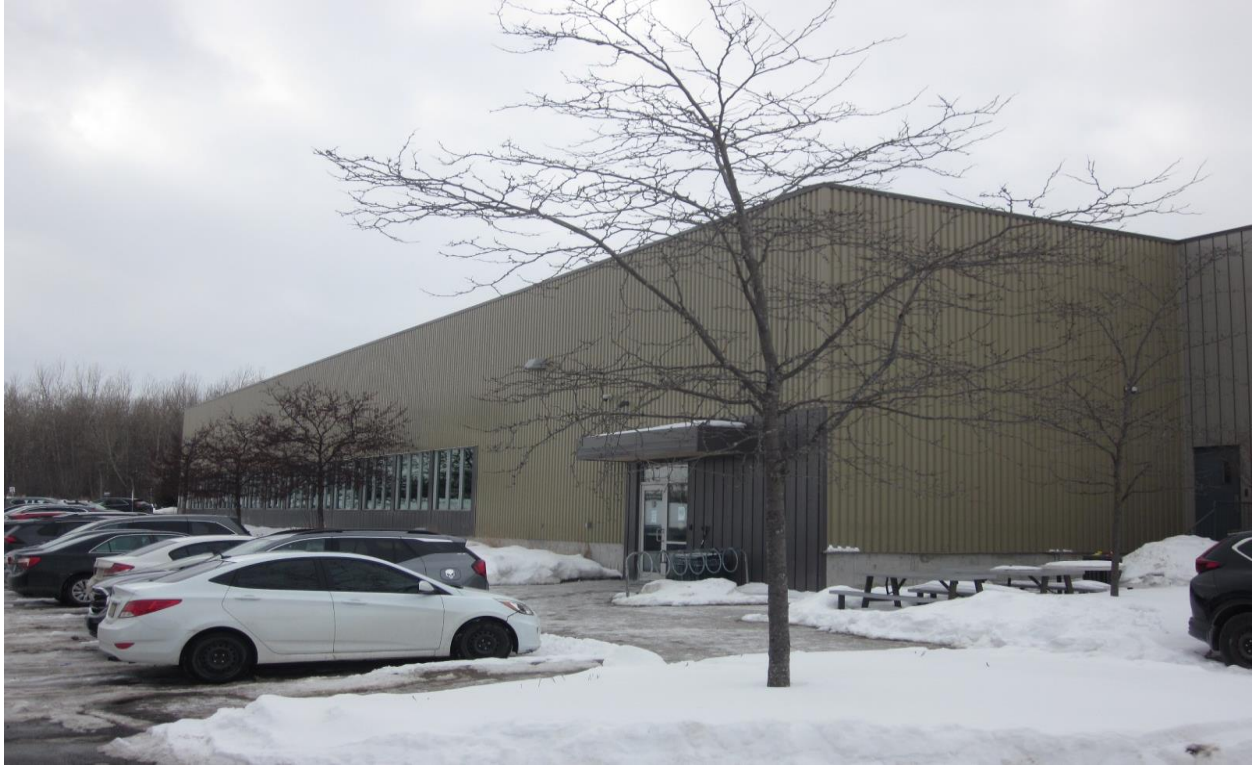
7	Crab apple (<i>Malus spp.</i>)	Good	13, 14 & 15	Maturing; three trees in total; dense crown with heavy fruit set; very good vigour; basal sprouting; cultivar; all three trees to be removed (conflict with construction)
8	Honey-locust (<i>Gleditsia triacanthos</i>)	Fair	10	Maturing; typical open crown form; fair vigour; very restricted rooting; introduced species to Eastern Ontario; to be removed (conflicts with construction)
9	Crab apple (<i>Malus spp.</i>)	Good	14	Maturing; dense crown with heavy fruit set; very good vigour; basal sprouting; cultivar; to be preserved
10	Red oak (<i>Quercus rubra</i>)	Good	13 avg.	Maturing; four trees in total; good upright forms; good vigour; native species; to be preserved
11	Colorado spruce (<i>Picea pungens</i>)	Fair	10 & 10	Maturing; two trees in total; fair crown density, growth increment and needle colour; introduced species; to be preserved
12	Austrian pine (<i>Pinus nigra</i>)	Good	14 & 14	Maturing; two trees in total; good crown density, growth increment and needle colour; introduced species; to be preserved

Picture 2. Tree groupings #6 and 7 at 2700 Swansea Crescent

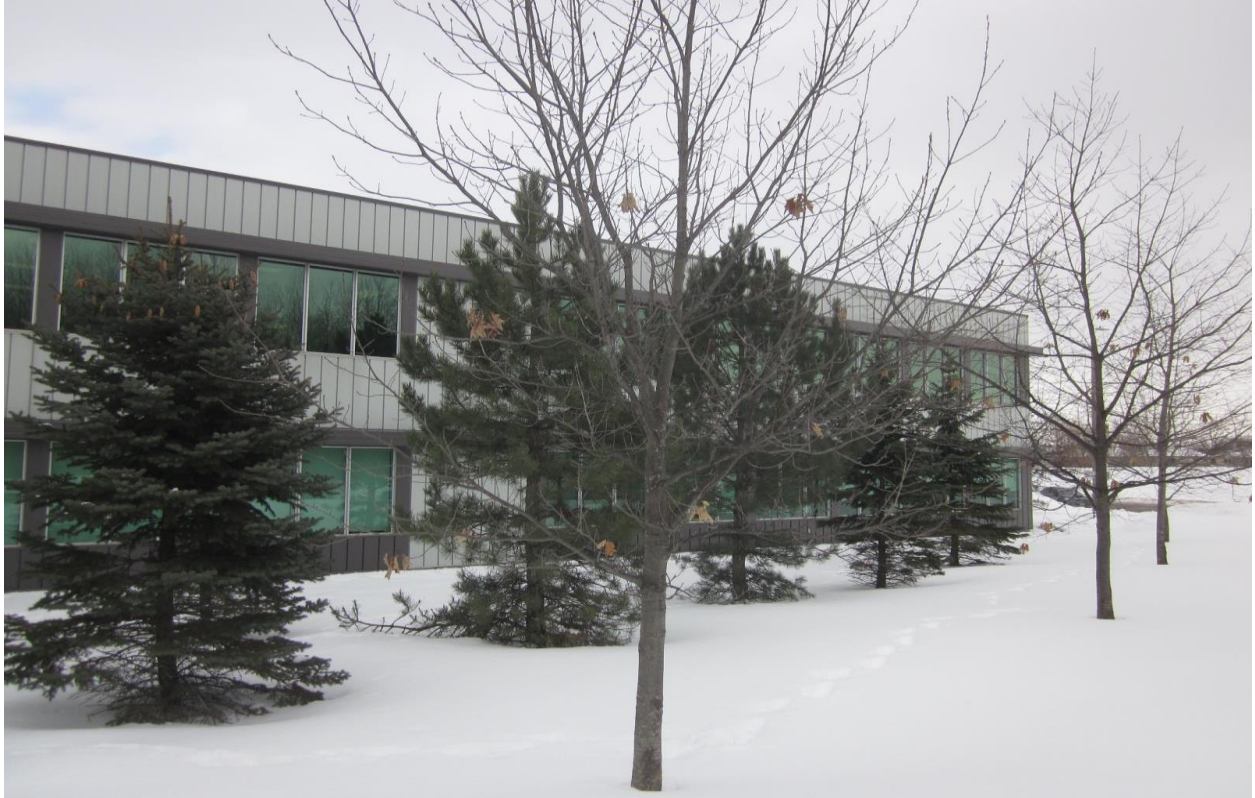
Picture 3. Tree groupings #10, 11 and 12 at 2700 Swansea Crescent

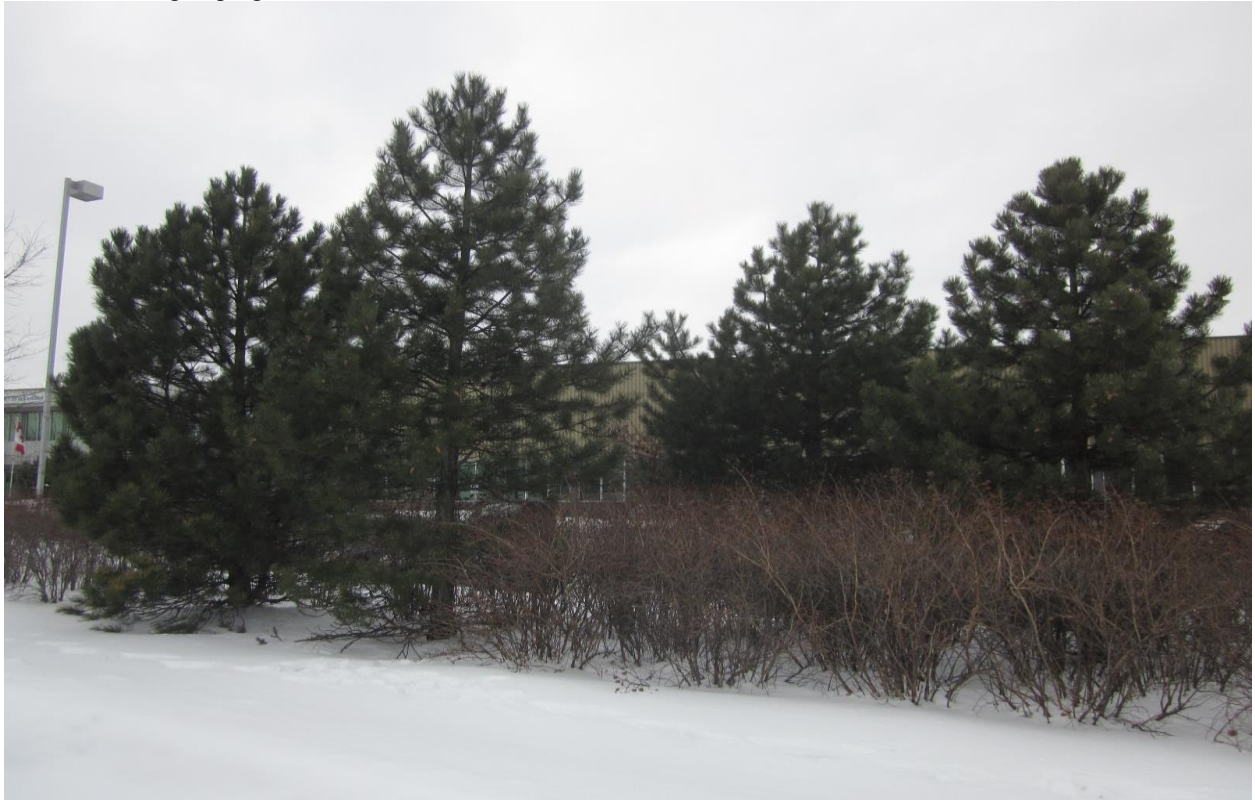
Tree No.	Tree species	Condition (VP→E)	DBH ¹ (cm)	Age class, tree condition notes, species origin & preservation status (to be removed or preserved and protected)
13	Colorado spruce (<i>Picea pungens</i>)	Good	10 avg.	Maturing; five trees in total; good crown density, growth increment and needle colour; introduced species; to be preserved
14	Austrian pine (<i>Pinus nigra</i>)	Fair	12	Maturing; lower stem divergent towards southeast – moved after planting; fair crown density, growth increment and needle colour; introduced species; to be preserved
15	Hackberry (<i>Celtis occidentalis</i>)	Good	15 & 16	Maturing; two trees in total; co-dominant stems at 2m from grade; broad crowns; native species; to be preserved
16	Austrian pine (<i>Pinus nigra</i>)	Good	15 avg.	Maturing; four trees in total; good crown density, growth increment and needle colour; introduced species; two of four trees to be removed (conflict with construction)

Picture 4. Tree groupings #16 at 2700 Swansea Crescent

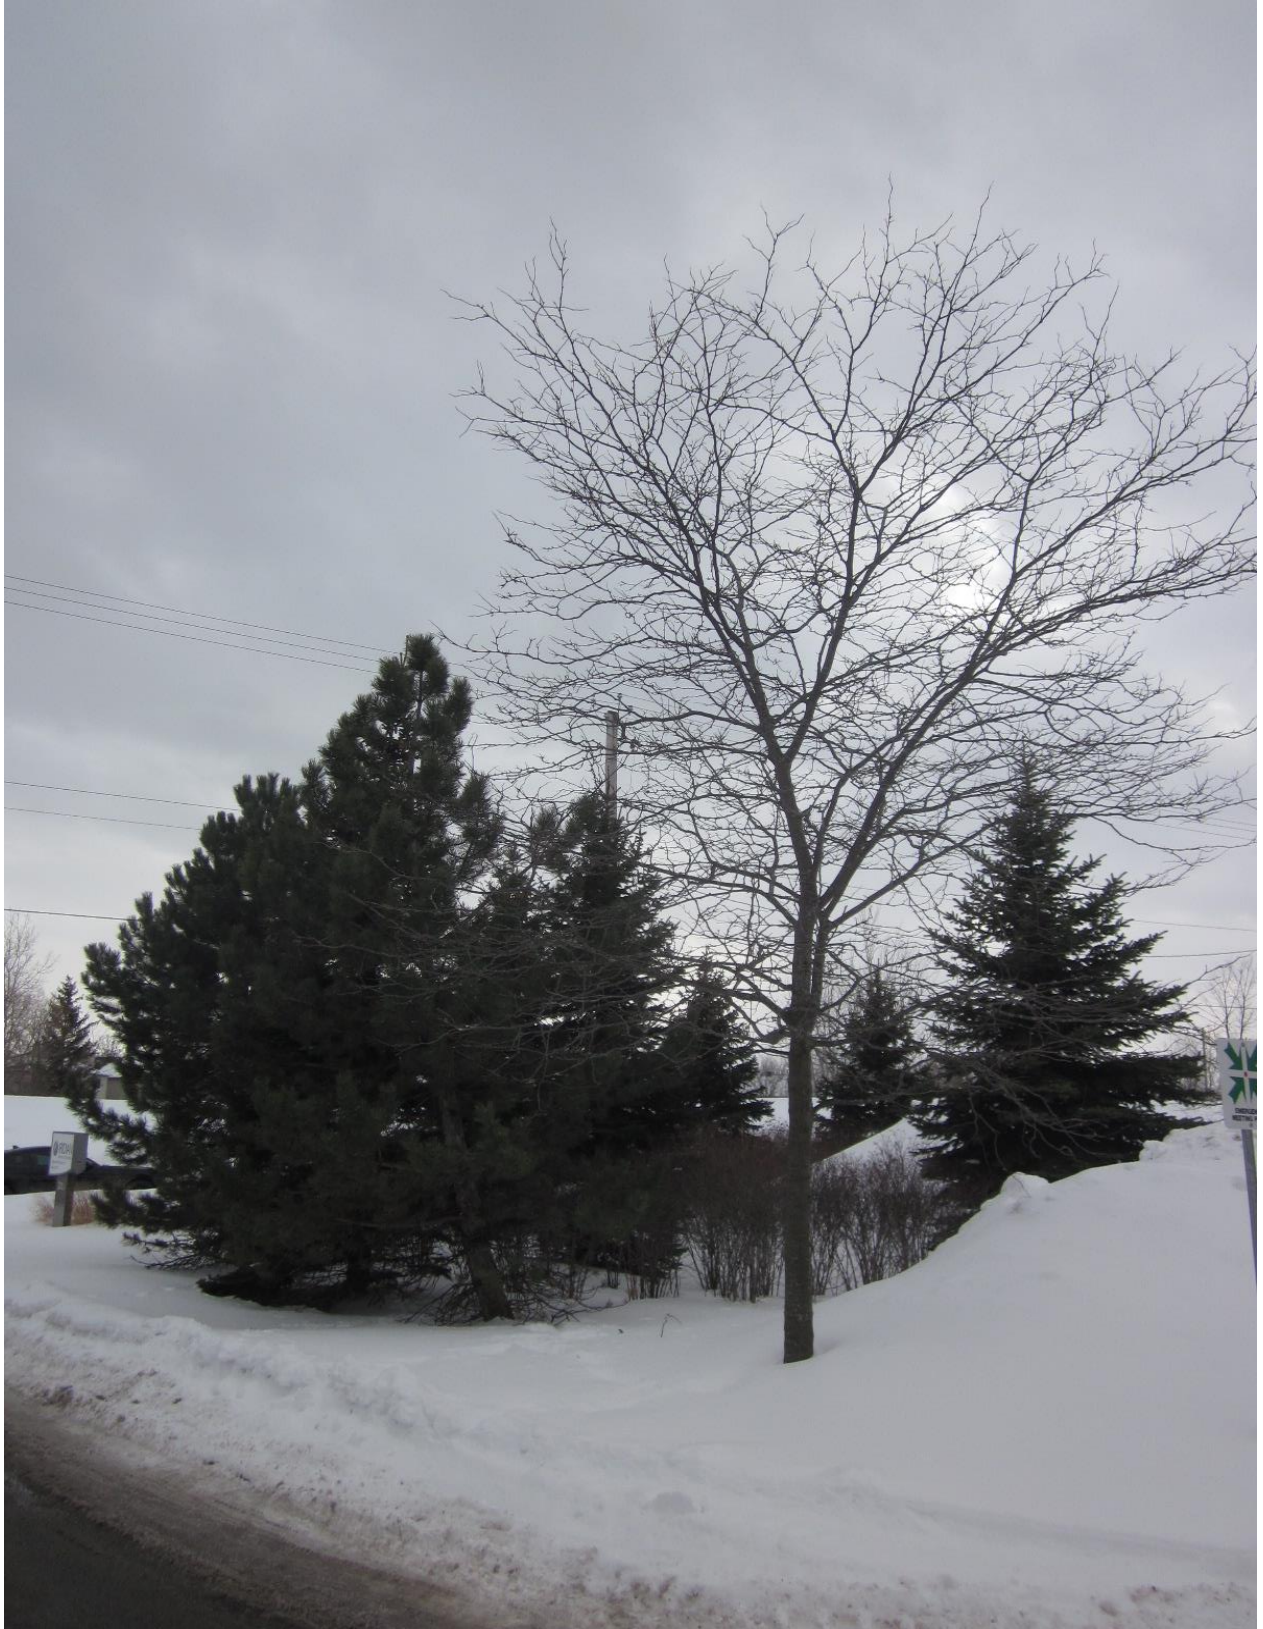
17	Hackberry (<i>Celtis occidentalis</i>)	Good	13 & 14	Maturing; two trees in total; co-dominant stems at 2m from grade; broad crowns; native species; to be preserved
18	Colorado spruce (<i>Picea pungens</i>)	Good	14 avg.	Maturing; five trees in total; fair crown density, growth increment and needle colour; introduced species; one of five trees to be removed (conflict with construction)
19	Honey-locust (<i>Gleditsia triacanthos</i>)	Fair	19	Maturing; typical open crown form; fair vigour; mildly restricted rooting; introduced species to Eastern Ontario; to be removed (conflict with construction)
20	Austrian pine (<i>Pinus nigra</i>)	Fair	15	Maturing; divergent and asymmetric towards southeast due to influence of tree #19; fair crown density, growth increment and needle colour; introduced species; to be removed (conflicts with construction)
21	Colorado spruce (<i>Picea pungens</i>)	Fair	14	Maturing; asymmetric towards southeast due to influence of trees #19 and 20; fair crown density, growth increment and needle colour; introduced species; to be preserved

22	Austrian pine (<i>Pinus nigra</i>)	Fair	15	Maturing; competing lateral at 2m on southeast; fair crown density, growth increment and needle colour; introduced species; to be preserved

Picture 5. Trees/groupings #19-22 at 2700 Swansea Crescent
