## **Tree Conservation Report**

1600 James Naismith Drive

September 28, 2022

Stantec Consulting Ltd.  
1331 Clyde Avenue  
Ottawa ON K2C 3G4  
Project No. 160410414

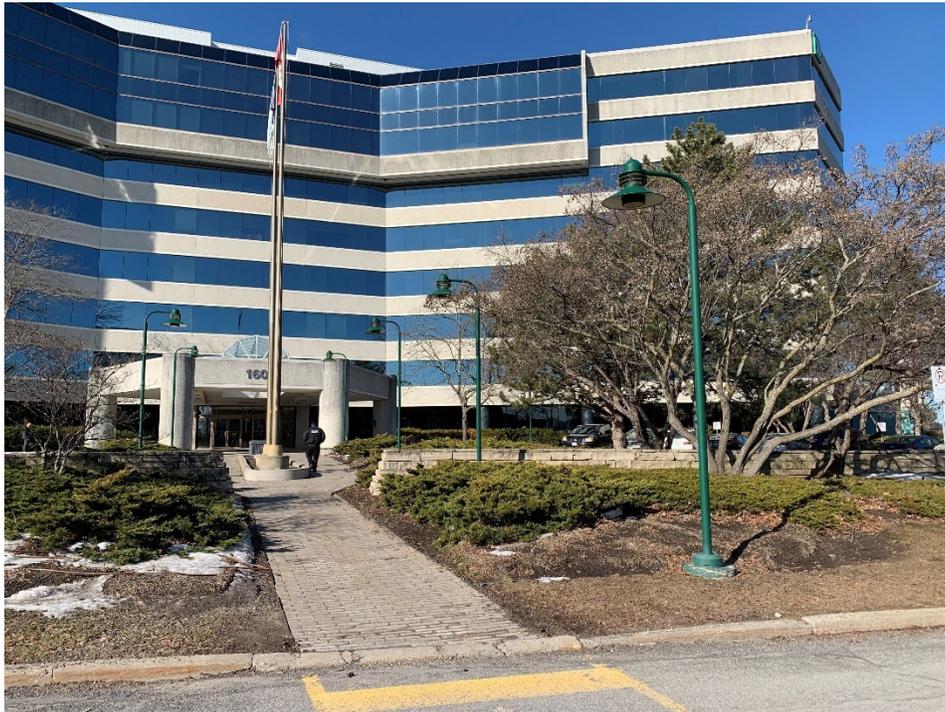
**Photograph 1 – Main walkway leading to East Entrance**

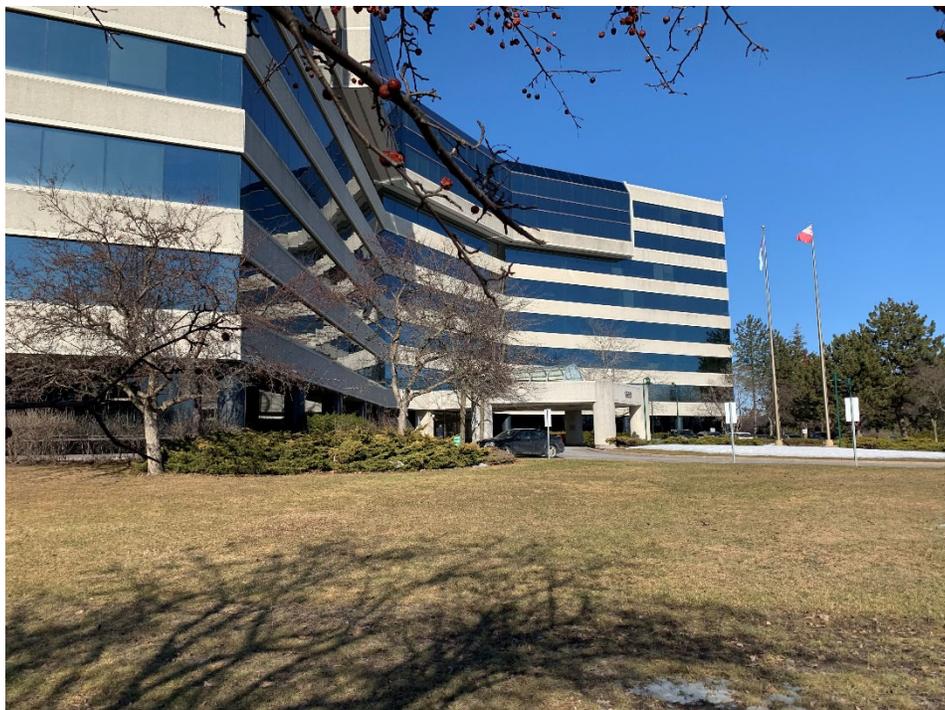
**Photograph 2 – Trees and planting beds to the south**

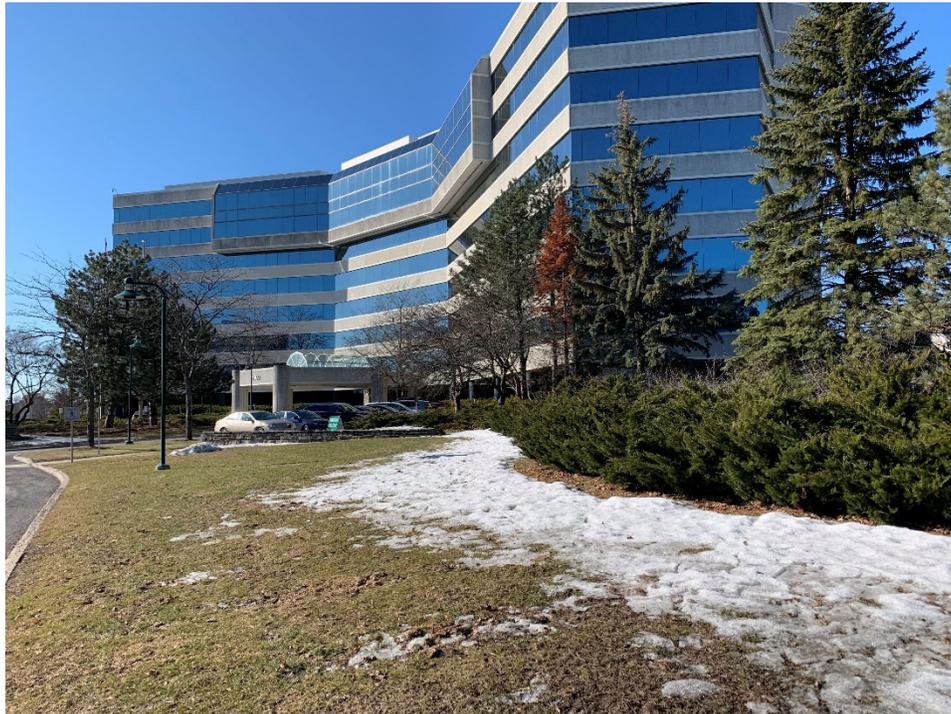
**Photograph 3 – Trees and planting beds to the north**

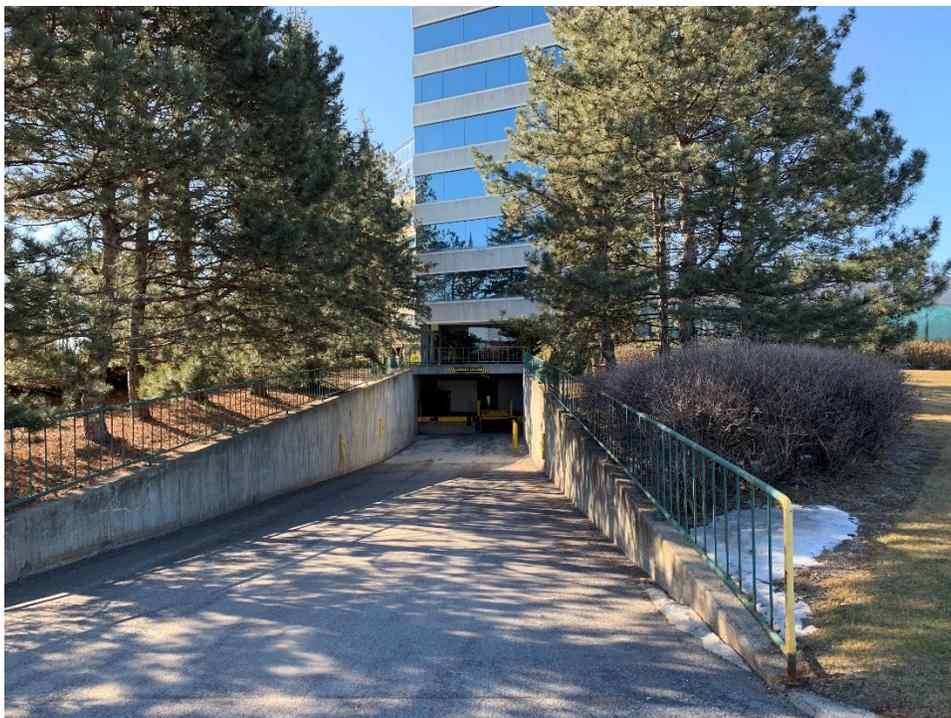
**Photograph 4 – Trees and plantings beds bordering the loading ramp**

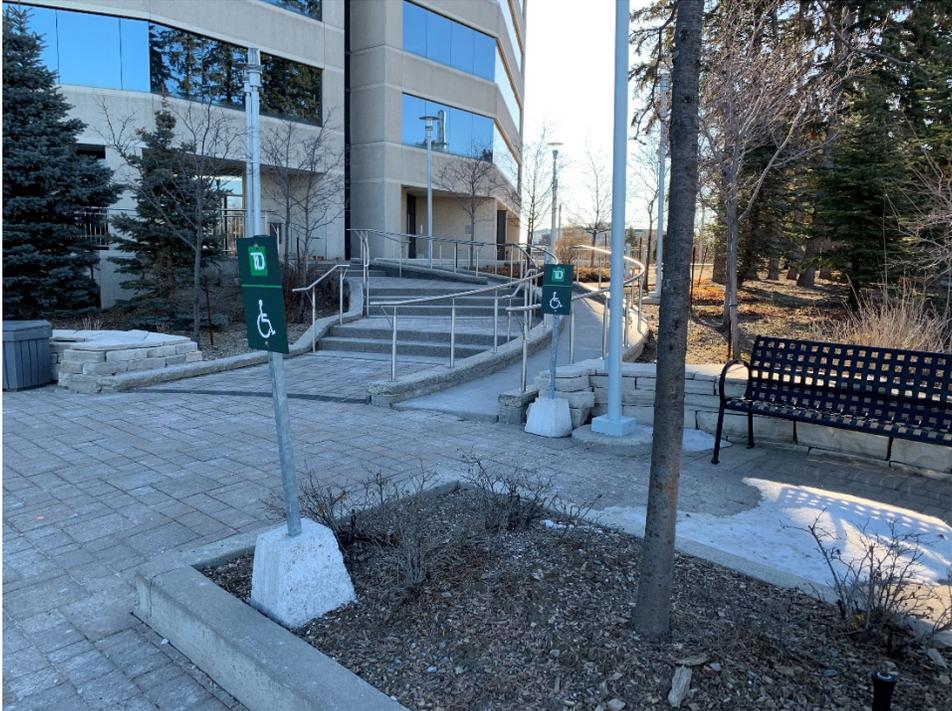
**Photograph 5 – West entrance and ramp**

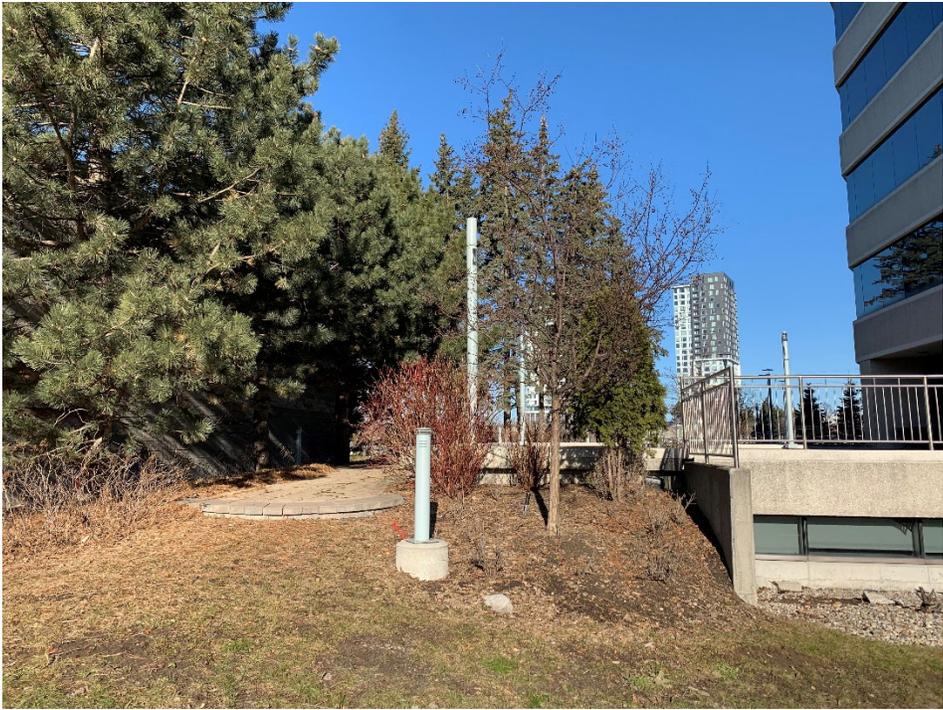
**Photograph 6 – Plantings at the western terrace**
