# TREE CONSERVATION REPORT

**30 Auriga Drive, Part 10**

Tree Conservation Report submitted as Partial  
Requirements for a Site Plan Control Application,  
November 22, 2022

**Date of Report:** November 22, 2022

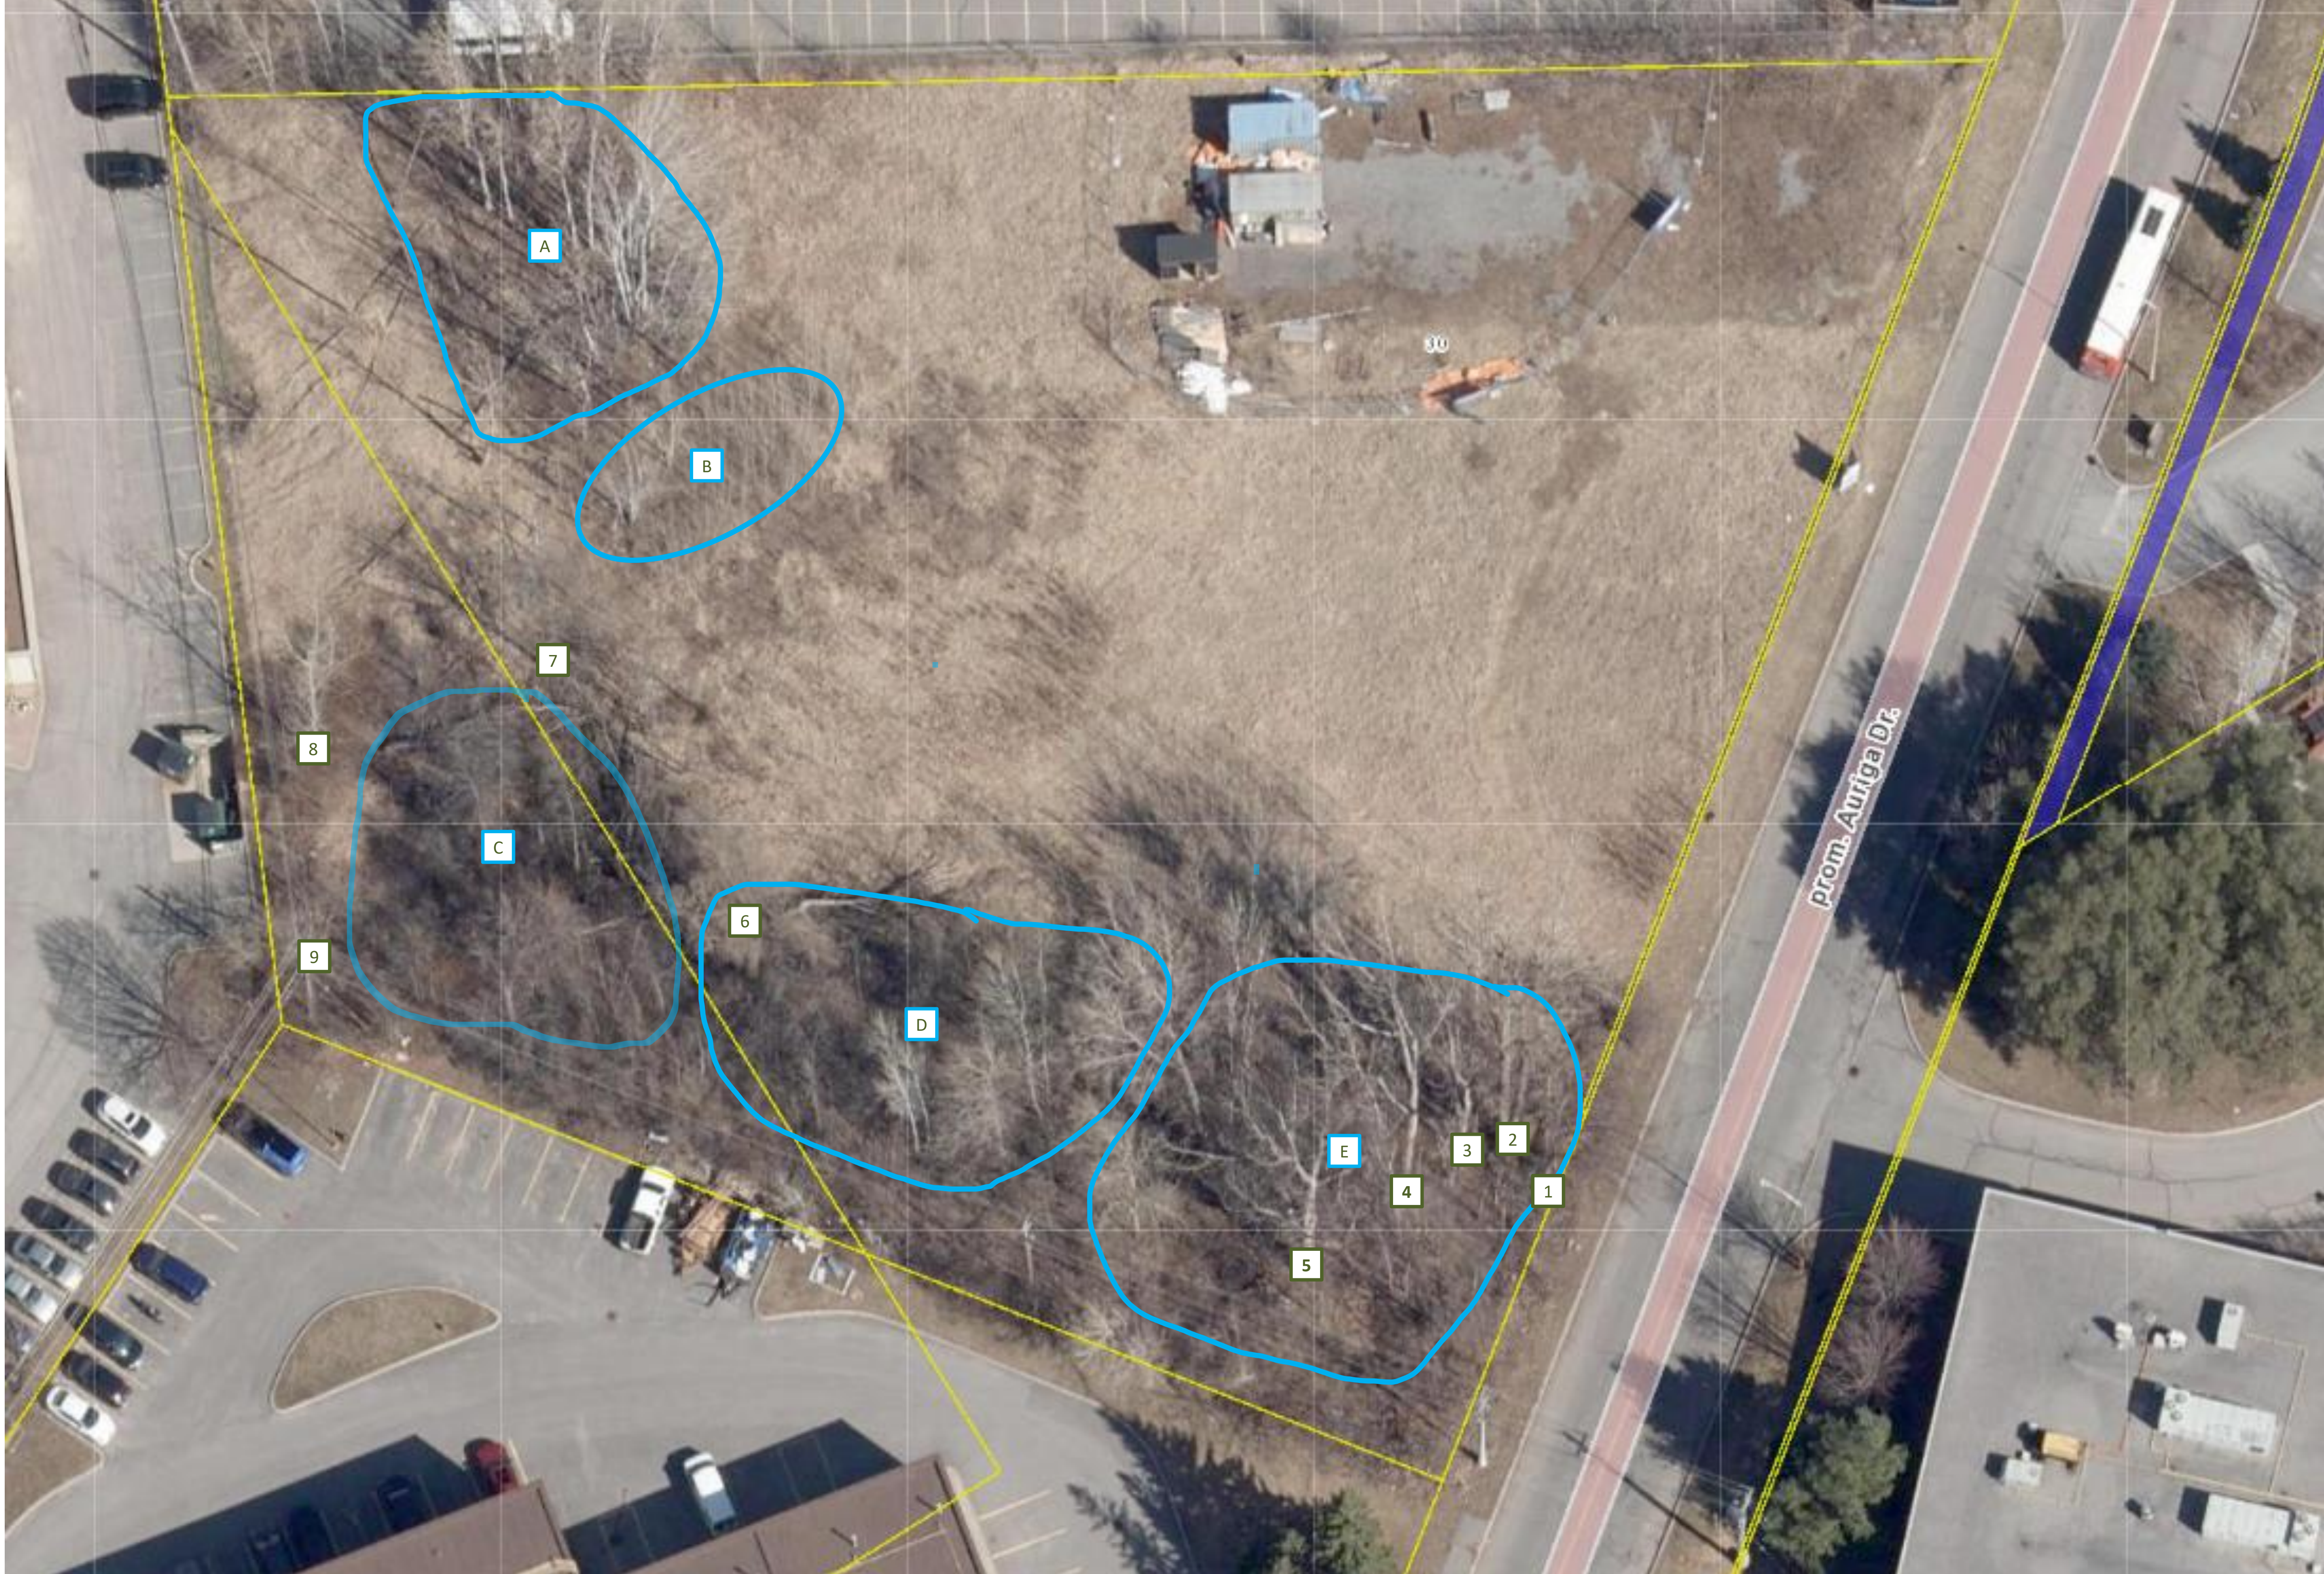
Tree Conservation Report Map#1 – Current Vegetation  
 Tree layer prepared by Dendron Forestry Services  
 Version 1.0, November 22, 2022  
 For more information, please contact [info@dendronforestry.ca](mailto:info@dendronforestry.ca)

Using the 2021 imagery from GeoOttawa, the tree inventory has been parceled into five polygons with similar vegetation types as identified in the *Current Vegetation Map#1*. The boundaries of these polygons are approximate, and the vegetation is described generally as follows:
