December 9, 2022

**RE: TREE CONSERVATION INVENTORY FOR 5254 BANK STREET, OTTAWA**

Table 1. Species, ownership, diameter, condition and status of trees at 5254 Bank Street

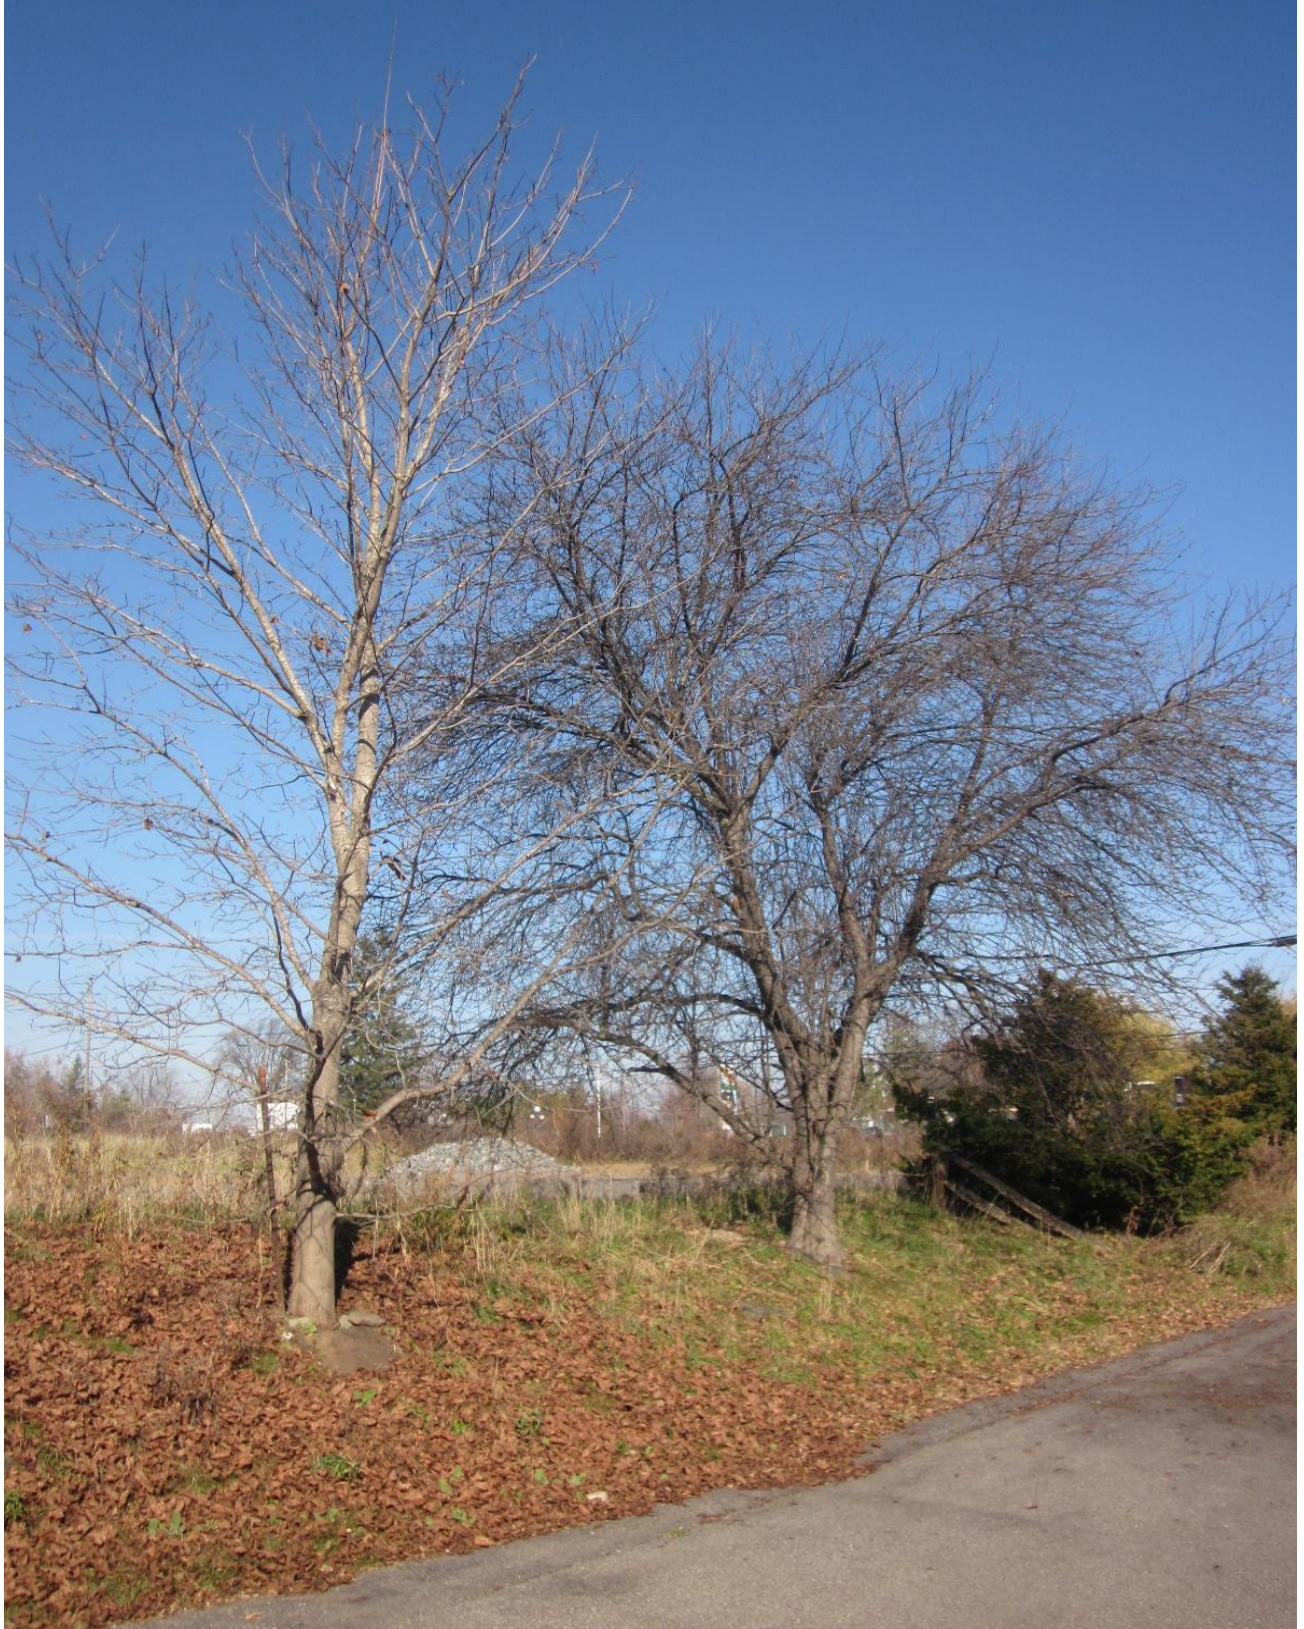
Tree No.	Tree species	Ownership <sup>1</sup>	DBH <sup>2</sup> (cm)	Tree Condition; Age Class; Condition Notes; Species Origin & <b>Preservation Status</b> (to be removed or preserved and protected)
1	Crab apple ( <i>Malus</i> spp.)	Shared	26	Fair; mature; central stem with competing laterals starting at 0.5m; broad, very dense crown; cultivar; <b>to be removed</b> (conflicts with excavation for edge of parking lot)
2	Norway maple ( <i>Acer platanoides</i> )	Shared	20	Good; maturing; central stem with competing laterals at 3m on west and 5m on southwest; dense crown; introduced invasive species; <b>to be removed</b> (conflicts with excavation for edge of parking lot)
3	Manitoba maple ( <i>Acer negundo</i> )	Neighbour	52 & 30	Fair; mature; double stemmed at grade; dominant stem upright but asymmetric towards south with divergent competing lateral on north; naturalized species; <b>to be preserved and protected</b>

Picture 1. Trees #1 and 2 (right to left), shared crab apple and Norway maple located at 5254 Bank Street

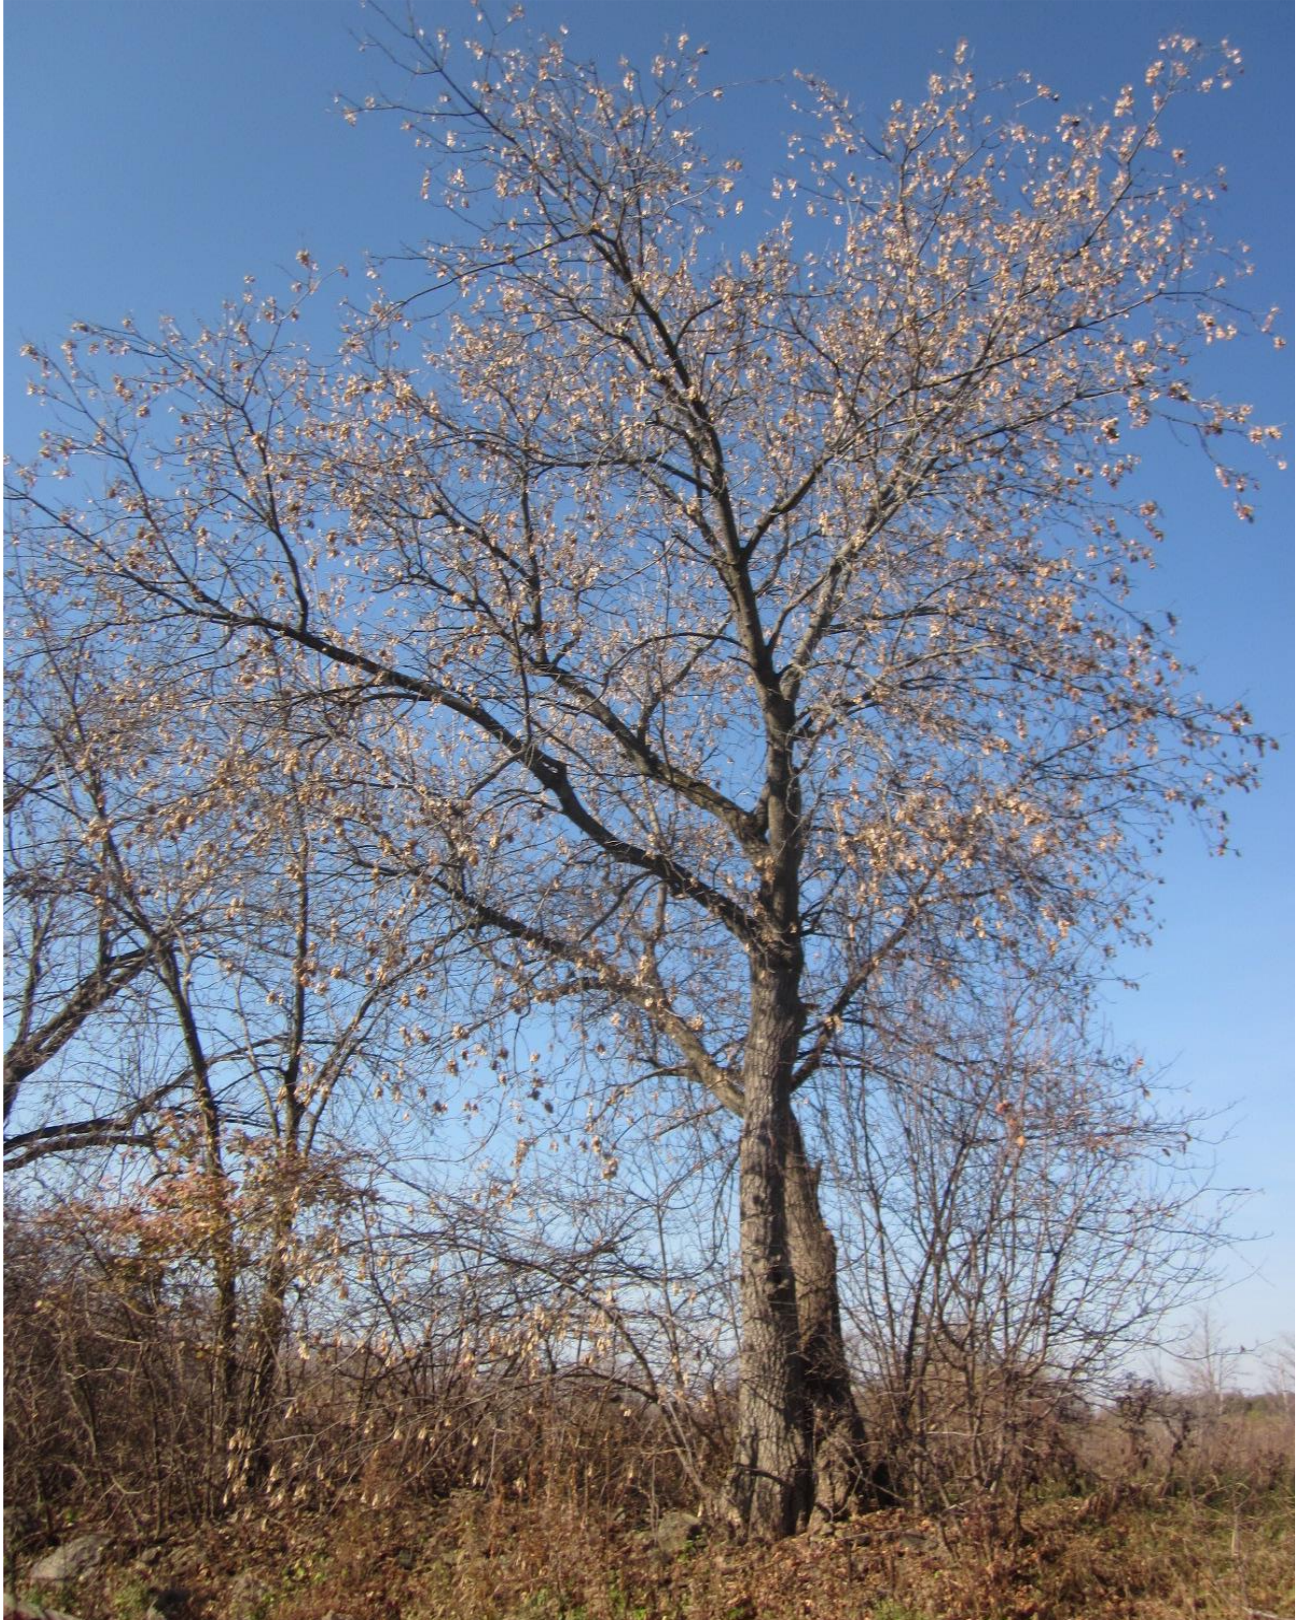
Picture 2. Tree #3, Manitoba maple adjacent to 5254 Bank Street

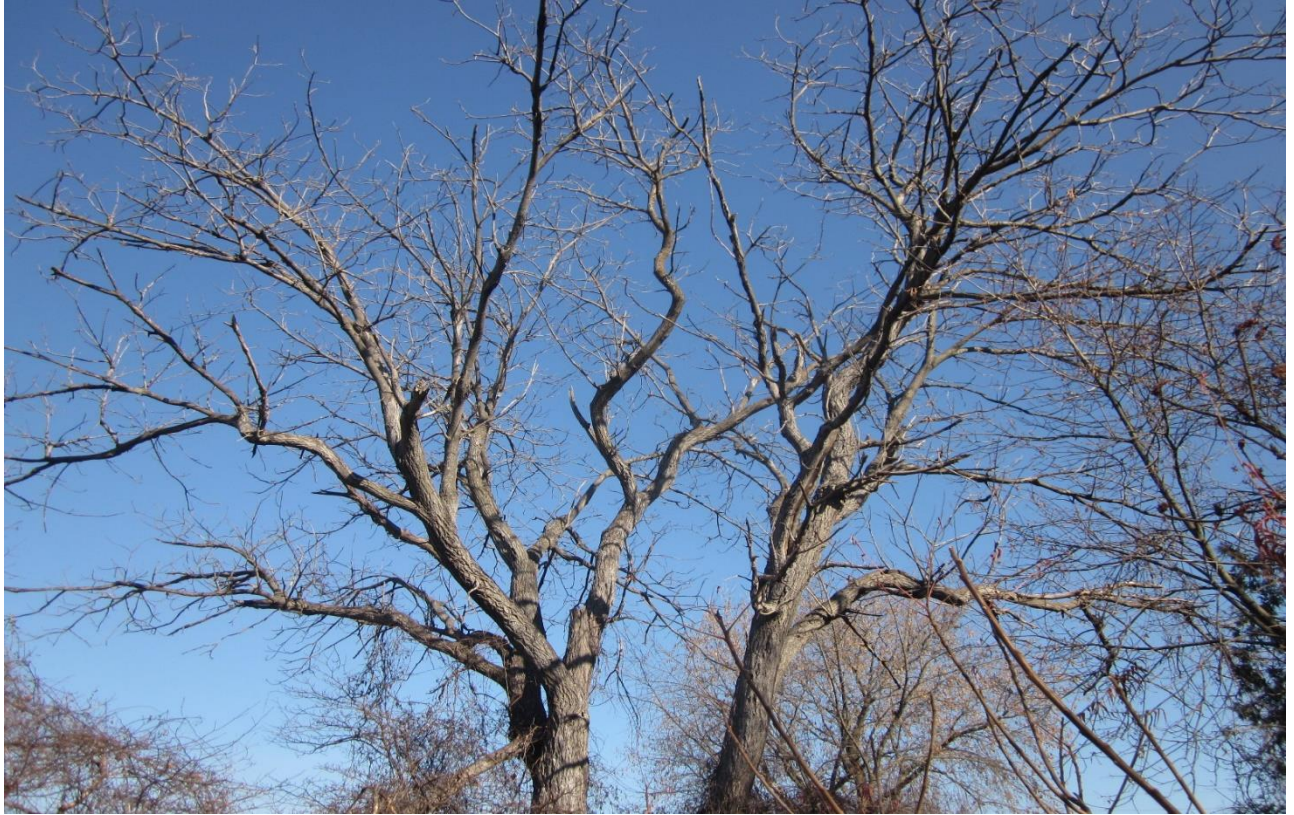
4	Butternut ( <i>Juglans cinerea</i> )	Neighbour	58 & 47	Fair; very mature; double-stemmed at 0.6m; very broad crown; native (endangered) species; <b>to be preserved and protected</b> (butternut health assessment to be completed in spring 2023)
5	White cedar ( <i>Thuja occidentalis</i> )	Shared		Poor; mature; multi-stemmed from 1.75m – topped in distant past; covered with heavy vine growth; native species; <b>to be removed</b> (conflicts with retaining wall)
6	Bitternut hickory ( <i>Carya cordiformis</i> )	Neighbour	31 & 27	Fair; mature; co-dominant stems at 0.3m; covered with heavy vine growth; native species; <b>to be removed</b> (conflicts with retaining wall)
7	Ash ( <i>Fraxinus</i> spp.)	Neighbour	18	Dead due to emerald ash borer ( <i>Agilus planipennis</i> ); native species; <b>to be removed</b> (for safety considerations)
8	White cedar ( <i>Thuja occidentalis</i> )/ Poplar ( <i>Populus</i> spp.)	Neighbour	30 avg.	Fair; mature; cedar/poplar thicket; native species; <b>to be preserved and protected</b> (though some trees may be terminally impacted by excavation for nearby retaining wall and so may need to be removed for safety considerations)

- 1) Endangered Species Act (2007): A mature butternut (*Juglans cinerea*) tree was identified on adjacent private property. This species of tree is listed as threatened under the Province of Ontario's Endangered Species Act (ESA, 2007) and so is protected from harm. This tree will be assessed following ESA protocol in spring 2023.
- 2) Migratory Bird Convention Act (1994): In the period between April and August of each year nest surveys are required to be performed by a suitably trained person no more than five (5) days before trees or other similar nesting habitat are to be removed.

Picture 3. Crown of butternut tree #4 adjacent to 5254 Bank Street

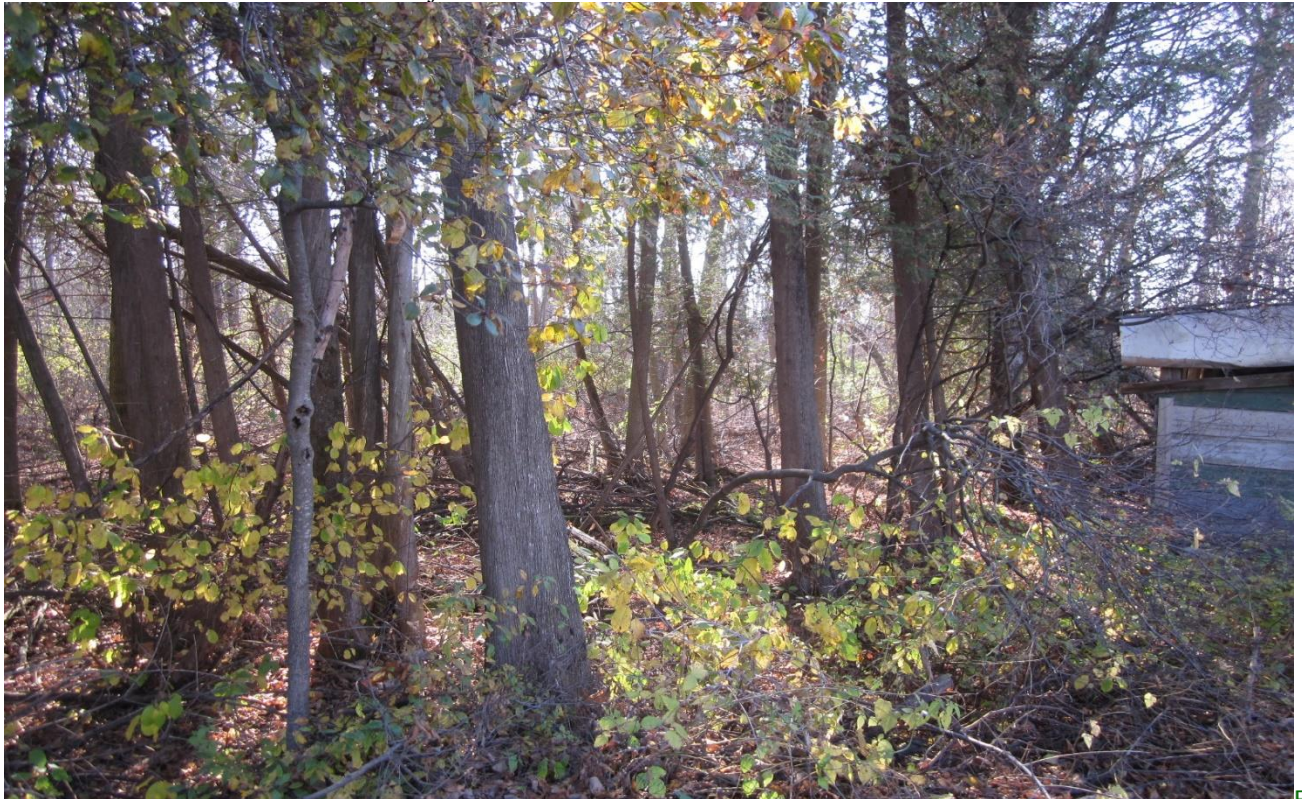
Picture 4. Stand #8, poplar and cedar trees adjacent to 5254 Bank Street

As excavation occurs within the CRZs of tree #6 and those within stand #8, the following measures will be taken:

1. Hydro excavation along the edge of excavation in proximity to the tree(s) to carefully expose roots. Exposed roots will then be cleanly cut and sealed before being reburied. Excavation can then resume using traditional mechanical means. Sealing the cleanly cut root ends with a beeswax product will help prevent the loss of moisture and facilitate healing.
2. If the excavation is to be left open for any time a covering of at least three layers of moistened burlap is to be draped over the exposed face of excavation closet to the tree. This will help reduce the loss of soil moisture.

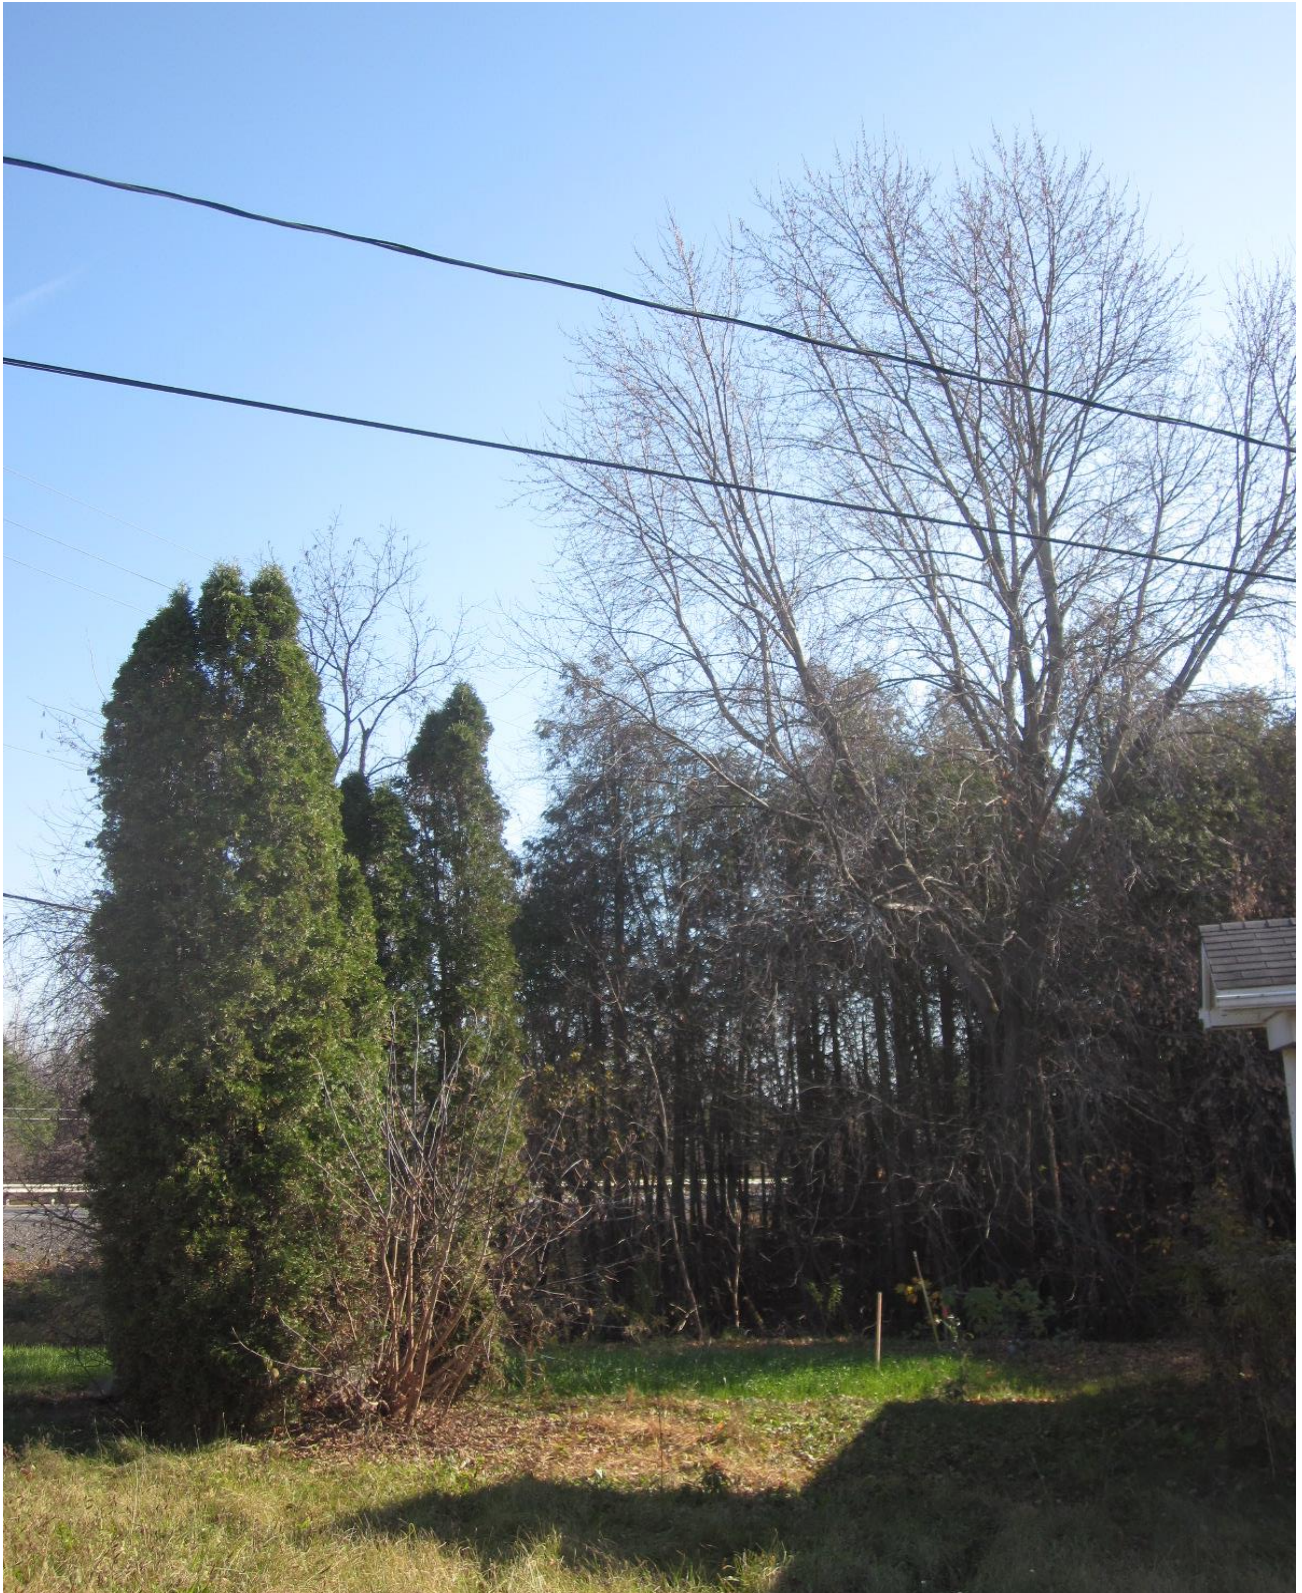
Tree No.	Tree species	Owner-ship <sup>1</sup>	DBH <sup>2</sup> (cm)	Tree Condition; Age Class; Condition Notes; Species Origin & <b>Preservation Status</b> (to be removed or preserved and protected)
9	Red maple ( <i>Acer rubrum</i> )	City	39 & 59	Good; very mature; co-dominant stems 0.2m; dominant stem with competing lateral on south; broad, dense generally symmetric crown; native species; <b>to be preserved and protected</b>
10	'Emerald' cedar ( <i>Thuja occidentalis</i> 'Smaragd')	City	13 avg.	Fair; mature; fair crown density, growth increment and needle colour; cultivar; <b>to be preserved and protected</b>

Picture 5. Tree #9 and 10 (right to left), maple and emerald cedar trees on City of Ottawa property adjacent to 5254 Bank Street
