# patersongroup remedial action plan

to:	10869279 Canada Inc Mr. Martin Chénier - chenierm@live.ca
re:	Environmental Remedial Action Plan
	Proposed Residential Development - 1649 Montreal Road & 741 Blair Road,
	Ottawa, Ontario
date:	January 24, 2022
file:	PE5061-RAP.01
from:	Nick Sullivan

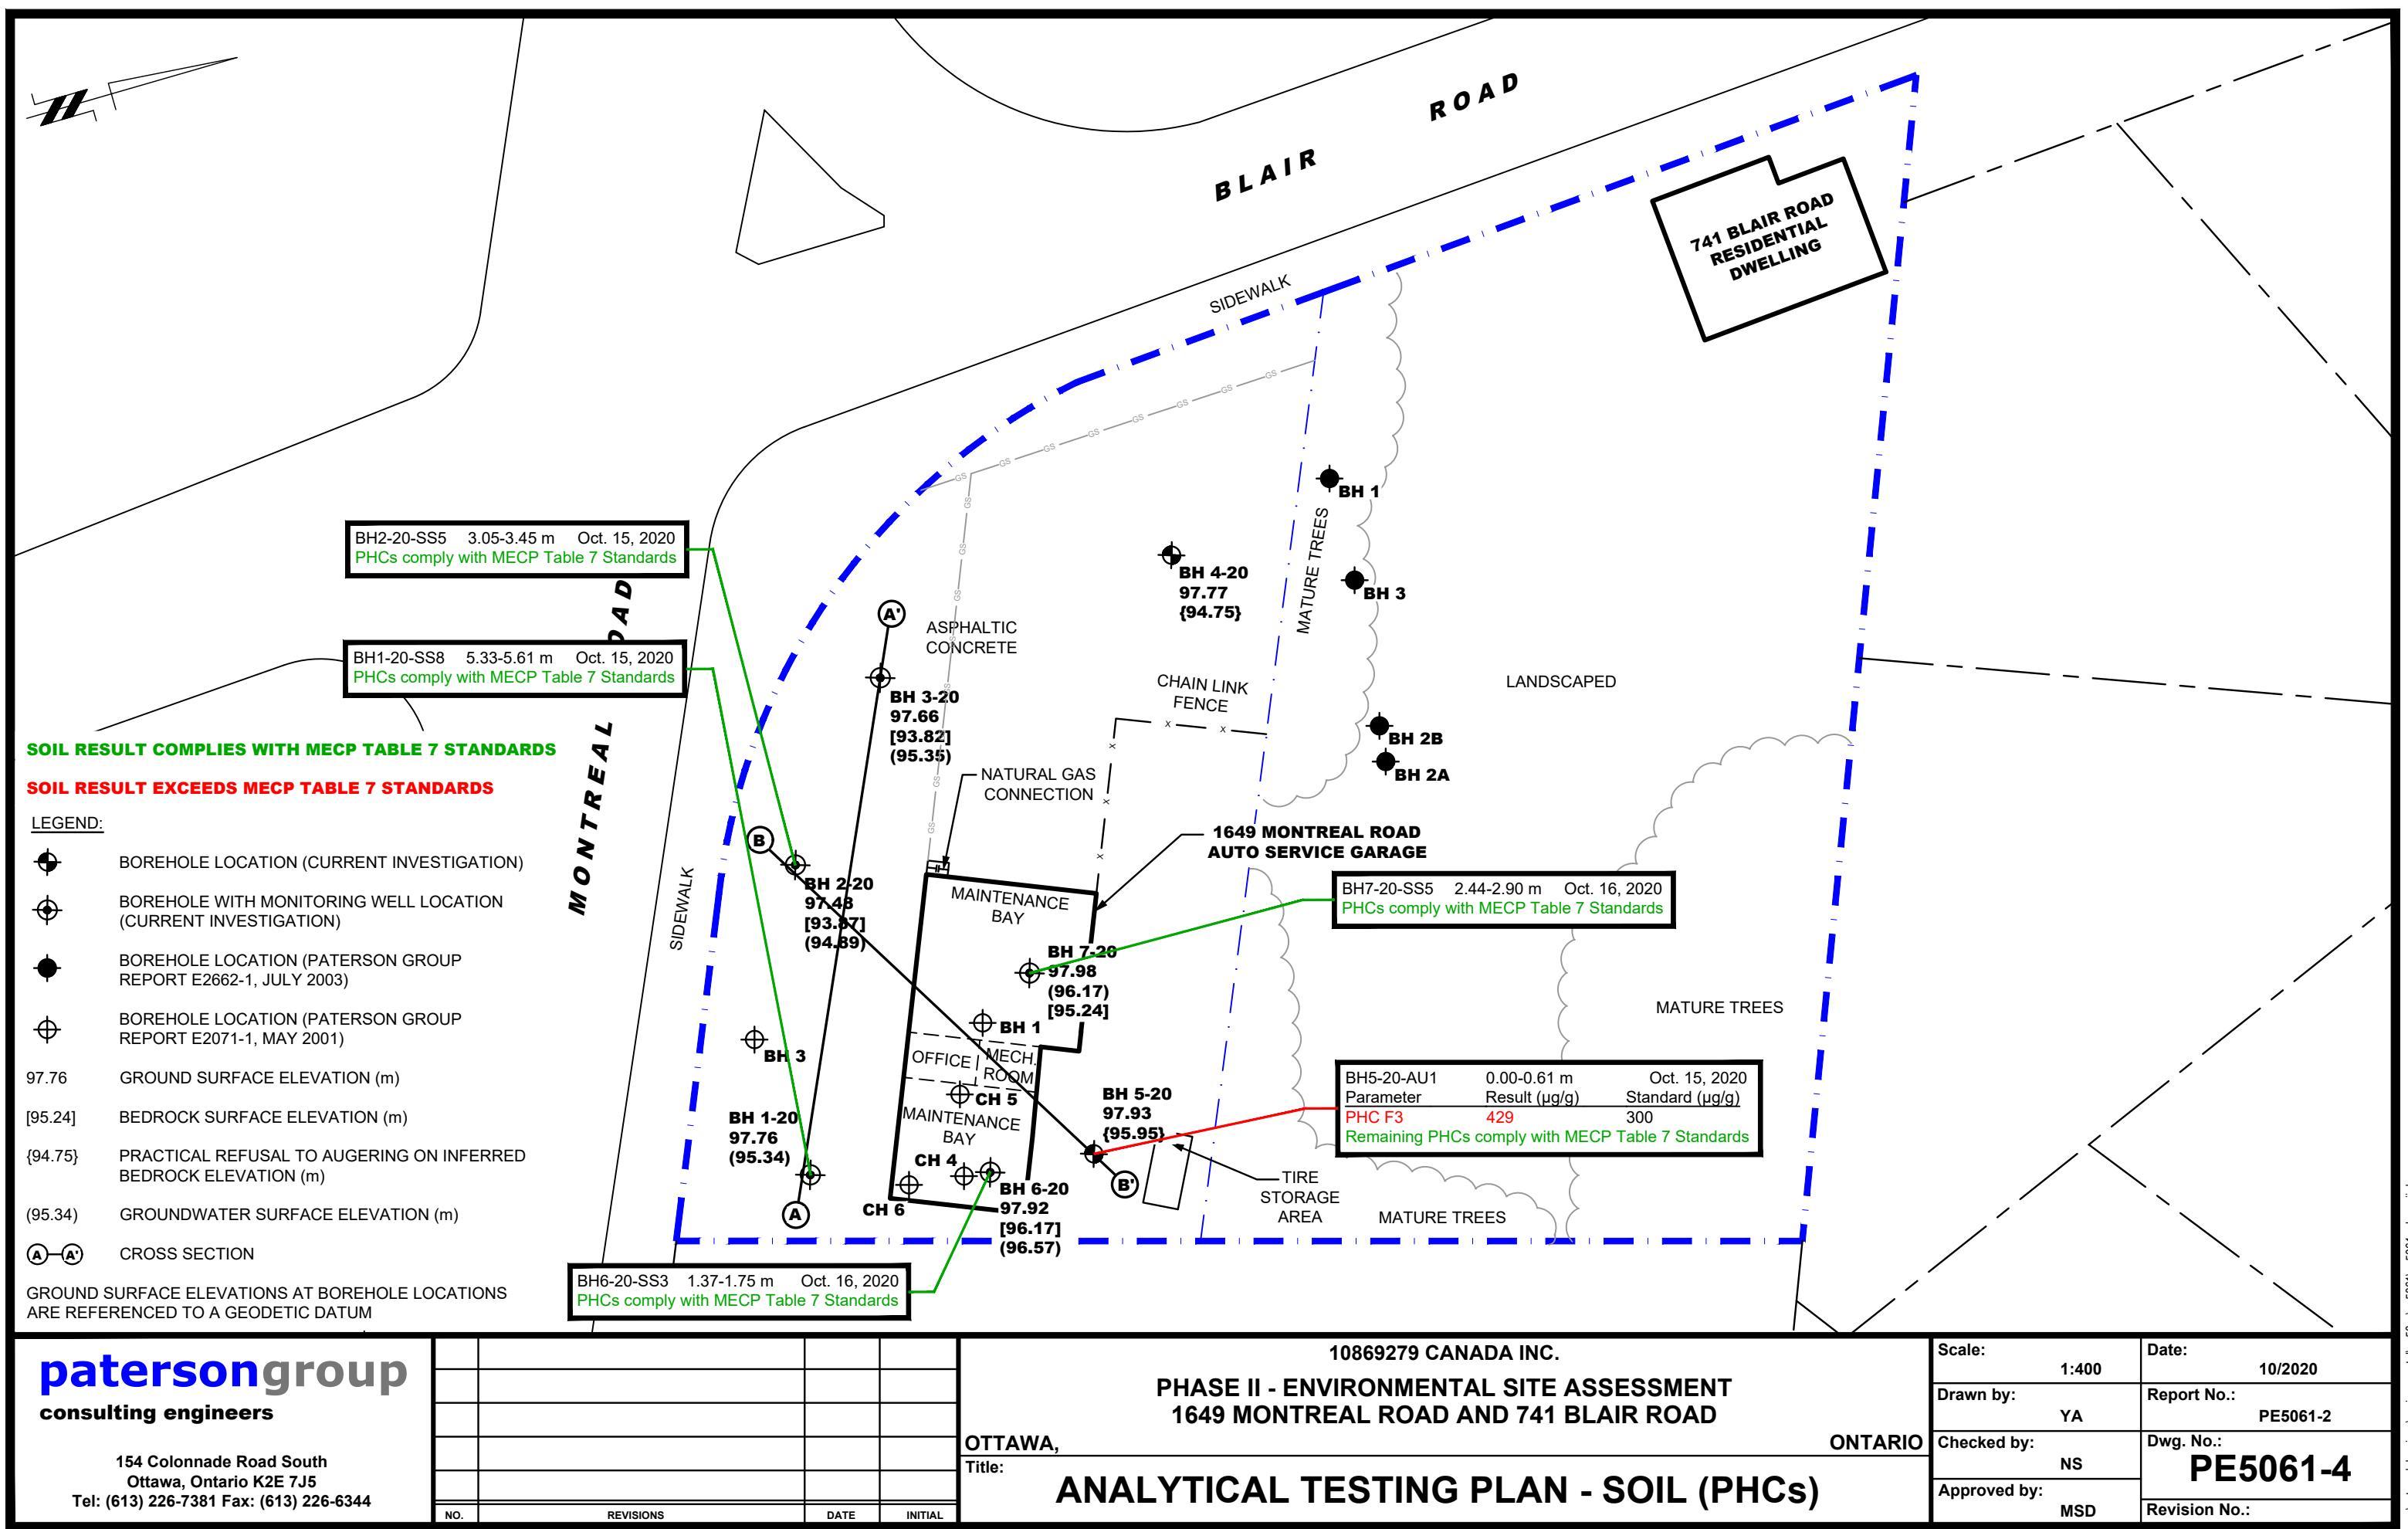
Nine (9) soil samples, recovered from the boreholes, were submitted for laboratory analysis of BTEX, PHCs (F1-F4), metals, and/or pH parameters. Based on the analytical test results, some petroleum hydrocarbon contamination was identified in the shallow layer of fill material (extending from ground surface to a depth of approximately 1.5 m) located at the rear of the auto service garage building.

The suggested action plan consists of a generic approach, where the excavation and removal of site soils will be undertaken. The suggested action plan is as follows:

- Let the solution of the soluti
- Paterson personnel will be present on-site to monitor the excavation and removal of any impacted soils.
- Excavated soils will be screened using visual and olfactory observations as well as a portable soil vapour analyser. Field observations will be used in combination with the collection and analytical testing of interim confirmatory base samples for PHC parameters in the area of contamination.
- Any impacted soils identified will be placed in trucks and hauled to an approved waste disposal facility. A toxicity characteristic leaching procedure (TCLP) sample will be obtained and submitted for laboratory analysis prior to the transportation of any impacted soils to a licensed waste disposal site.
- □ Based on the findings of the Phase II ESA, the groundwater beneath the Phase II property is not contaminated.
