May 3, 2023

RE: TREE CONSERVATION REPORT FOR 2700 SWANSEA CRESCENT, OTTAWA

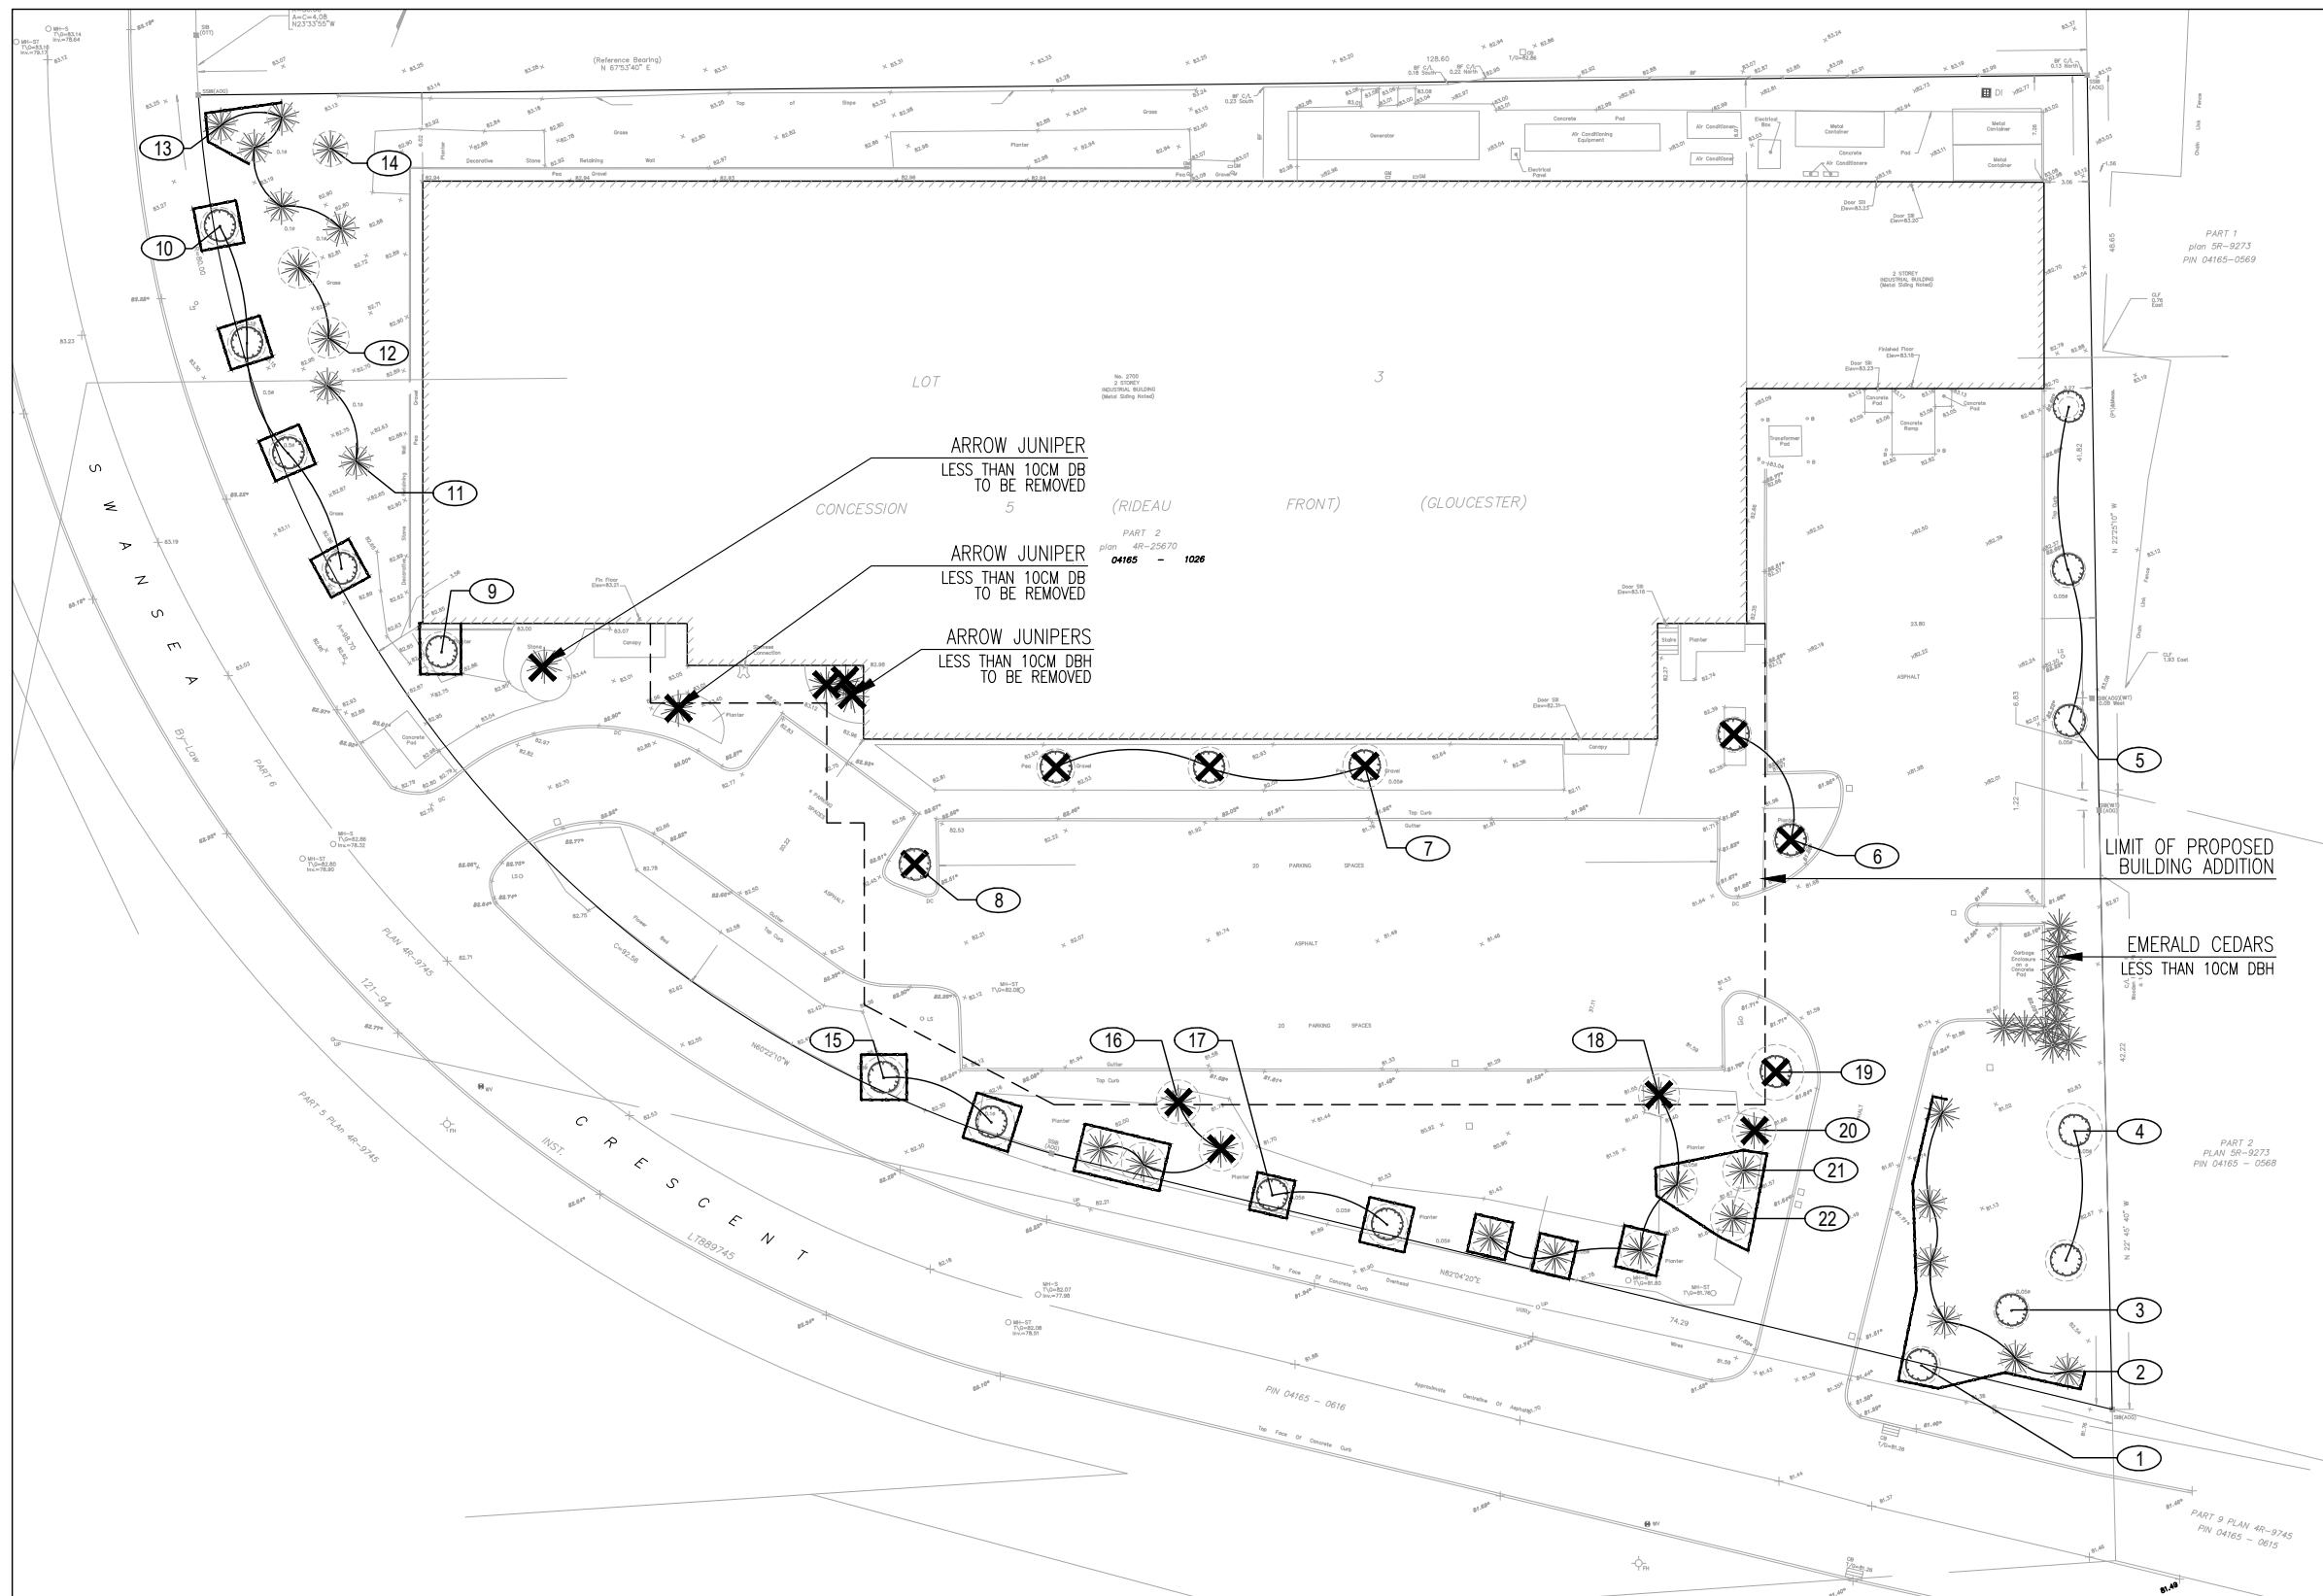
drawing MAP # 1A - CURRENT VEGETATION			
scale 1:500	date JULY 6, 2022	project no. XX	dwg. no. MAP 1A
drawn by HP	checked by MR	revision no. 1

REFER TO MAP # 1B FOR TREE PROTECTION DETAIL

1. Erect a fence at the critical root zone (CRZ¹) of trees;
2. Do not place any material or equipment within the CRZ of the tree;
3. Do not attach any signs, notices or posters to any tree;
4. Do not raise or lower the existing grade within the CRZ without approval;
5. Tunnel or bore when digging within the CRZ of a tree;
6. Do not damage the root system, trunk or branches of any tree;
7. Ensure that exhaust fumes from all equipment are NOT directed towards any tree's crown.

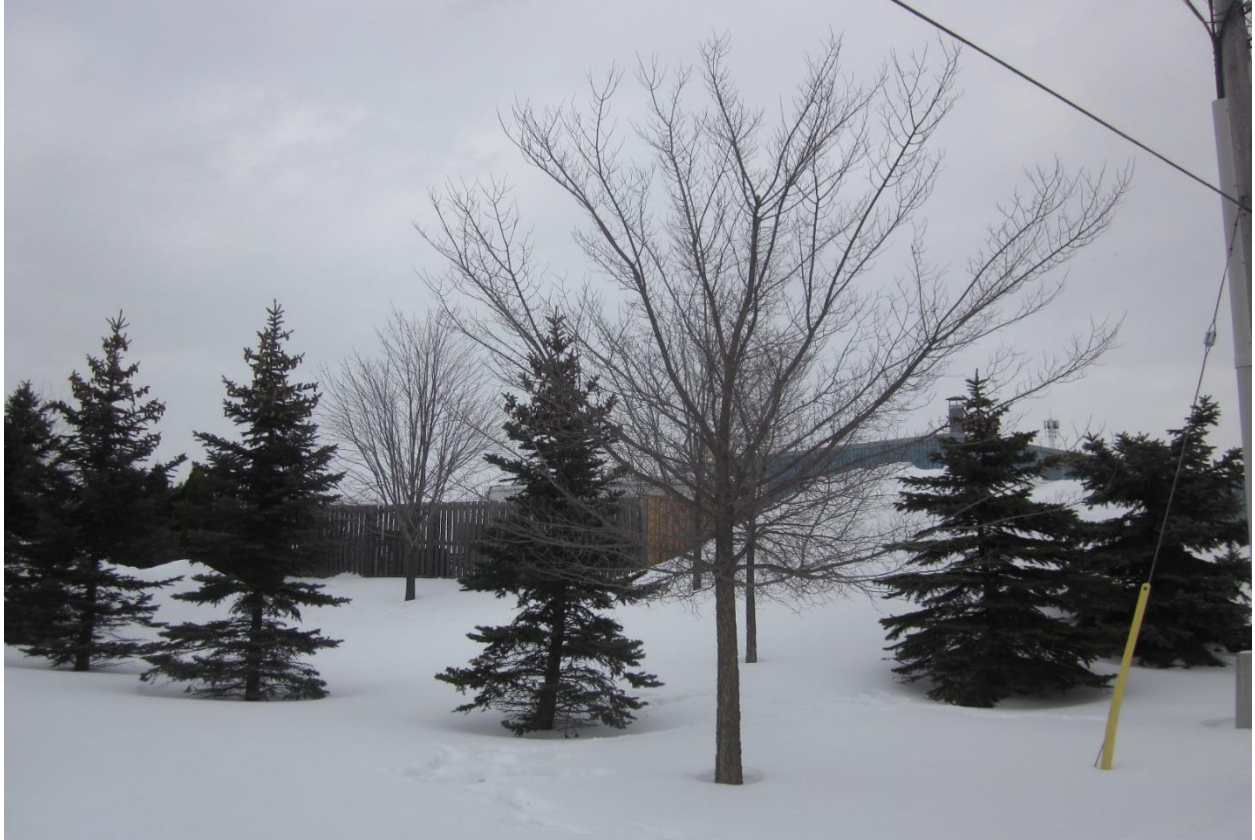
Picture 1. Trees/groupings #1-4 at 2700 Swansea Crescent

Tree No.	Tree species	Condition (VP→E)	DBH ¹ (cm)	Age class, tree condition notes, species origin & preservation status (to be removed or preserved and protected)
1	Hackberry (<i>Celtis occidentalis</i>)	Good	13	Maturing; good form and vigour; native species; to be preserved (shared with the City of Ottawa)
2	Colorado spruce (<i>Picea pungens</i>)	Good	10 avg.	Maturing; six trees in total; generally good form and vigour; introduced species; to be preserved
3	Hackberry (<i>Celtis occidentalis</i>)	Good	12	Maturing; good form and vigour; native species; to be preserved
4	Freeman maple (<i>Acer x. freemanii</i>)	Fair	14 & 19	Maturing; two trees in total; co-dominant leaders; very good vigour; cultivar; to be preserved
5	Freeman maple (<i>Acer x. freemanii</i>)	Poor to Fair	7, 12 & 12	Maturing; three trees in total; co-dominant leaders; poor to fair vigour; cultivar; to be preserved
6	Honey-locust (<i>Gleditsia triacanthos</i>)	Fair	8 & 12	Maturing; two trees in total; typical open crown forms; fair vigour; restricted rooting; introduced species to Eastern Ontario; both trees to be removed (conflict with construction)

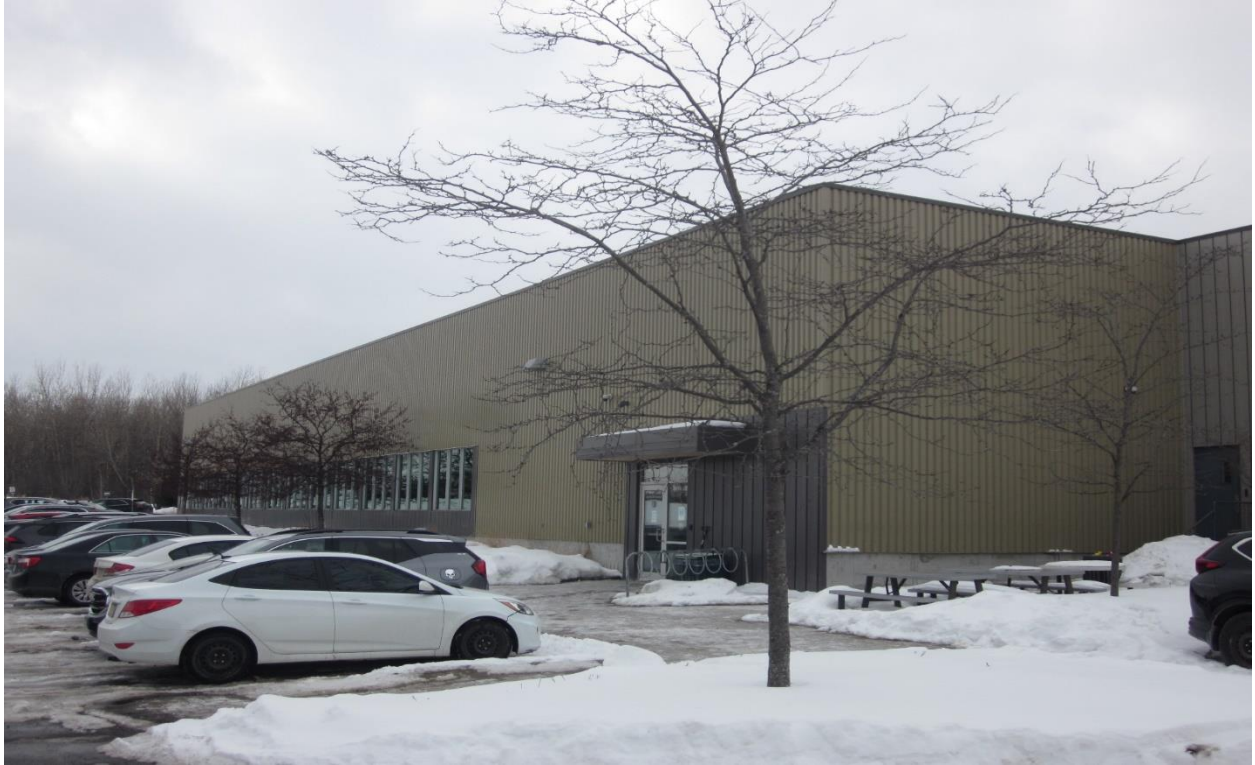
Picture 2. Tree groupings #6 and 7 at 2700 Swansea Crescent

7	Crab apple (<i>Malus</i> spp.)	Good	13, 14 & 15	Maturing; three trees in total; dense crown with heavy fruit set; very good vigour; basal sprouting; cultivar; all three trees to be removed (conflict with construction)
8	Honey-locust (<i>Gleditsia triacanthos</i>)	Fair	10	Maturing; typical open crown form; fair vigour; very restricted rooting; introduced species to Eastern Ontario; to be removed (conflicts with construction)
9	Crab apple (<i>Malus</i> spp.)	Good	14	Maturing; dense crown with heavy fruit set; very good vigour; basal sprouting; cultivar; to be preserved
10	Red oak (<i>Quercus rubra</i>)	Good	13 avg.	Maturing; four trees in total; good upright forms; good vigour; native species; to be preserved
11	Colorado spruce (<i>Picea pungens</i>)	Fair	10 & 10	Maturing; two trees in total; fair crown density, growth increment and needle colour; introduced species; to be preserved
12	Austrian pine (<i>Pinus nigra</i>)	Good	14 & 14	Maturing; two trees in total; good crown density, growth increment and needle colour; introduced species; to be preserved

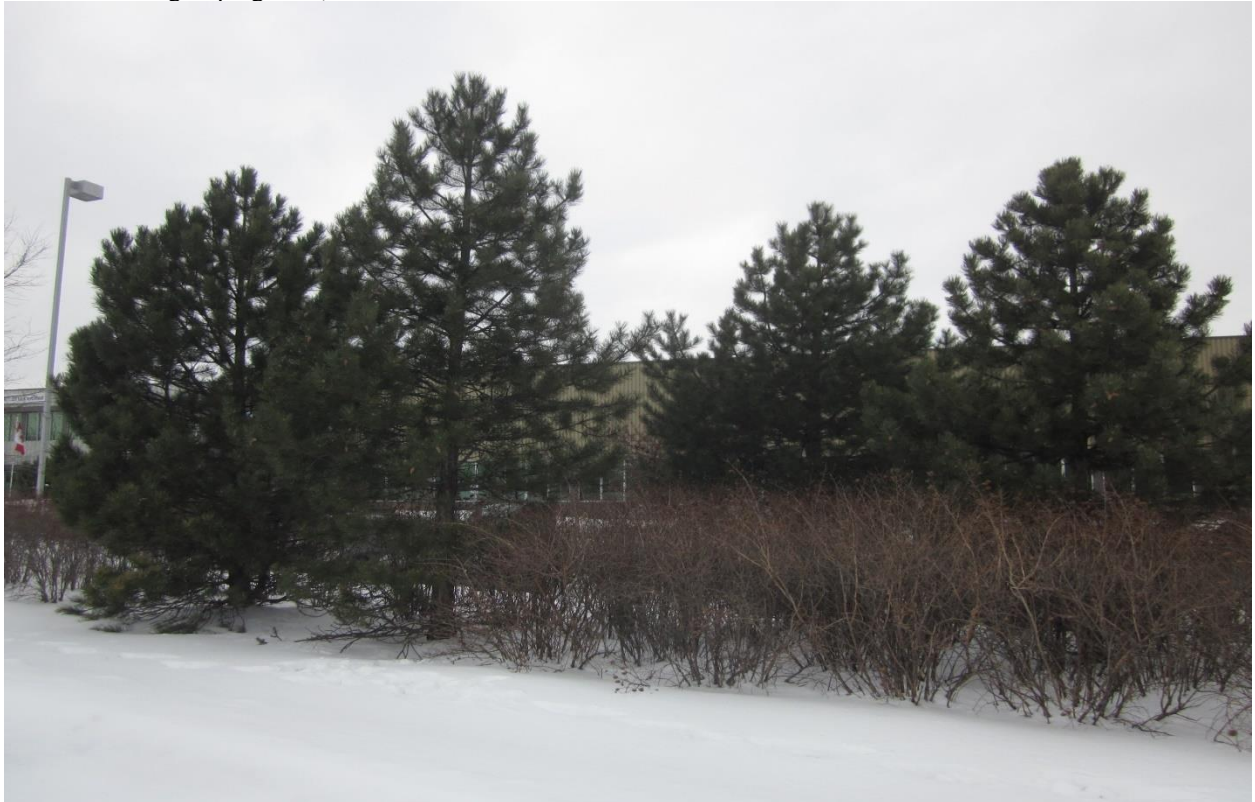
Picture 4. Tree groupings #16 at 2700 Swansea Crescent

Tree No.	Tree species	Condition (VP→E)	DBH ¹ (cm)	Age class, tree condition notes, species origin & preservation status (to be removed or preserved and protected)
13	Colorado spruce (<i>Picea pungens</i>)	Good	10 avg.	Maturing; five trees in total; good crown density, growth increment and needle colour; introduced species; to be preserved
14	Austrian pine (<i>Pinus nigra</i>)	Fair	12	Maturing; lower stem divergent towards southeast – moved after planting; fair crown density, growth increment and needle colour; introduced species; to be preserved
15	Hackberry (<i>Celtis occidentalis</i>)	Good	15 & 16	Maturing; two trees in total; co-dominant stems at 2m from grade; broad crowns; native species; to be preserved
16	Austrian pine (<i>Pinus nigra</i>)	Good	15 avg.	Maturing; four trees in total; good crown density, growth increment and needle colour; introduced species; two of four trees to be removed (conflict with construction)
