# TREE CONSERVATION REPORT ADDENDUM

3100 Leitrim Road

Tree Conservation Report Addendum submitted as  
Partial Requirements for a Site Plan Control  
Application, May 25, 2023

**Date of Report:** May 26, 2023

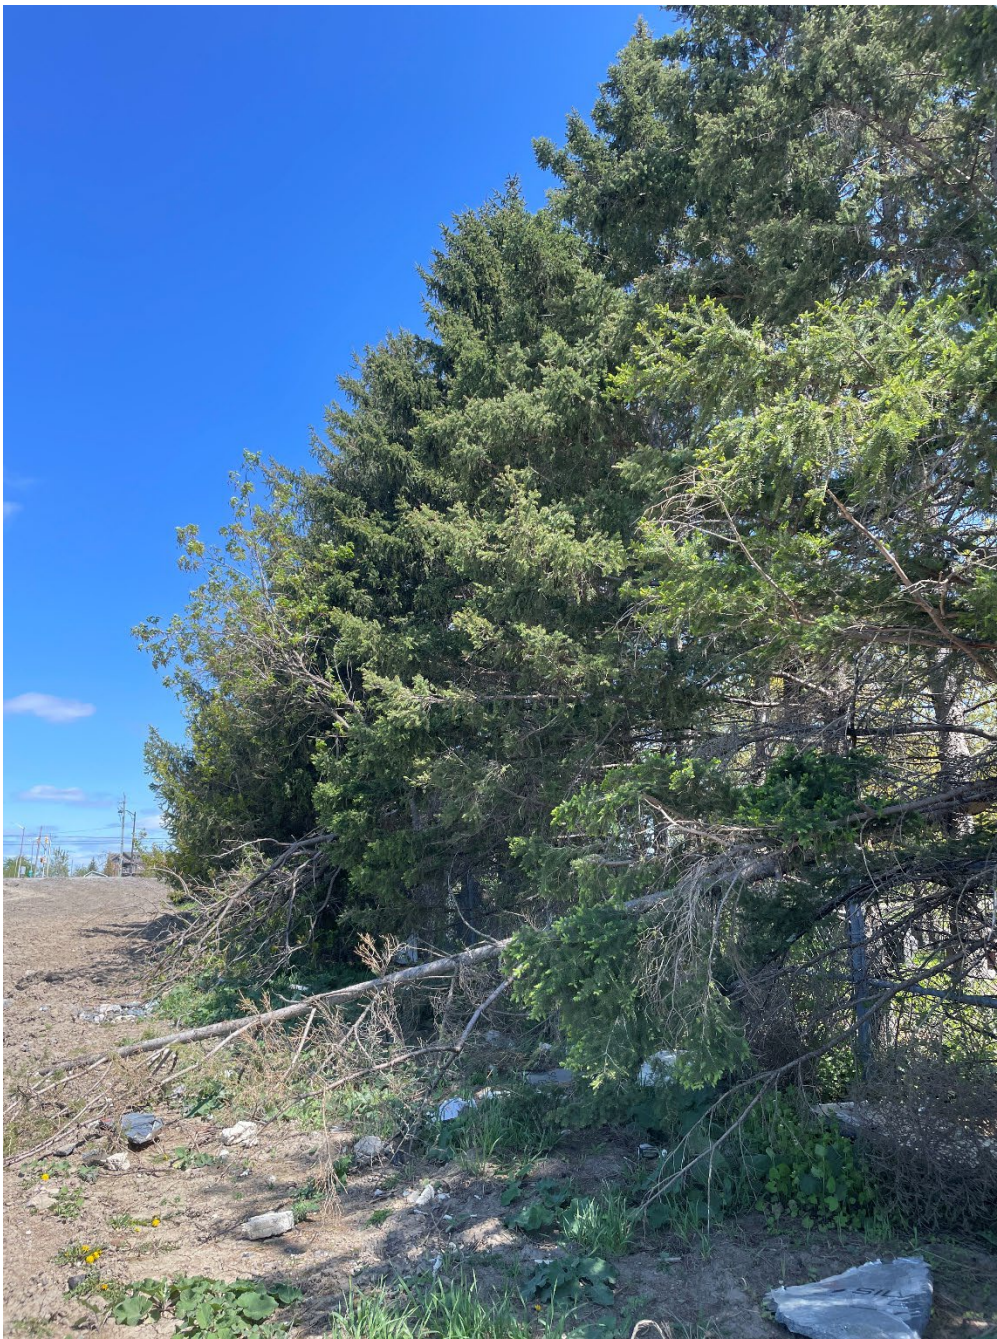
In addition to the roots, the branches will also conflict with the proposed retaining wall, and significant pruning will be required. Branches of some of the larger spruce extend out up to 4 m past the property line in some locations and are close to the ground. It is unlikely that the branches will extend to the new roadway which will be set back approximately 3 m from the property line.

Figure 1: Hedgerow facing towards Bank Street. Note the low hanging branches that will require pruning

The overhanging branches should be pruned by a certified arborist prior to construction commencing.

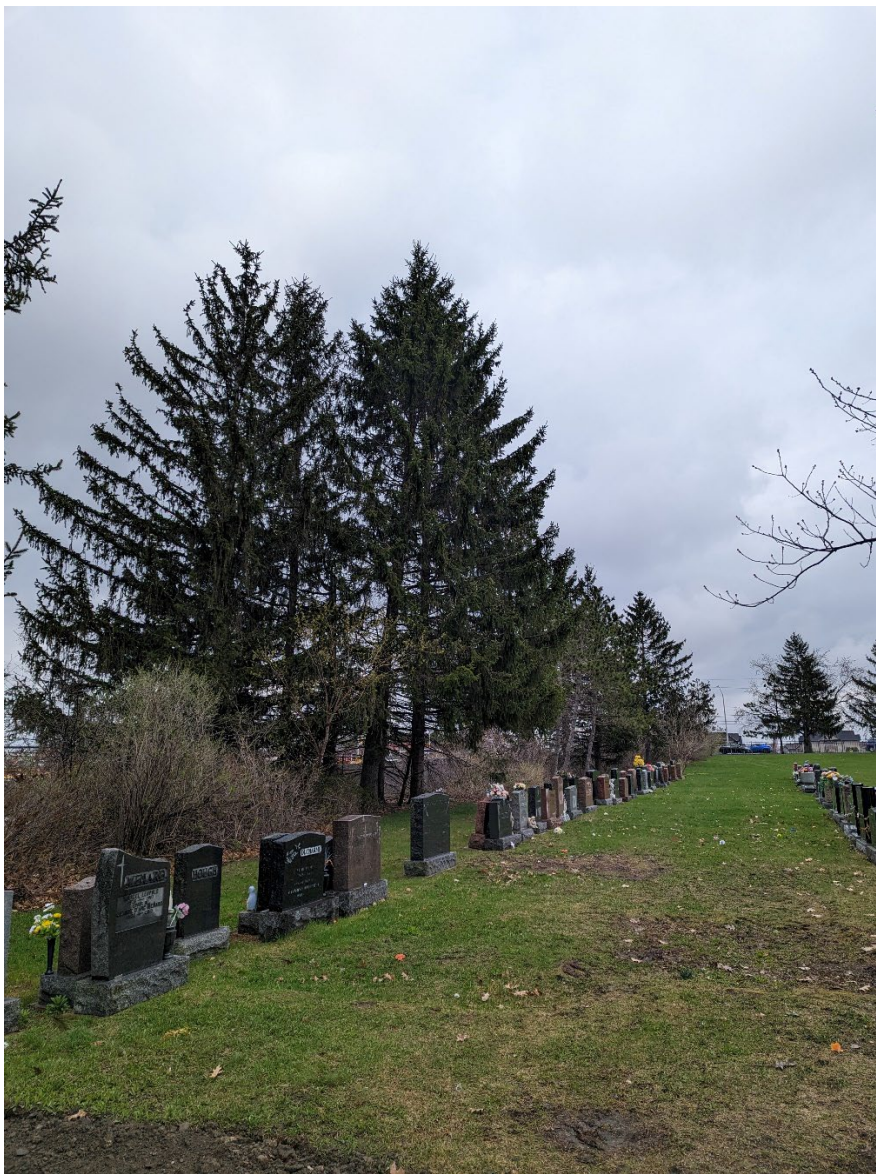
Figure 2: View of the hedgerow facing bank street from the cemetery side.
