August 28, 2020

RE: TREE CONSERVATION REPORT FOR 30-48 CHAMBERLAIN AVENUE, OTTAWA

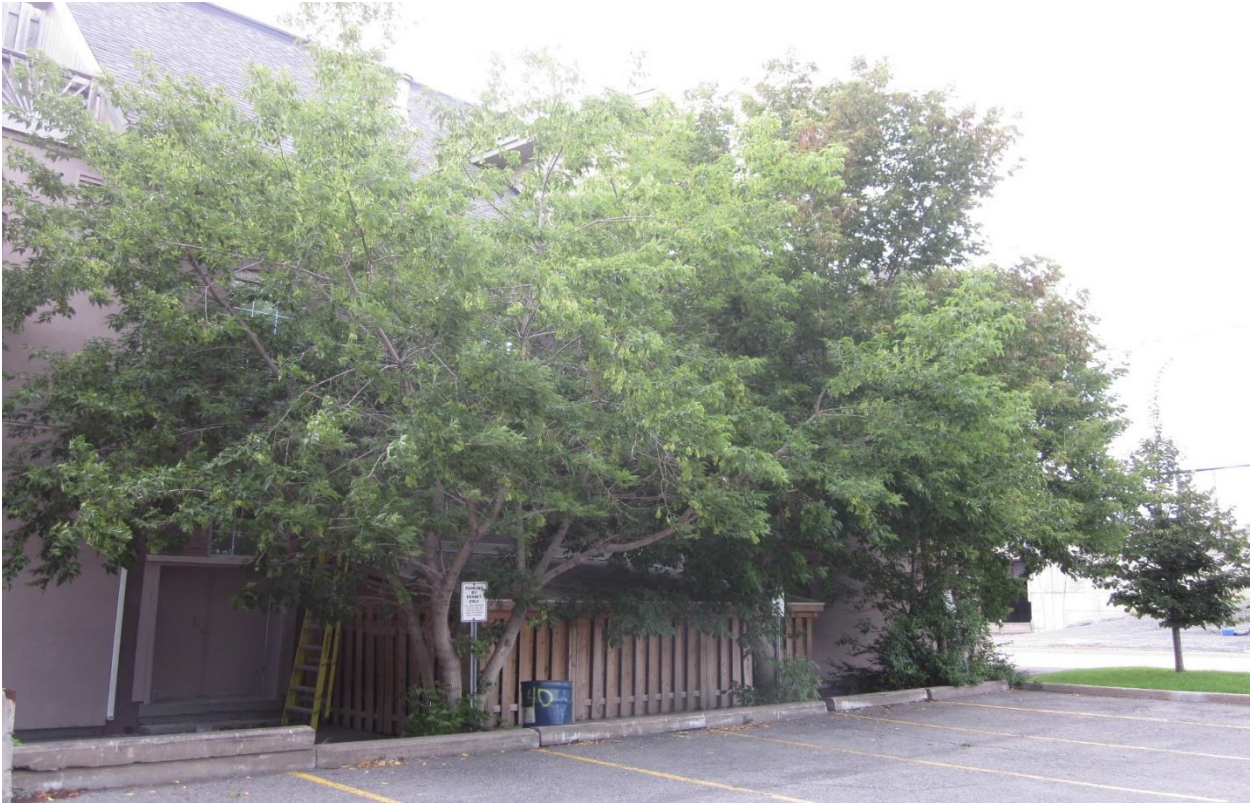
Tree No.	Tree Species	Condition (VP→E or dead)	DBH ¹ (cm)	Ownership	Age Class, Tree Condition Notes & Preservation Status (to be removed or preserved and protected)
1	Little-leaf linden (<i>Tilia cordata</i>)	Good	14	Neighbour	Juvenile; planted; recently pruned from Hydro lines; introduced species; to be preserved and protected
2	Manitoba maple (<i>Acer negundo</i>)	Fair	13 avg.	Neighbour	Maturing; double stemmed from grade; originated from seed - naturalized species; to be preserved and protected
3	Manitoba maple	Fair	23	Neighbour	Maturing; single stemmed; originated from seed - naturalized species; to be preserved and protected
4	Manitoba maple	Fair	15 avg.	Neighbour	Maturing; four stemmed from grade – all divergent due to competition for sunlight; originated from seed - naturalized species; to be preserved and protected
5	White cedar (<i>Thuja occidentalis</i>)	Fair	+/- 20	Neighbour	Mature; multi-stemmed from grade; crown heavily asymmetric towards east due to shade cast by tree #7; native species; to be preserved and protected

Picture 2. Trees #1-4 (right to left) – Little-leaf linden and Manitoba maples on neighbouring private property

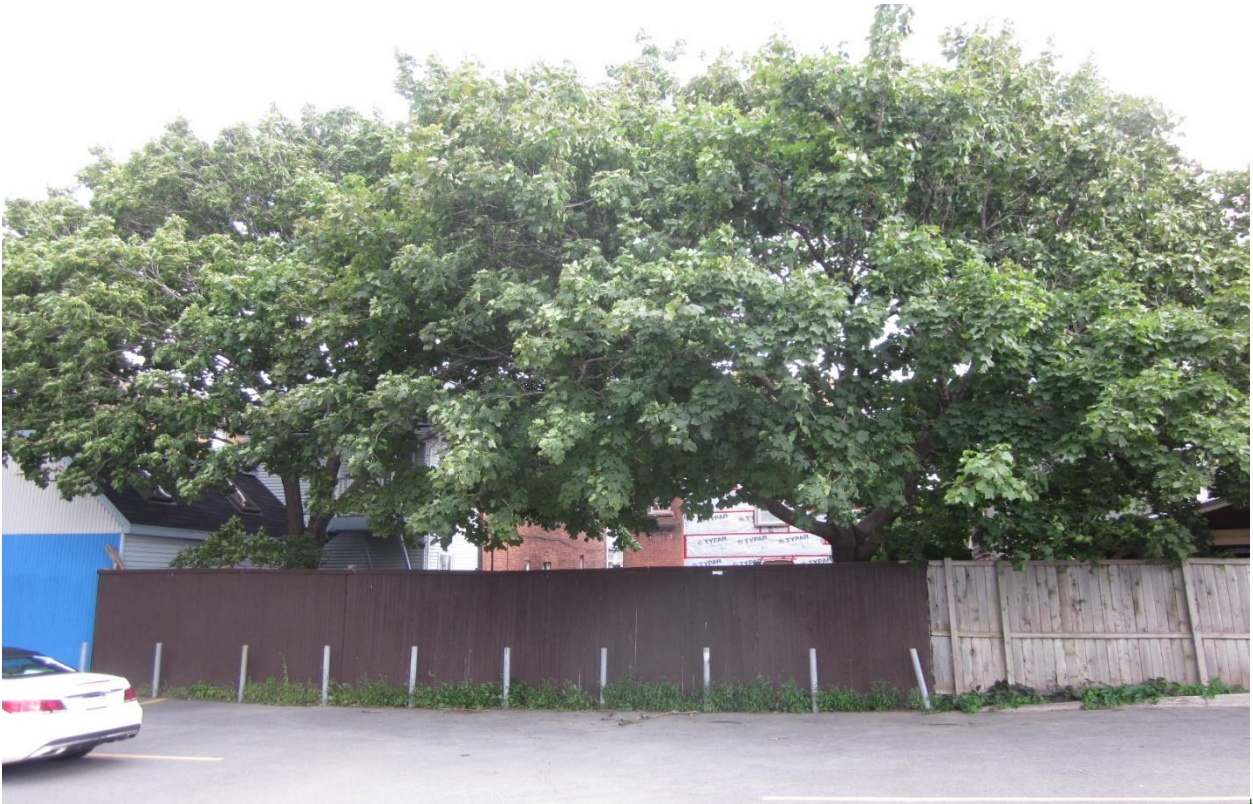
Tree No.	Tree Species	Condition (VP→E or dead)	DBH ¹ (cm)	Ownership	Age Class, Tree Condition Notes & Preservation Status (to be removed or preserved and protected)
9	Norway maple	Poor	+/-40	Neighbour	Mature; co-dominant stems at 3.5m with weak union; competing laterals at 3m on west and 3.5m on southwest and northeast – poor growth form; very broad crown; introduced invasive species; to be preserved and protected
10	Norway maple	Fair	+/- 20	Neighbour	Mature; single stemmed to 3.5m with co-dominant leaders; crown asymmetric toward south/southeast; introduced invasive species; to be preserved and protected
11	Norway maple	Poor	+/-35	Neighbour	Mature; tri-dominant stems at 2m; eutypella canker (<i>Eutypella parasitica</i>) at 2m; competing lateral on southwest side; introduced invasive species; to be preserved and protected
12	Crab apple (<i>Malus</i> spp.)	Very good	+/15	Neighbour	Mature; dense crown; heavy fruit year in 2020; cultivar; to be preserved and protected

Picture 3. Trees #8 and 9 – Norway maples on neighbouring private property
