June 5, 2023

# RE: TREE CONSERVATION REPORT FOR 400 COVENTRY ROAD, OTTAWA

400 COVENTRY ROAD

TREE CONSERVATION PLAN

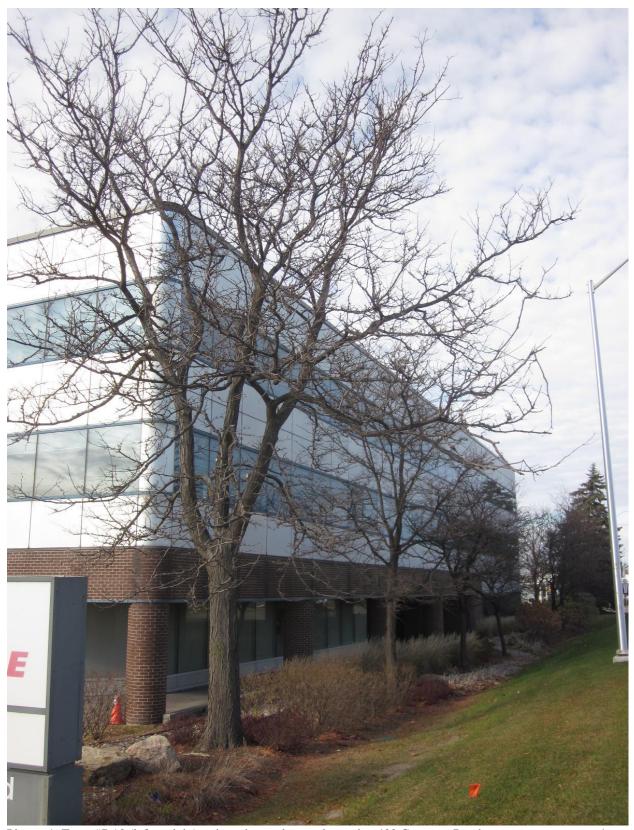
Picture 1. Trees #7-10 (left to right), private honey-locusts located at 400 Coventry Road

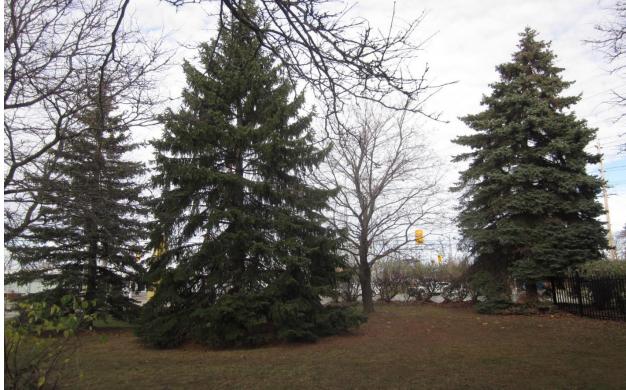
Picture 3. Trees #16-19 (right to left), located at 400 Coventry Road

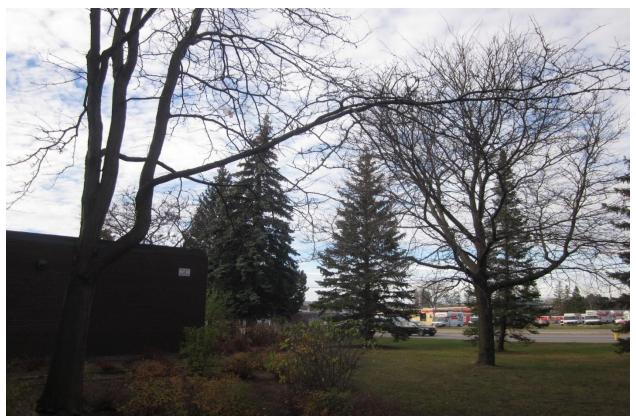
Picture 4. Trees #15 (left), 20-23 (background right to left), located at 400 Coventry Road

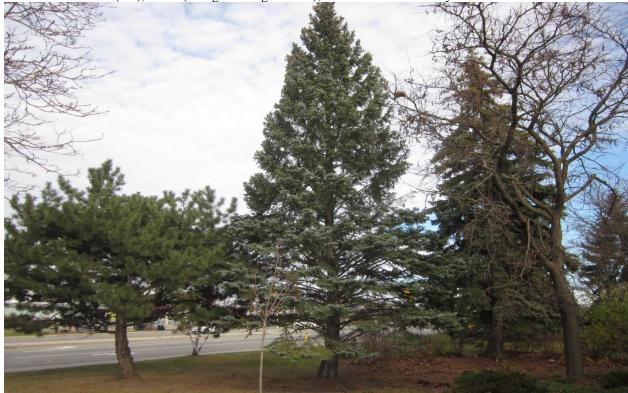
Picture 5. Tree #24 (far right), 23, 26 and 27(background right to left), located at 400 Coventry Road

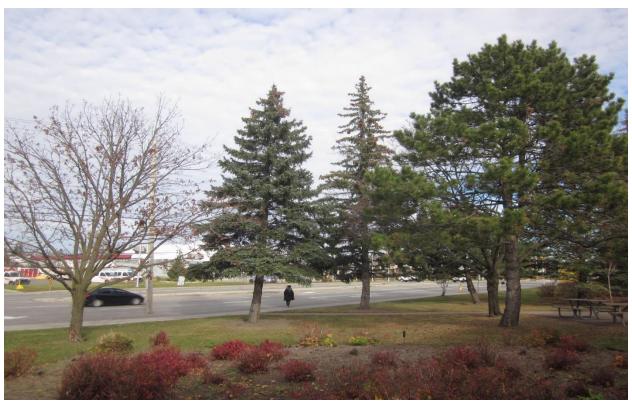
Picture 6. Trees #30 (right), 28, 31 and 32 (right to left), located at 400 Coventry Road

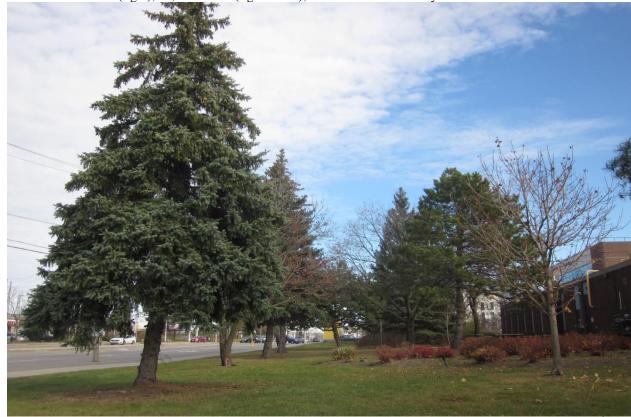
33	Colorado spruce (Picea pungens)	Private	33.5	Good; mature; good pyramidal form; scattered Cytospora canker ( <i>Leucostoma kunzei</i> ): good crown density, growth increment and needle colour; introduced species; <b>to be removed</b> (conflicts with construction)

Picture 7. Trees #33 (spruce left) and 34 (maple right), located at 400 Coventry Road

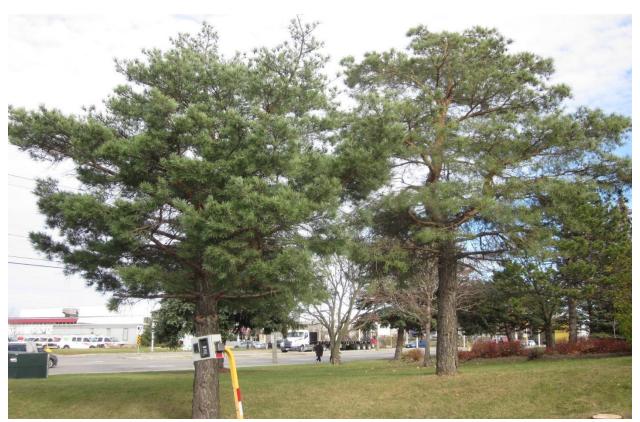
Picture 8. Trees #35 and 36 (right to left), private Scots pines located at 400 Coventry Road

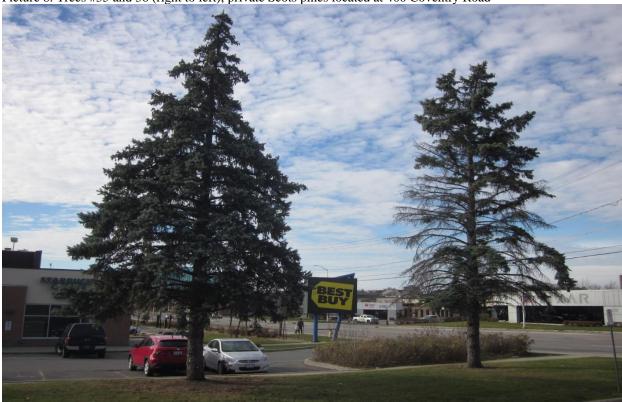
Picture 9. Trees #37 and 38 (left to right), private Colorado spruce located at 400 Coventry Road
