URBAN FORESTRY & FOREST MANAGEMENT CONSULTING

May 29, 2023

RE: TREE CONSERVATION REPORT FOR 3447 OLD ALMONTE ROAD, OTTAWA (CORKERY COMMUNITY CENTRE)

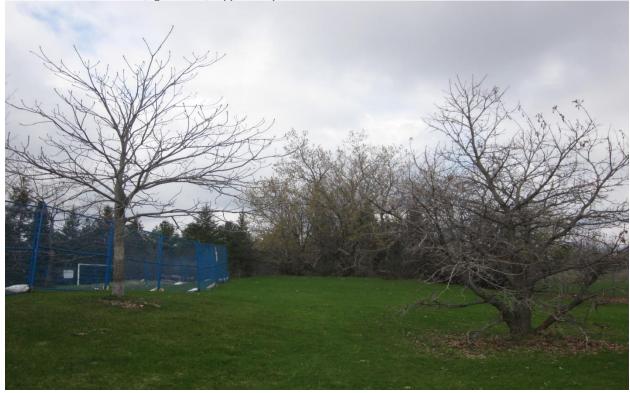
Picture 2. Trees #5 and 6 (right to left), oak and planted butternut trees at 3447 Old Almonte Road

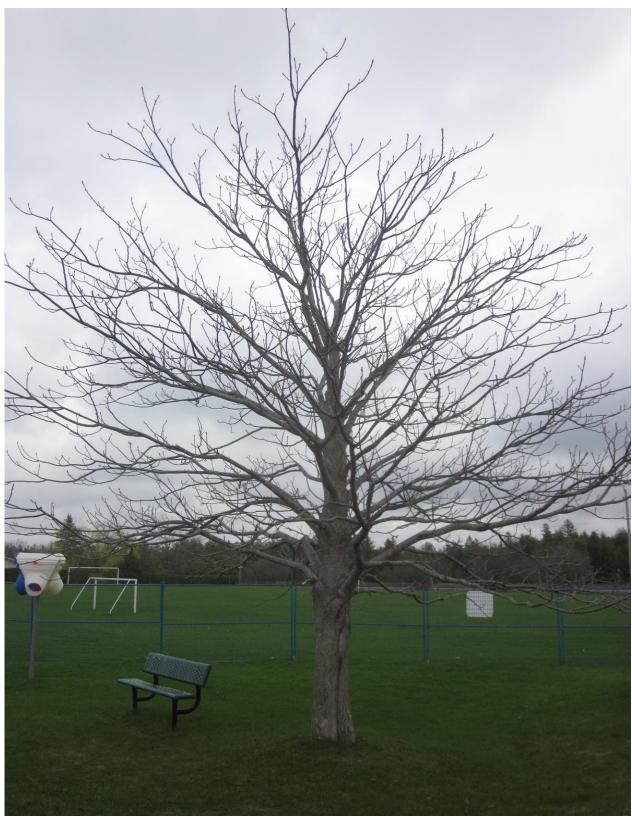
Picture 3. Tree #4, planted butternut at 3447 Old Almonte Road

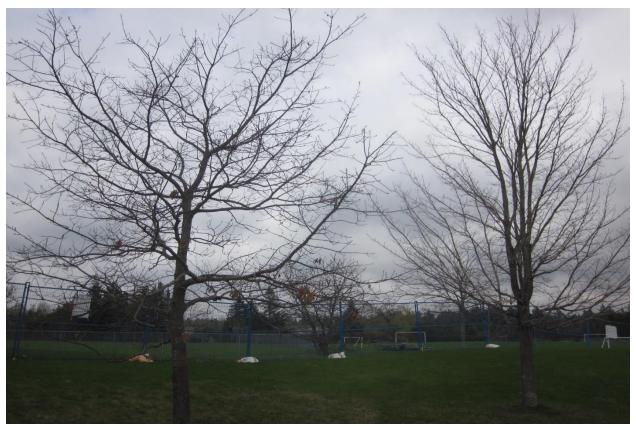
Picture 4. Trees #7 and 8 (right to left), maple and oak trees at 3447 Old Almonte Road

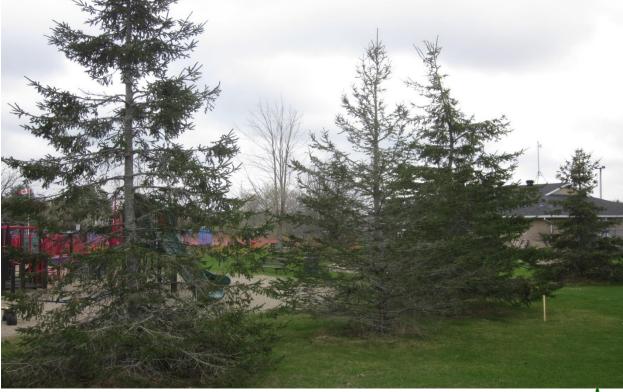
Picture 5. Trees #9-13, line of white spruce at 3447 Old Almonte Road
