TREE CONSERVATION REPORT ADDENDUM

98-100 Bearbrook Road

Tree Conservation Report Addendum submitted as
Partial Requirements for a Site Plan Control
Application, June 12, 2023

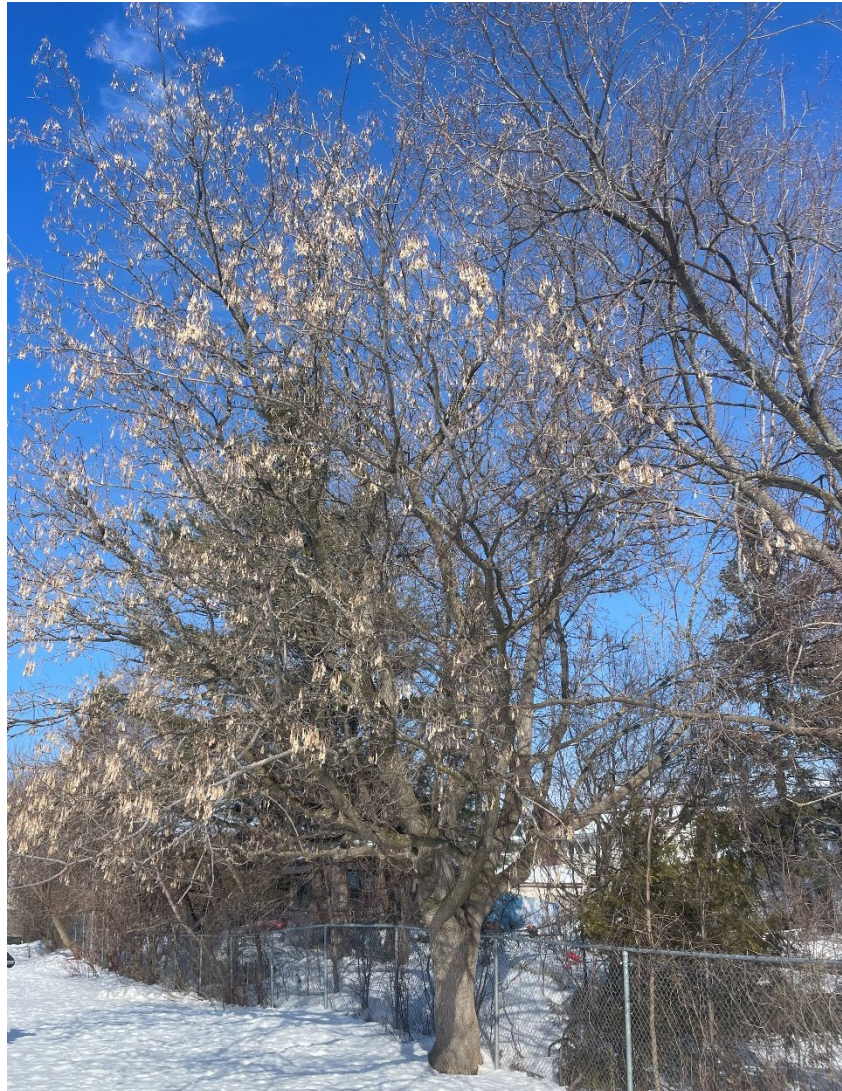
Tree 37 is set back from the property line approximately 130cm. This is 2x the tree's combined diameter¹ and therefore within the range of best practices. To ensure best outcomes for this tree and safety on site, a certified arborist is to be engaged to uncover the roots with an air spade and sever them by hand prior to excavation. This will promote faster sealing of the root wounds post construction and the arborist is able to assess the tree's stability at that time based on size and positioning of roots cut. A similar process is to be followed for **Tree 1**. This tree is close to the line of excavation but will suffer less root loss due to being positioned at the corner of the lot.

Figure 1: Manitoba maple to be retained

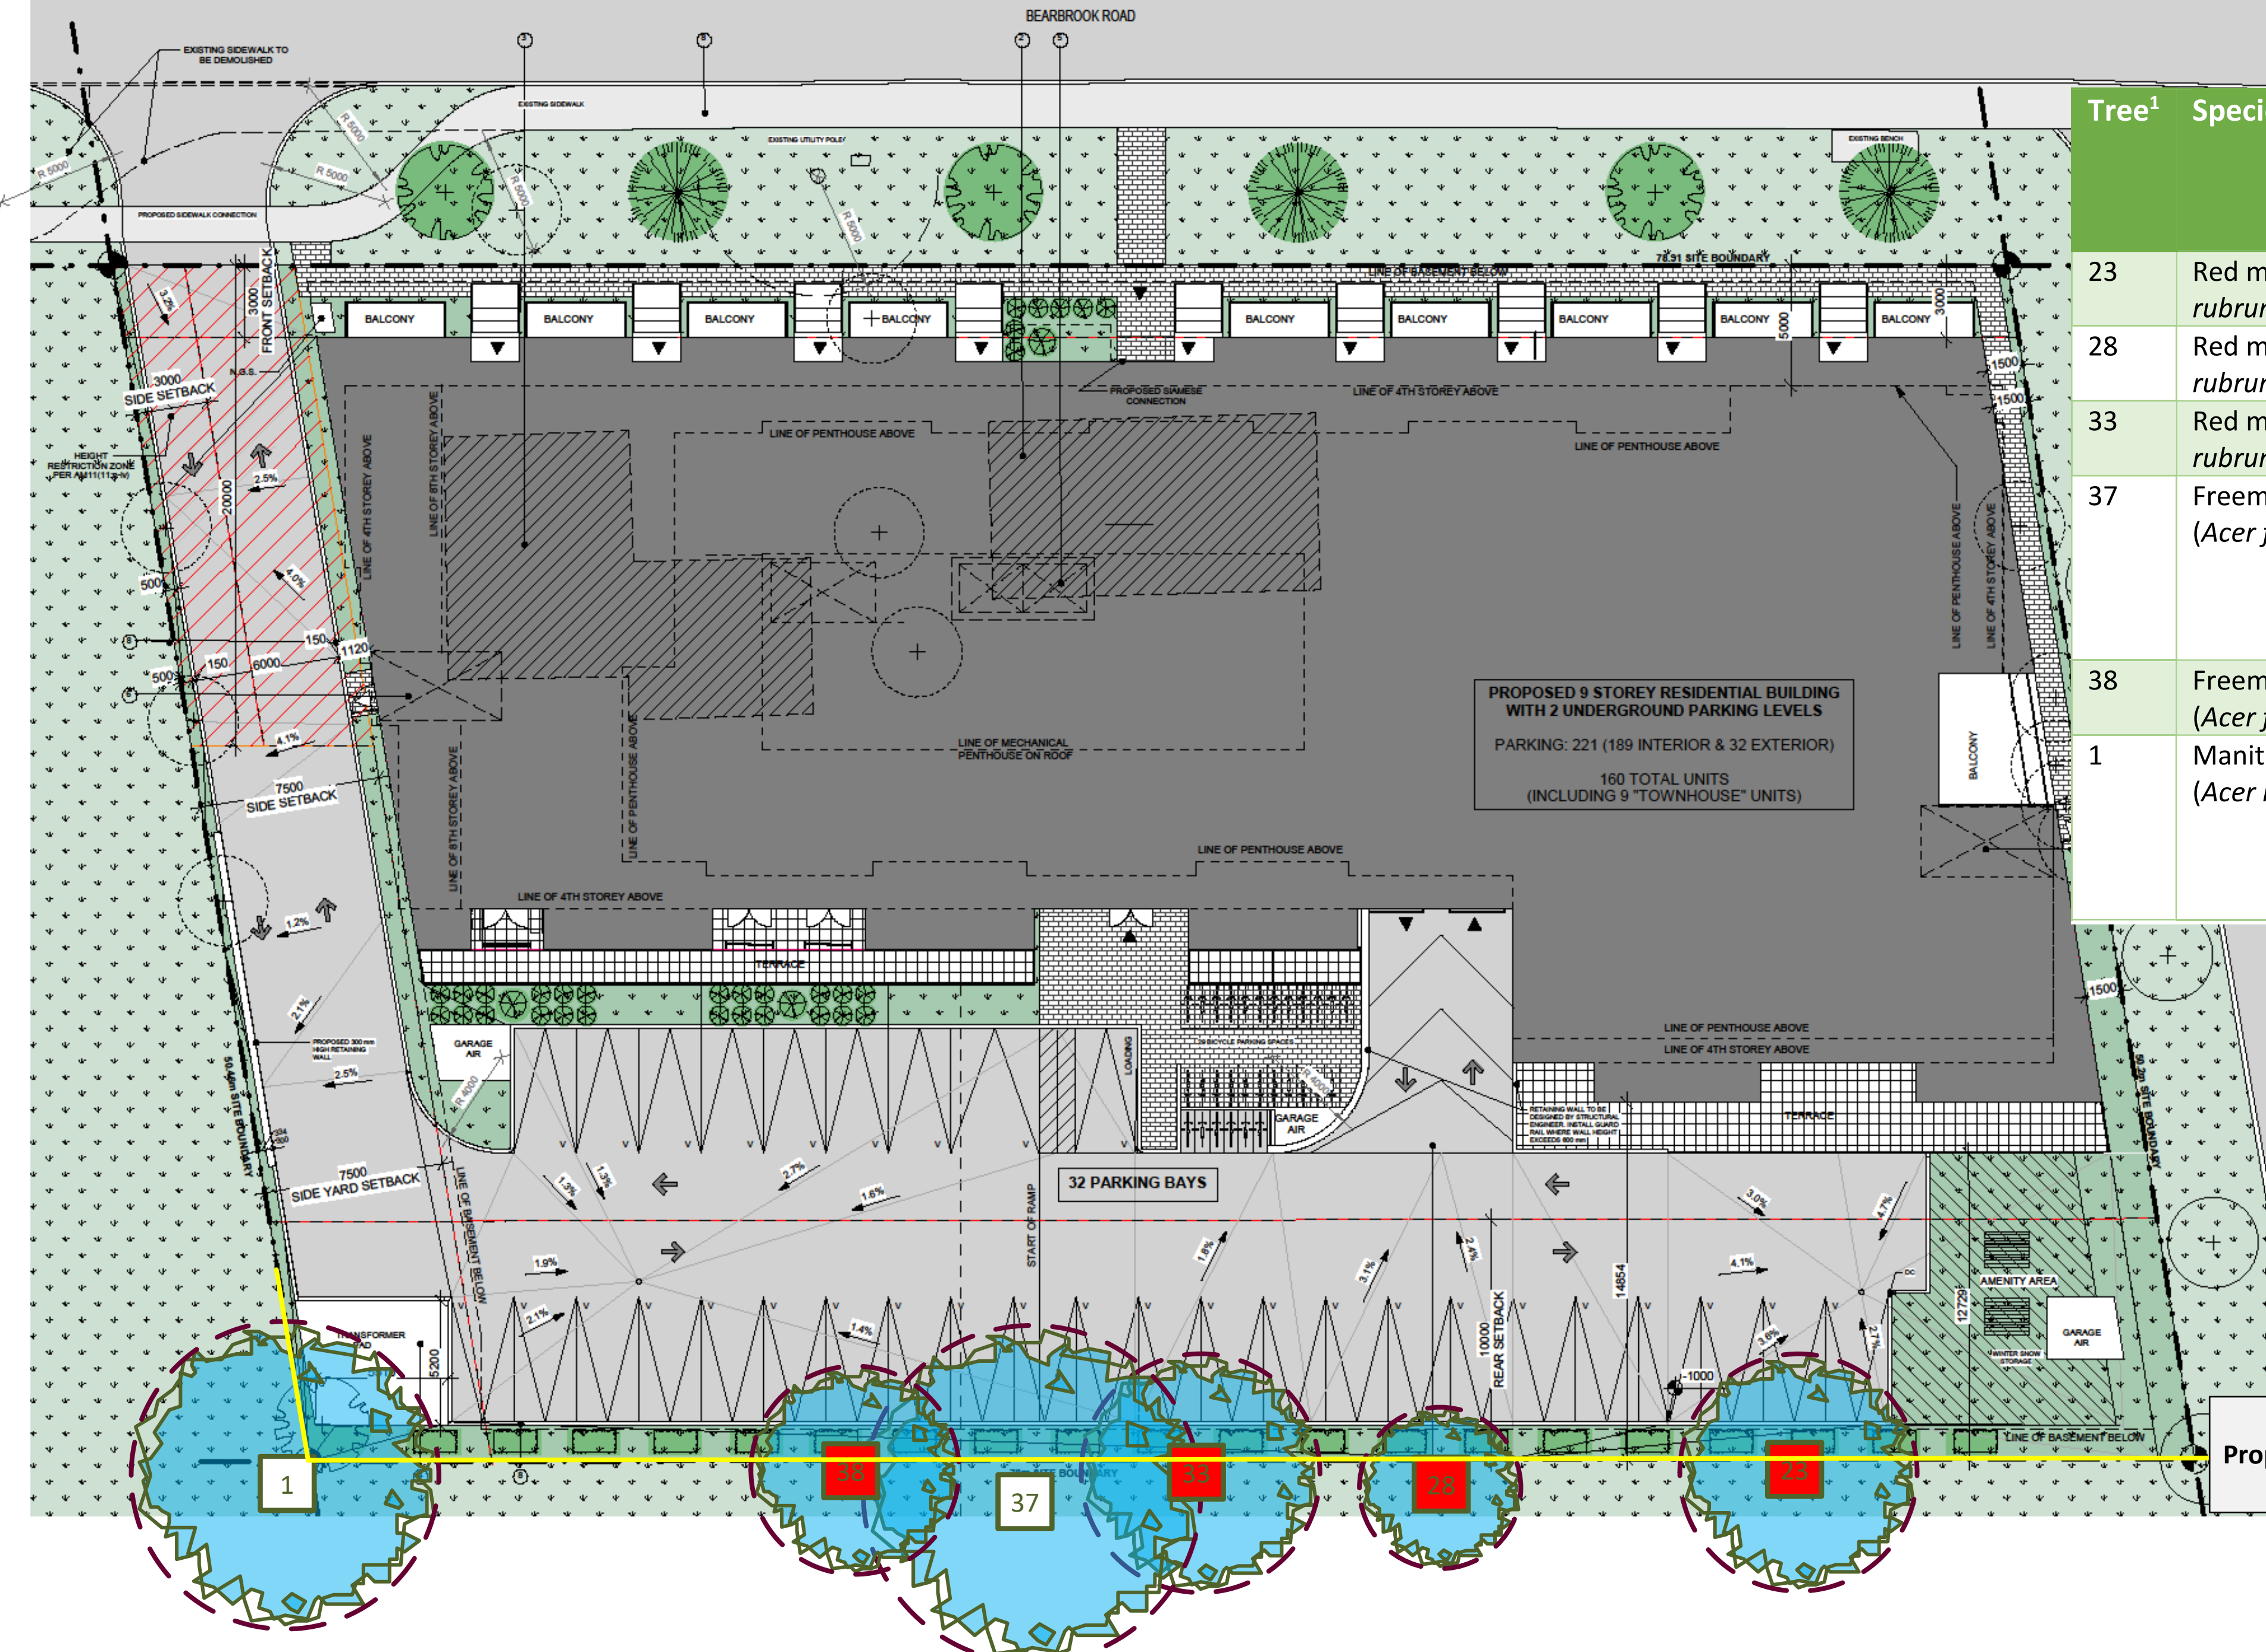
Tree ¹	Species	Diameter at breast height (dbh)	Condition	Action
23	Red maple (<i>Acer rubrum</i>)	37, 28	Fair/Good	Remove
28	Red maple (<i>Acer rubrum</i>)	31	Fair	Remove
33	Red maple (<i>Acer rubrum</i>)	46	Good	Remove
37	Freeman maple (<i>Acer freemanii</i>)	49, 43	Fair/Good	Certified arborist to uncover roots with air spade and sever roots by hand. Arborist to make determination about stability at that time.
38	Freeman maple (<i>Acer freemanii</i>)	40	Good	Remove
1	Manitoba maple (<i>Acer negundo</i>)	59	Fair	Certified arborist to uncover roots with air spade and sever roots by hand. Arborist to make determination about stability at that time.
